# **EX-USS TORTUGA (LSD 26) SALVAGE REPORT**

**14 SEPTEMBER 1989**

**SUPERVISOR OF SALVAGE  
U.S. NAVY**

The June - August 1989 removal and scuttling of the ex-USS TORTUGA (LSD 26) from San Miguel Island was a unique off-shore salvage operation for several reasons: the entire hull was fully flooded and open to the sea; complex salvage computer programming was utilized on-scene for the first time; and the effect of on-board hazardous substances at times dictated the salvors' actions.

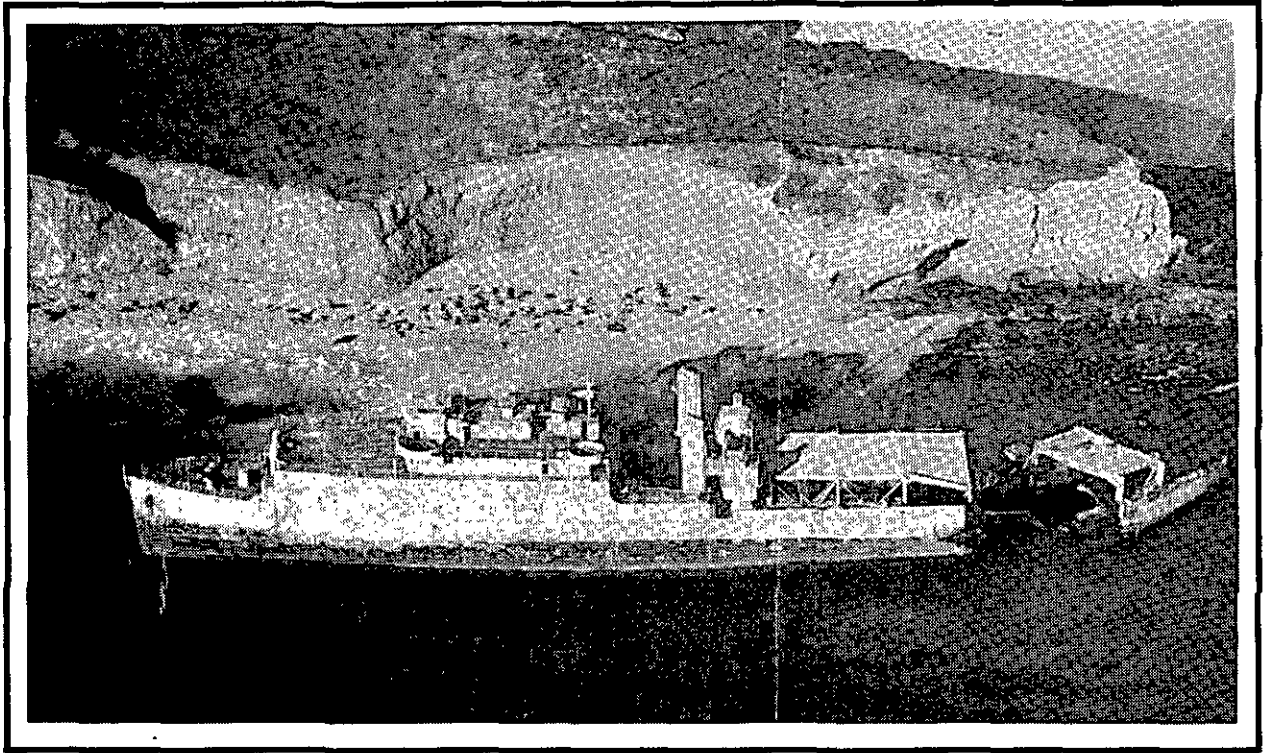
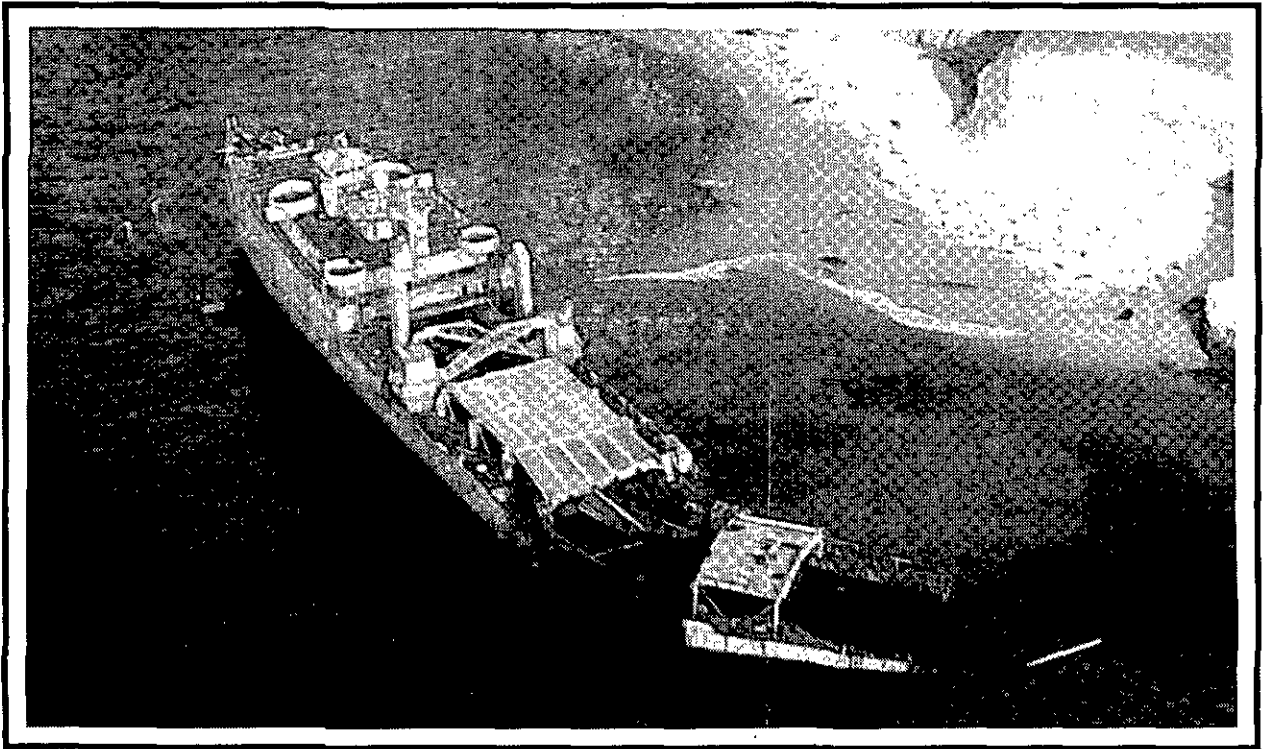
FIGURE 5-1. Two Views of TORTUGA as Originally Stranded on San Miguel Island.

**Actual Condition of TORTUGA.** At the conclusion of the survey, it was believed that TORTUGA was impaled in several places on a jagged rock bottom; however, once the operation got underway, the vessel was discovered to be significantly impaled only by one large boulder in the starboard auxiliary machinery room, and was otherwise resting on a sand-covered rock ledge. The numerous holes in the bottom shell plating may have been caused for the most part by this single boulder. Survey results had also suggested that the hull plating was cracked extensively around Frame 41, but no evidence of actual hull cracking that would have threatened the structural integrity of the hull girder was found during the removal effort; i.e., all hull damage was local in nature. Figures 5-1 through 5-5 show actual conditions of the stranded TORTUGA.

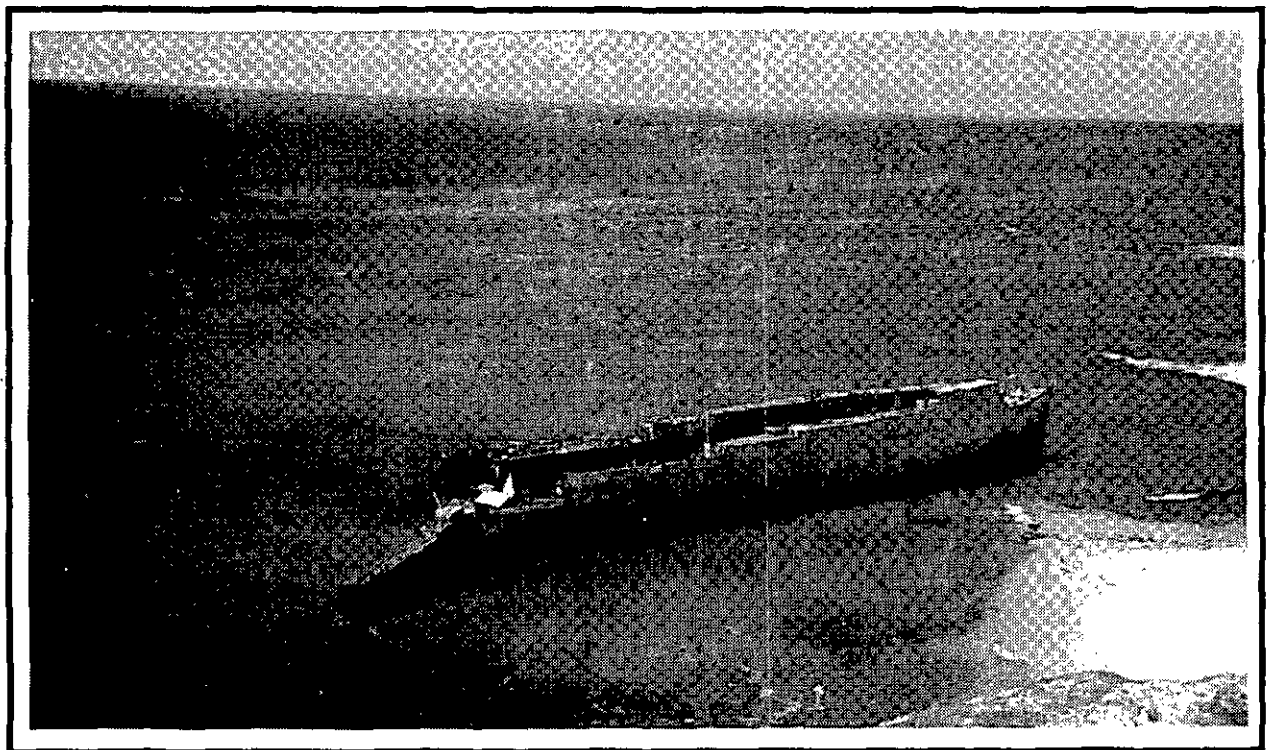
**FIGURE 5-13. Top Side Weight Partially Removed.**

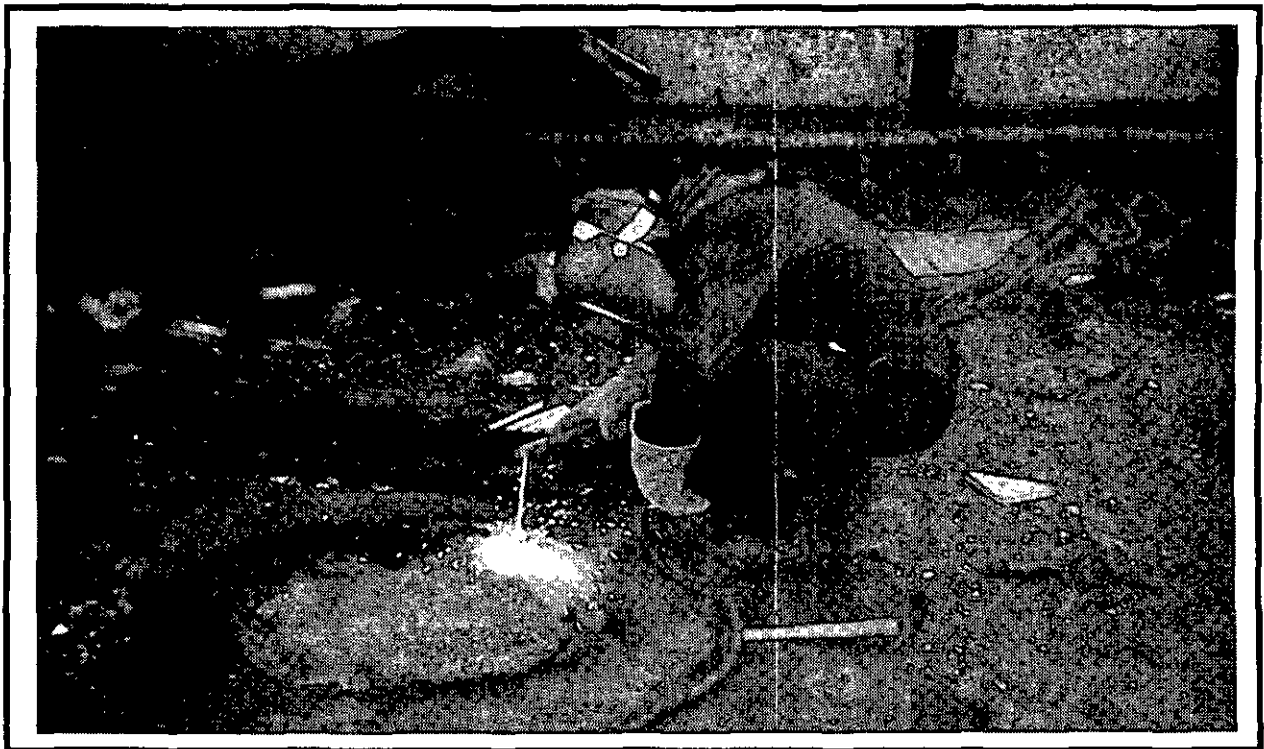
**FIGURE 5-17. Welding Close Tank Tops.**

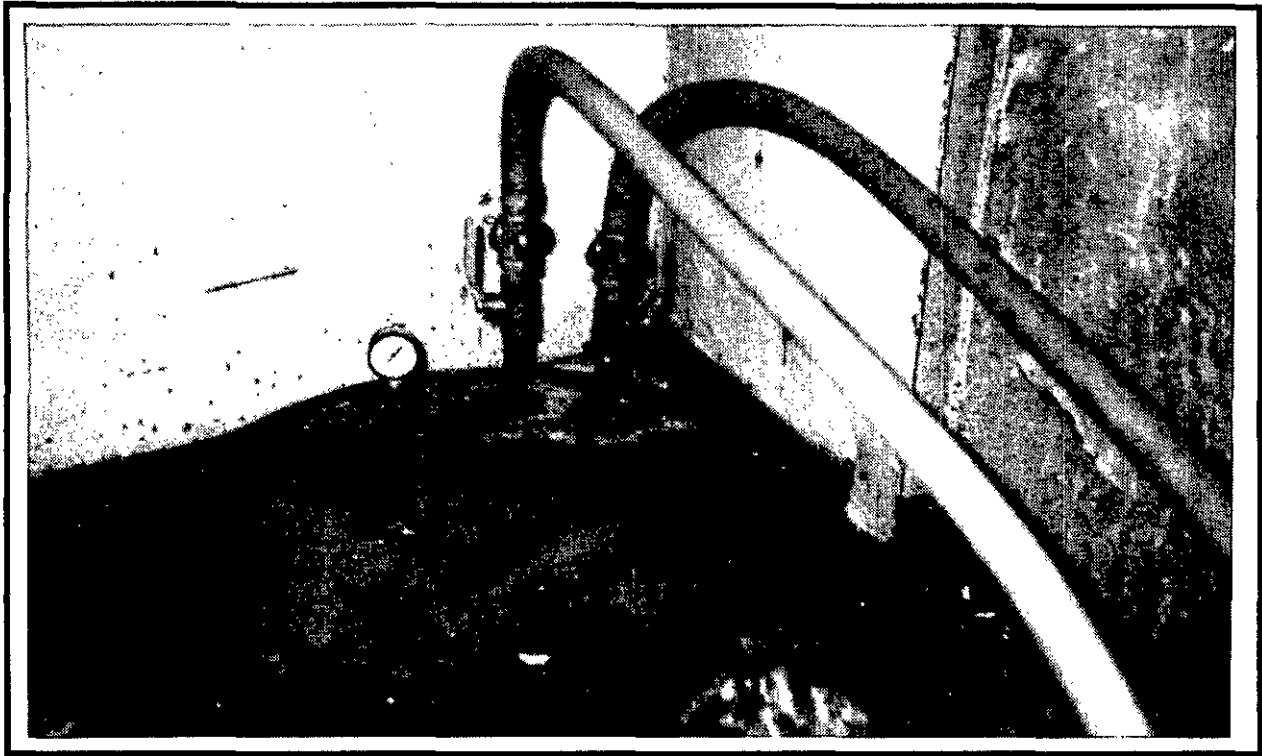
**FIGURE 5-18. Tank Top Sealed with Hose Connections to the Manifold.**

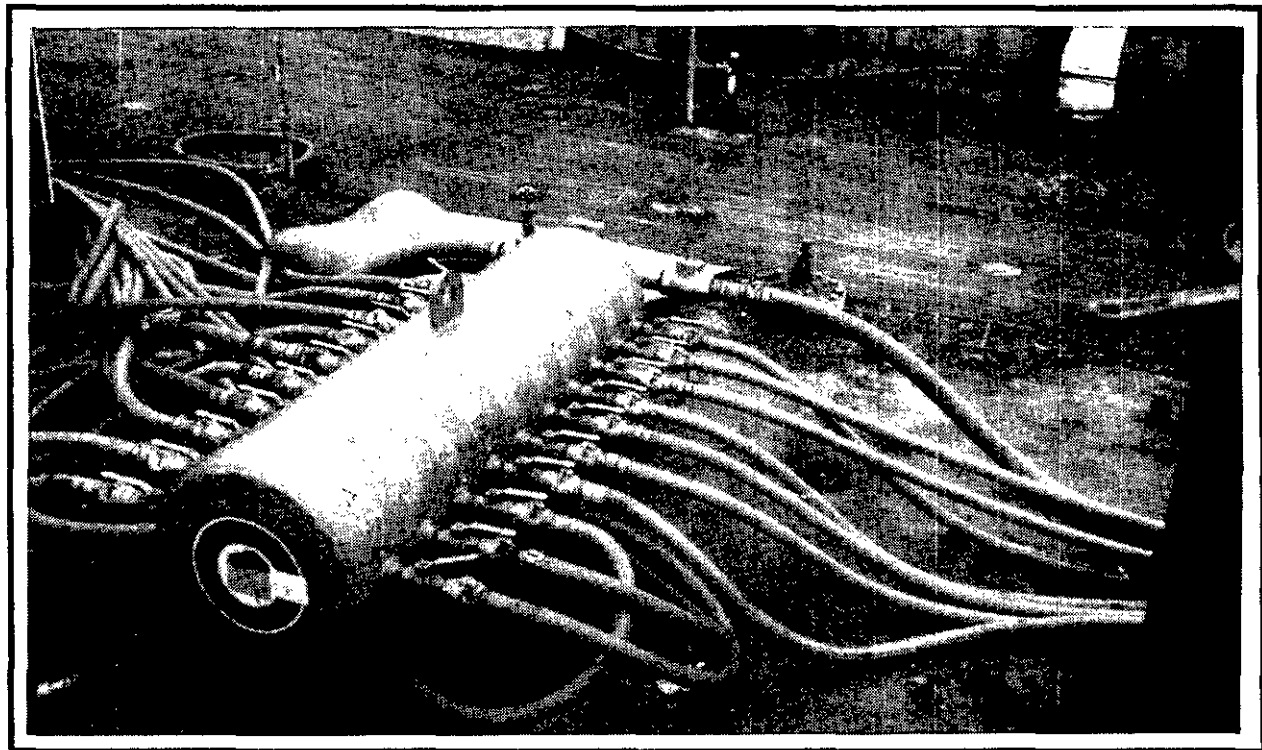
**FIGURE 5-19. Primary Manifold to all Tank Tops.**

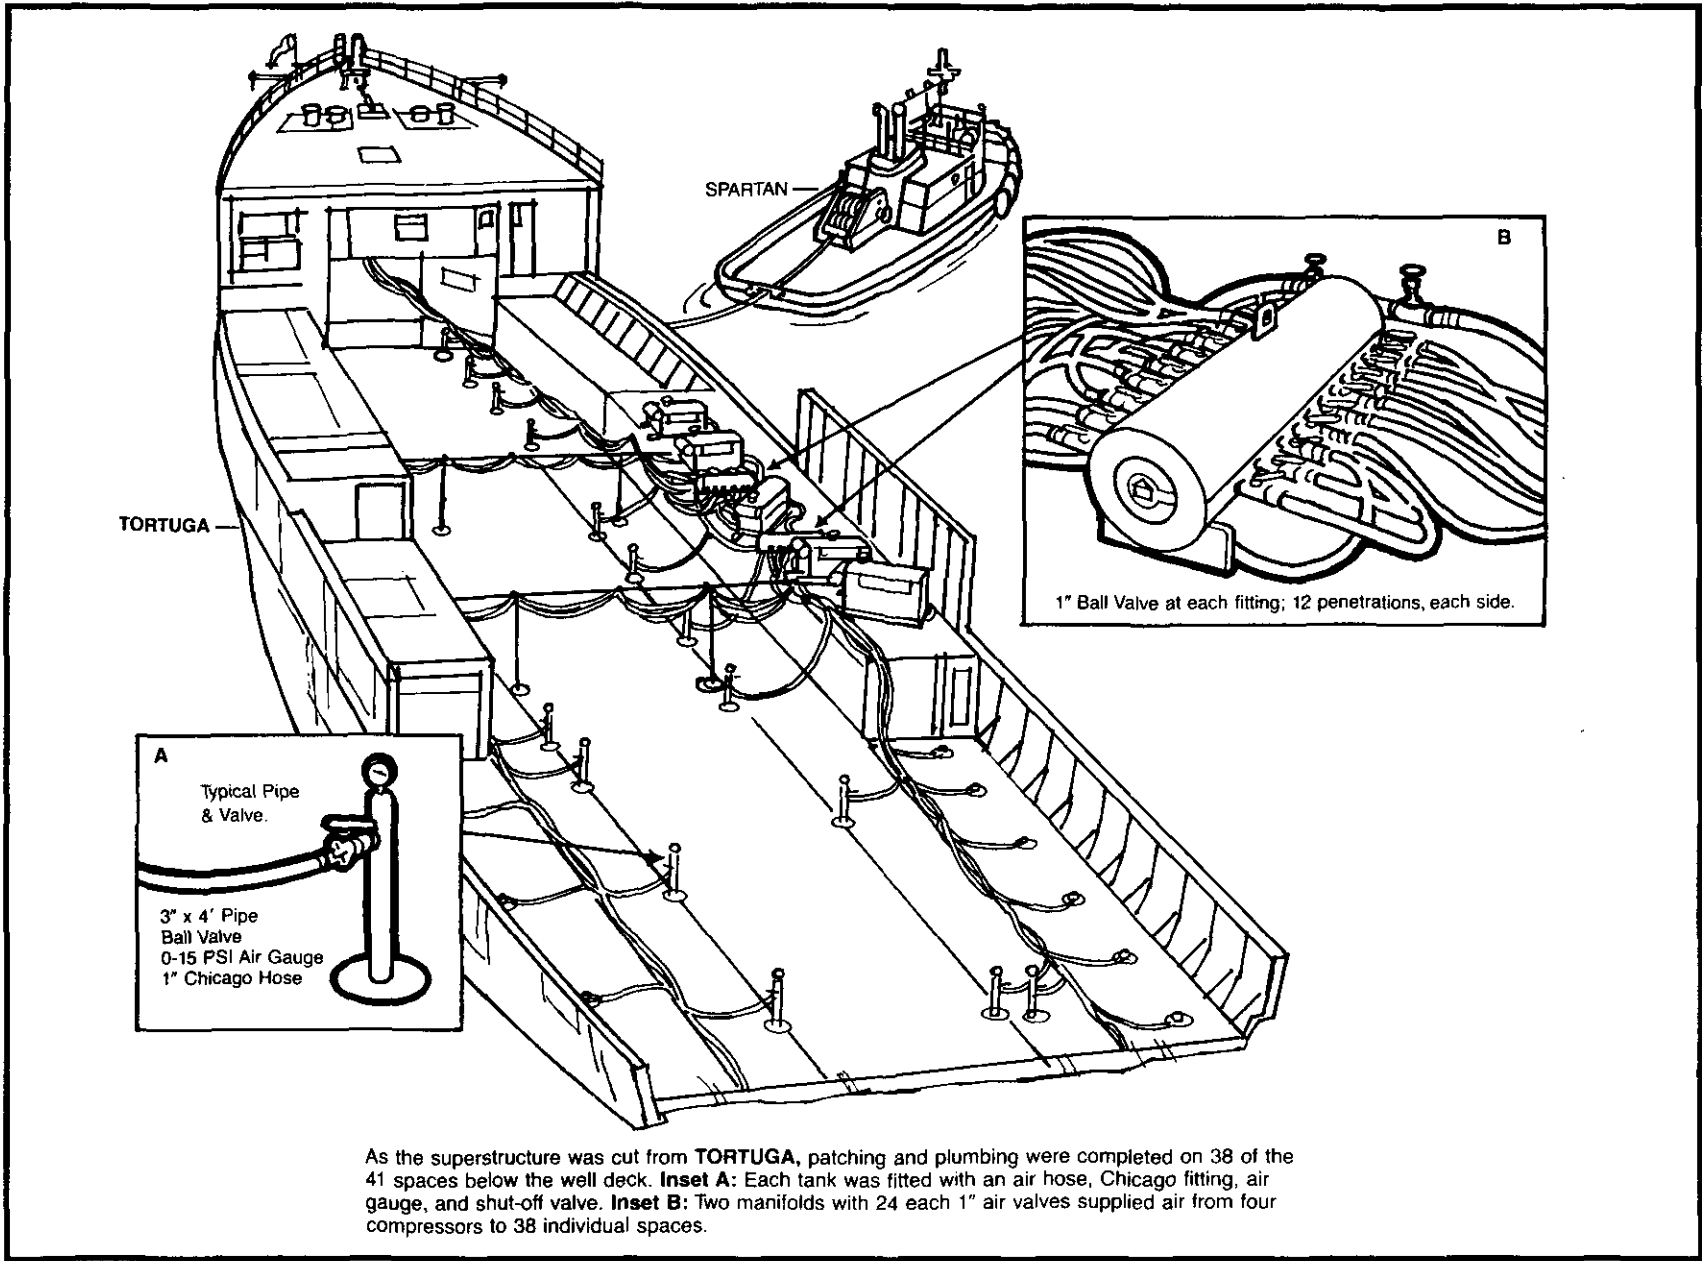
FIGURE 5-20. Plumbing of Spaces Below the Well Deck.

checked for further leaks and timed to determine how long it would hold air. Any leaks or fractures found were then patched or welded. Finally, all of the 38 plumbed spaces were pressurized and checked for their ability to maintain an air bubble.
