Description of document:	US Navy Salvage Report: Suez Canal Salvage Operations in 1974
Requested date:	20-December-2007
Released date:	17-December-2008
Posted date:	05-May-2009
Title of document	Suez Canal Salvage Operations in 1974
Source of document:	Department of the Navy Naval Sea Systems Command NAVSEAFOIA@navy.mil

SUEZ CANAL SALVAGE OPERATIONS IN 1974

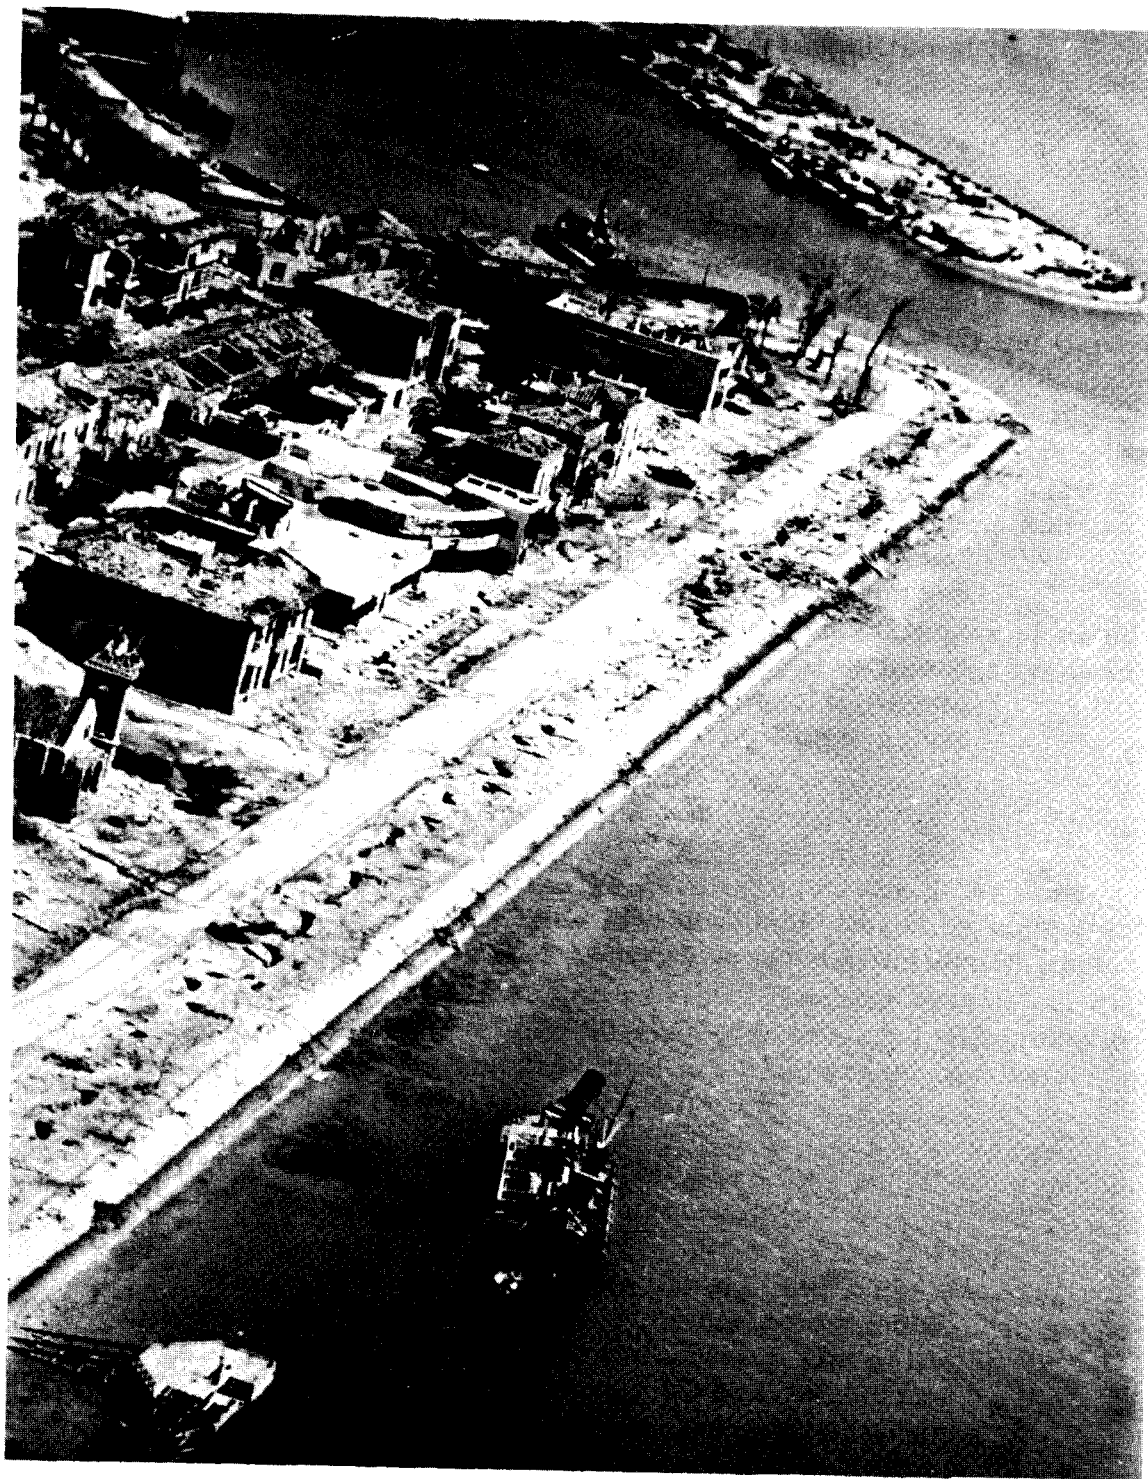
FIGURE III-4
Southern Entrance to Canal Showing
Characteristic Port Taufiq Devastation

and Port Taufiq was devastated during two wars. A section of the city along the Canal bank showing typical damage is presented in Figure III-4. Under these conditions and with limited resources to obtain U. S. standards of messing and berthing, the SCA performed ably. As the operation progressed, additional efforts by Murphy Pacific contributed significantly to the improvement of living conditions.

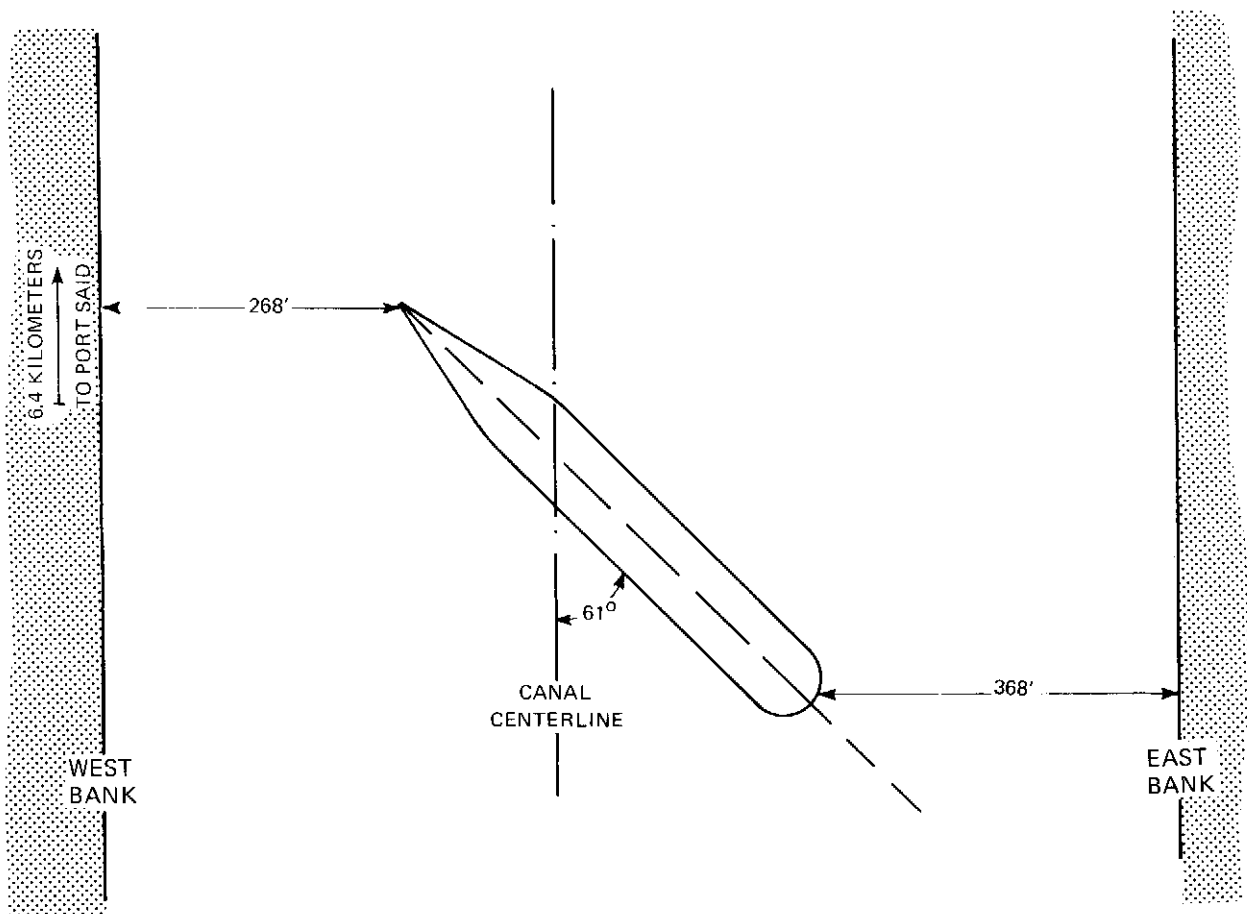
FIGURE IV-1
Location of ISMAILIA in Canal

ISMAILIA, one of the two wrecks located in the Northern Zone of the Canal, was a cargo ship displacing about 1,400 tons. The 1967 SCA survey reported that ISMAILIA was resting on its starboard side; it was, in fact, found upright. The bow of the wreck pointed toward the west bank of the Canal, as shown in Figure IV-1. The depth of water was 52 feet, and there was less than 20 feet of water over the main deck.

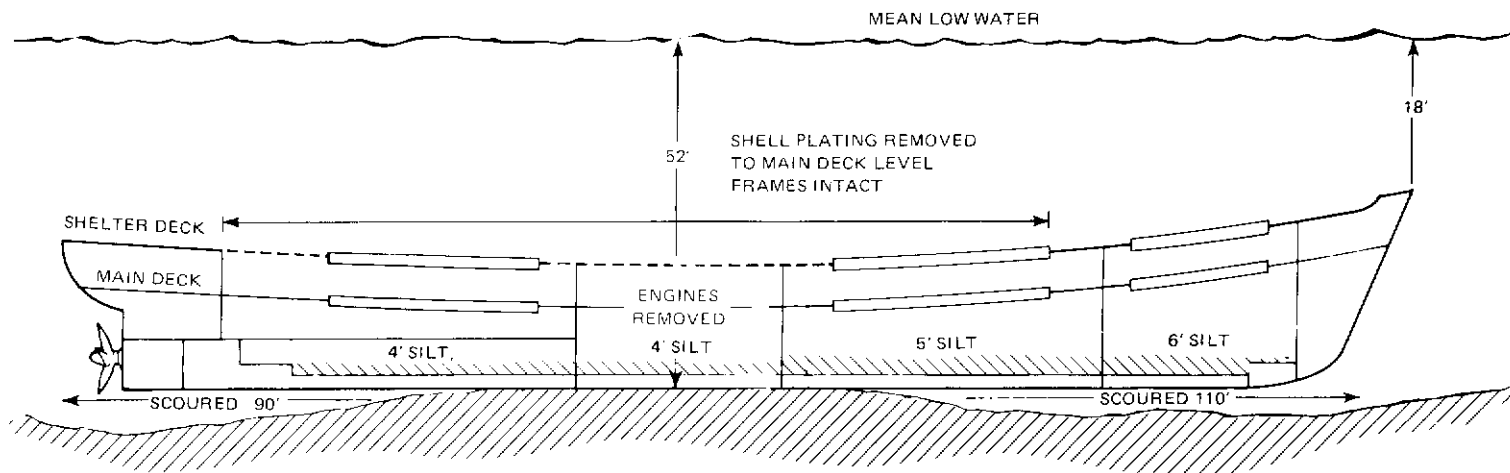
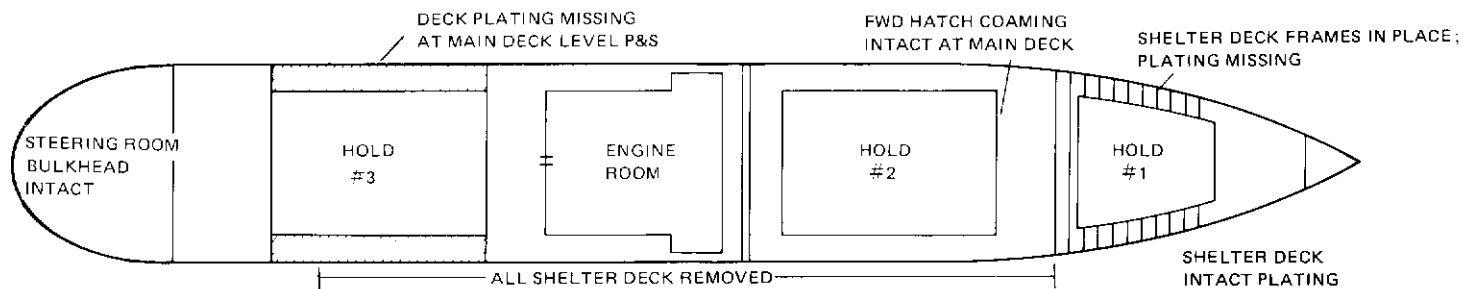
FIGURE IV-2
 Condition of ISMAILIA at Survey

There was considerable silting within the wreck. The silt, estimated to have a total weight of 2,257 tons, was

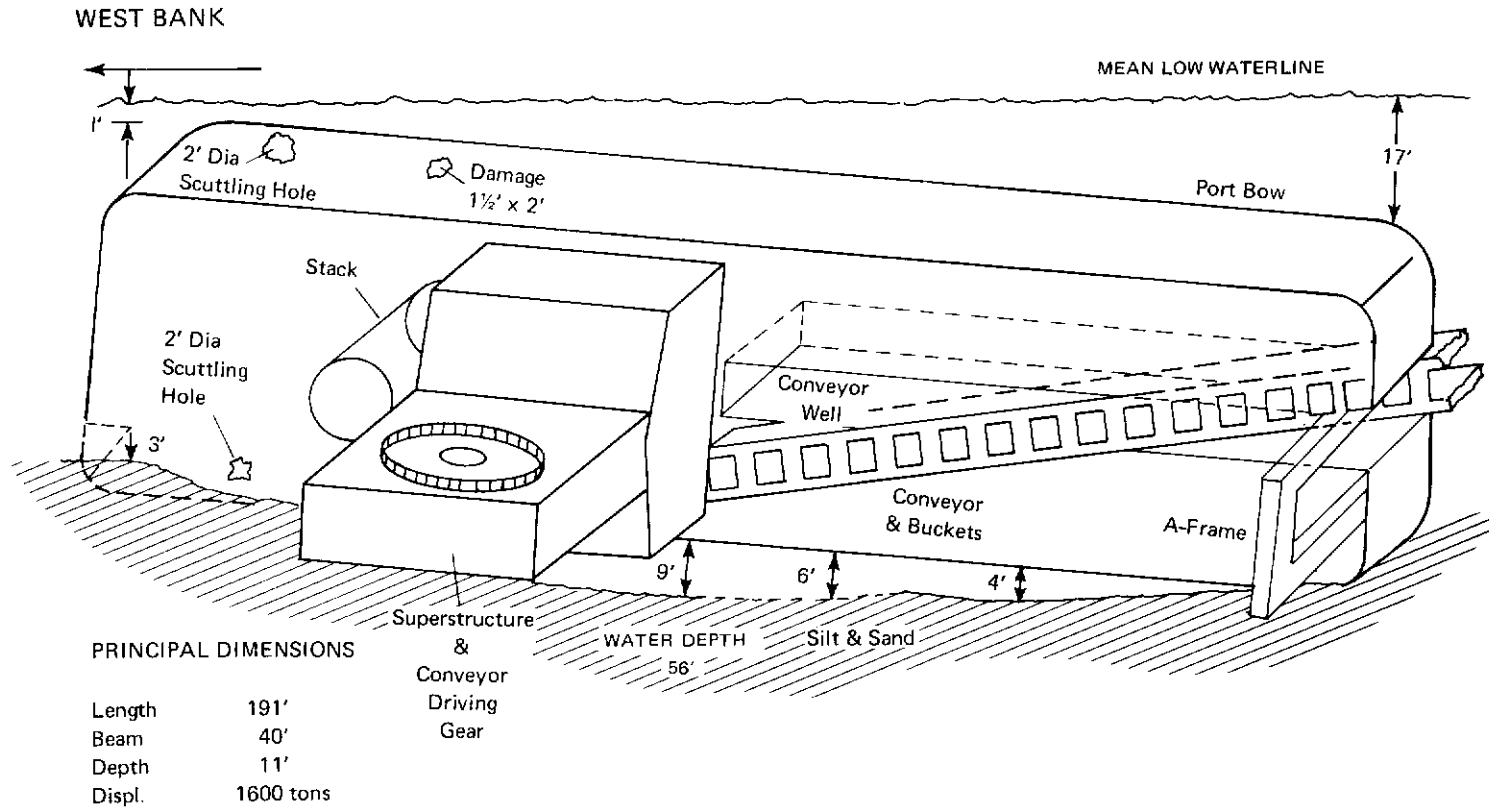
FIGURE IV-5
Condition of DREDGE 23 at Survey

The hull of the dredge had deteriorated. The wooden shelter deck above the main deck had been carried away, leaving only a few pipe stanchions for roof support. The dredge buckets were still attached to the ladder but had slipped off their tracks. The boom protruded about 15 feet beyond the bow, hanging 8 feet below the hull but clear of the bottom. The hull was supported at the ends and the Canal bottom had scoured to a maximum depth of about 9 feet in the center one-third. The dredge was silted in the machinery spaces to a maximum depth of approximately 2 feet. Figures IV-5 and IV-6 illustrate the condition of DREDGE 23 at survey.

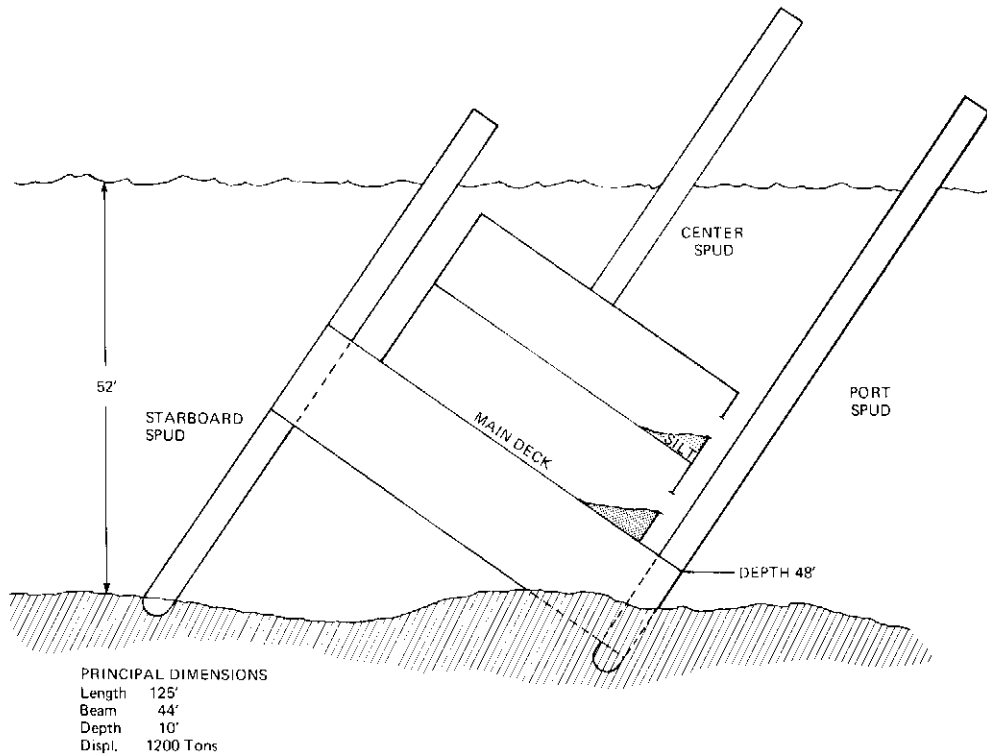
FIGURE IV-10
Condition of Dredge KASSER,
at Survey, Front View

The survey determined that the wreck could be side-lifted by two lift craft. Passing of lift wires would not be difficult. Stern lifting was not feasible as the deadweight of the wreck, including the silt deposits, exceeded the combined stern-lift capacity of the two lift craft.

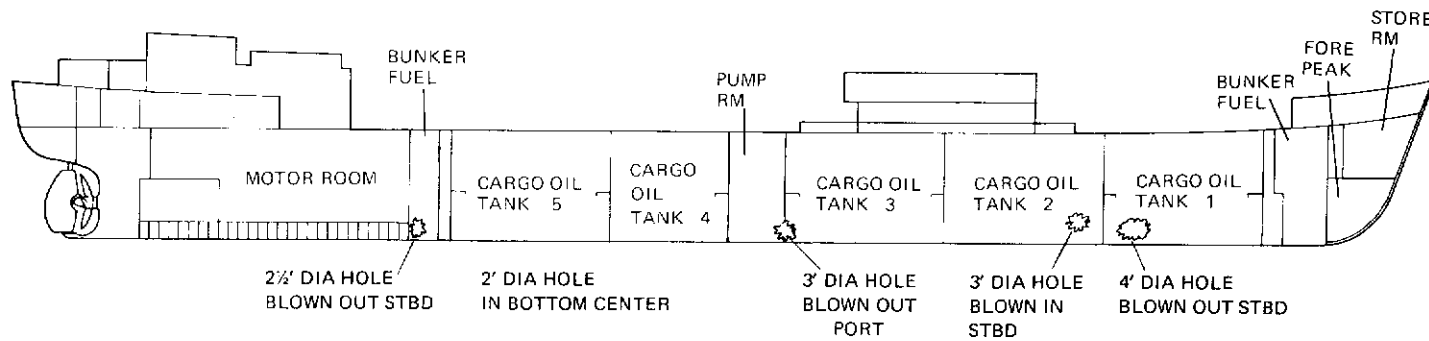
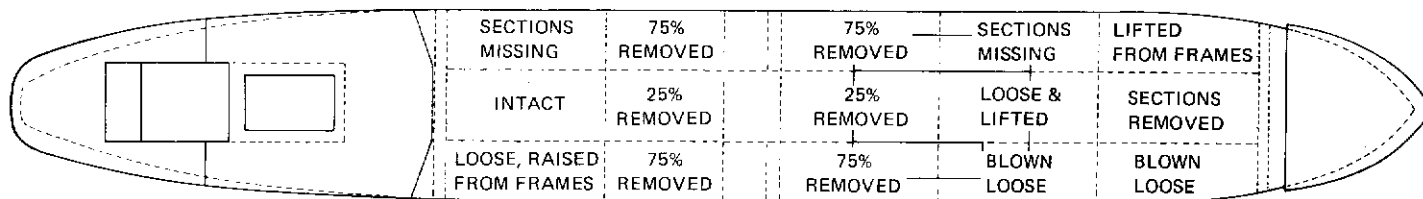
FIGURE IV-17
 Condition of Tanker MAGD at Survey

Space	Damage	Location	Upper Deck Plate
<u>Tank No. 1</u> Port Center Starboard	4' scuttle hole	Above turn of bilge	Sections removed Lifted from deck frames Blown loose
<u>Tank No. 2</u> Port Center Starboard	2' scuttle hole 1' x 2' scuttle hole 1' x 2' scuttle hole 3' hole blown in	Bottom Bottom next to No. 3 port Bottom next to No. 3 center 10' turn of bilge	Sections missing Loose and lifted Blown loose
<u>Tank No. 3</u> Port Center Starboard Starboard	1' x 2' scuttle hole 1' x 2' scuttle hole 3' scuttle hole 18" scuttle hole	Bottom next to No. 2 port Bottom next to No. 2 center Aft bulkhead at bilge turn Bottom	75% removed 25% removed 75% removed
<u>Tank No. 4</u> Port Center Starboard	14" diam. pipe hole	Bottom	75% removed 25% removed 75% removed
<u>Tank No. 5</u> Port Starboard	2' scuttle hole	Bottom	Sections missing Appeared intact Loose and raised from deck frames
Aft starboard Cross bunker Engine room Forward cross Bunker Forecastle	2-1/2' scuttle hole	Bilge turn	Intact Gaps in plates

HULL DAMAGE

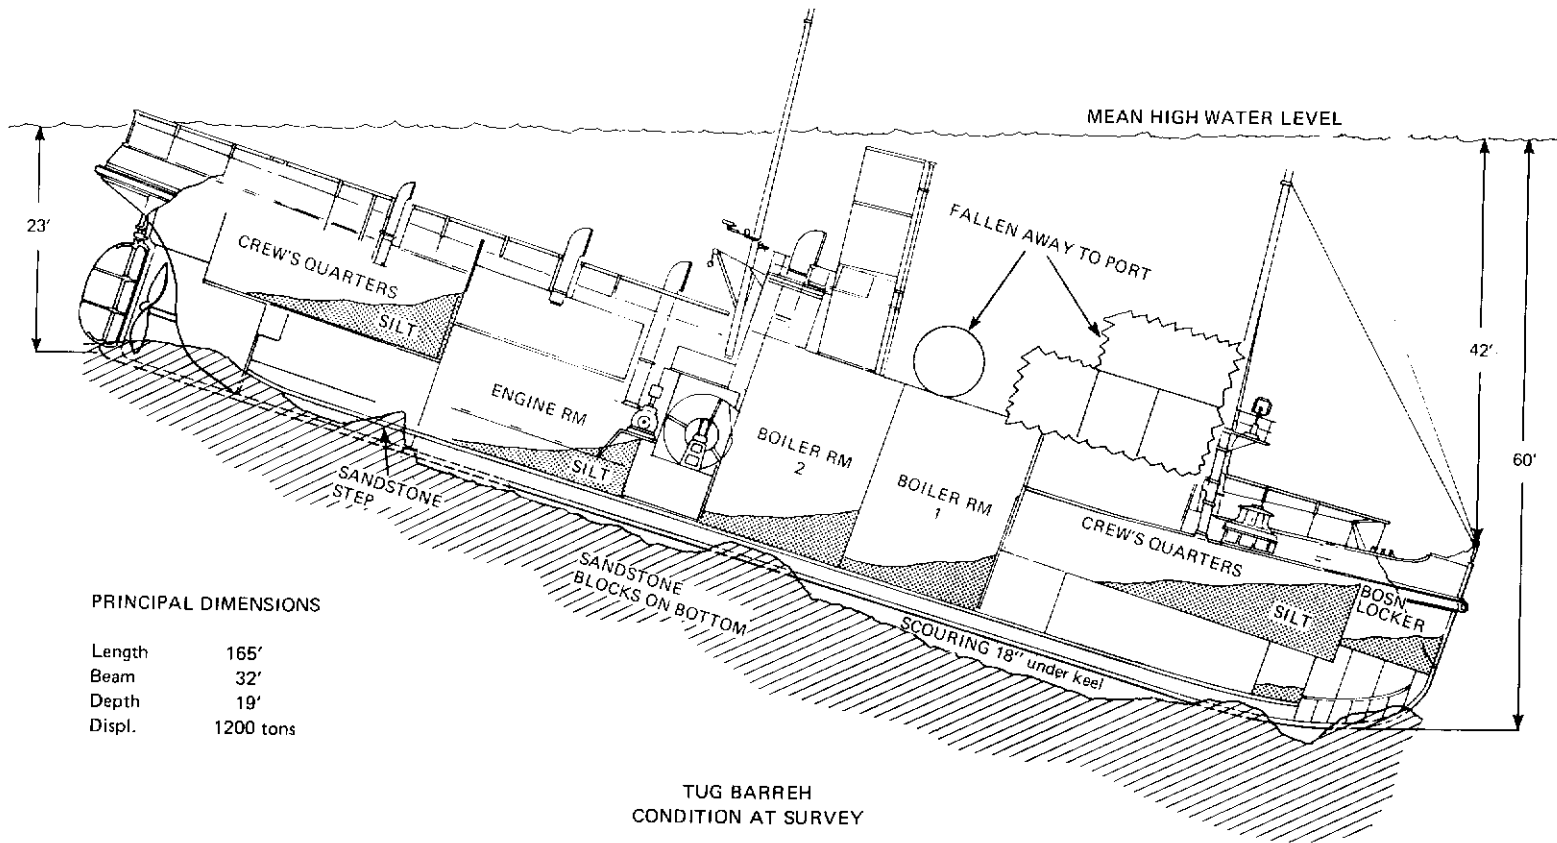
FIGURE IV-20
Condition of Tug BARREH at Survey

BARREH	10-degree port list	Hull sound; stack and superstructure gone; eight portholes broken, open, or missing	Supported generally on hard sandstone bottom, except bow on soft sand	Silt to 4 feet in engine room, 3 feet in boat-swain locker and compartment aft of engine room; also in boiler rooms and crew's quarters	Lift

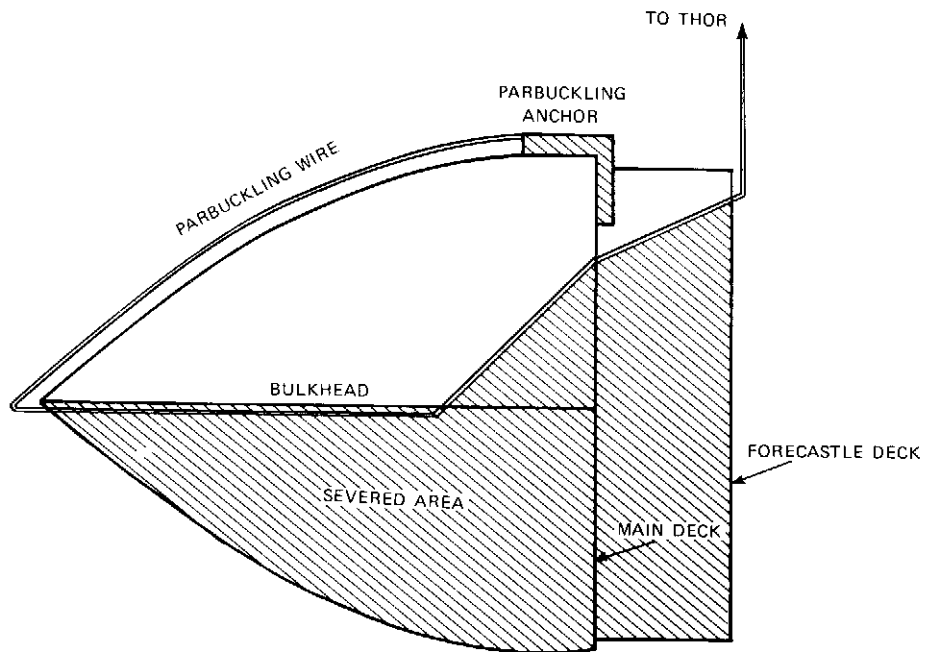
FIGURE VII-17
Damage to MAGD Bow Section During First
Parbuckling Attempt

Early in the morning of 18 November, parbuckling commenced. ROLAND, exerting a force of 80 to 120 tons, appeared to be pulling the wire through the hull. After rotating the bow 20 degrees, the parbuckling effort was suspended until the situation could be assessed. After inspecting the section, divers reported that the forward parbuckling wire on the wreck from THOR had been improperly placed in a weak area away from its prescribed position. The wire was actually bearing against the forecastle deck and had cut this deck completely and all but 10 feet of the main deck. The longitudinal bulkhead dividing the forward ballast tanks was ripped 15 feet down from the main deck and the side was cut down to the heavy strength members near the keel. The cut down the side crossed the transverse bulkhead. This bulkhead, the side plating, and stiffeners provided sufficient strength to hold the section together. A sketch of the damage is shown in Figure VII-17.
