Description of document:	US Navy Salvage Report: USCGC Mesquite Salvage Operation Dec 89 - July 90, 19 July 1991
Requested date:	20-December-2007
Released date:	17-December-2008
Posted date:	05-May-2009
Title of document	SL740-AC-RPT-010/SUPSALV, 0910-LP-488-0600, USCGC Mesquite Salvage Operation Dec. '89 – July '90 Keweenaw Peninsula, Michigan
Source of document:	Department of the Navy Naval Sea Systems Command NAVSEAFOIA@navy.mil

USCGC MESQUITE SALVAGE OPERATION DEC. '89 - JULY '90 KEWEENAW PENINSULA, MICHIGAN

19 JULY 1991

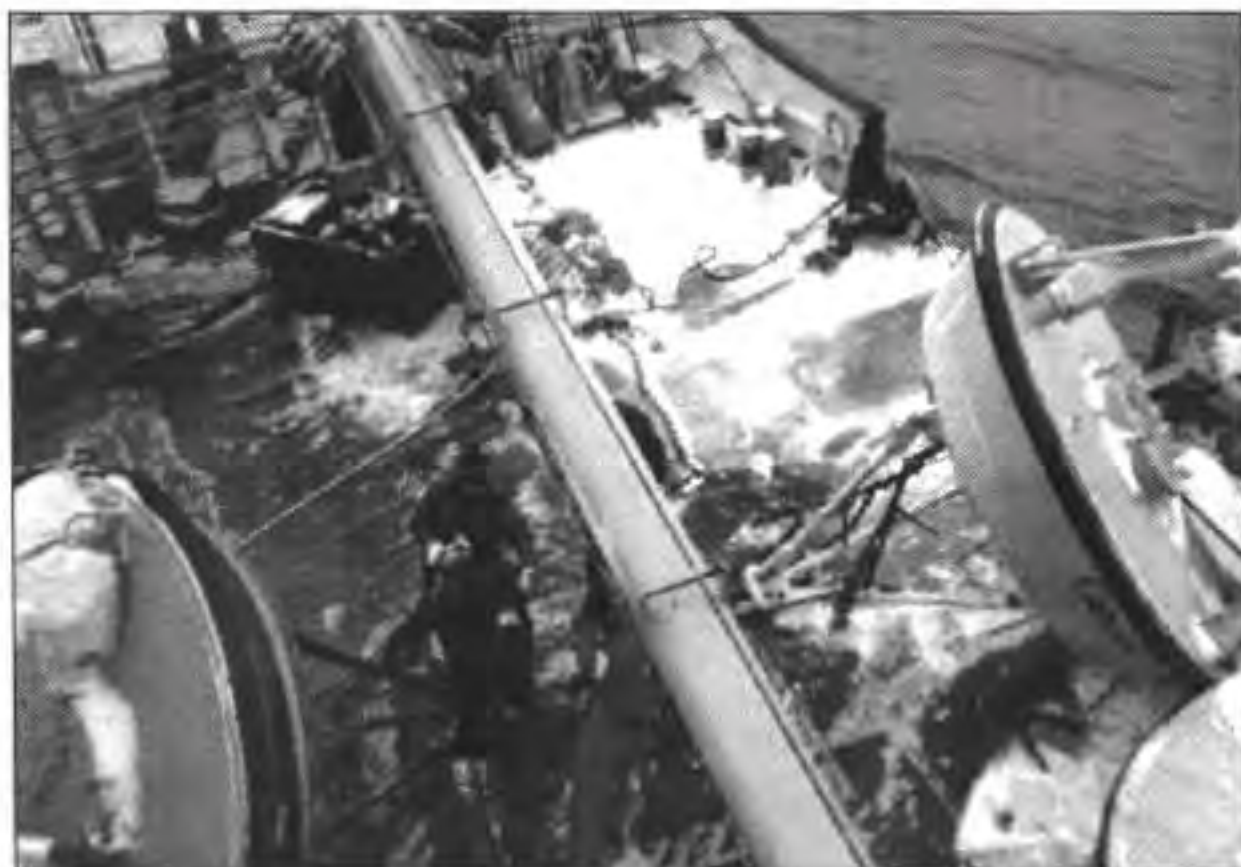
Figure 2-1. Slippery Deck Conditions on MESQUITE.

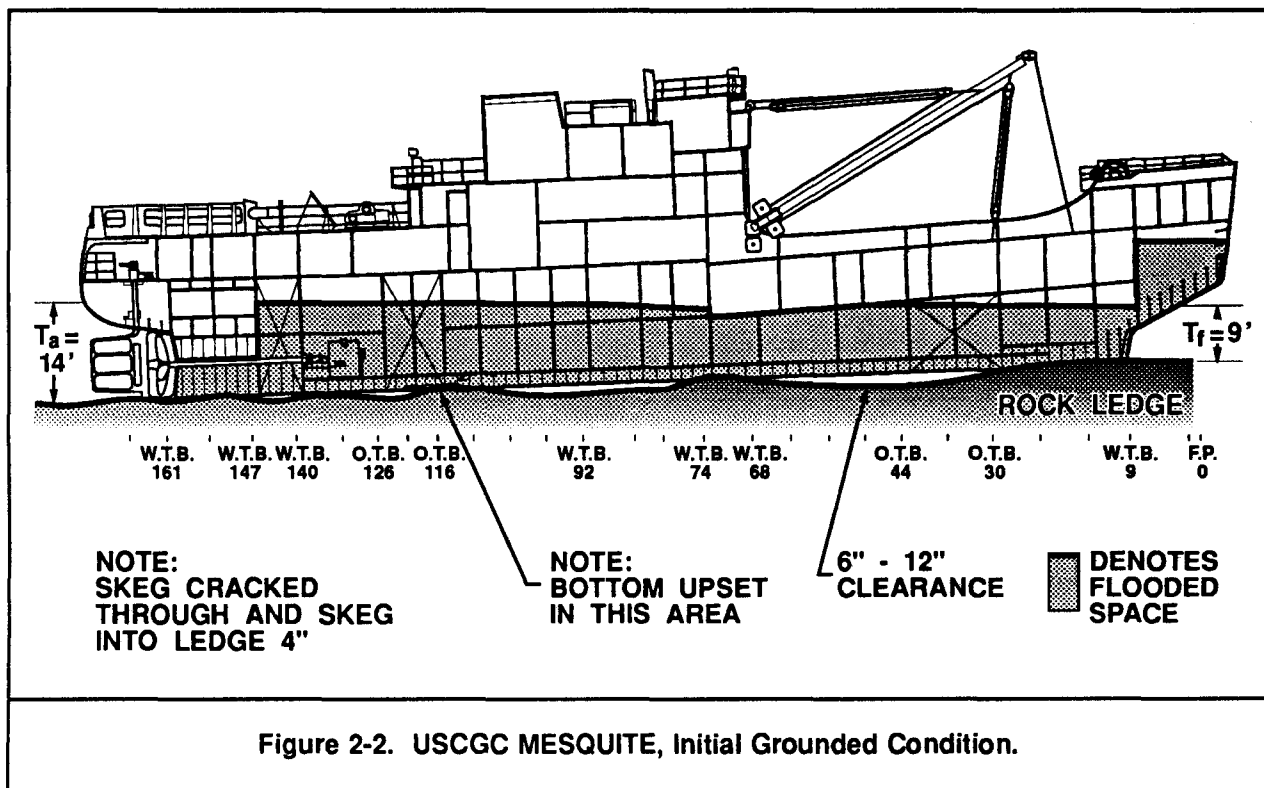
The ship was supported intermittently along its length, with about 25 percent of the keel in contact with the bottom. The longest bearing areas were at the stem, skeg, starboard-side Frame 116, and the port side from Frames 44 to 62. There were many locations where the vessel did not bear on the rock ledge, but in several areas there was not enough clearance between the keel and the bottom for divers to see the keel or A-strake. Damage to the hull consisted of upset hull plating along the ship's length, primarily along the keel and 8 to 10 feet outboard of the centerline, to port and starboard. There was significant upsetting in way of the main cargo hold and the engineering store room; the latter was holed. Three large cracks began in the engine room at Frame 115 and extended aft into the centerline fuel tank, B-2-F.

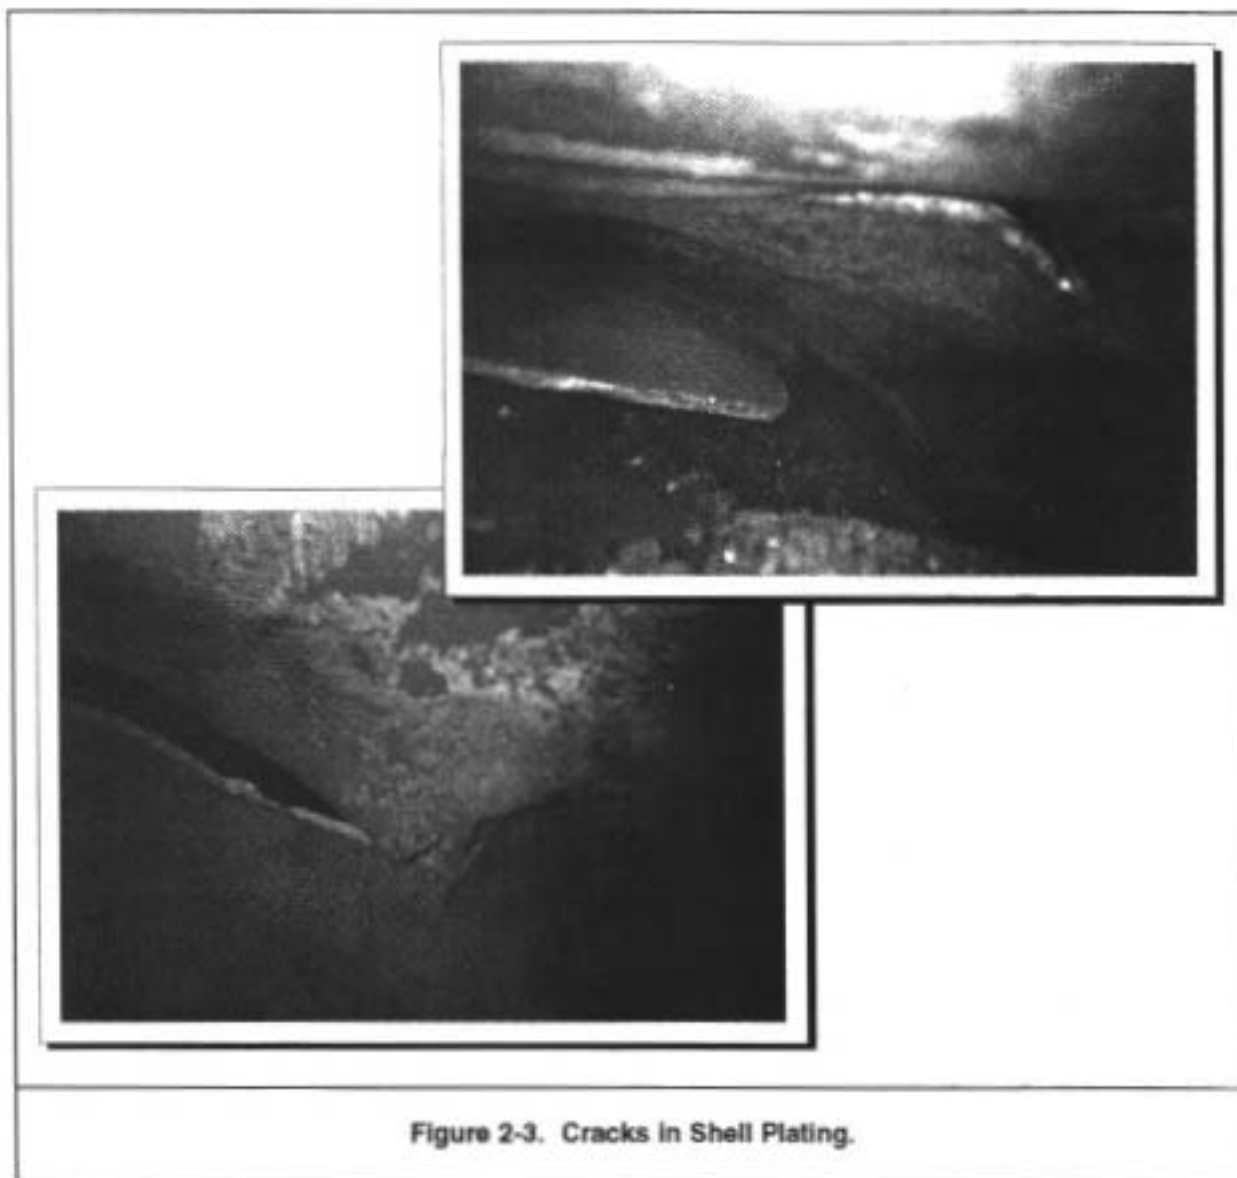
Figure 2-3. Cracks in Shell Plating.

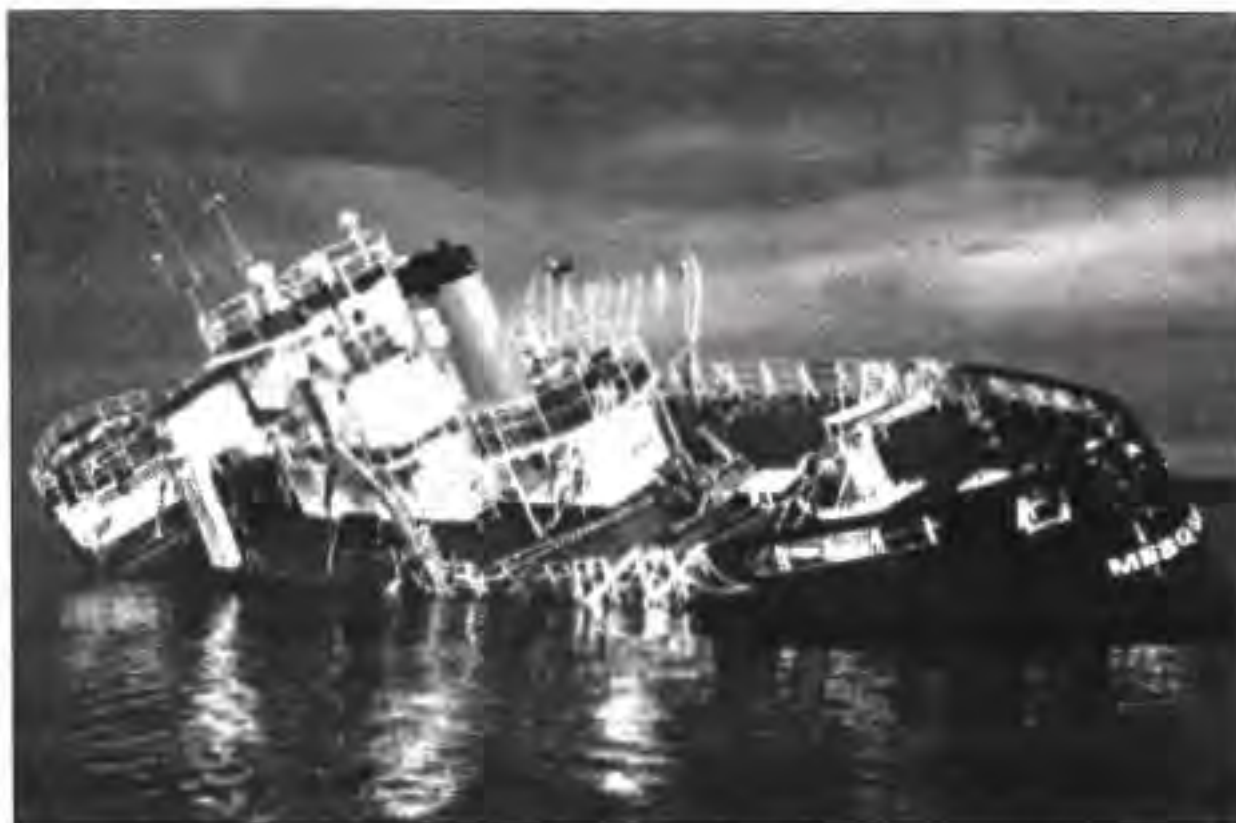
Figure 3-1. Condition of USCGC MESQUITE During the Resurvey on 22 May 1990.

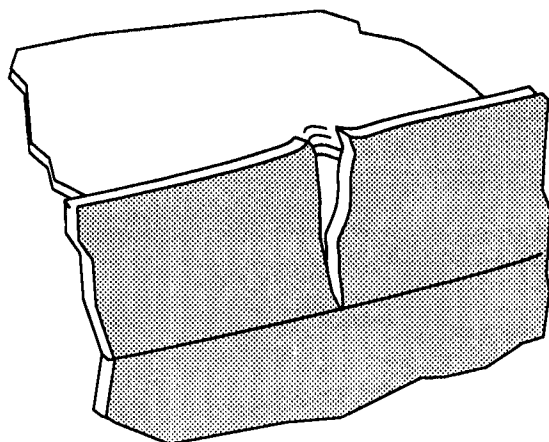
**CRACK LEFT IN DECK
EDGE AFTER REMOVAL
OF PARBUCKLING WIRES**

**PLATE OF 1" STEEL IS CUT
AND FITTED BEHIND SHEER
STRAKE AND WELDED TO
STRAKE - CRACK WAS FILLED**
