USS FRANK KNOX (DDR-742) STRANDING SALVAGE

NAVSHIPS 0994-002-6010

DEPARTMENT OF THE NAVY
NAVAL SHIP SYSTEMS COMMAND
WASHINGTON, D.C.

1968

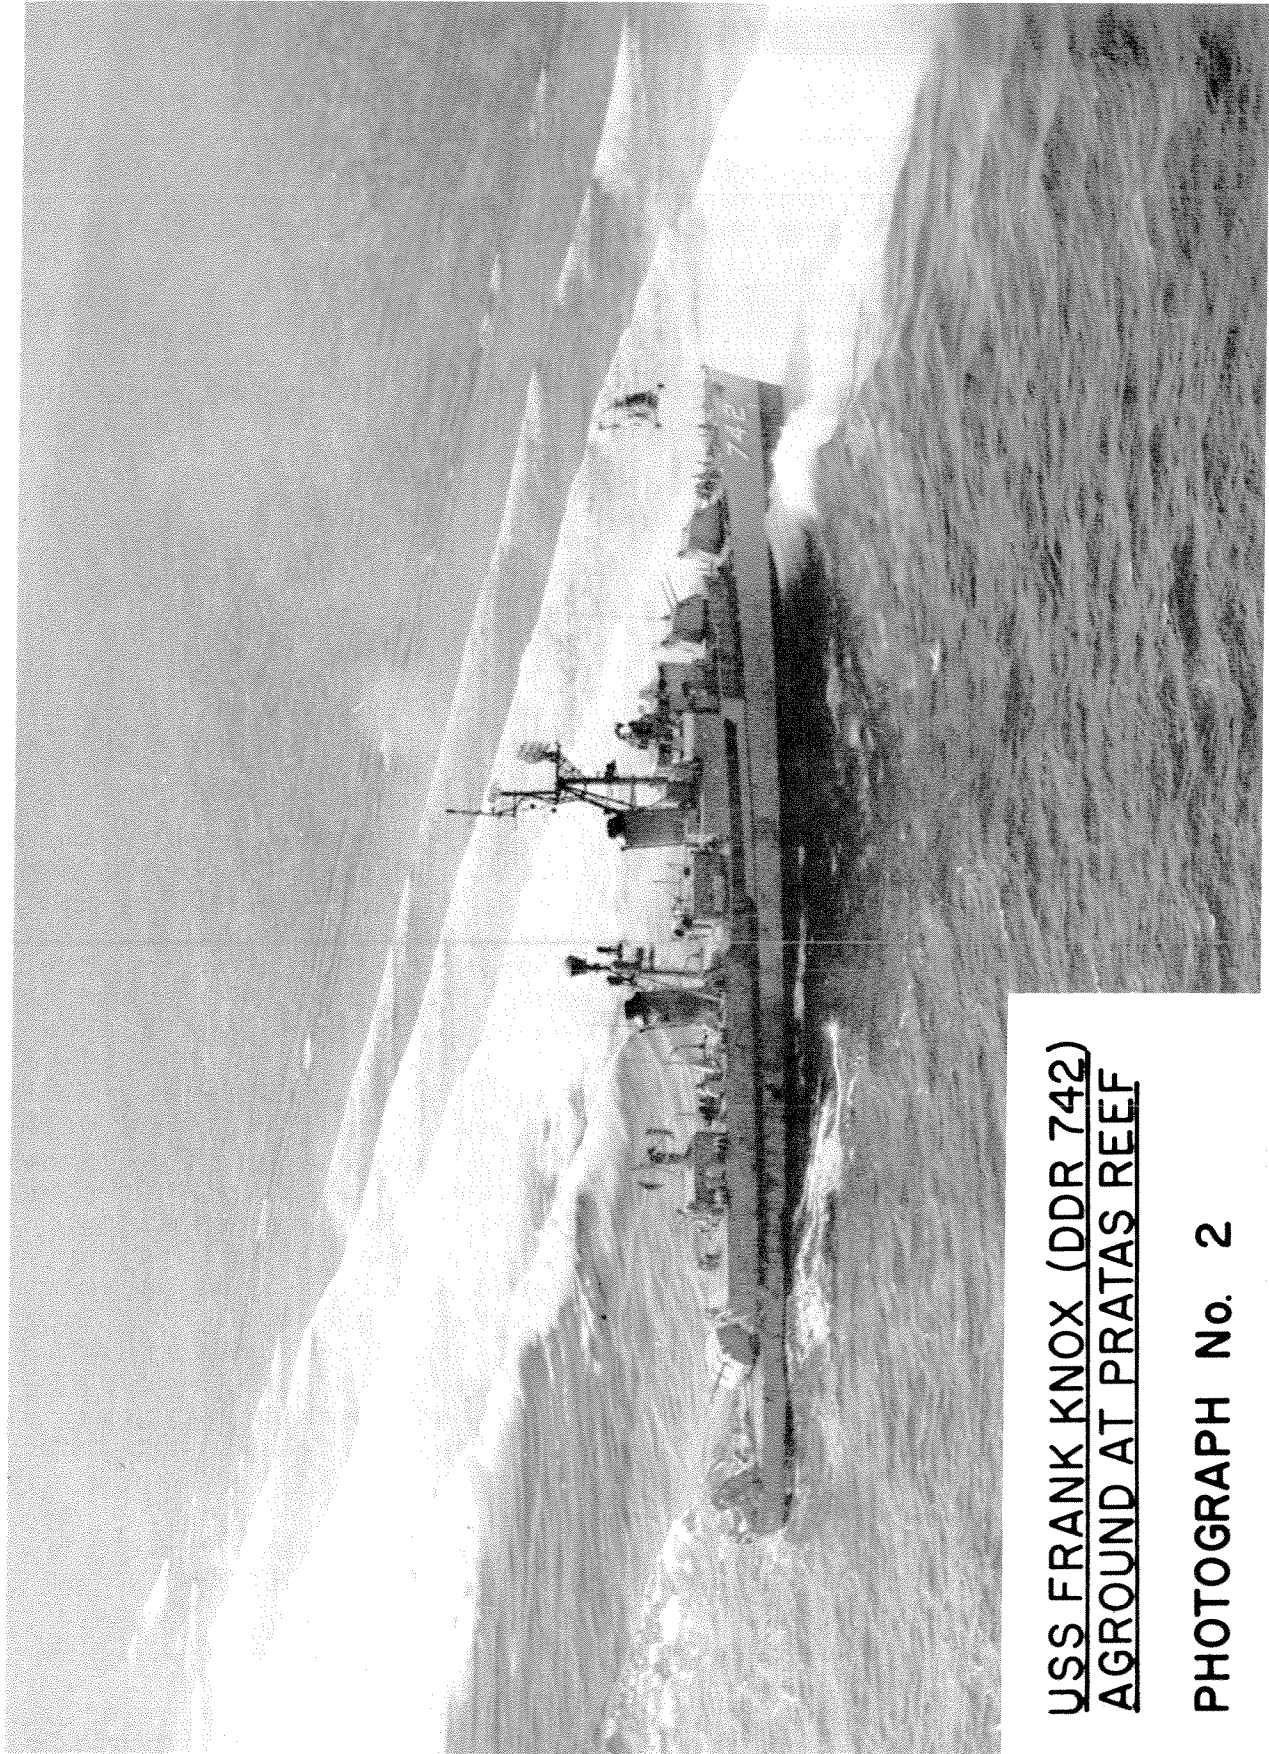
PHOTOGRAPH No. 2

USS FRANK KNOX (DDR 742)
AGROUND AT PRATAS REEF

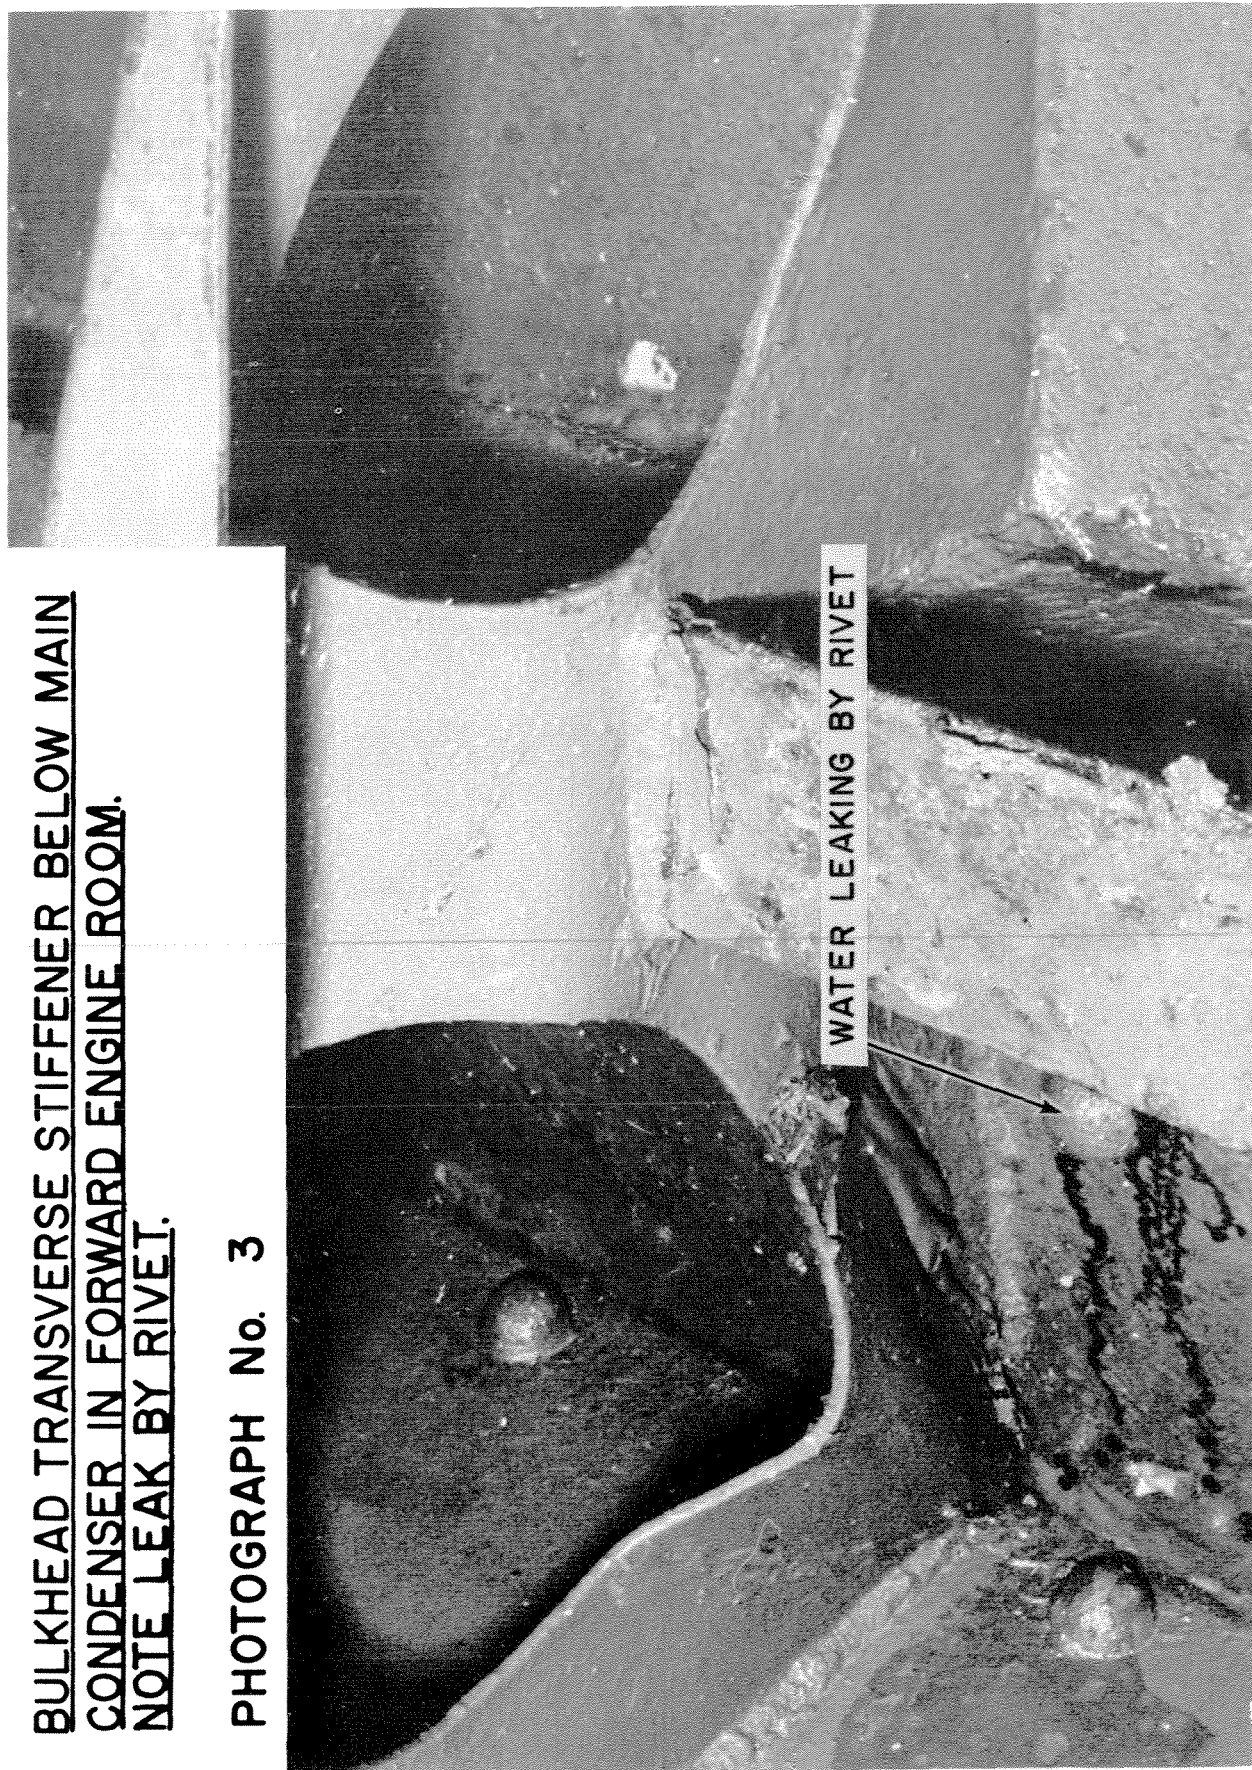
PHOTOGRAPH No. 3

BULKHEAD TRANSVERSE STIFFENER BELOW MAIN
CONDENSER IN FORWARD ENGINE ROOM.
NOTE LEAK BY RIVET.

During the day, winds had been from the west with much rain, and there was a 1-2 foot swell. Shortly after securing the pulling effort, the wind shifted to the southeast and began building rapidly as did the swells. By 1600, the winds, swell and surf, broad on the starboard side, caused the ship to roll and work heavily; heading began to shift to the right, that is, toward a broached position. Reballasting of the destroyer's forward tanks commenced immediately. GRAPPLE commenced heaving again to prevent broaching and FRANK KNOX backed on engines. It appeared that GRAPPLE's Eells anchor was no longer holding, so engines were used at full power with occasional heaving on beach gear. This effort managed to hold the ship's heading, but the destroyer continued to sustain a terrific beating. The bottom in the forward fireroom and forward engine room worked badly and smaller structural members began to take a permanent set; rivets began to leak. (See Photograph 3 page 10.)

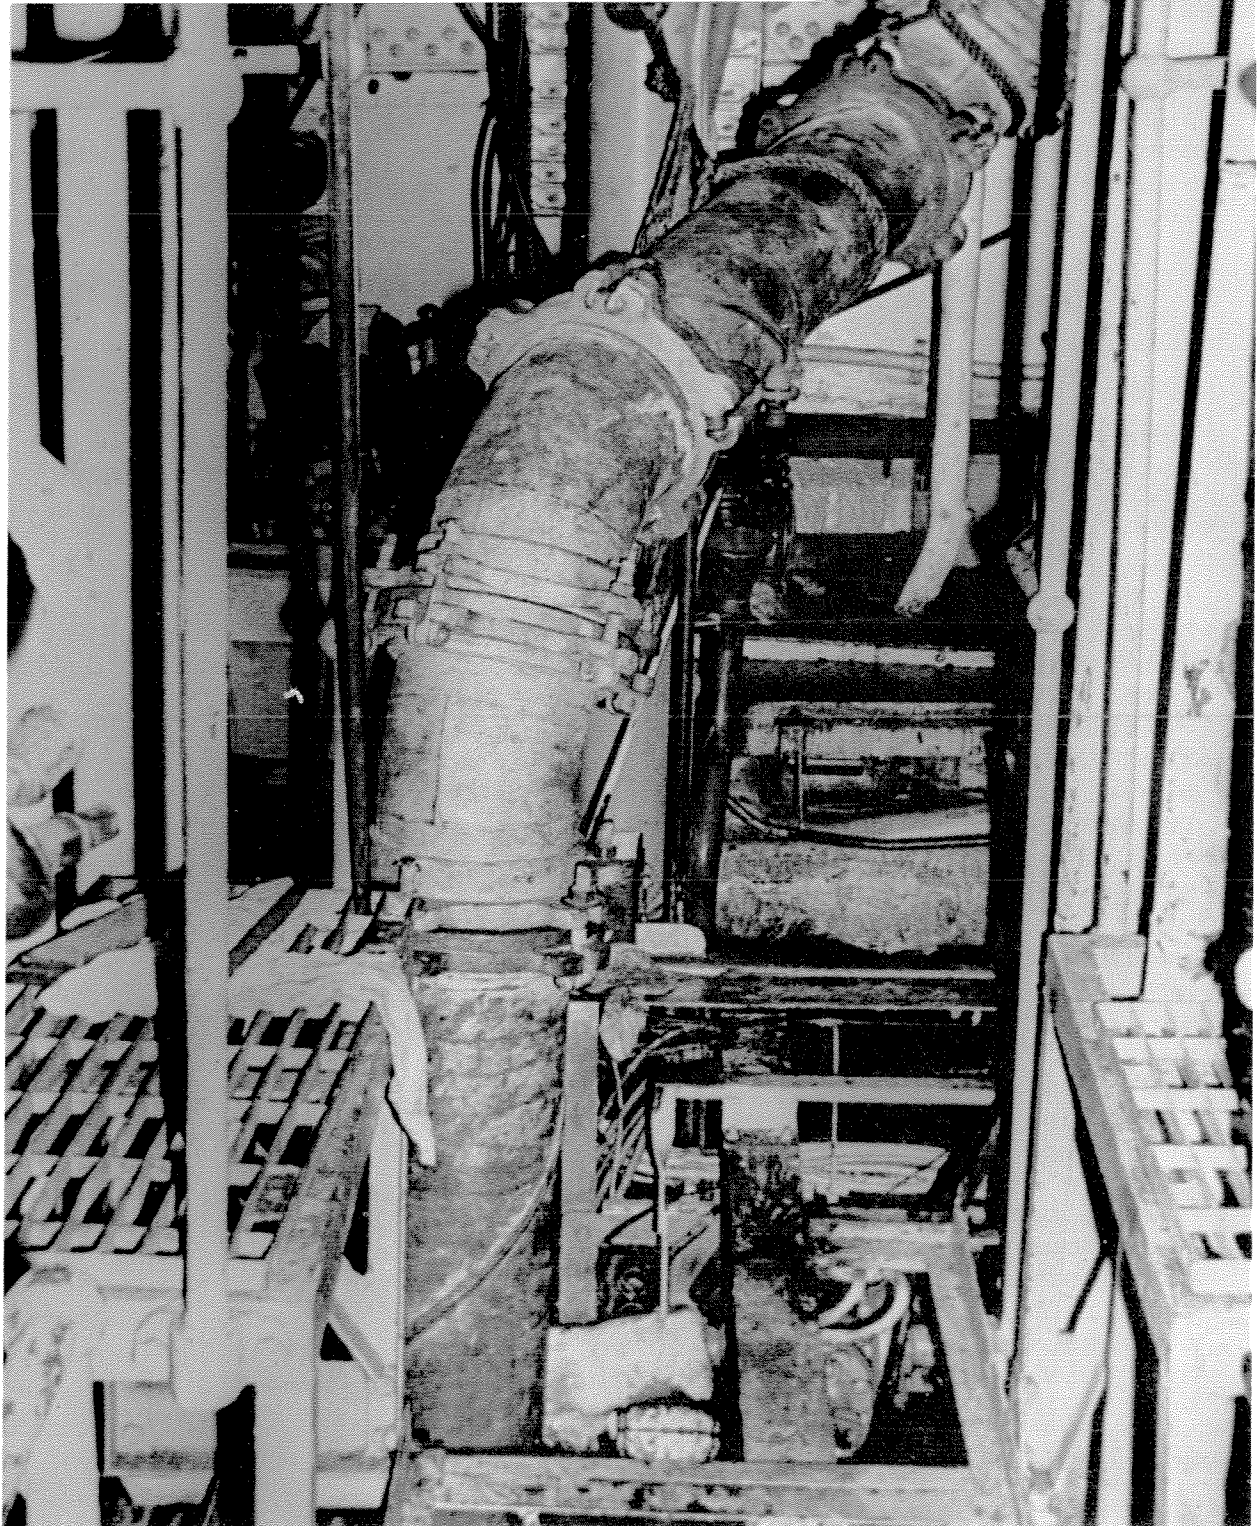
PHOTOGRAPH No. 4

SUCTION PIPING FOR 10 INCH
PUMP IN FORWARD FIRE ROOM

Hopes for easily dewatering the forward engine room and fire-room ended on 22 July, when test pumping with the six-inch electric pumps revealed large leaks; the water level in each space could only be lowered about six inches. Plans were immediately made to use 10-inch gasoline driven salvage pumps in these spaces. The pumps weighed 2700 pounds and were, therefore, far beyond the capacity of IWO JIMA helicopters. Boating conditions were still impossible, so nothing could be immediately done about the large pumps. However, 10-inch foot valves and suction piping were transferred by helicopter, so that the time-consuming rigging of the pump suctions did proceed with one suction being placed down the port side access to each forward space. (See Photograph 4, page 17.)

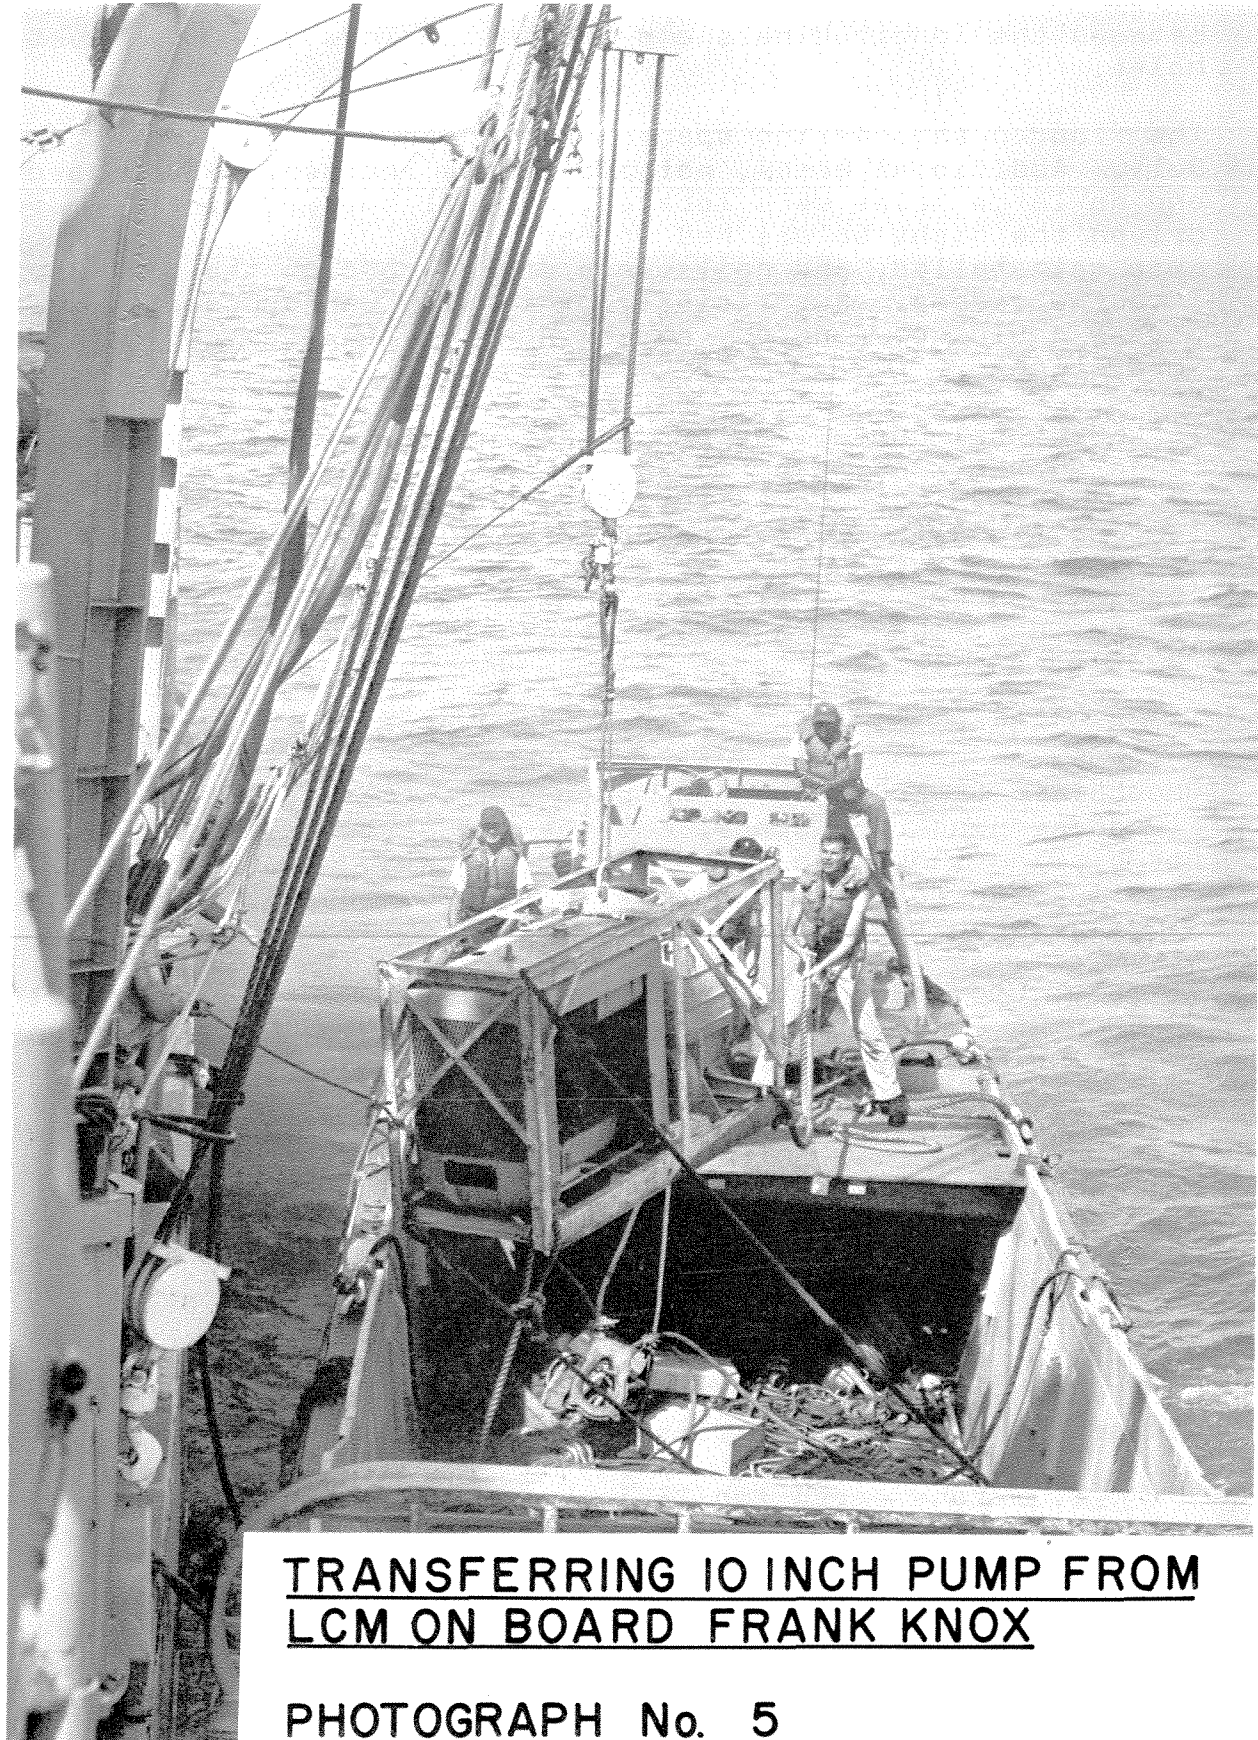
PHOTOGRAPH No. 5

TRANSFERRING 10 INCH PUMP FROM
LCM ON BOARD FRANK KNOX

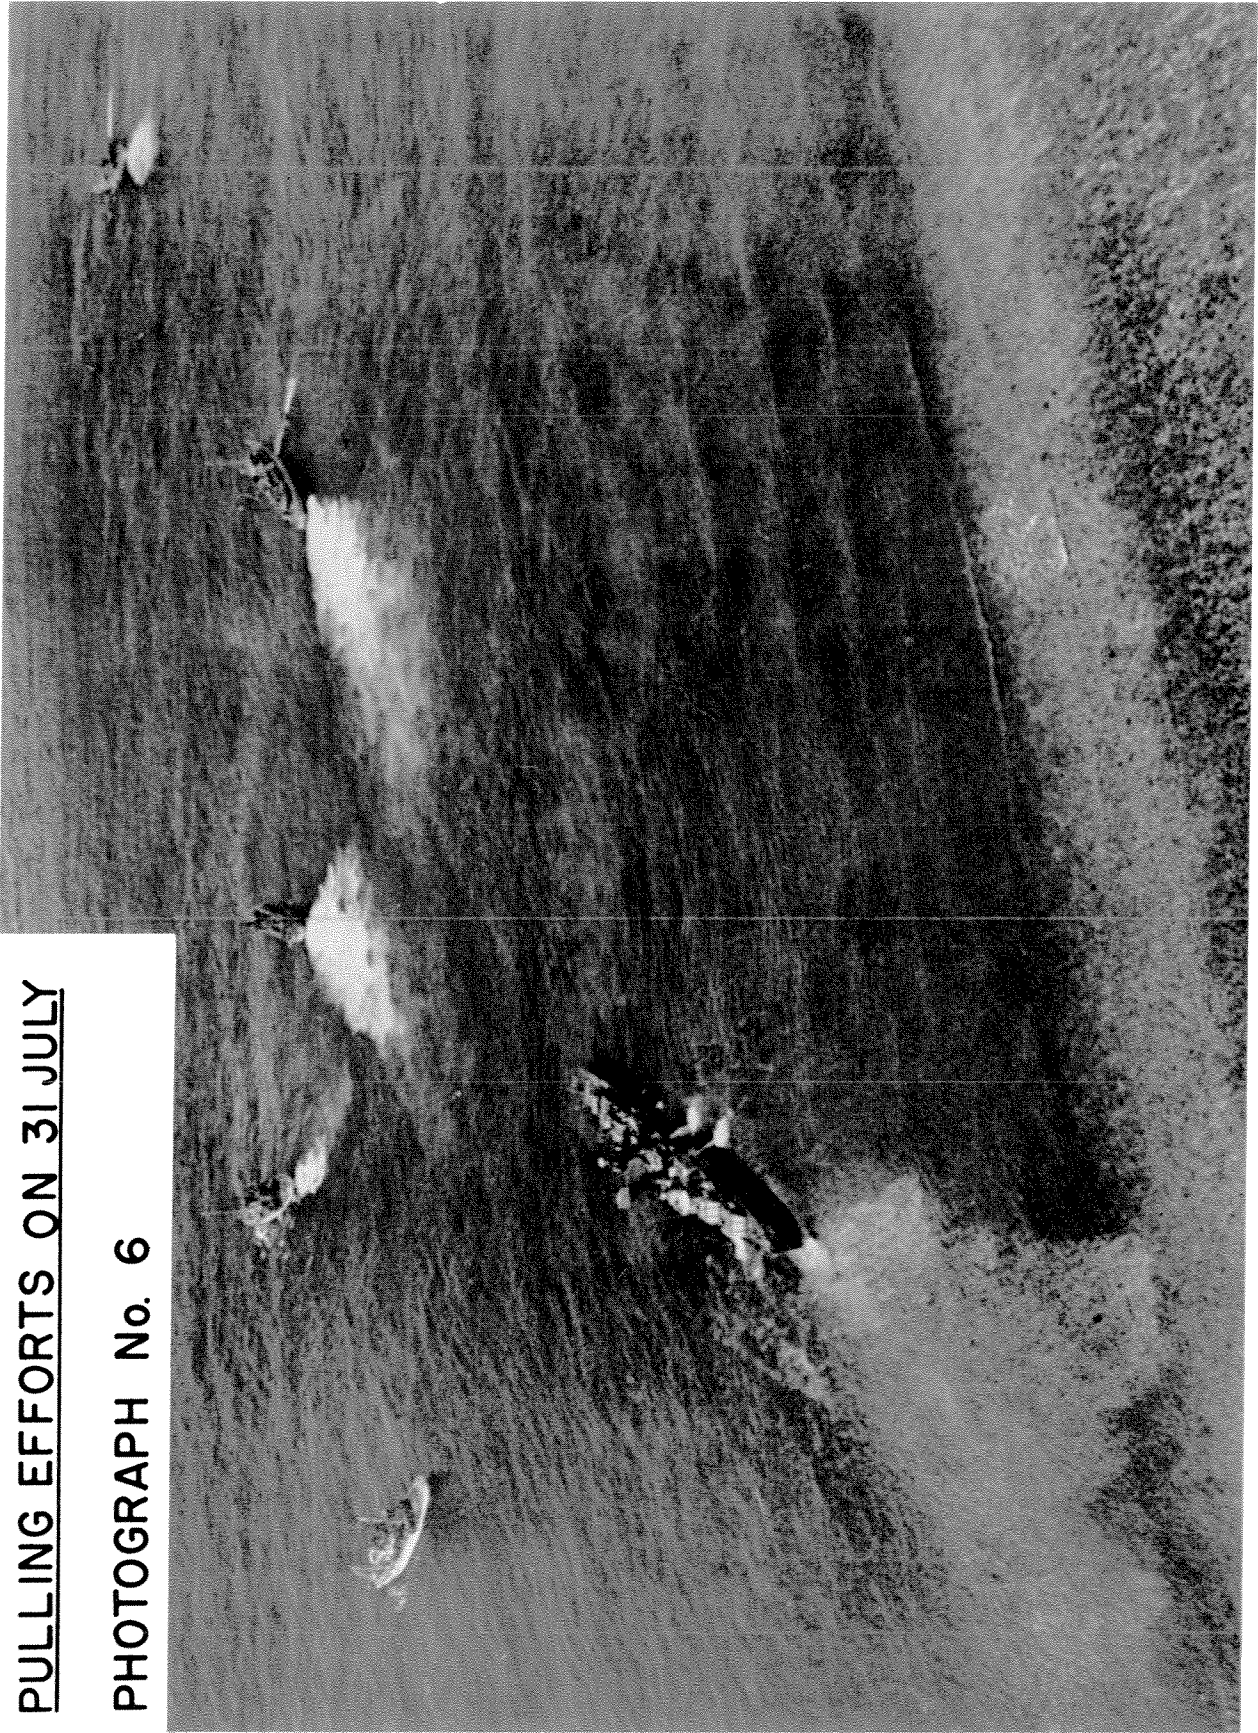
PHOTOGRAPH No. 6

PULLING EFFORTS ON 31 JULY

NOTE: In Photograph 6, page 27, note the general view of pulling effort on 31 July 1965. Shown clockwise from FRANK KNOX are USS GRAPPLE (ARS 7), USS CONSERVER (ARS 39), USS SIOUX (ATF 75), (each with two sets of beach gear), and USS GREENLET (ASR 10); GREENLET pulling with engines only. USS COCOPA (ATF 107) (shown at upper right) assisting GREENLET in holding her position in a 5-knot lateral current. (Note wash on port side of the two ARS produced by the current.) CONSERVER and SIOUX used main engines to supplement the pull on their beach gear anchors which were not holding well. This effort was successful in rotating the stern of FRANK KNOX into deeper water, which left the ship in a much better position. The original grounded position of the stricken ship can be seen about 75 feet to starboard of its present position. The ship had bounced laterally along the reef the night of 20 July during tropical storm "Gilda." It was at this time that the majority of the serious damage to FRANK KNOX occurred. The white area forward of FRANK KNOX is a deposit of fine coral sand which was ground by the action of the destroyer's hull pounding and working against the bottom.

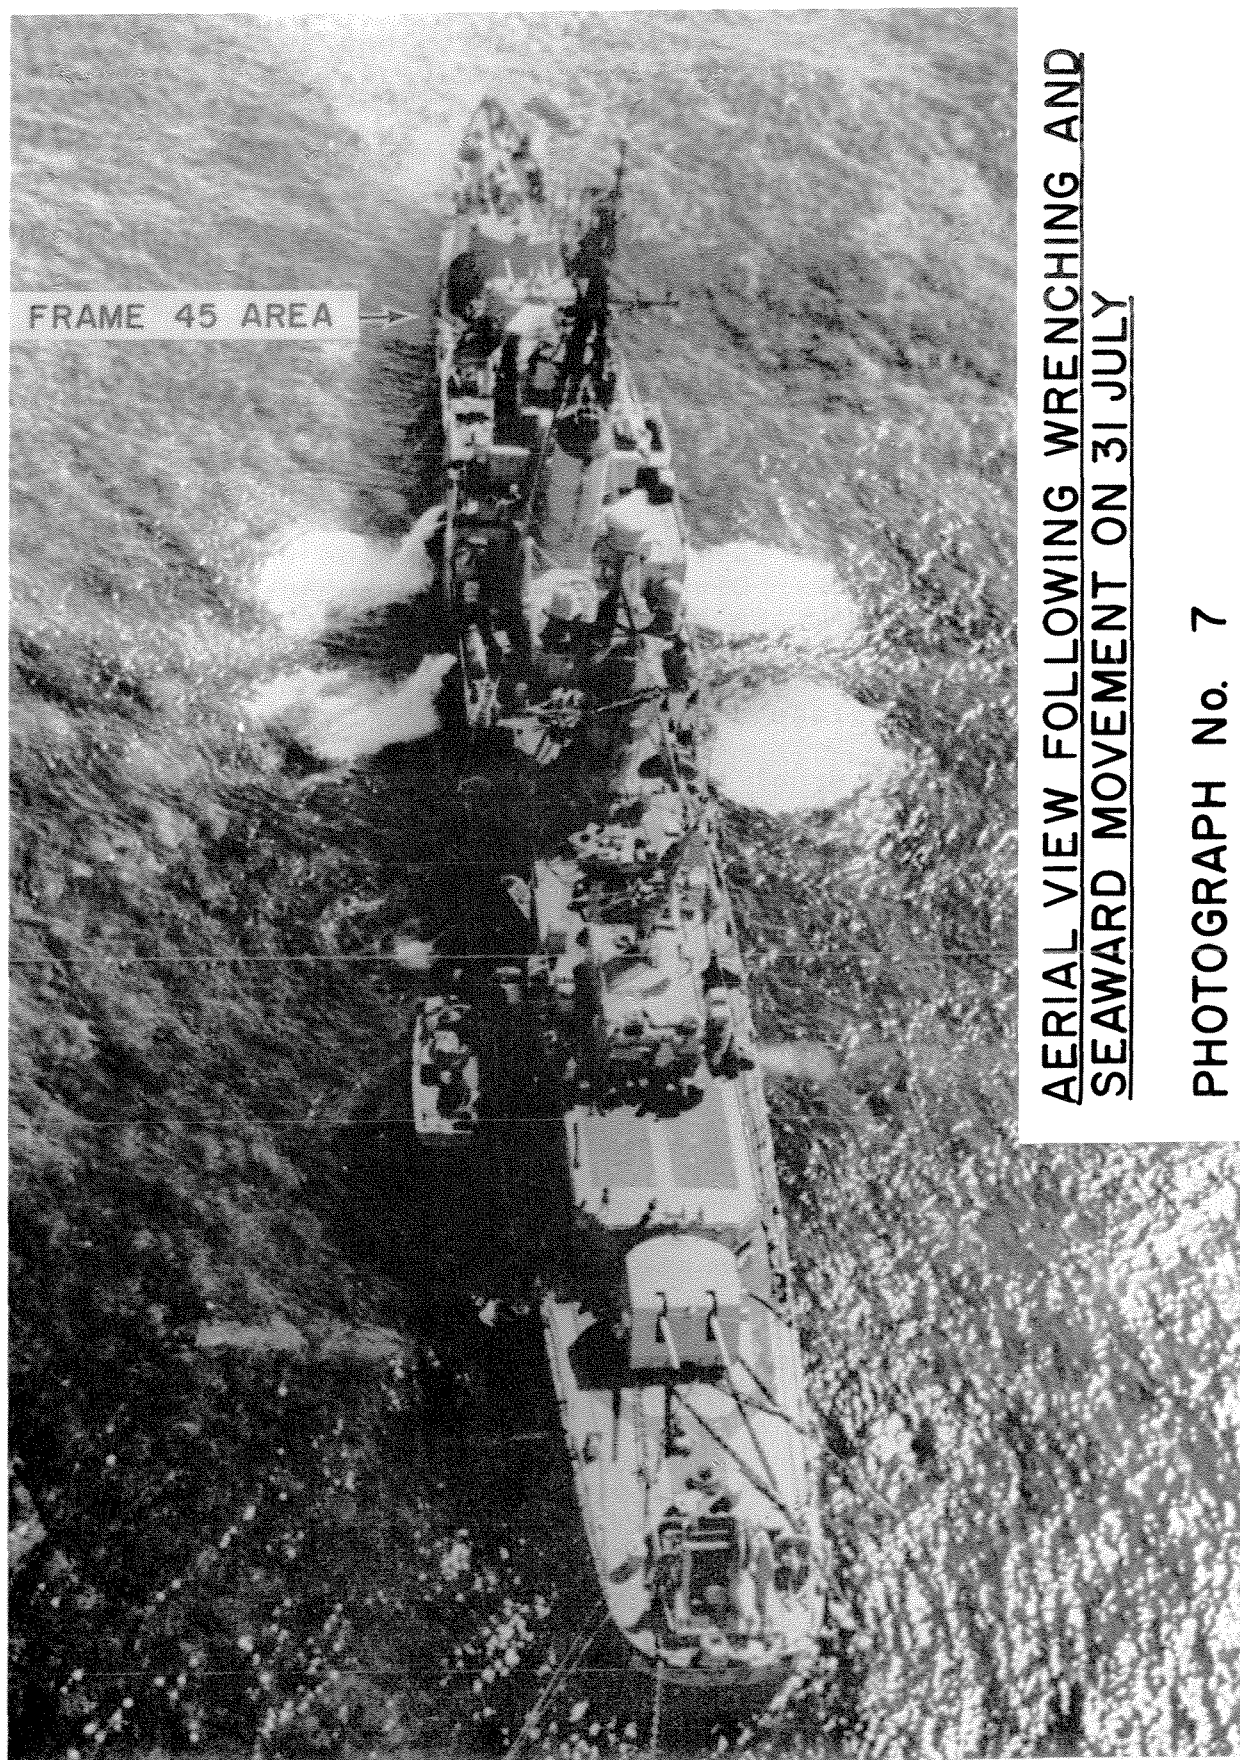
PHOTOGRAPH No. 7

AERIAL VIEW FOLLOWING WRENCHING AND
SEAWARD MOVEMENT ON 31 JULY

NOTE: In Photograph 7, page 29, note an aerial view of FRANK KNOX following the successful wrenching of the stern to starboard and moderate movement to seaward on 31 July. The original grounded position was at the upper right; the position prior to wrenching was off the port side. The scar on the coral to port of mount 53 was caused by the propellers when the ship bounced along the reef during the storm of 20 July. The connections for the tow wires are made up on the fantail. Clockwise, the wires are GRAPPLE's, CONSERVER's and SIOUX's (each with a 2 1/4-inch chain bridle passed around the base ring of mount 53), GREENLET's (with a two-inch wire bridle around mount 53), and the beach gear wire for the set being heaved on by the destroyer.

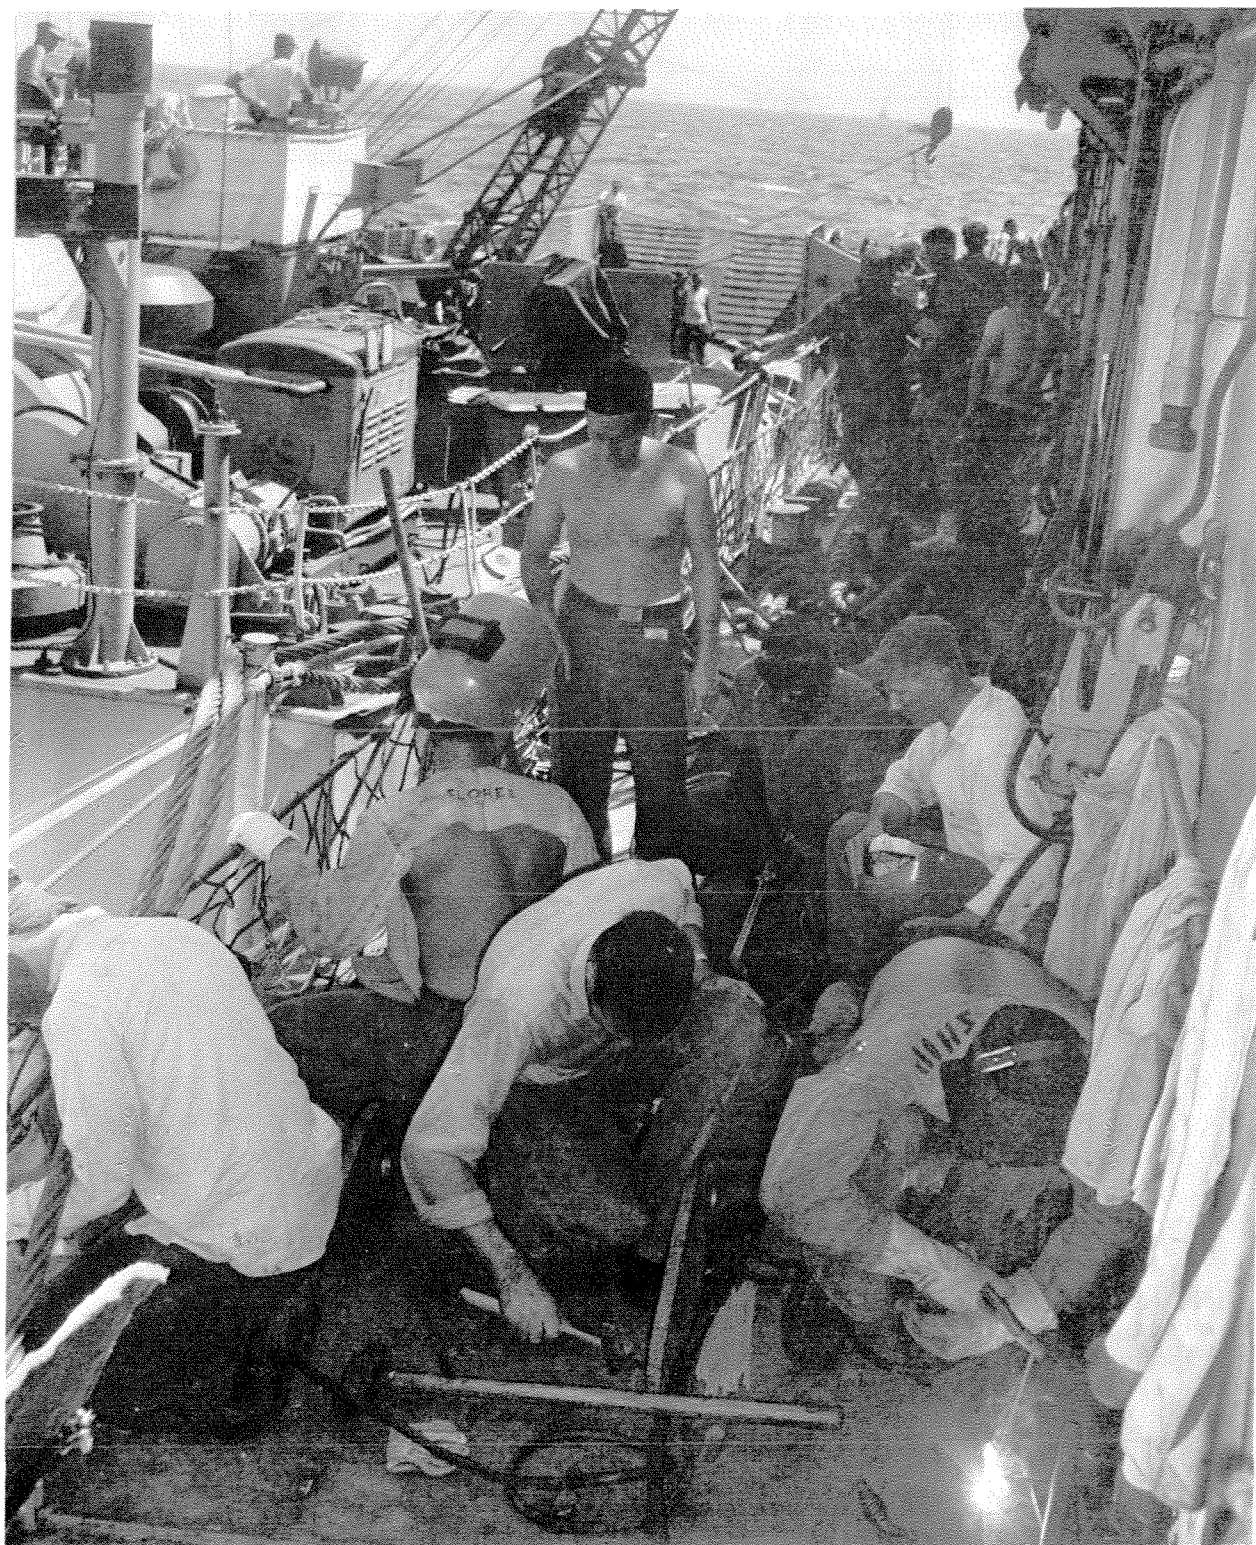
PHOTOGRAPH No. 8

WELDING PLATES WITH PADEYES AT FRAME 112
STBD FOR HOLDING STANDING BEACH GEAR BLOCKS

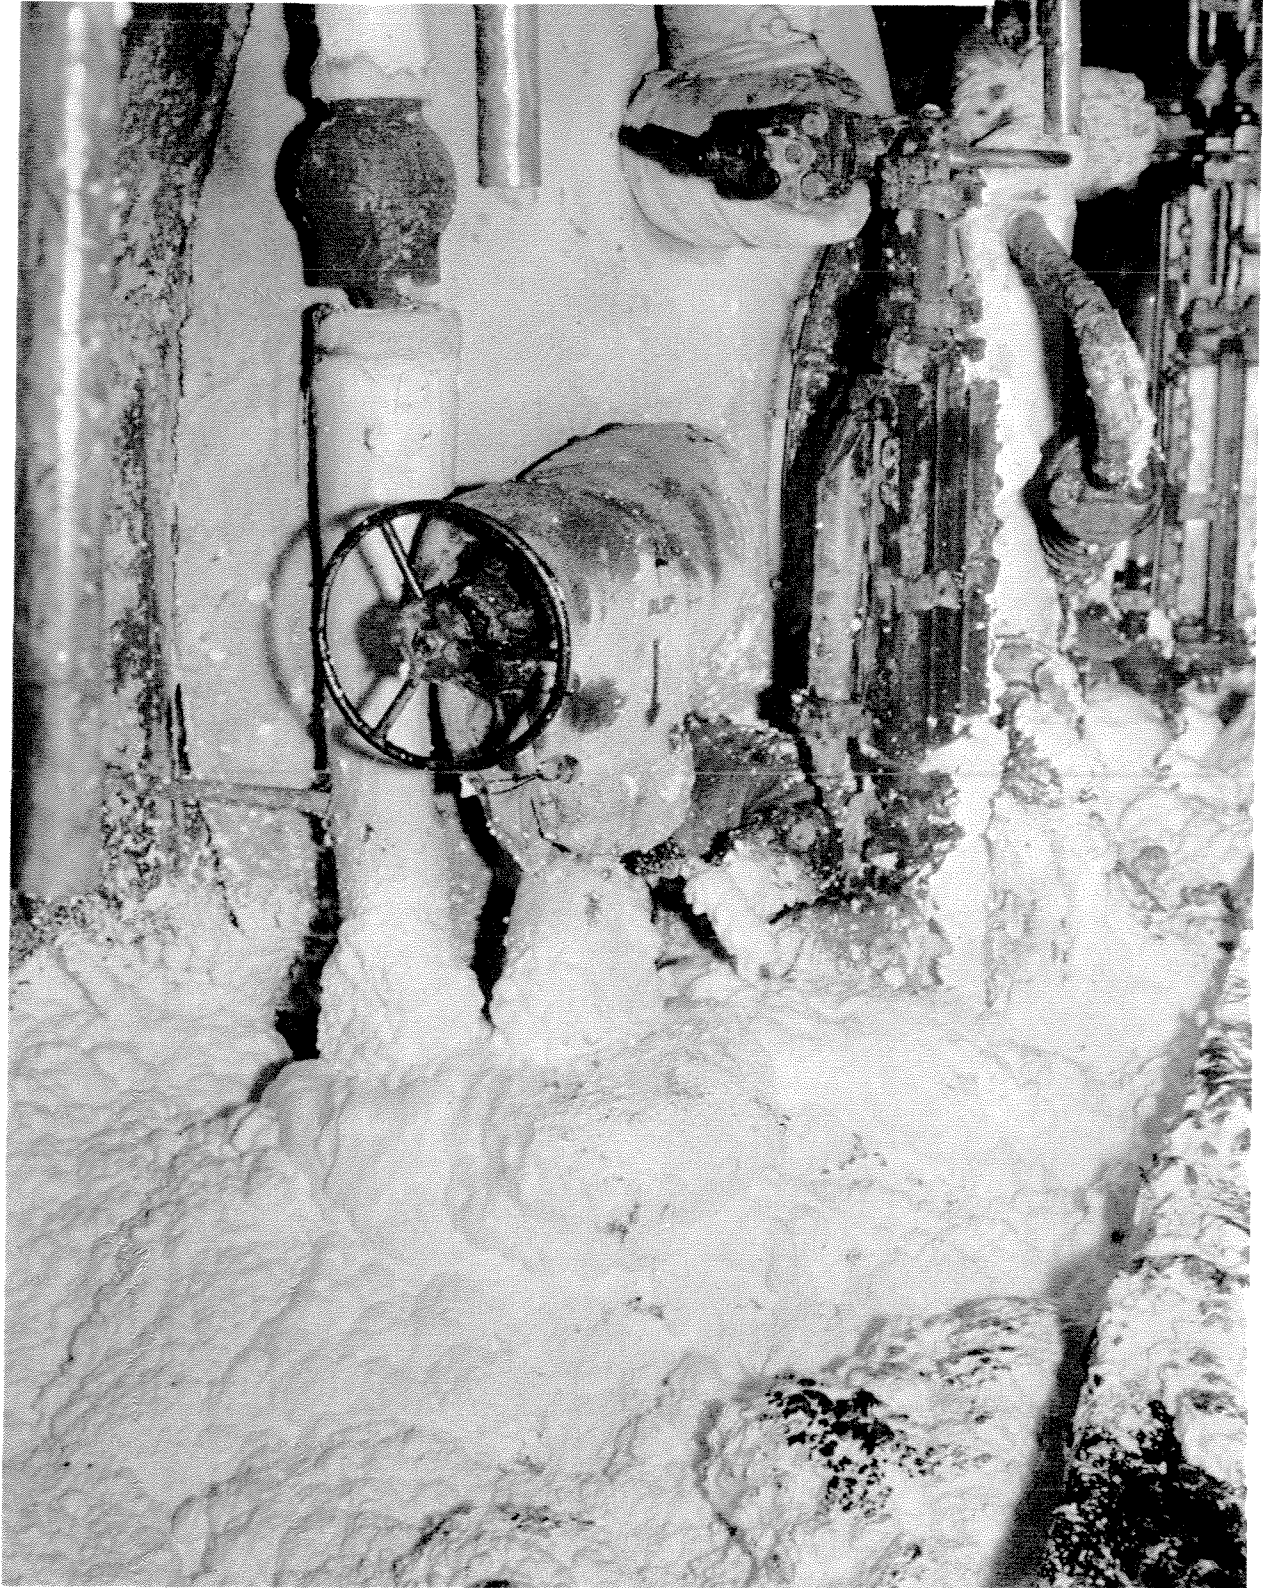
PHOTOGRAPH No. 9

HARDENED FOAM IN FWD FIREROOM

NOTE: In Photograph 9, page 41, note the view from starboard in forward fireroom aboard FRANK KNOX showing hardened foam built up around steam drum of number 2 boiler. Note handrails and hangers that had been cutoff to reduce obstructions to laying a plywood deck over the foam. This decking scheme was later abandoned.

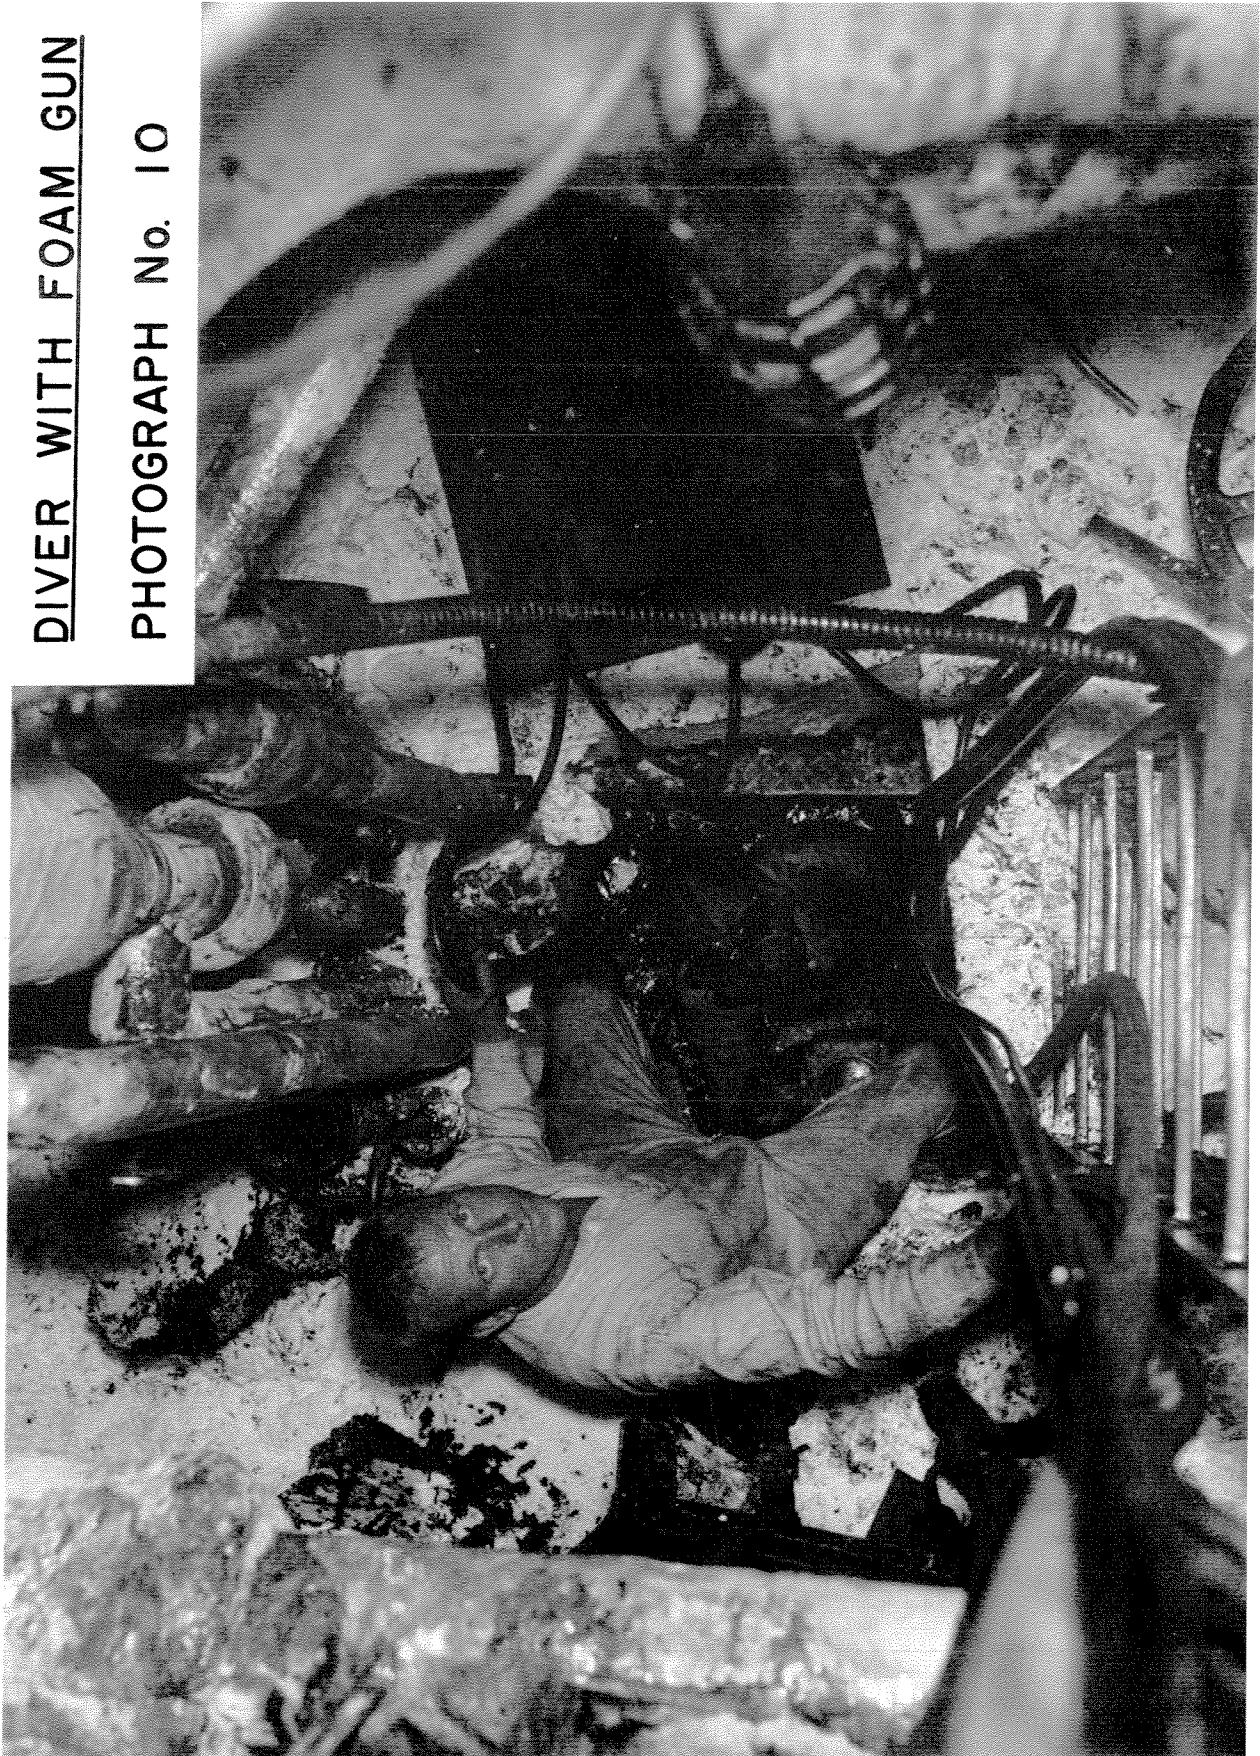
PHOTOGRAPH No. 10

DIVER WITH FOAM GUN

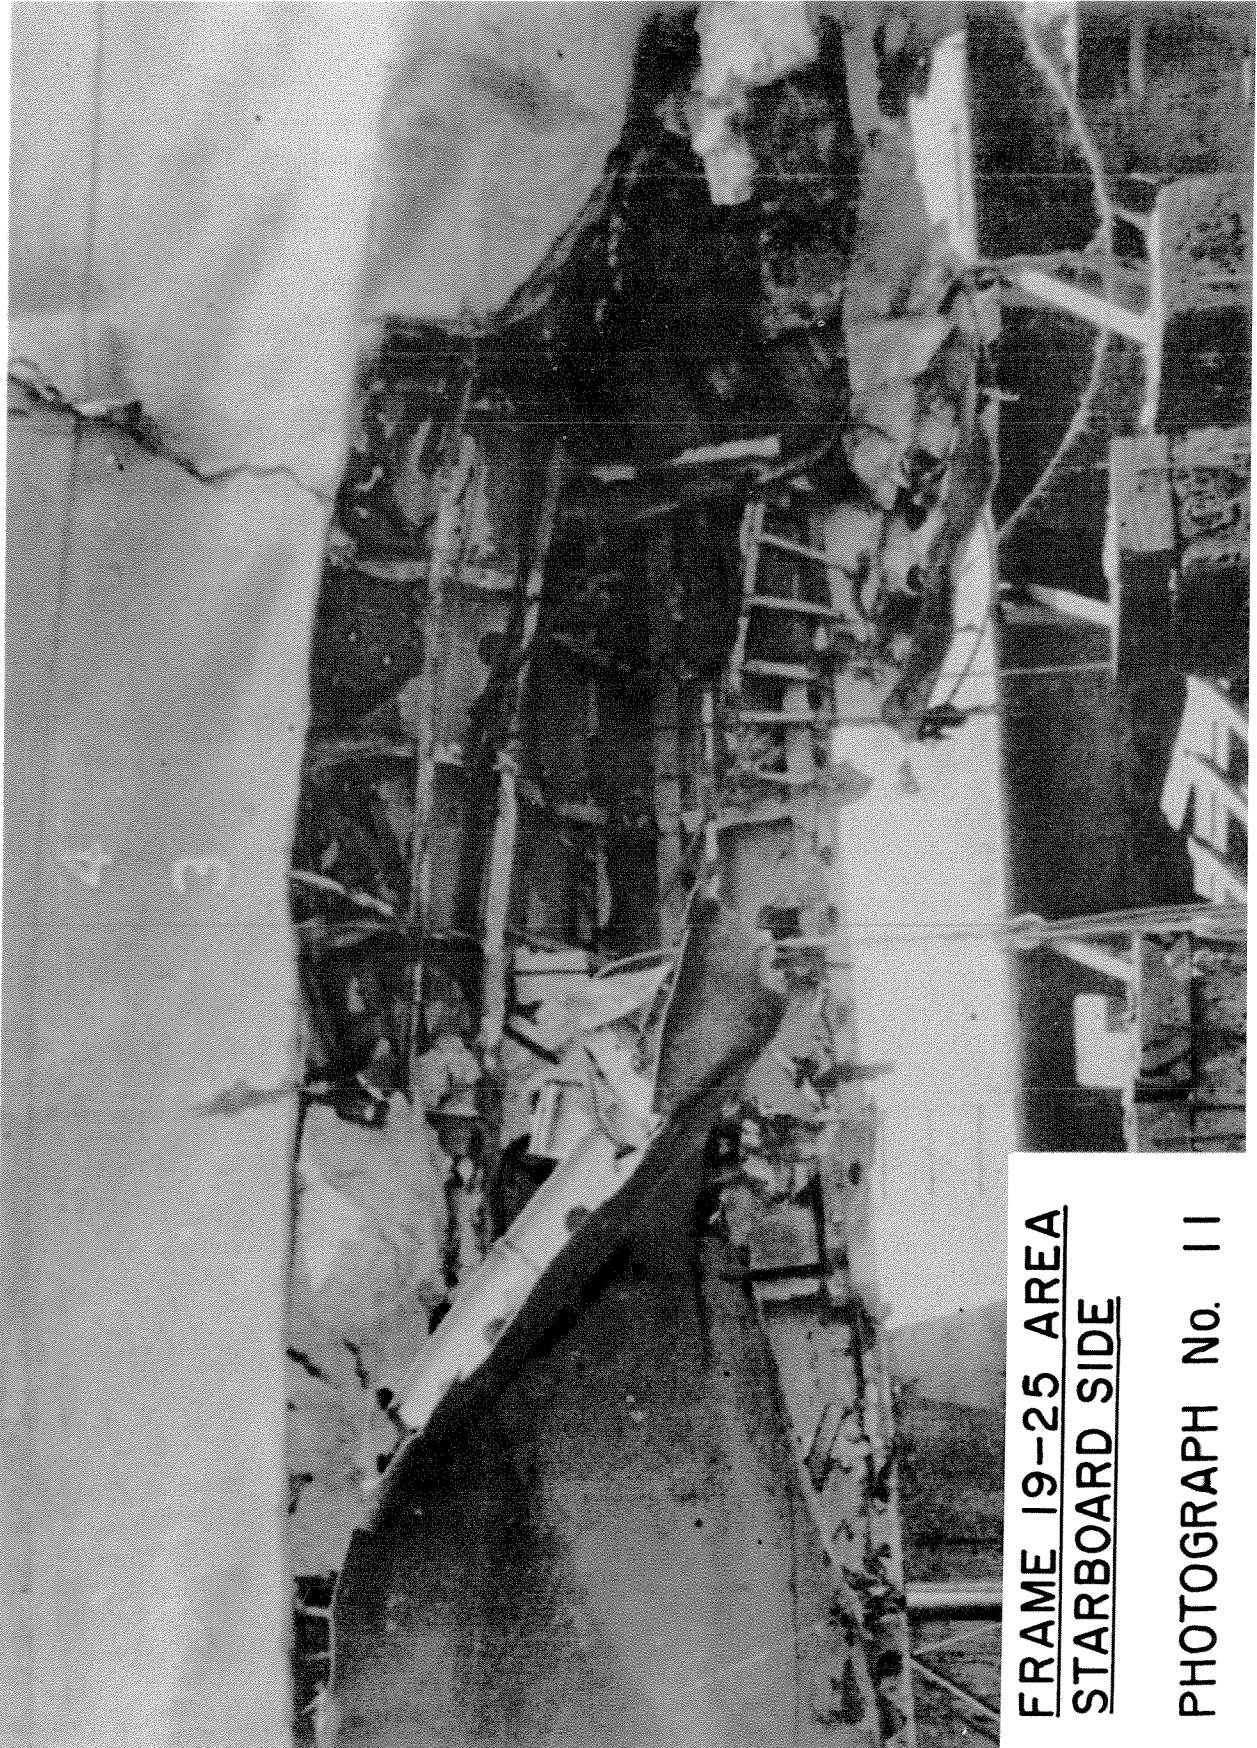
PHOTOGRAPH No. 11

FRAME 19-25 AREA
STARBOARD SIDE
