USS FRANK KNOX (DDR-742) STRANDING SALVAGE

NAVSHIPS 0994-002-6010

DEPARTMENT OF THE NAVY
NAVAL SHIP SYSTEMS COMMAND
WASHINGTON, D.C.

1968

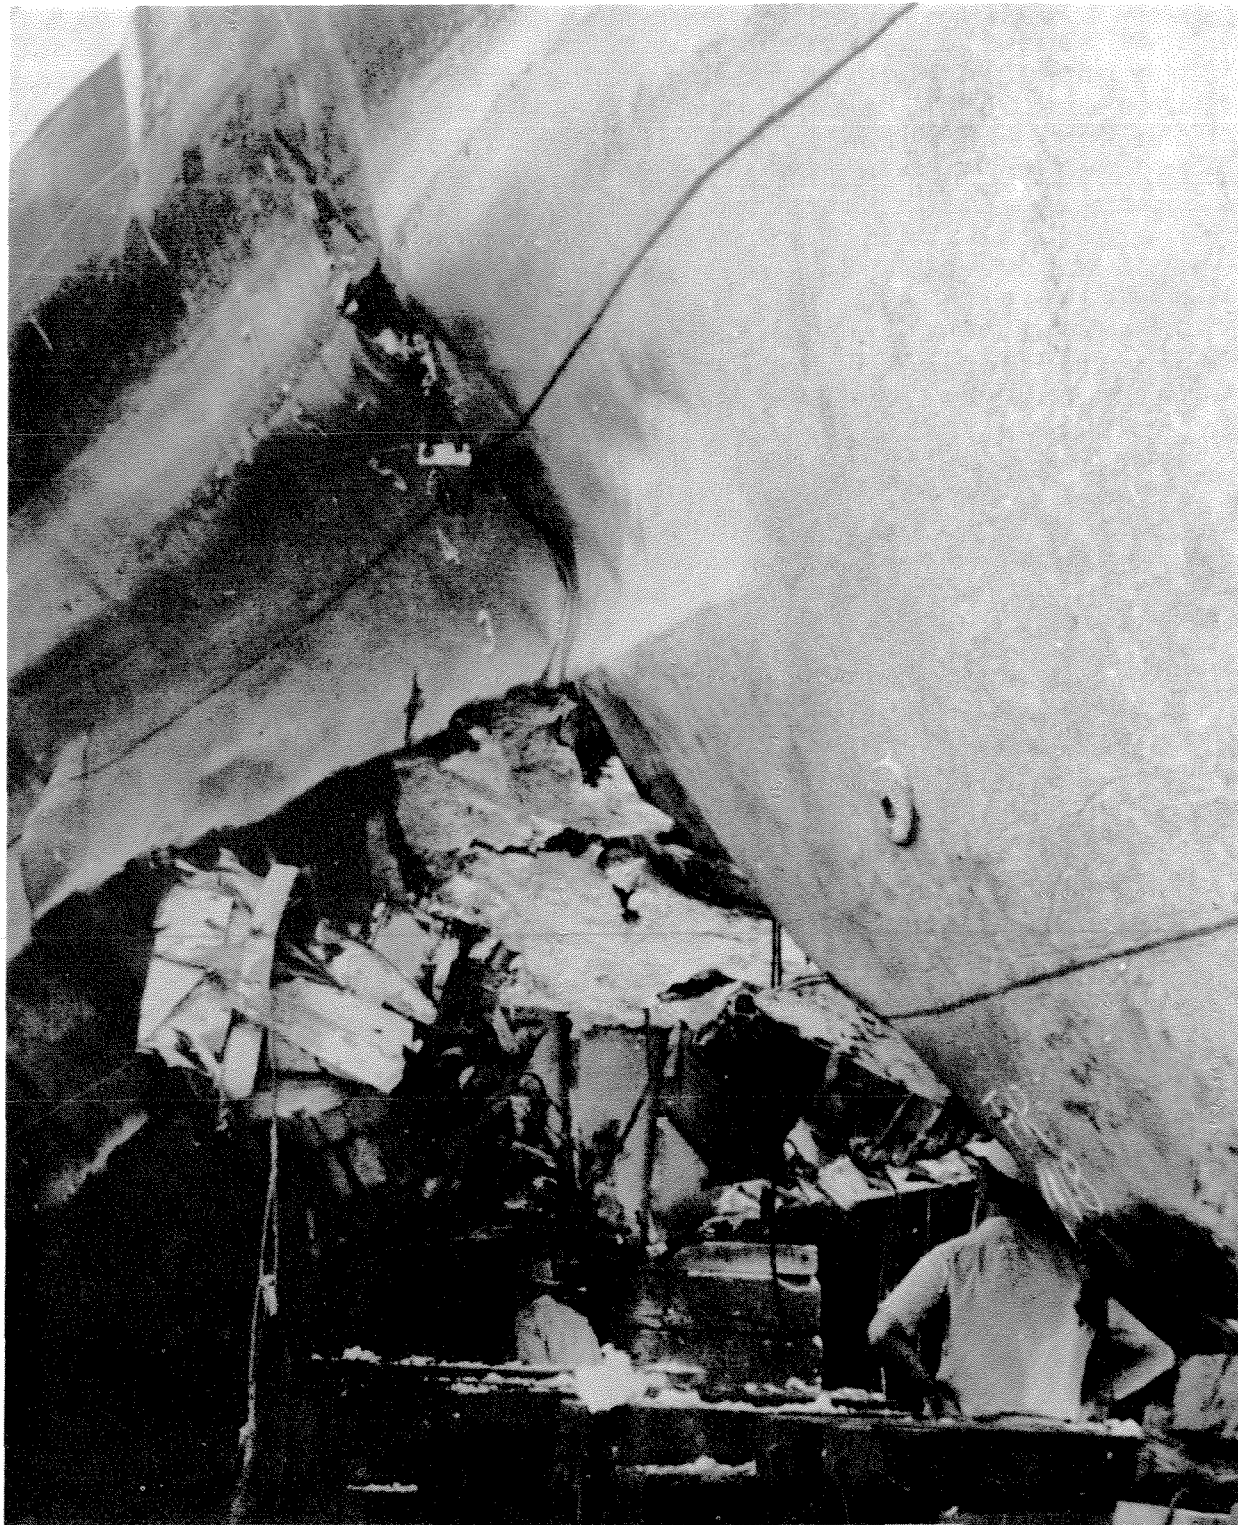
PHOTOGRAPH No. 12

LOOKING AFT ON STARBOARD SIDE
INTO A-503-A

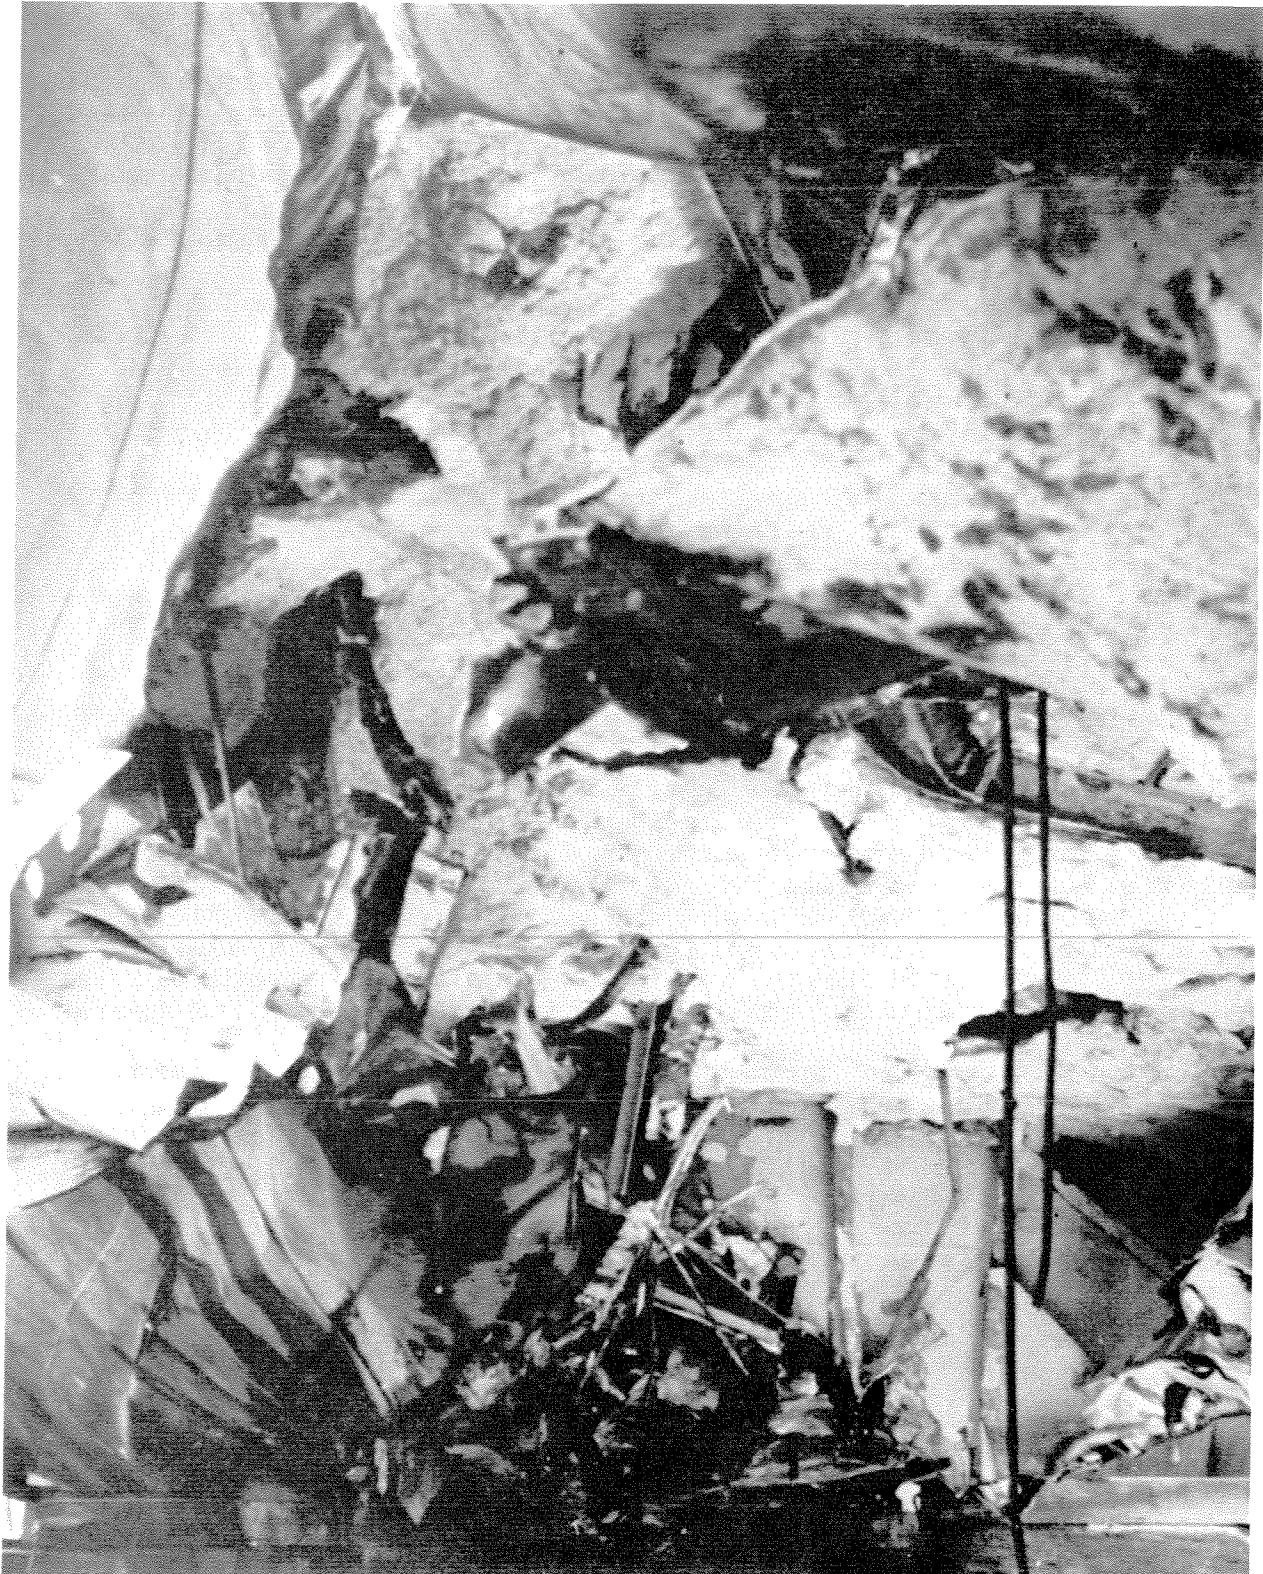
PHOTOGRAPH No. 13

LOOKING UP FROM FRAME 18

ORIGINAL KEEL LINE

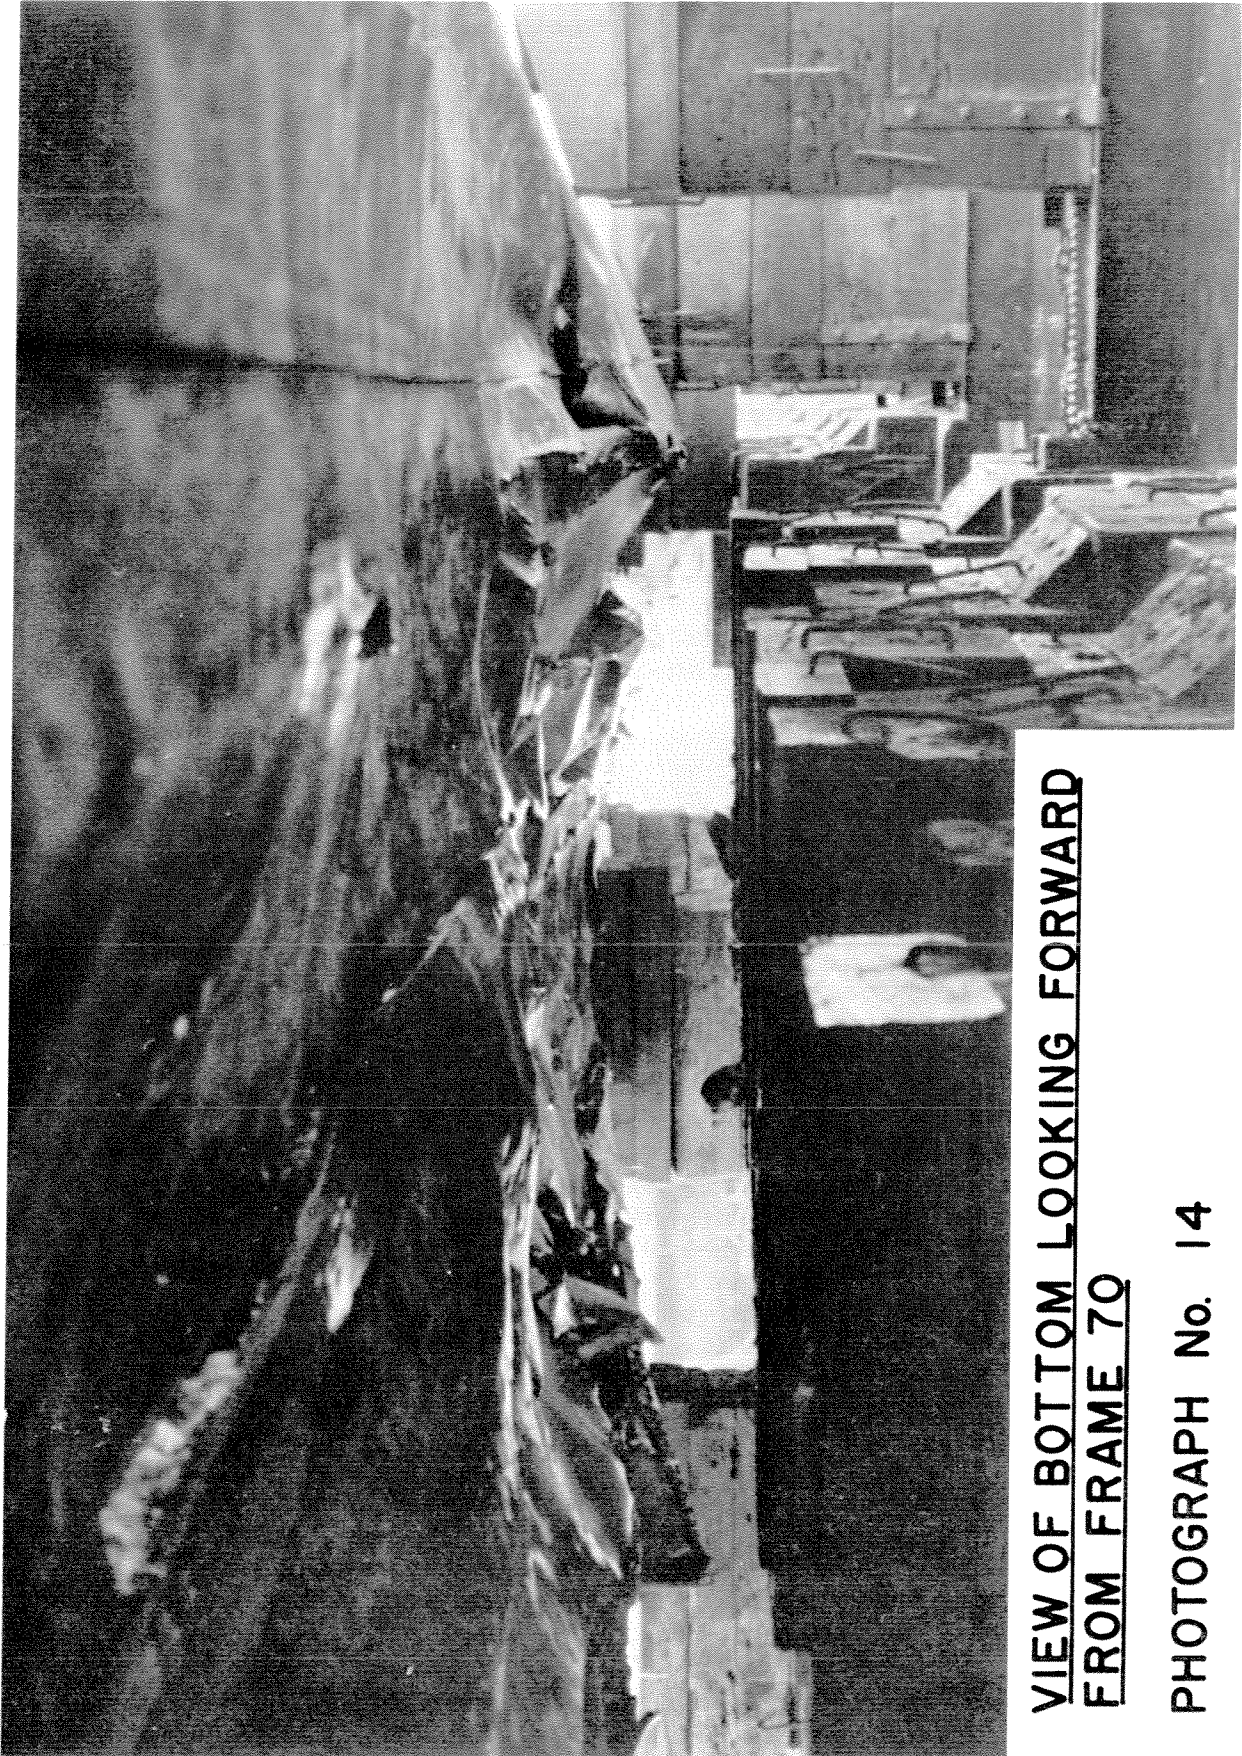
PHOTOGRAPH No. 14

VIEW OF BOTTOM LOOKING FORWARD
FROM FRAME 70

In Photograph 14, page 63, note the damaged bottom plating of the destroyer. Patching of the bottom was very difficult; diligent efforts to stop the water from flooding proved unsuccessful because the damage was too extensive and too severe (as is evidenced in the photograph).

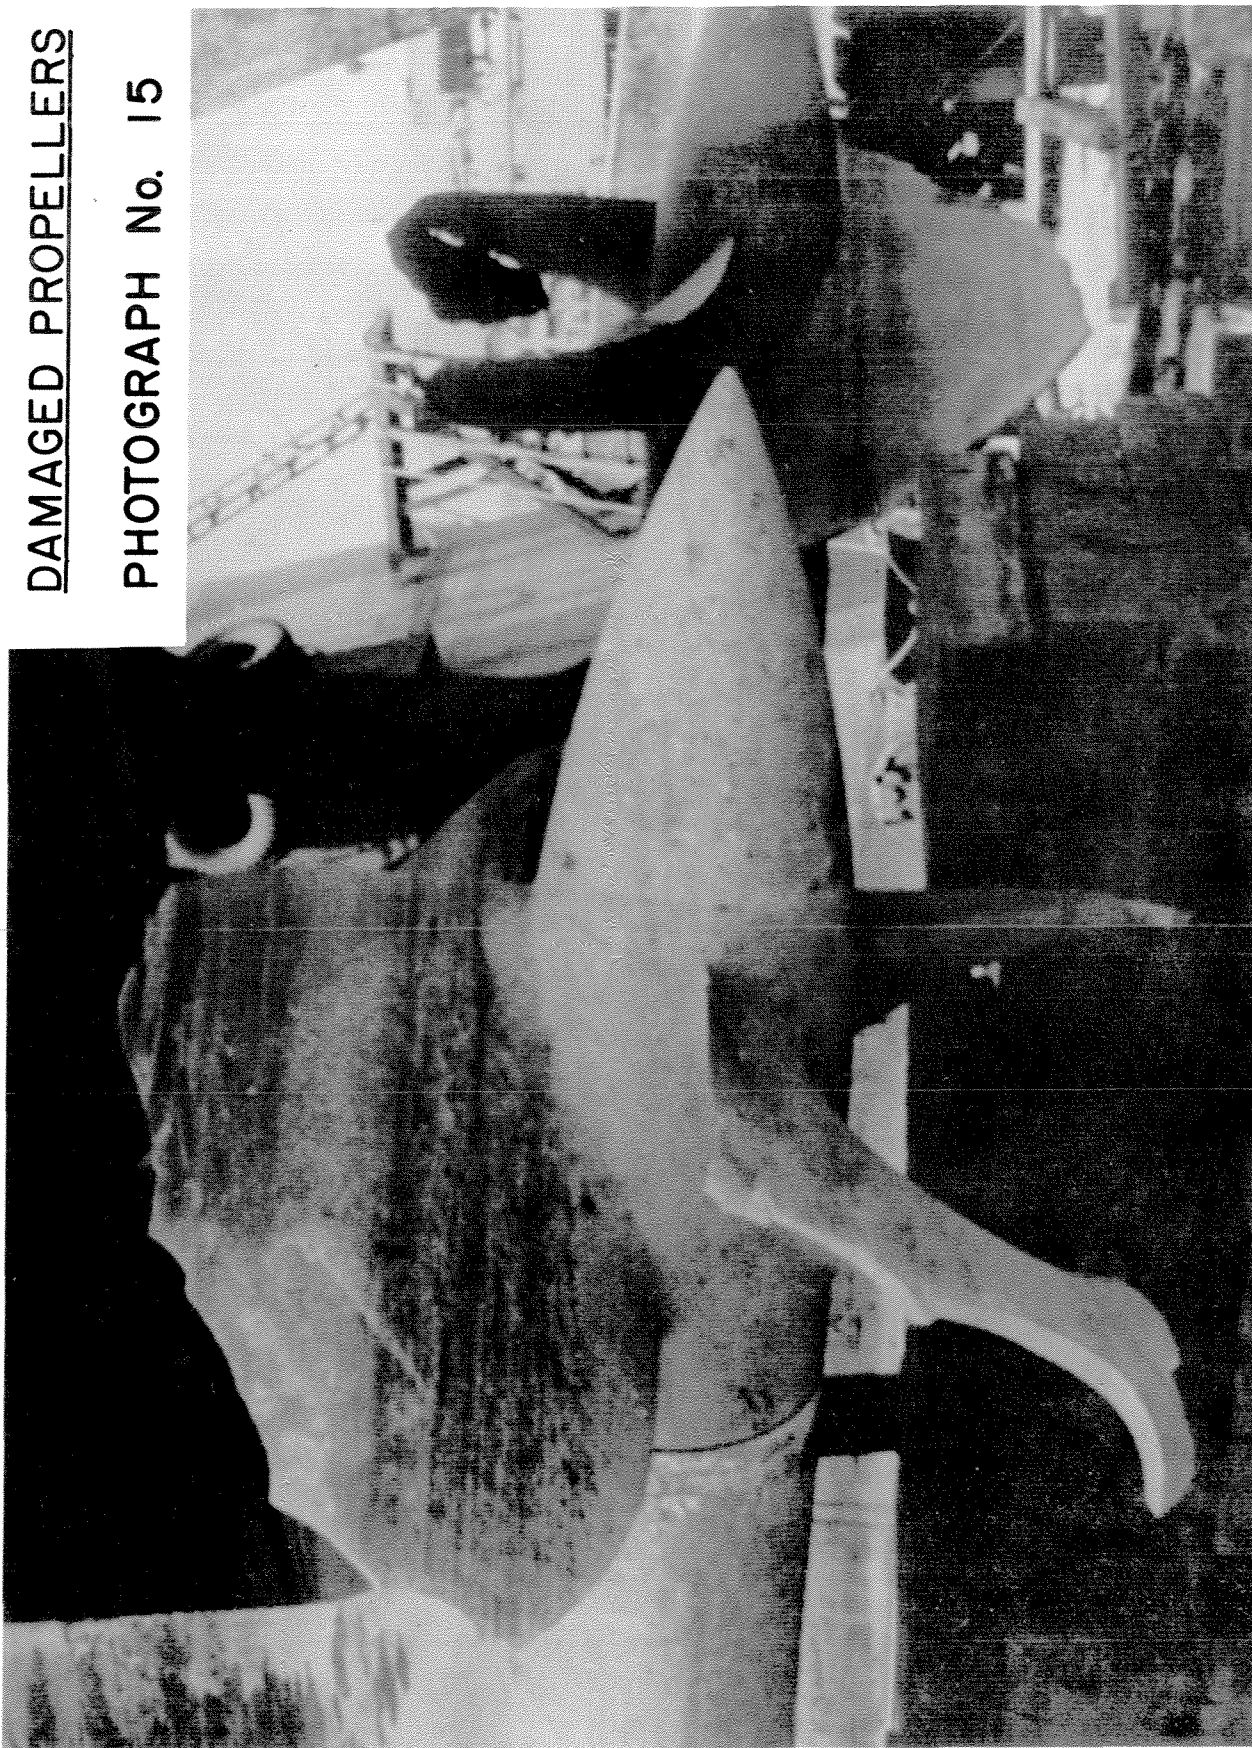
PHOTOGRAPH No. 15

DAMAGED PROPELLERS

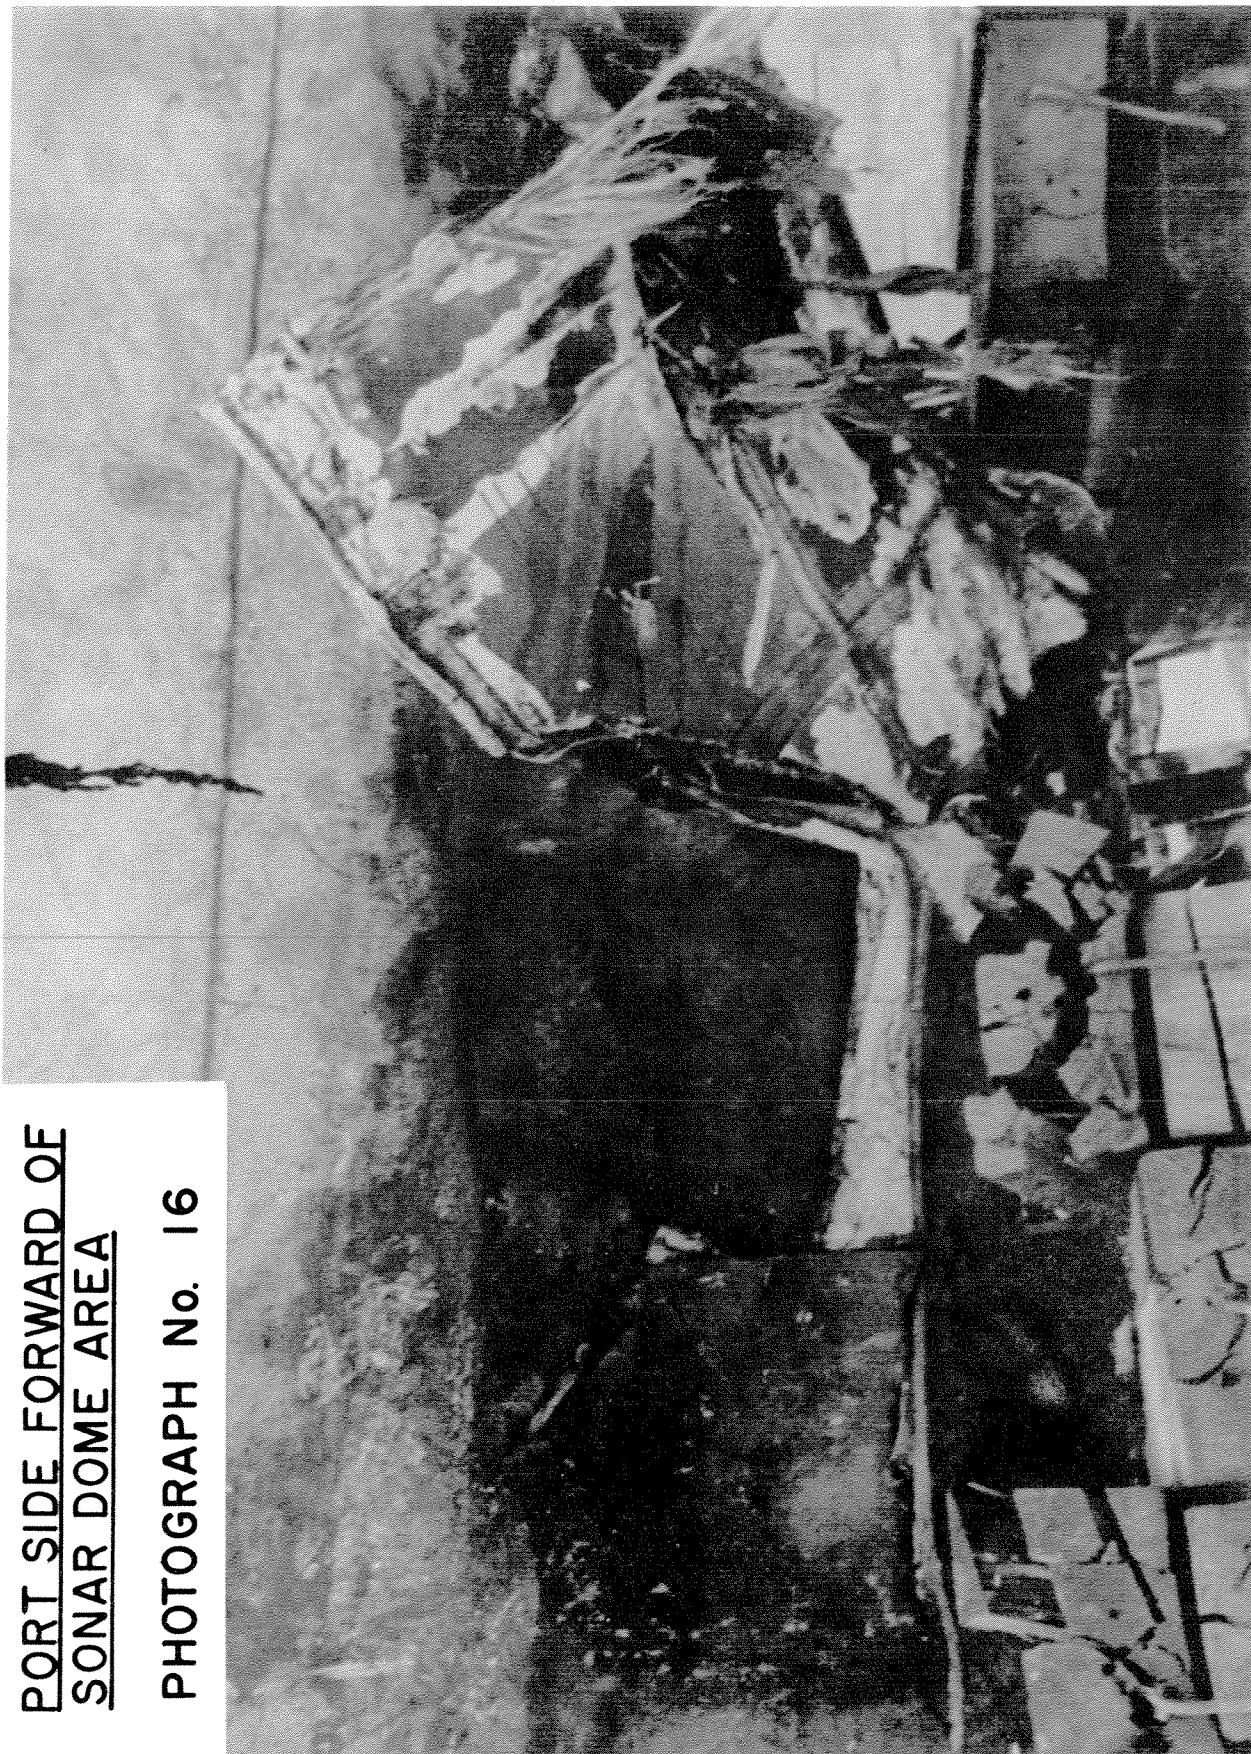
PHOTOGRAPH No. 16

PORT SIDE FORWARD OF
SONAR DOME AREA

NOTE: Photographs 14, 15 and 16 were taken in drydock; they exemplify some of the damage done to the ship.

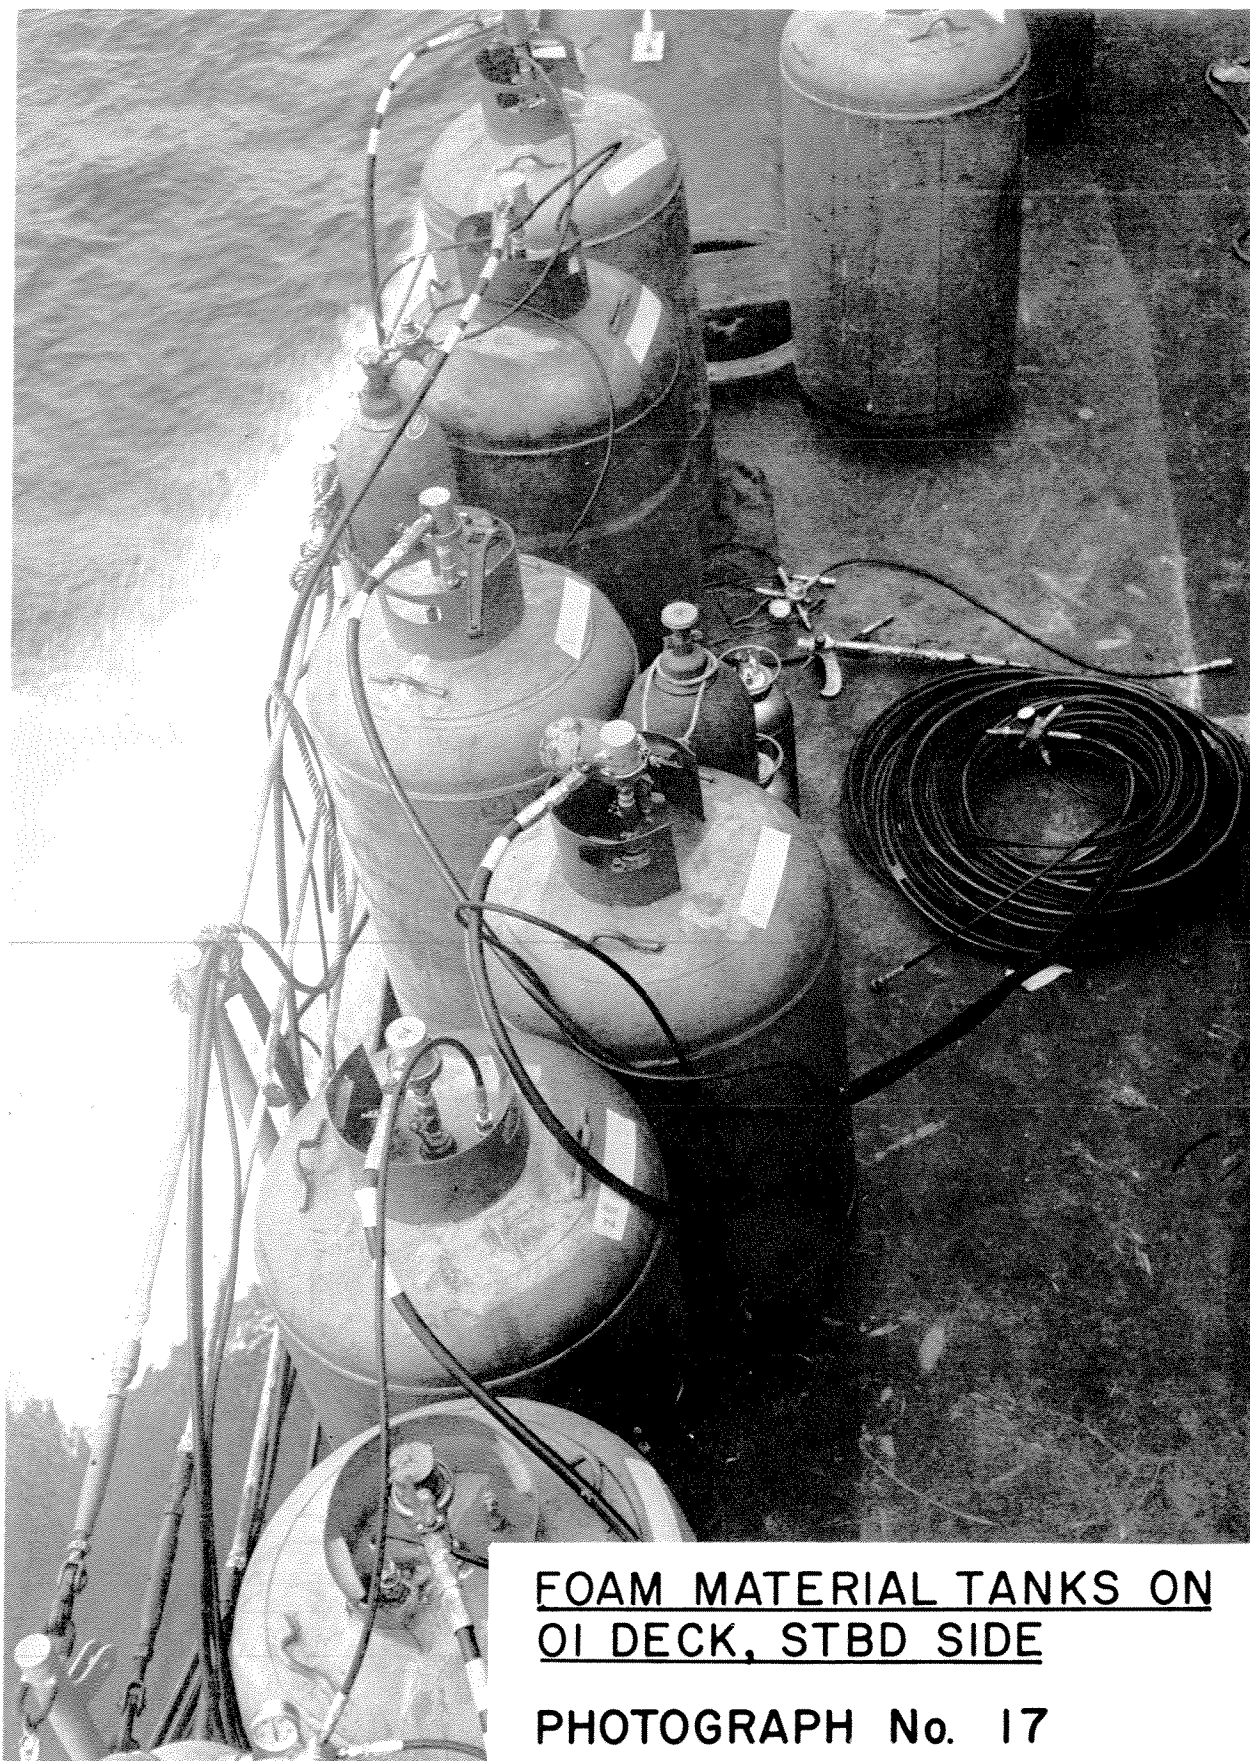
PHOTOGRAPH No. 17

NOTE: In Photograph 17, page 70, note several "pairs" of foam mixing tanks aboard USS FRANK KNOX. At the foam filling station (not shown here), resin and Freon are pumped into one tank, while the other tank is filled with a catalyst and Freon in the proper proportions. The materials are then mixed by rolling the tanks. For the foaming operation, the filled tanks of a pair are connected to the gun by separate hoses where the materials are mixed together. The Freon forms small bubbles in the mixture which quickly expands and hardens in a matter of minutes. The materials are forced through the hose under pressure by an inert gas, nitrogen, in this case. Each pair contains about 1000 lbs. of material that will displace approximately 10 tons of water when mixed and expanded. It takes approximately one hour to expand one pair through one gun.

FOAM MATERIAL TANKS ON
OI DECK, STBD SIDE

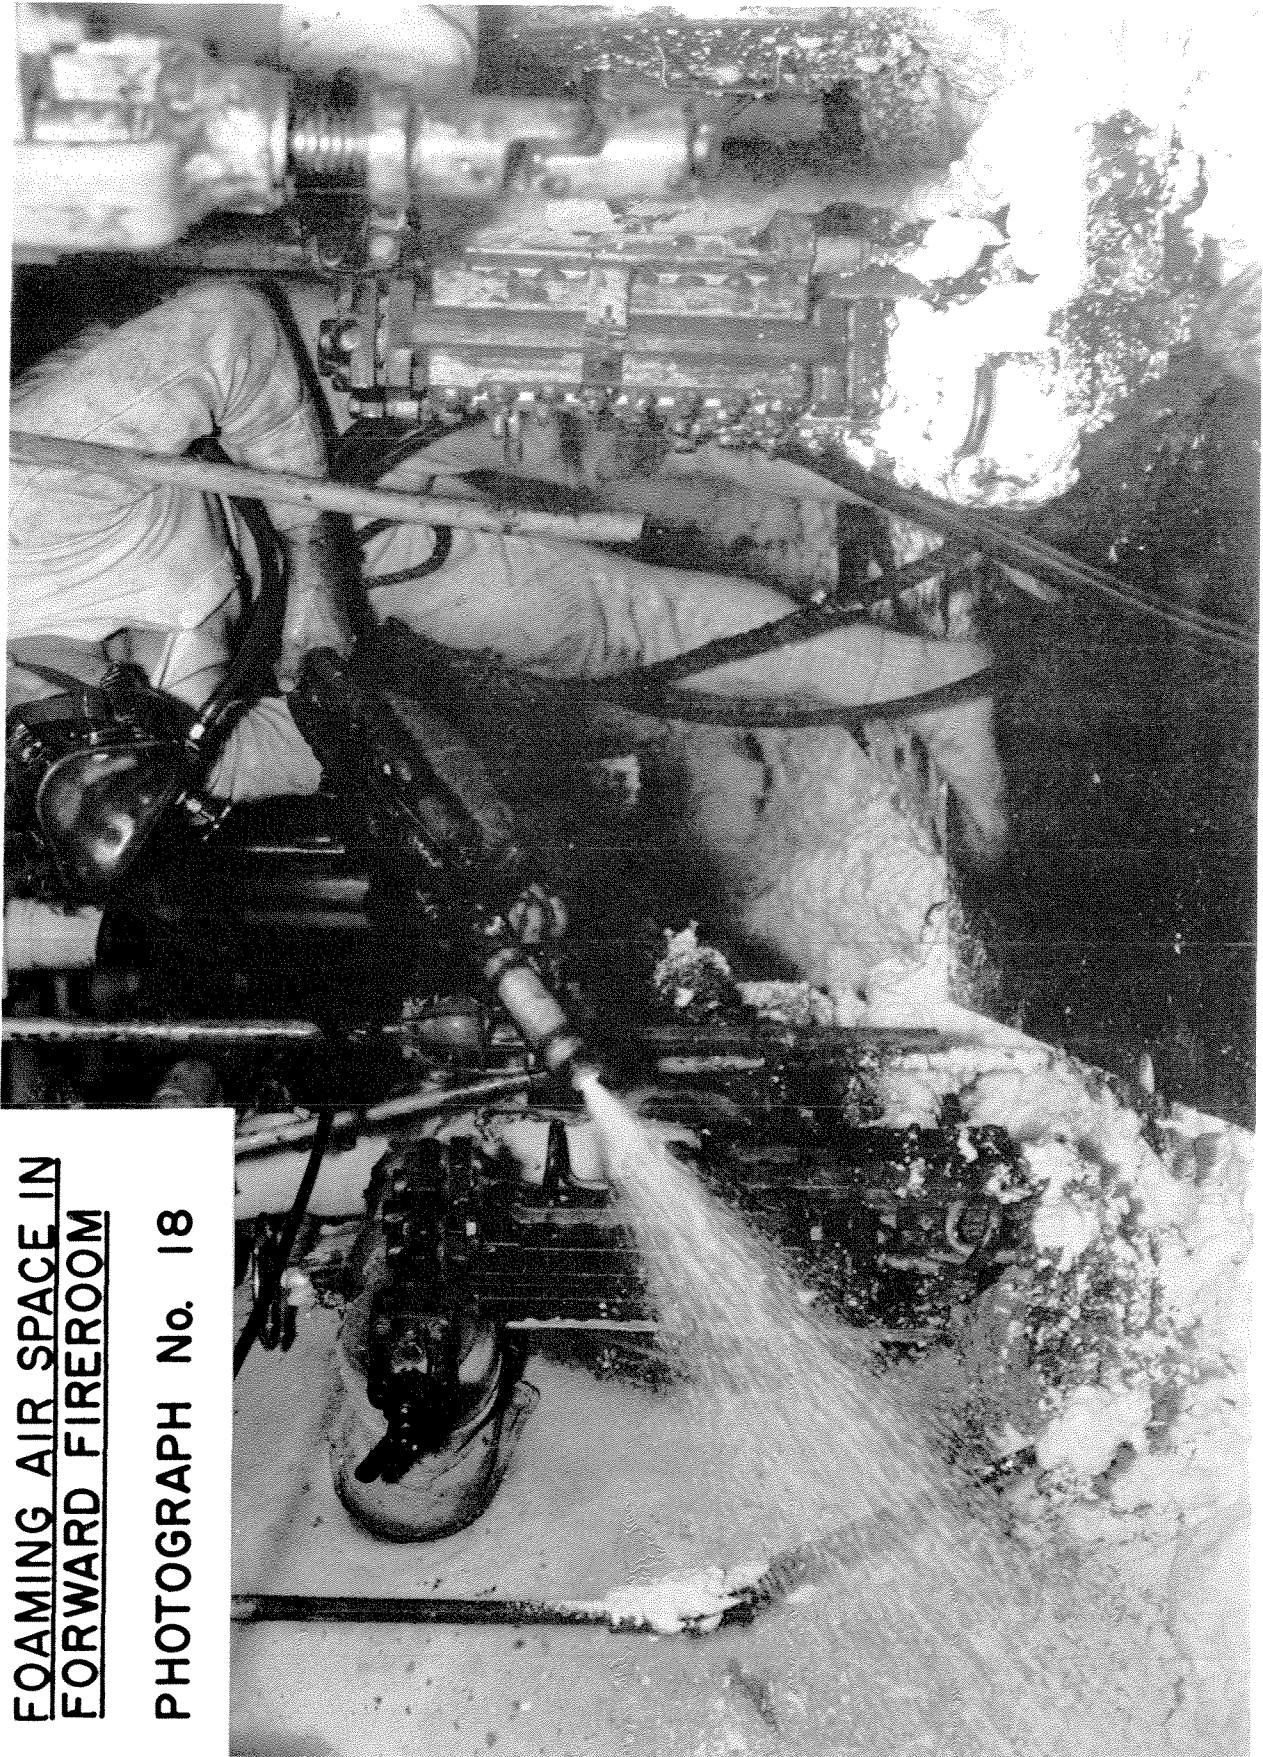
PHOTOGRAPH No. 18

NOTE: In Photograph 18, page 72, note a diver from USS GREENLET (ASR 10) building up a layer of foam in the upper level of the forward fireroom of FRANK KNOX. (It was necessary to foam above the waterline prior to proceeding with the underwater portions.) The diver is standing on plywood that had been laid on a layer of foam about two feet thick. Note the gun with two separate supply hoses carrying the resin and catalyst. The materials are mixed together in the small mixing chamber beyond the trigger. A barrel of appropriate length was added to the mixing chamber for foaming underwater.

**FOAMING AIR SPACE IN
FORWARD FIREROOM**

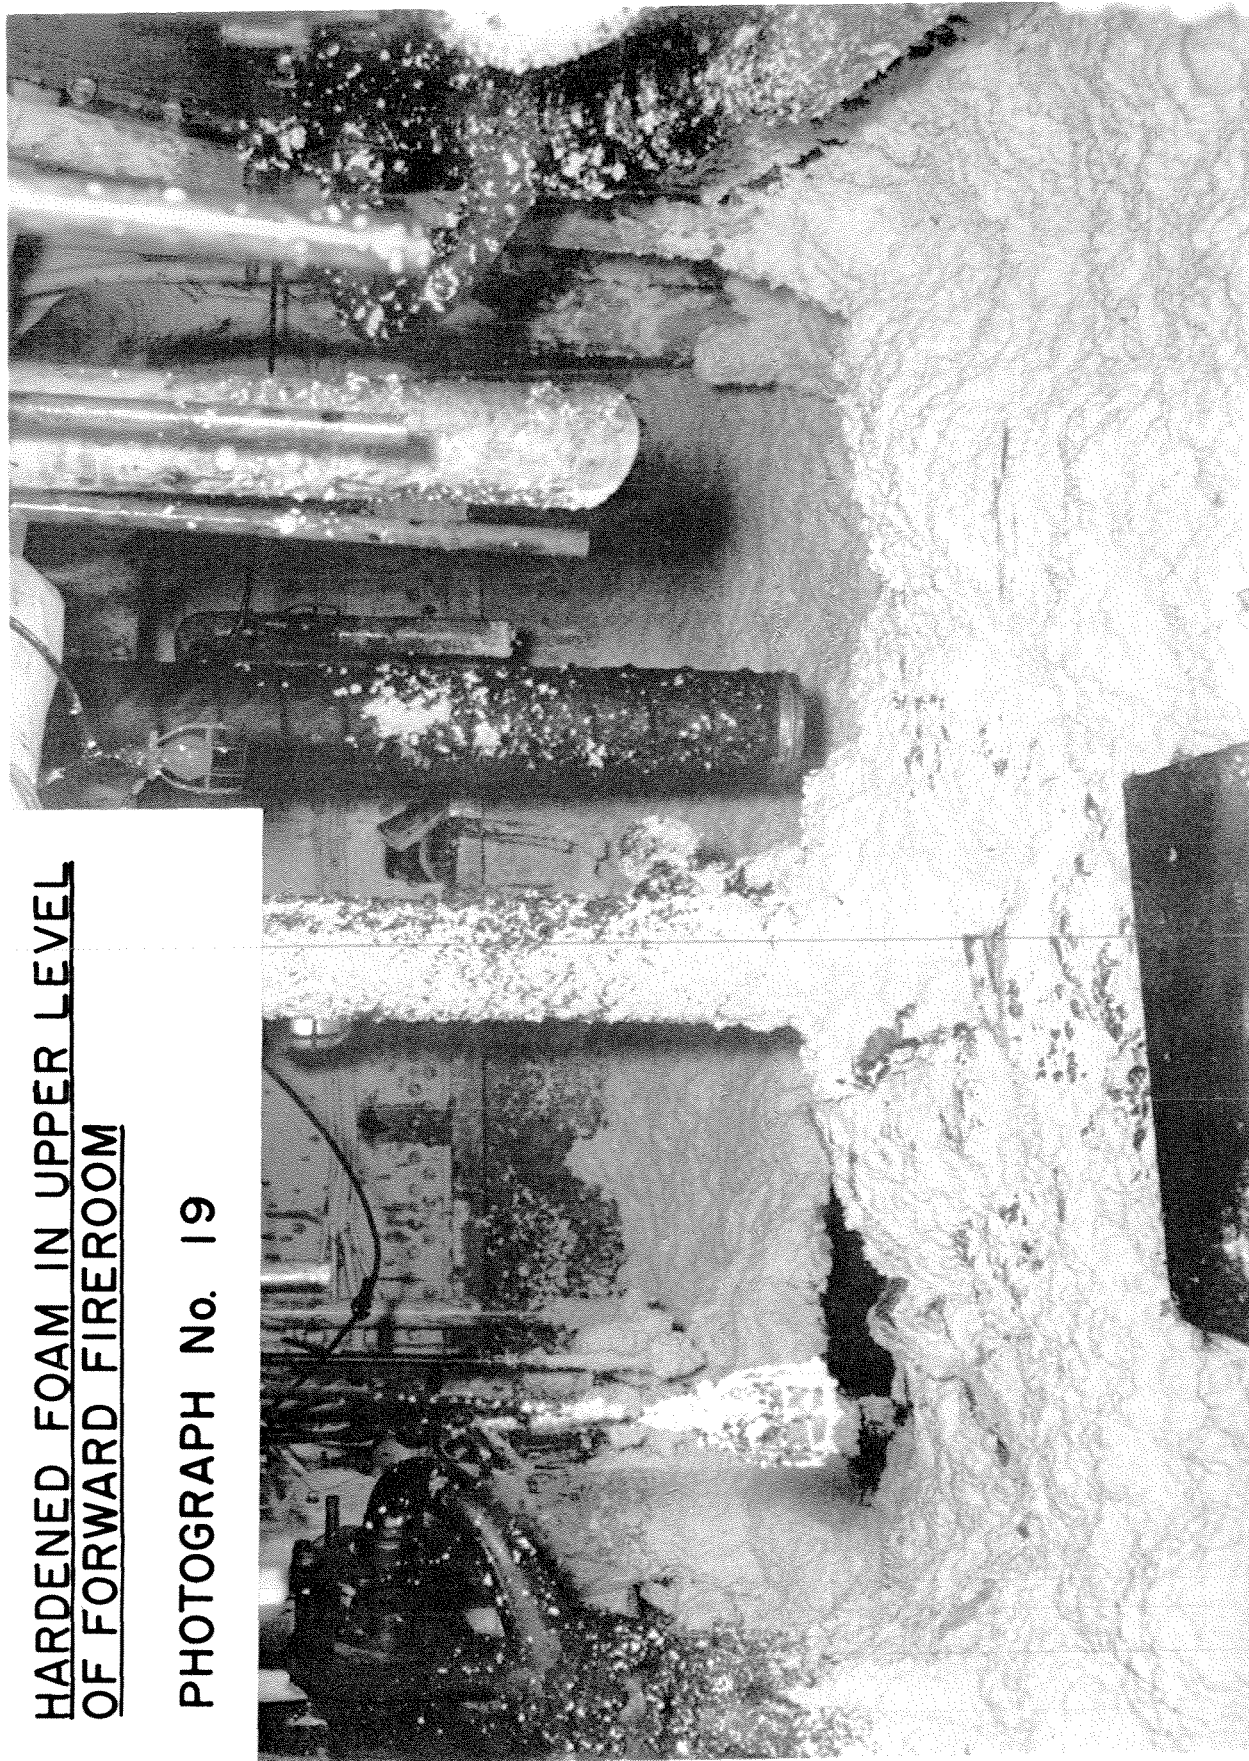
PHOTOGRAPH No. 19

HARDENED FOAM IN UPPER LEVEL
OF FORWARD FIREROOM

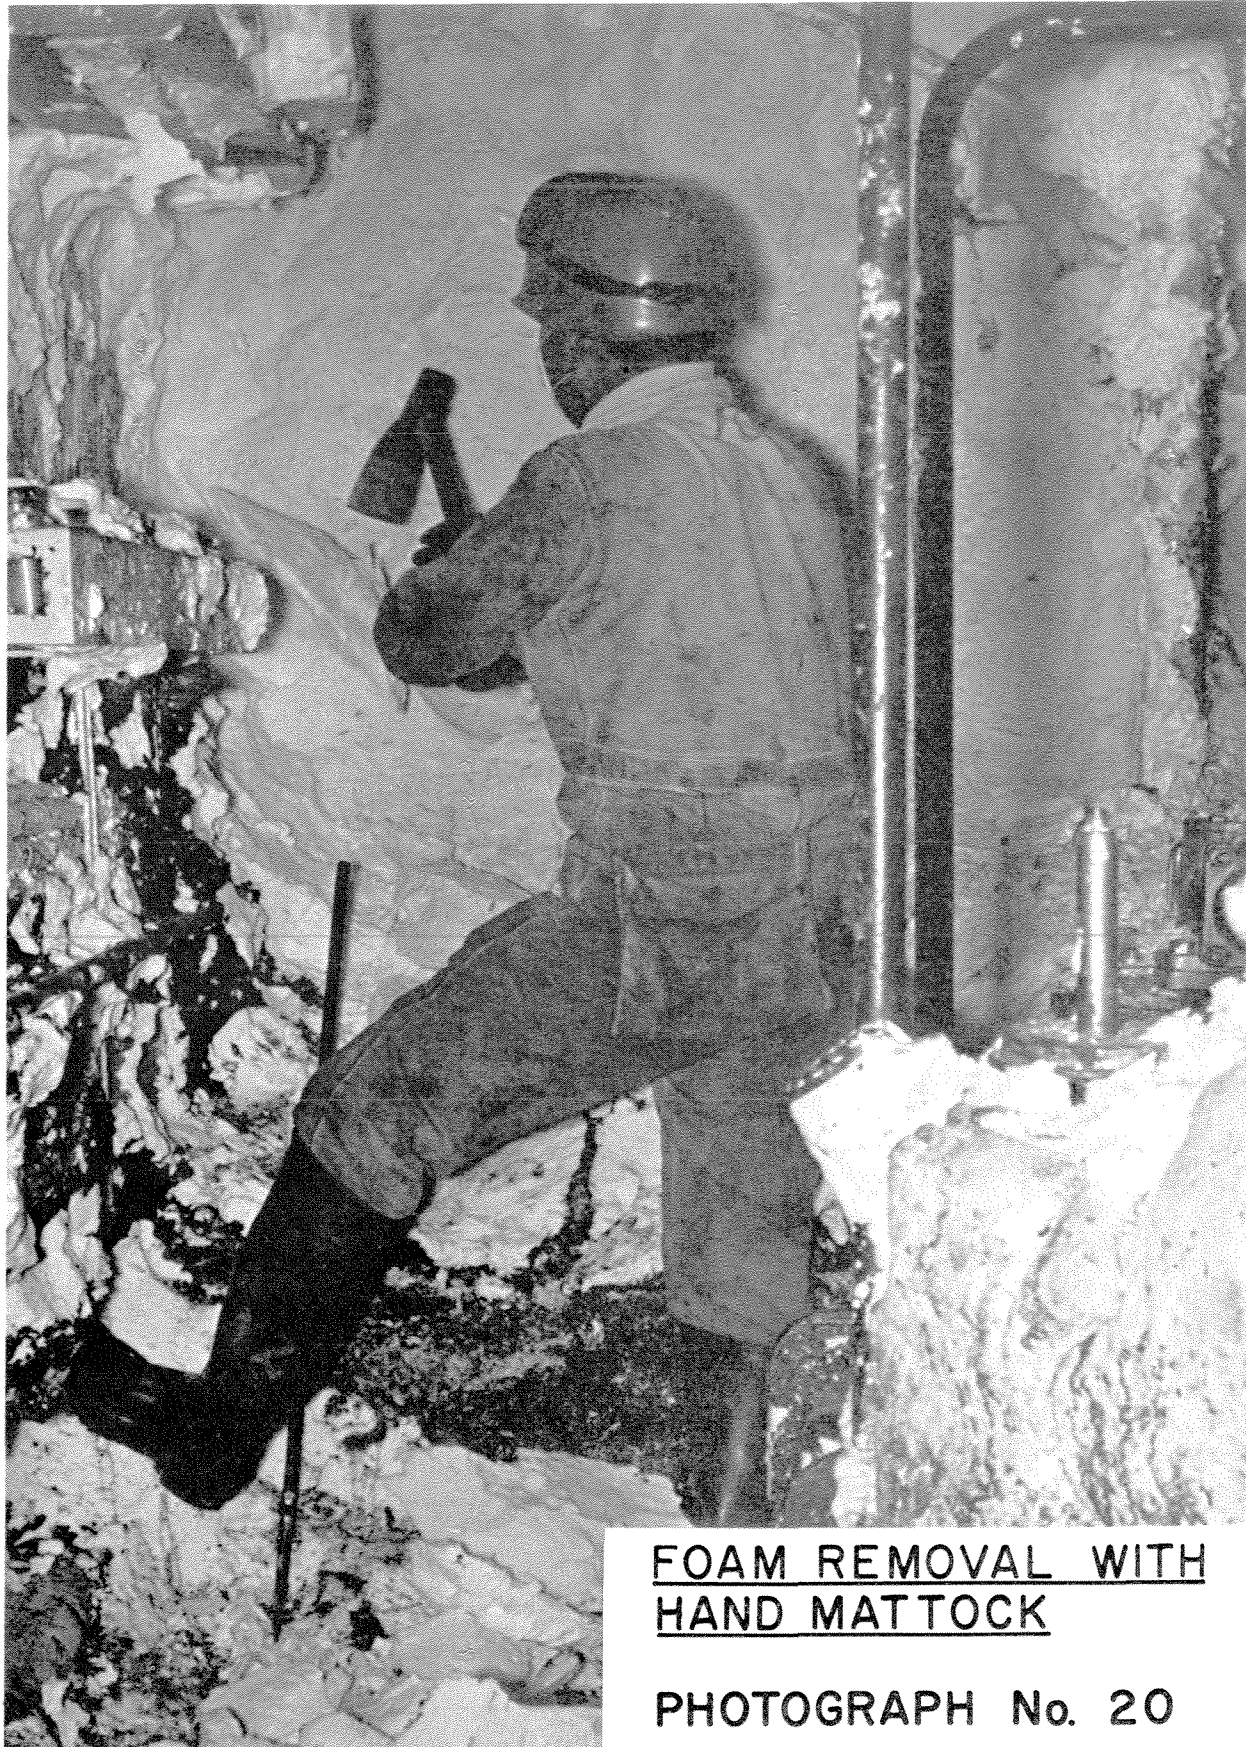
PHOTOGRAPH No. 20

FOAM REMOVAL WITH
HAND MATTOCK

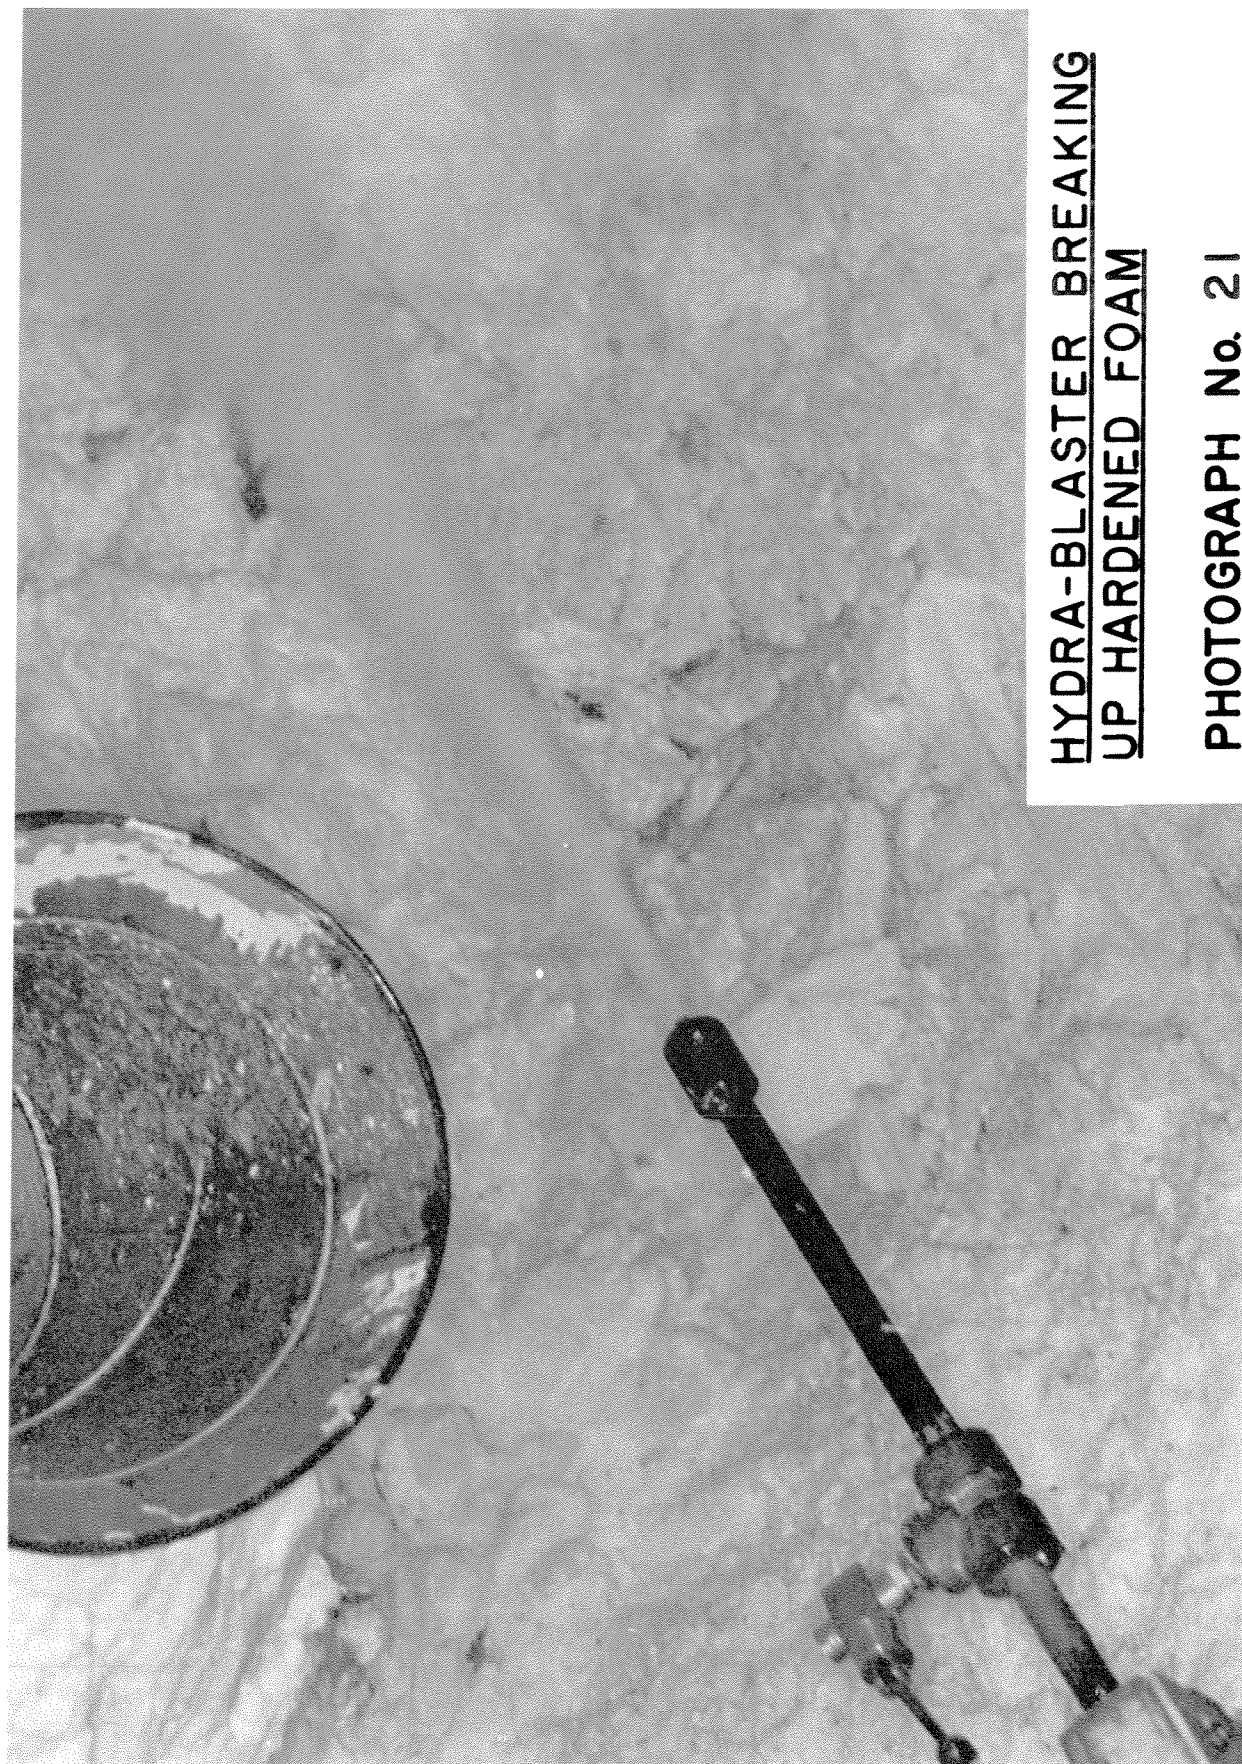
PHOTOGRAPH No. 21

**HYDRA-BLASTER BREAKING
UP HARDENED FOAM**
