USS FRANK KNOX (DDR-742) STRANDING SALVAGE

NAVSHIPS 0994-002-6010

DEPARTMENT OF THE NAVY
NAVAL SHIP SYSTEMS COMMAND
WASHINGTON, D.C.

1968

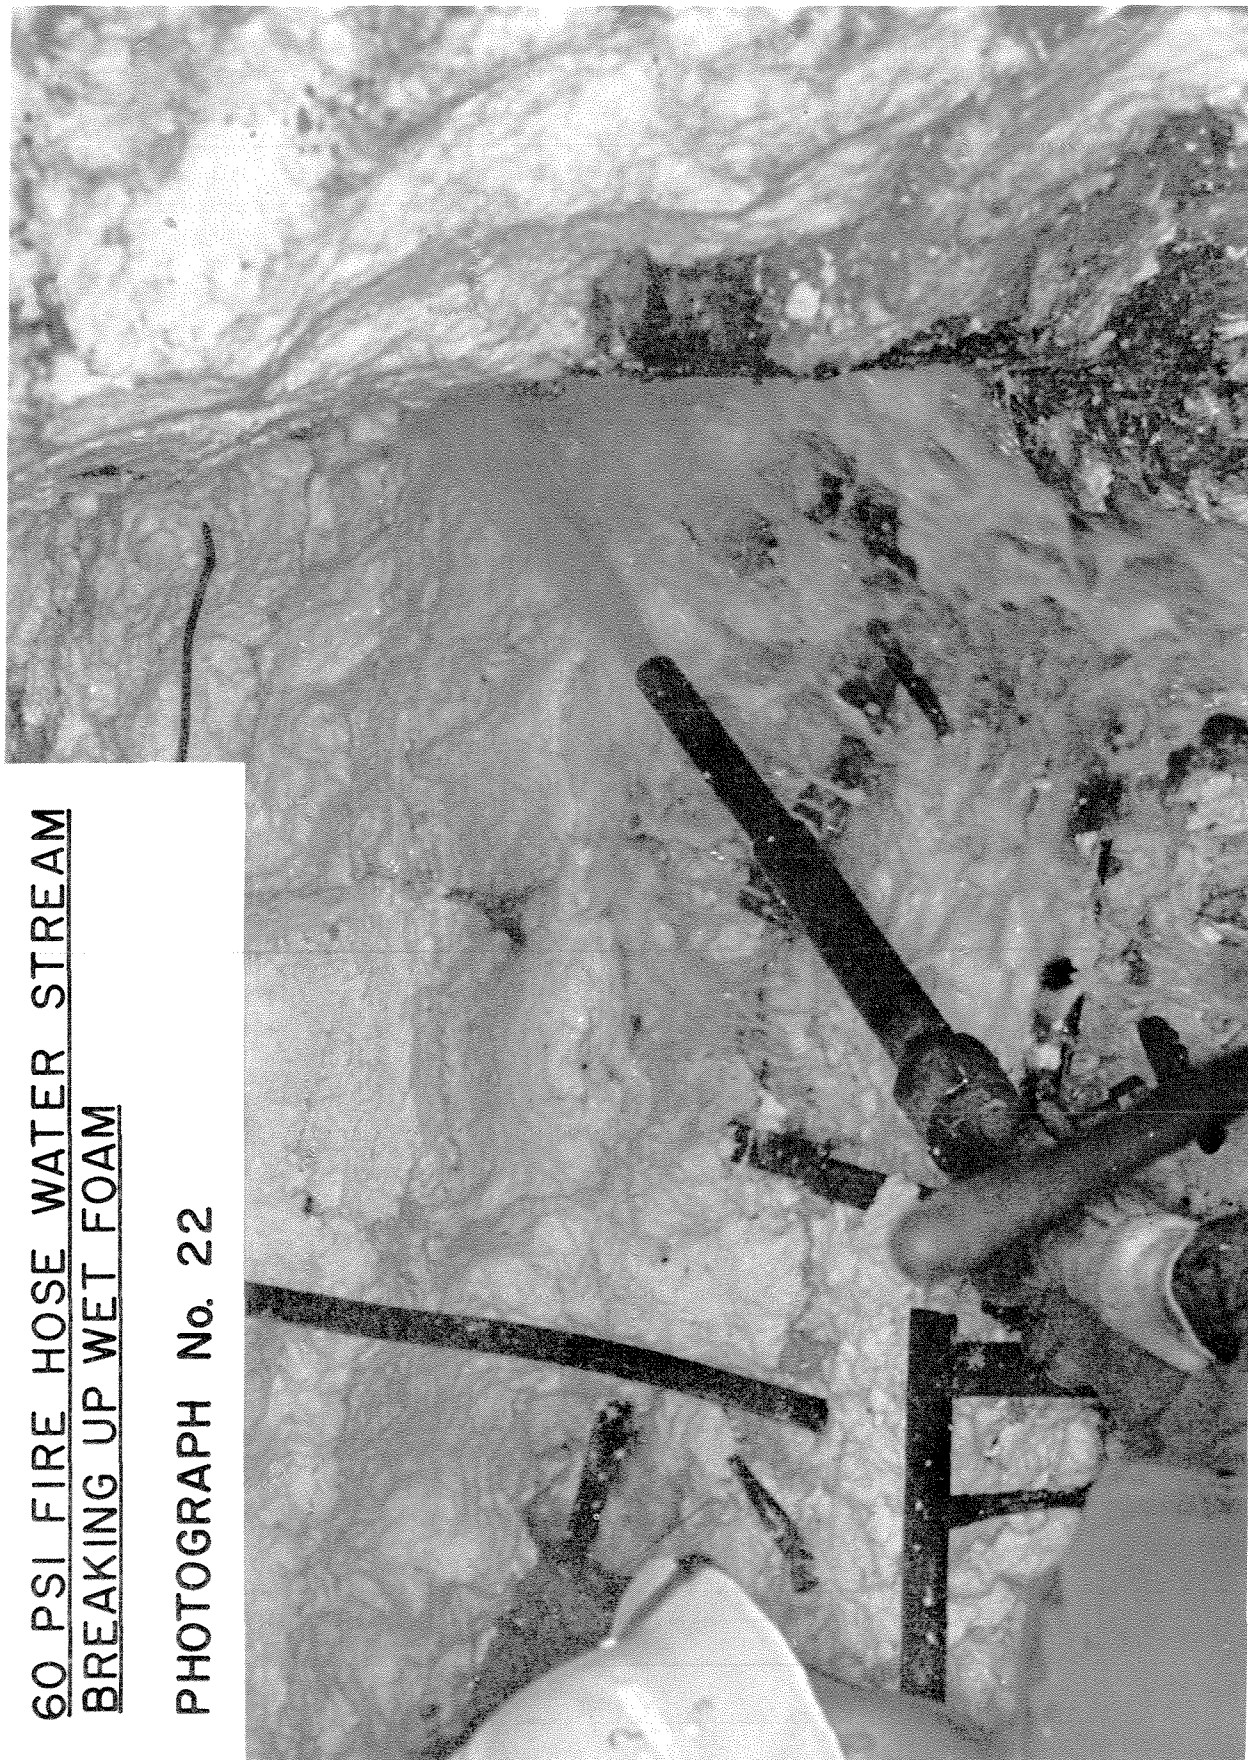
PHOTOGRAPH No. 22

60 PSI FIRE HOSE WATER STREAM
BREAKING UP WET FOAM

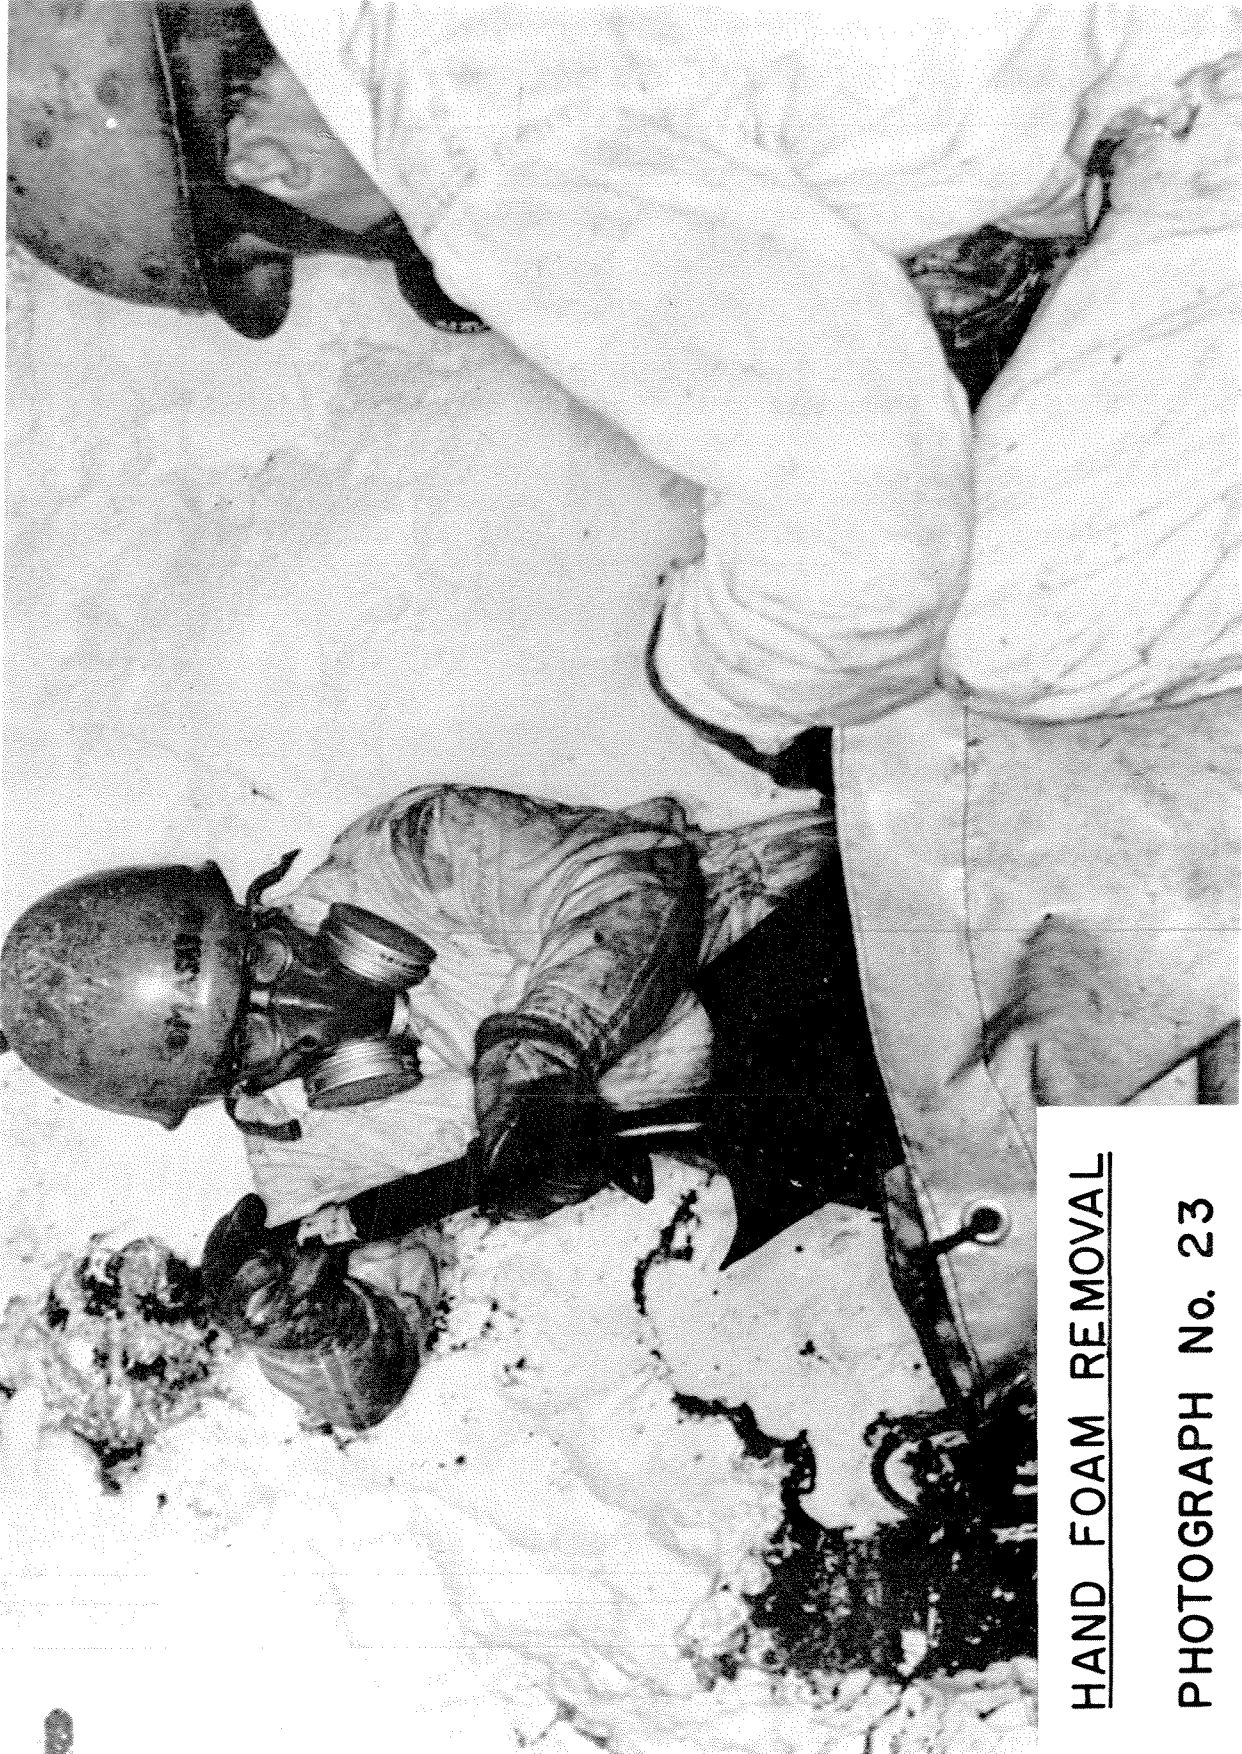
PHOTOGRAPH No. 23

HAND FOAM REMOVAL
