Wiss, Janney, Elstner Associates, Inc.
330 Pfingsten Road
Northbrook, Illinois 60062
847.272.7400 tel
www.wje.com

September 1, 2020

Response Plan for the Arecibo Observatory Cable Failure

RESPONSE PLAN FOR THE AUXILIARY CABLE FAILURE AT THE ARECIBO OBSERVATORY

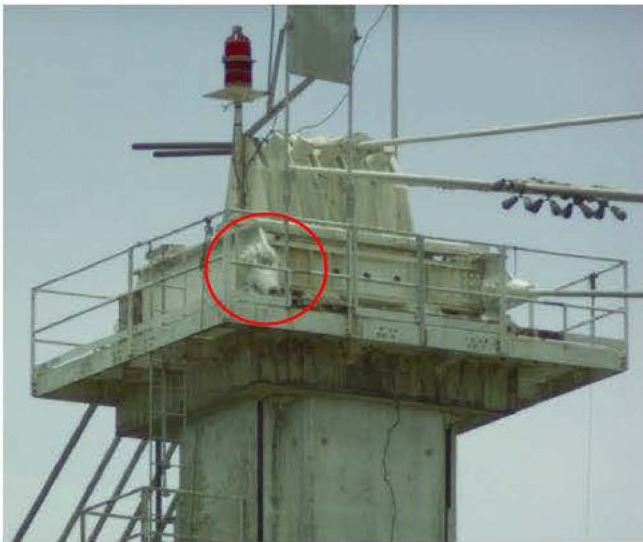
Once Step 1.1 is complete, recovery of the failed clevis can commence. Removal of the clevis will require personnel to climb Tower T4, secure the clevis to the tower, remove the pin, and then lower the clevis to the ground. This work will be done during low wind conditions and in accordance with a task-specific safety plan. All personnel will have appropriate PPE and will be tied off to proper anchorages during their ladder ascent/descent and while working on the top platform. Personnel working on the top platform should remain next to the failed socket and avoid positioning themselves in front of or below any other live cable socket. Figure 5 is a long-distance view of the failed clevis.

Figure 5. Failed clevis (circled). Photo from AO.

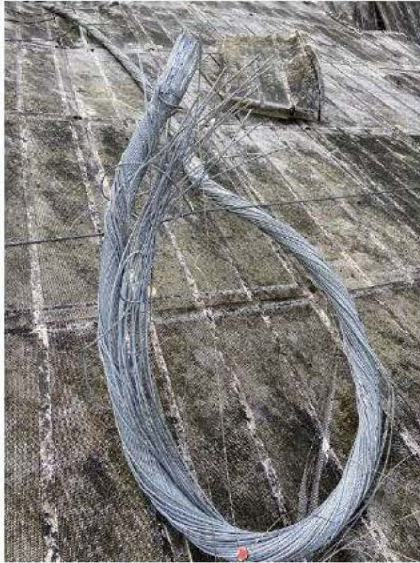
Approximately 10 feet of the failed cable including the failed end should be recovered (see Figure 6). This will require accessing the lower portion of the primary reflector, securing the individual wires using steel clamps (hose clamps or similar), holding the segment of cable with a material handler, cutting the cable with an electric saw, and lowering the material to the ground. This work will be done during low wind

Figure 6. Cable end to be recovered.
Photo from AO.

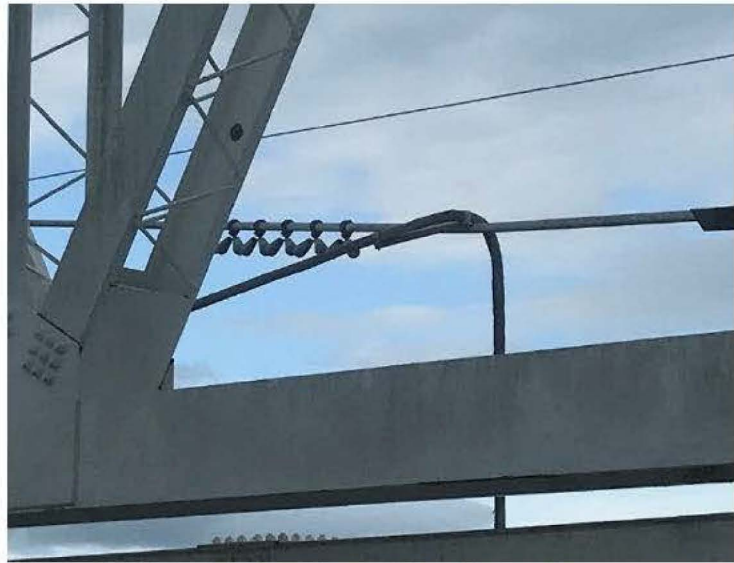
Figure 7. Failed cable draped over T12 auxiliary cable.
Photo from AO.

Removal of the remaining attached socket and draped length of cable can proceed after the monitoring and socket bypass retrofits of Steps 1.3 and 1.4 have been installed. These steps will provide further assurance that work on and below the platform will be reasonably safe. Removal of the still-connected socket and cable must avoid damaging the auxiliary cable from Tower T12 over which the failed cable is draped (see Figure 7 above). Because it is advantageous to save the socket and cable for testing, the retrieval effort will need to secure the socket and adjustment rod connection, detach the connection assembly, lift and rotate the assembly away from the supporting cable, and lower it to the ground.
