Description of document: General Services Administration (GSA) Infrastructure Assessment for the Weaver Building (the HUD Headquarters Building) 2013-2025

PROJECT: Department of Housing & Urban development (HUD) Headquarters – Weaver Building
Investigation of Deteriorated Concrete Beams, Floors & Walls

Robert C. Weaver Garage Feasibility Study Final Report Submission

ROBERT C. WEAVER BUILDING

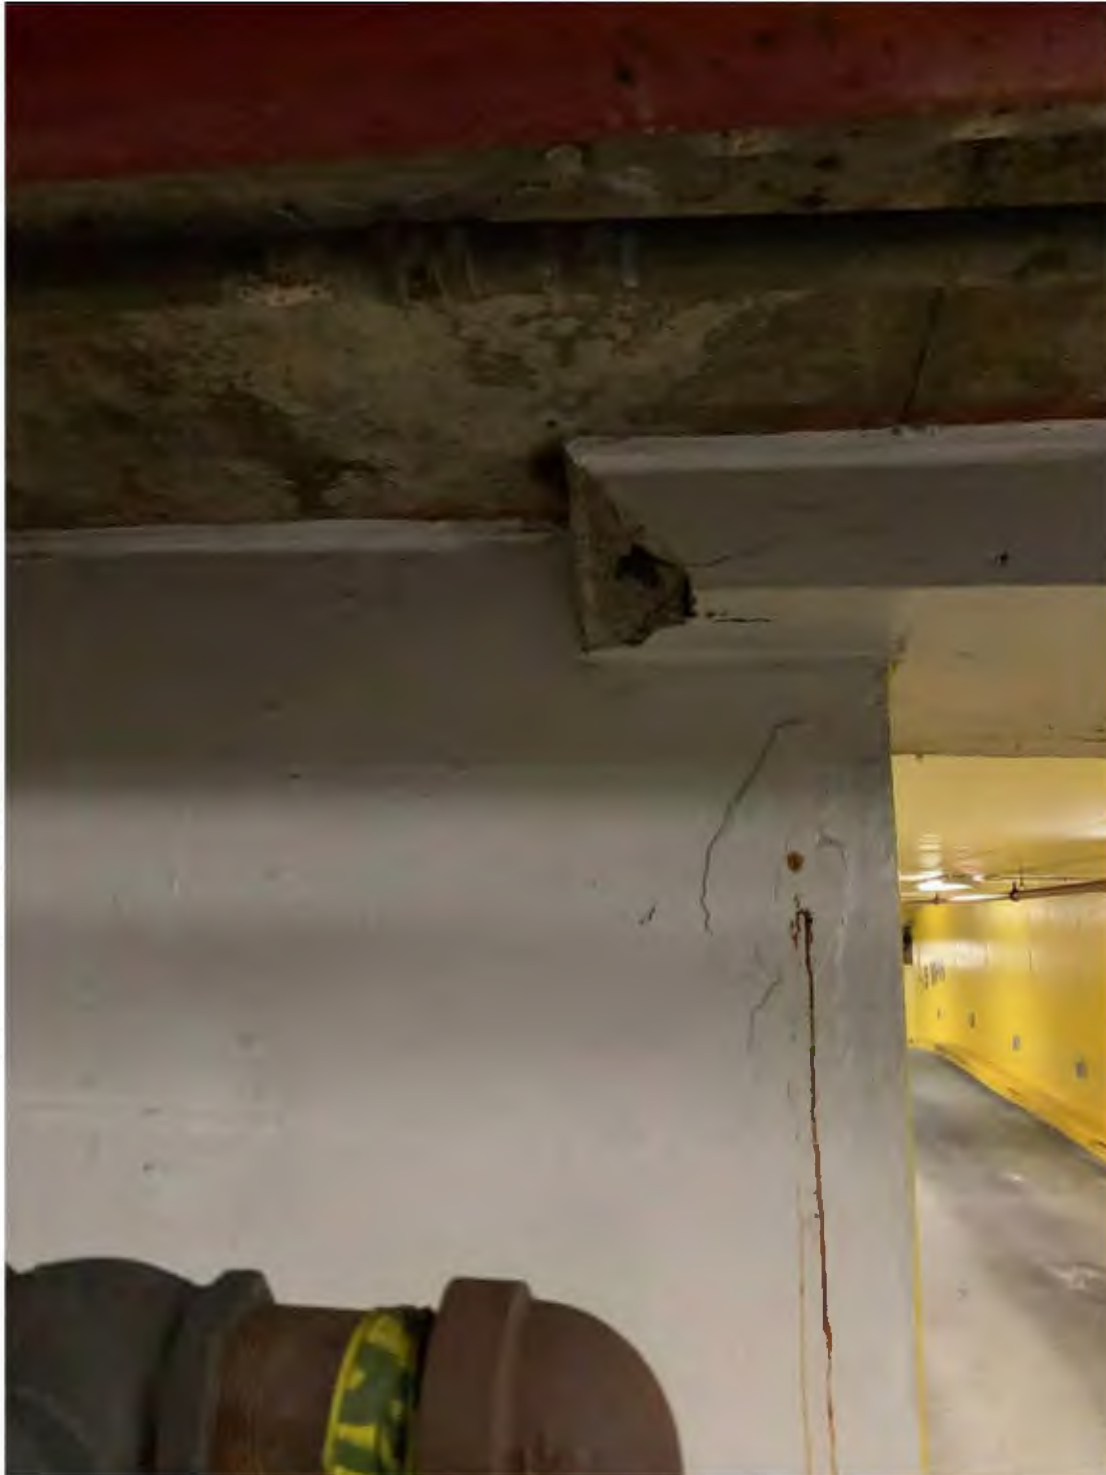
The OPDQ structural engineers noted that the concrete beam at the end of the ramp leading to the Eastern part of the Garage had heavy deterioration with wide horizontal cracks, delaminated concrete and exposed and rusted reinforcing bars. The damage to the concrete beams was noticed at all levels of the landing area. There were signs of efflorescence and water infiltration at some areas of the concrete ramp. Adjacent to the Beams, the concrete waffle floor slabs also showed horizontal cracks, delaminated concrete and rusted reinforcing bars. The concrete beams are supported by concrete walls at the landing area. Those concrete walls show vertical cracks that almost go the whole floor height.

Picture 1: Cracks in Concrete Wall

- 4) Conduct a study and perform the design for solutions on how to repair and strengthen the concrete walls that have been compromised due to cracks.
- 5) Perform periodic inspections of the temporary shoring.

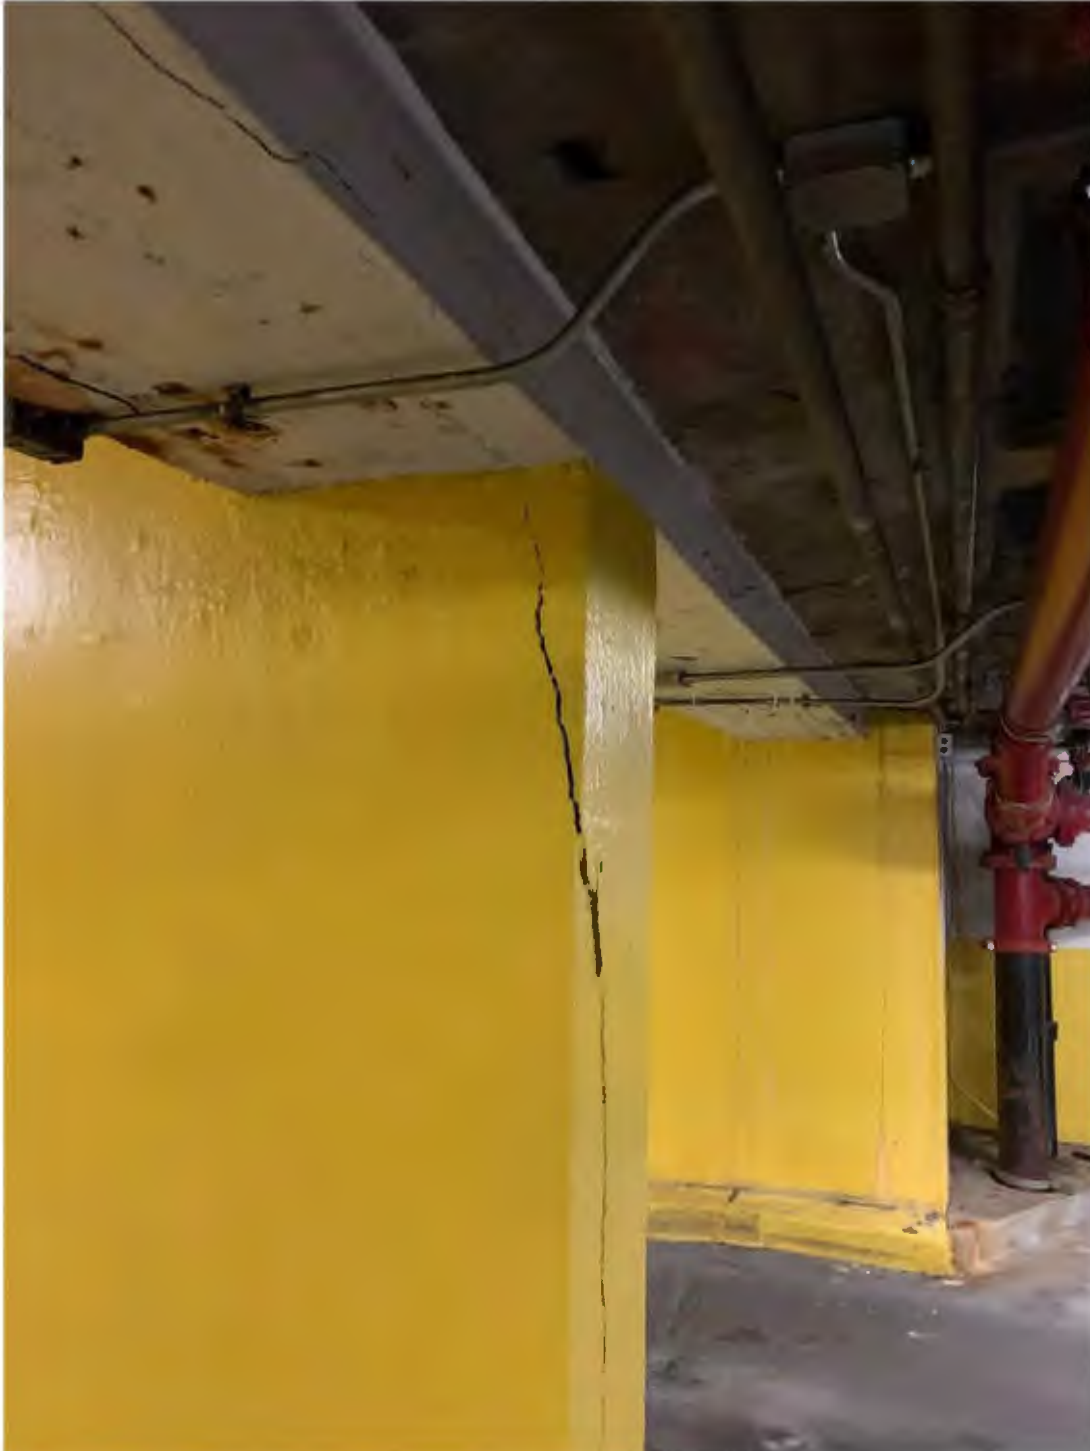
Picture 2: Cracks in Concrete Wall

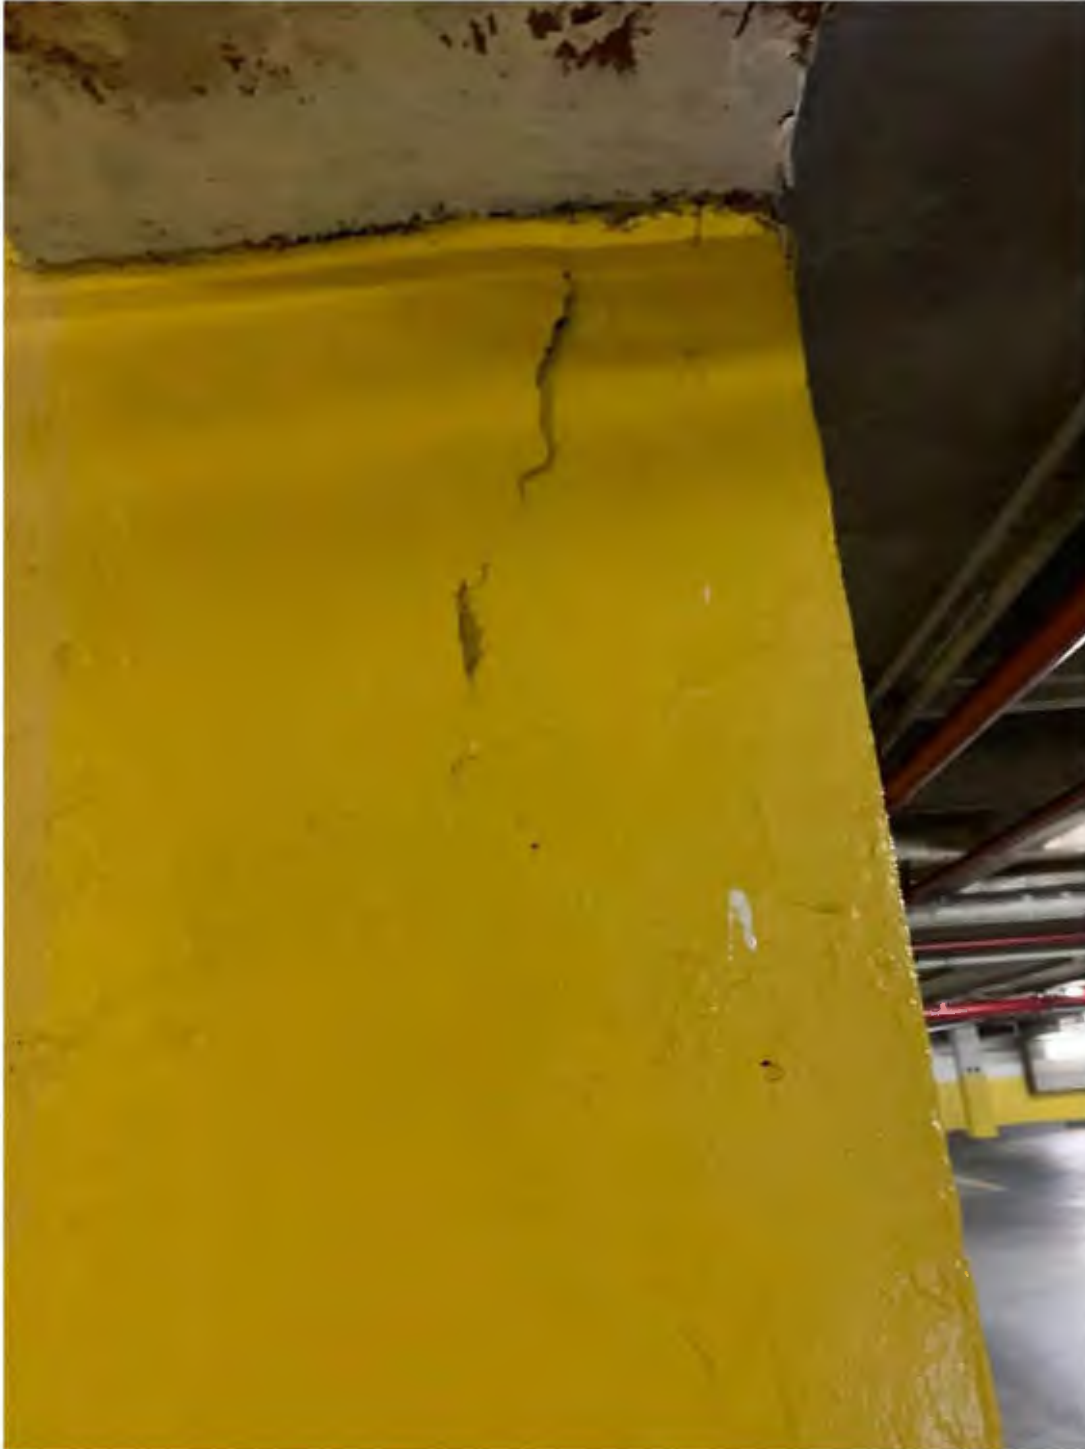
Picture 3: Cracks in Concrete Wall

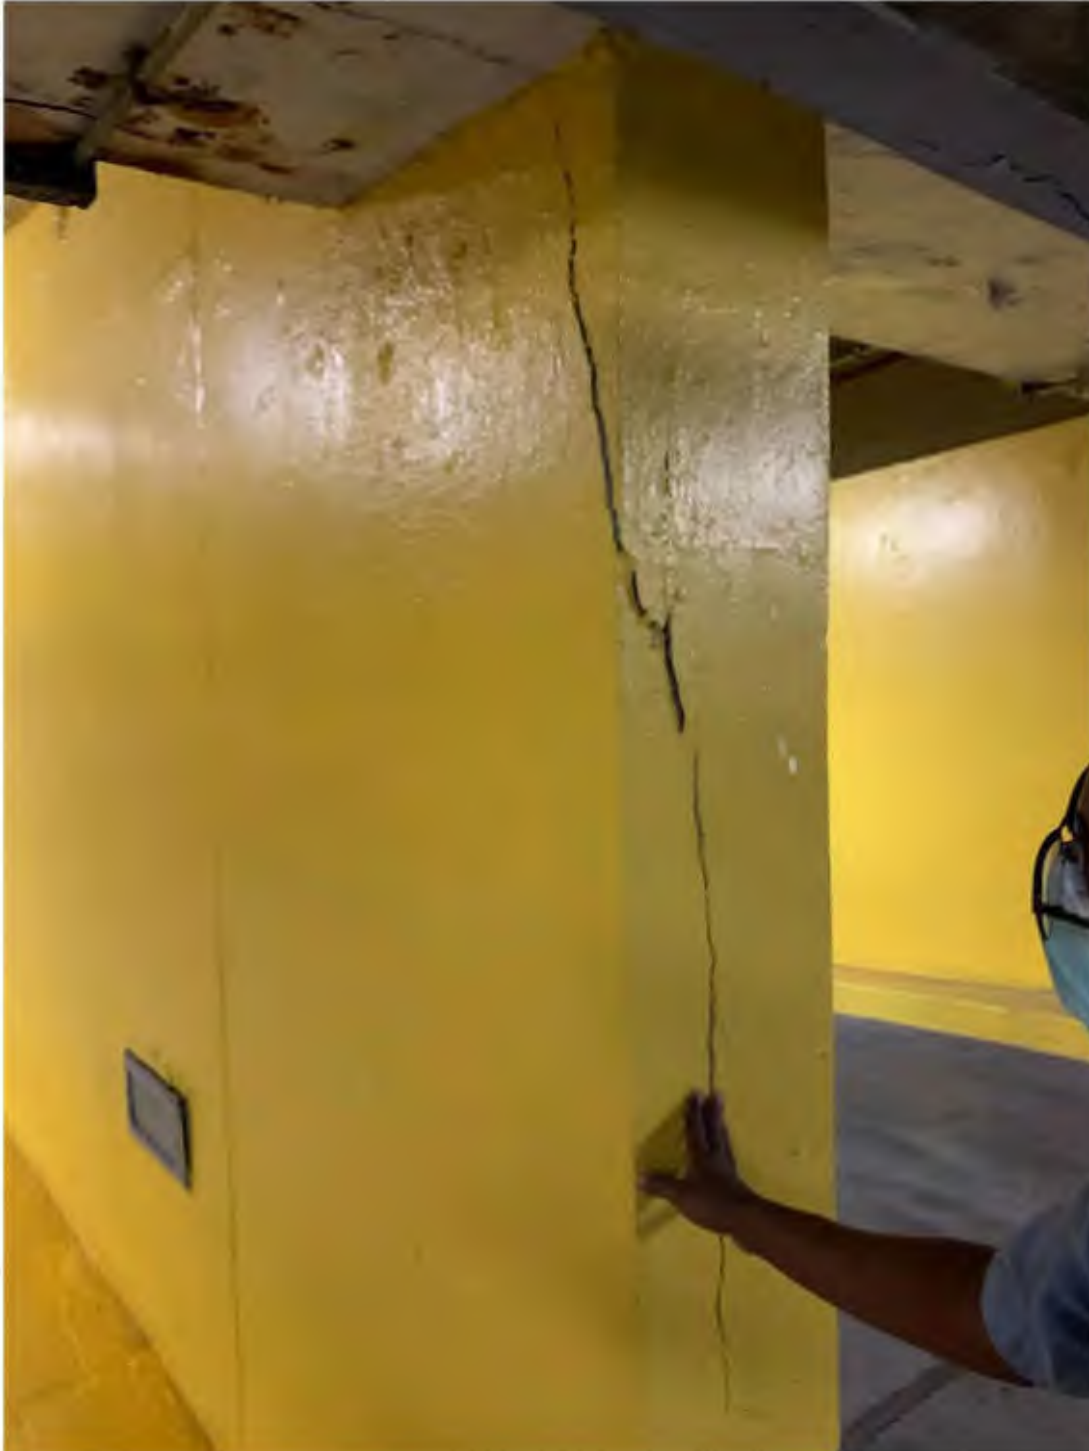
Picture 4: Cracks in Concrete Wall

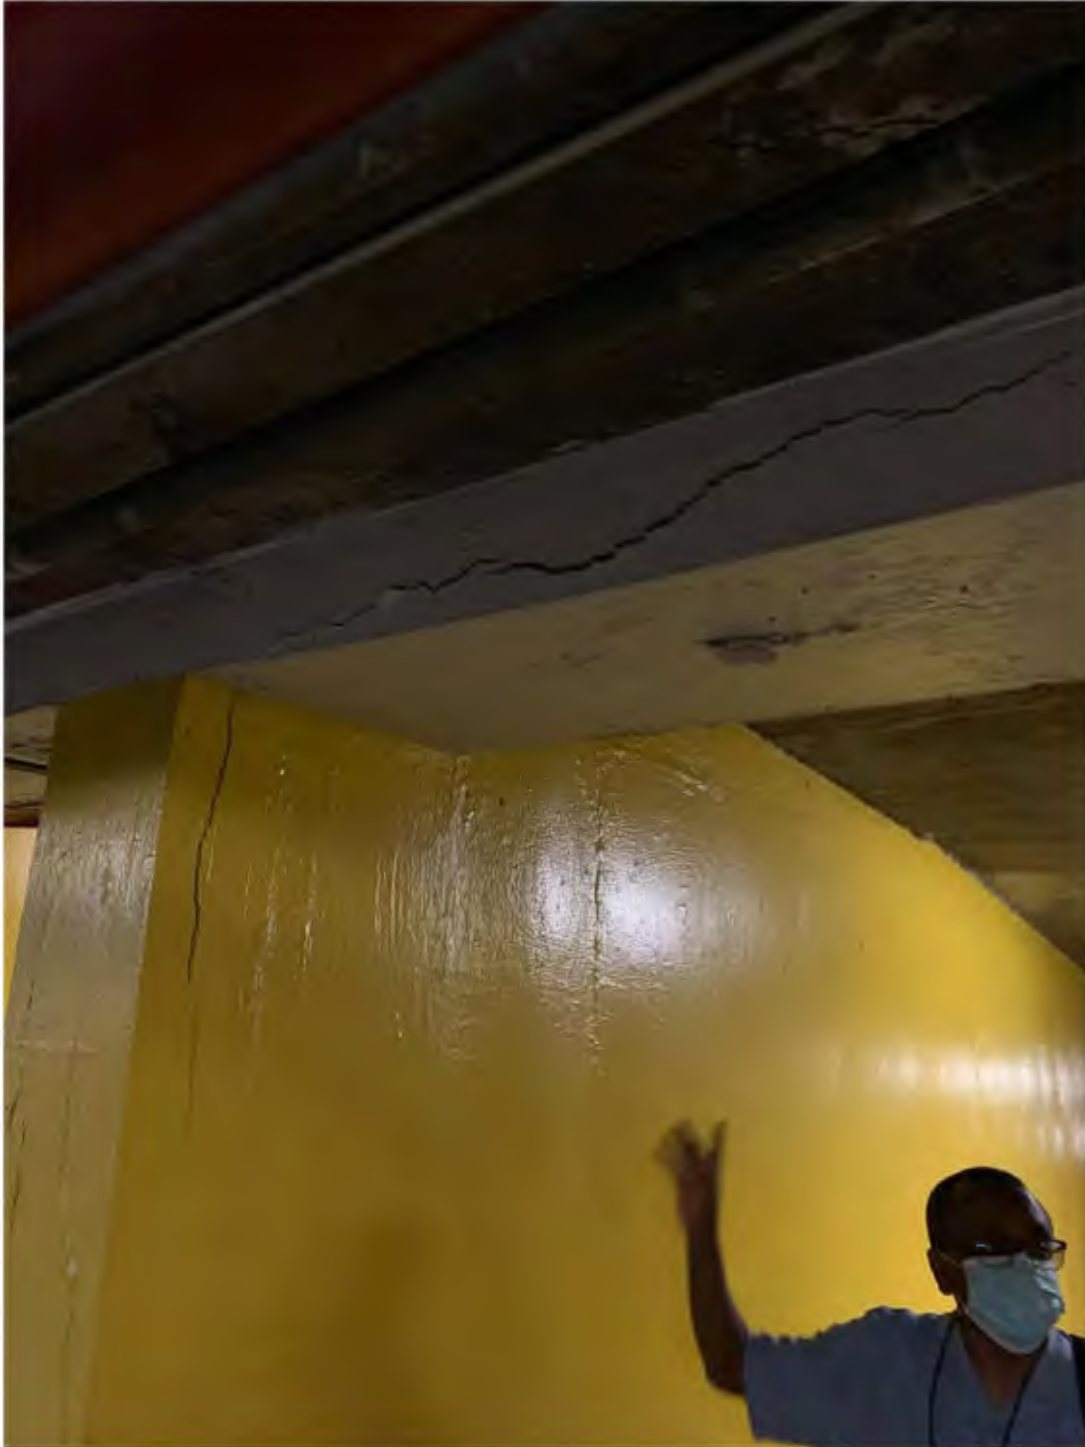
Picture 5: Cracks in Concrete Wall Beam Intersection

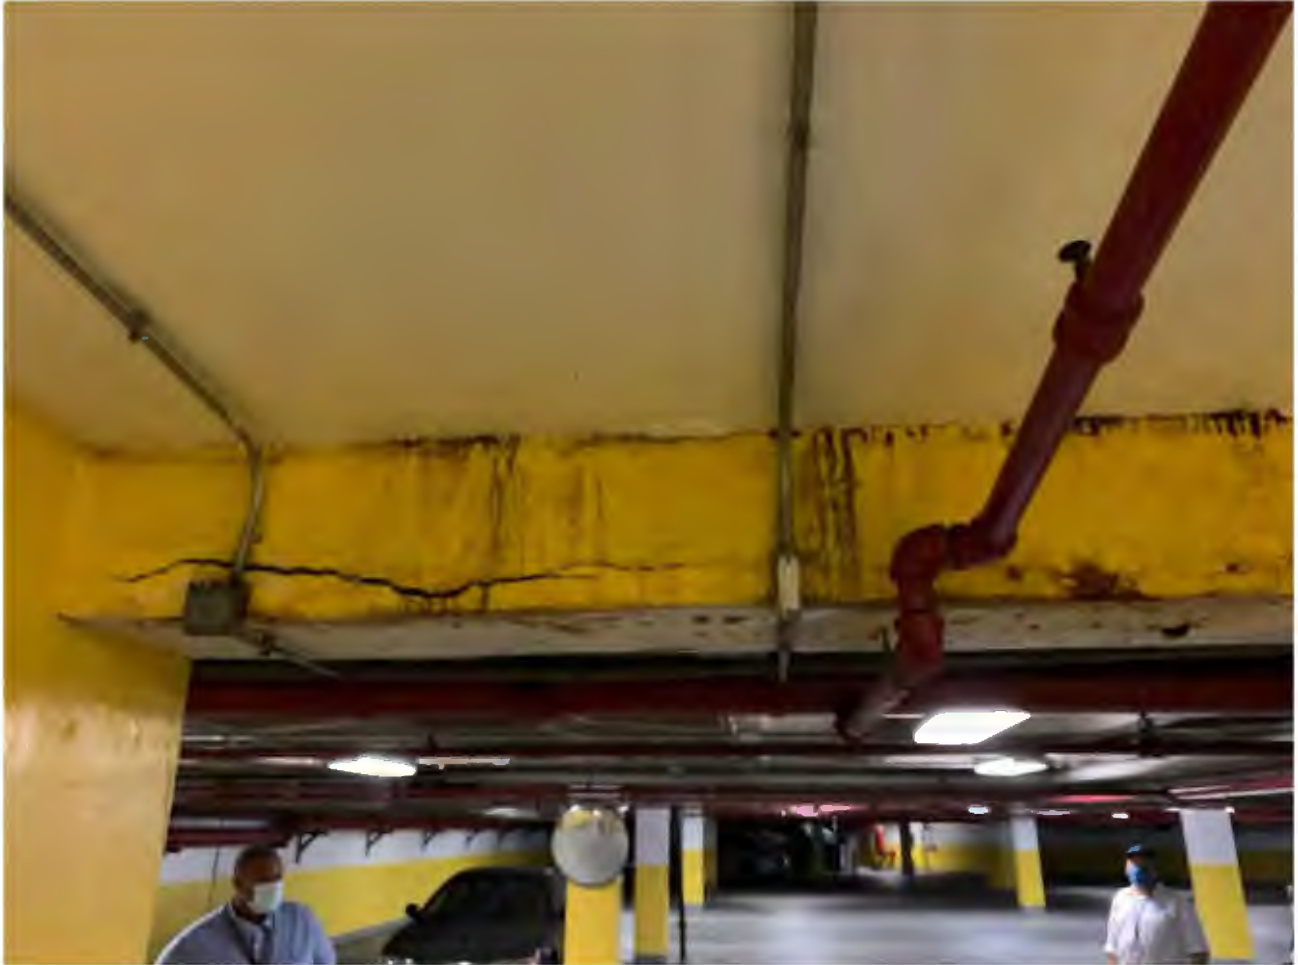
The beams with heavy cracks, rusted rebar have a compromised structural integrity. This deficiency was identified in 2013 and replacement in kind was shown in the repair drawings. Even though excessive structural deformation of the beams was not observed, immediate action is required to mitigate this deficiency.

Picture 6: Deteriorated Concrete Beam

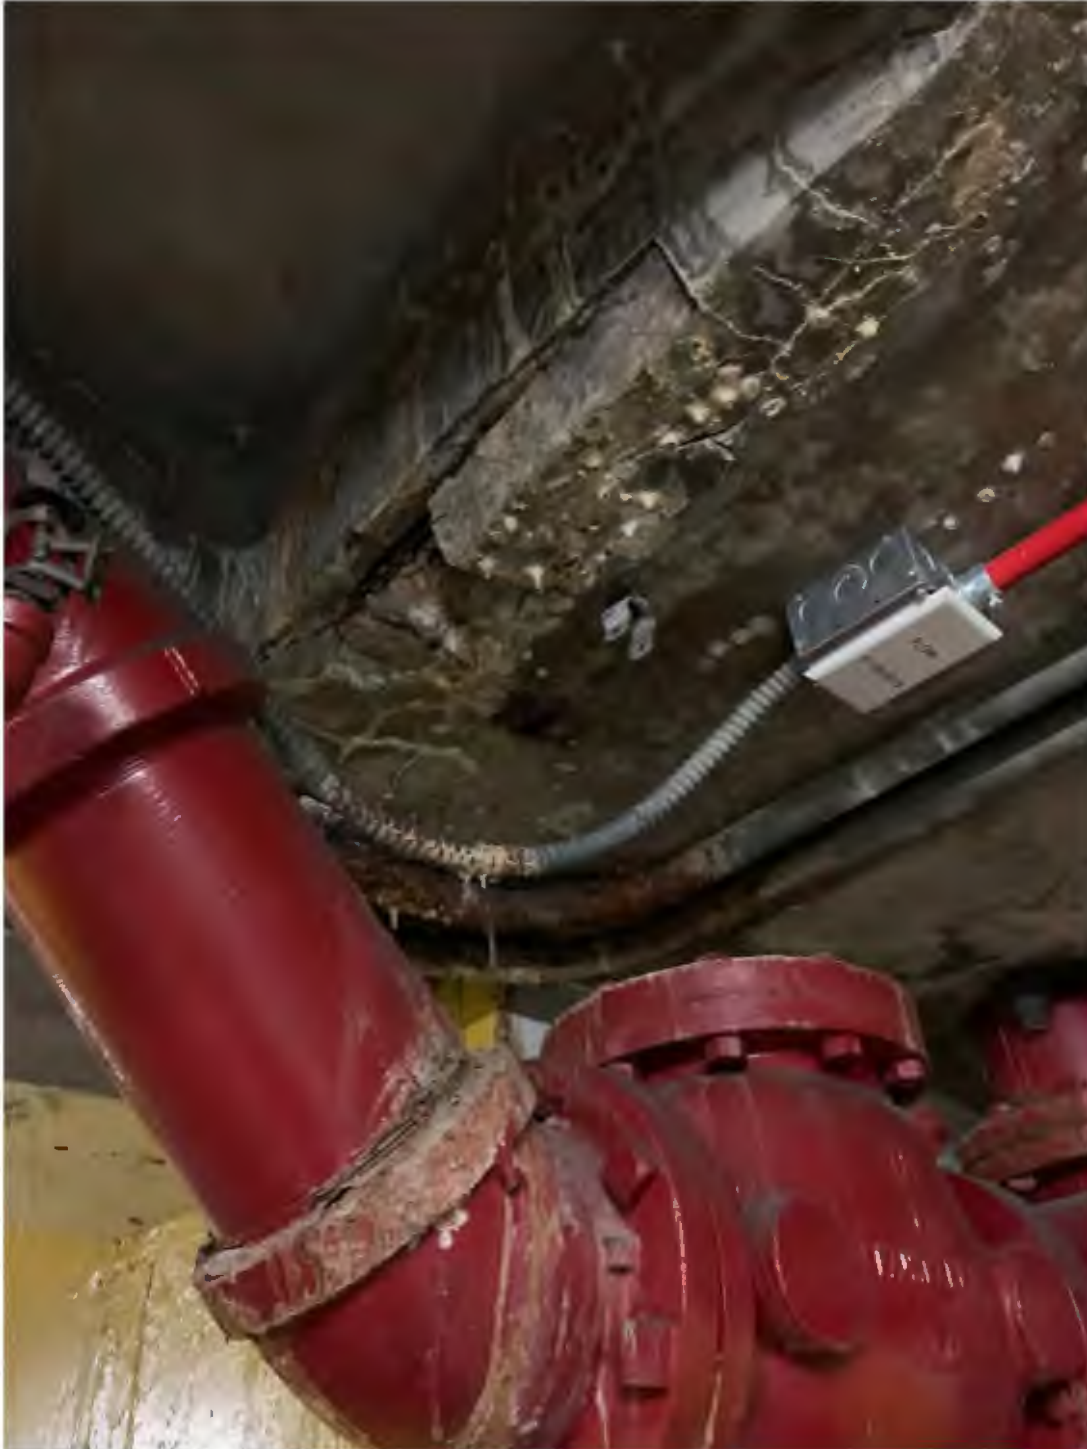
Picture 7: Deteriorated Concrete Beam

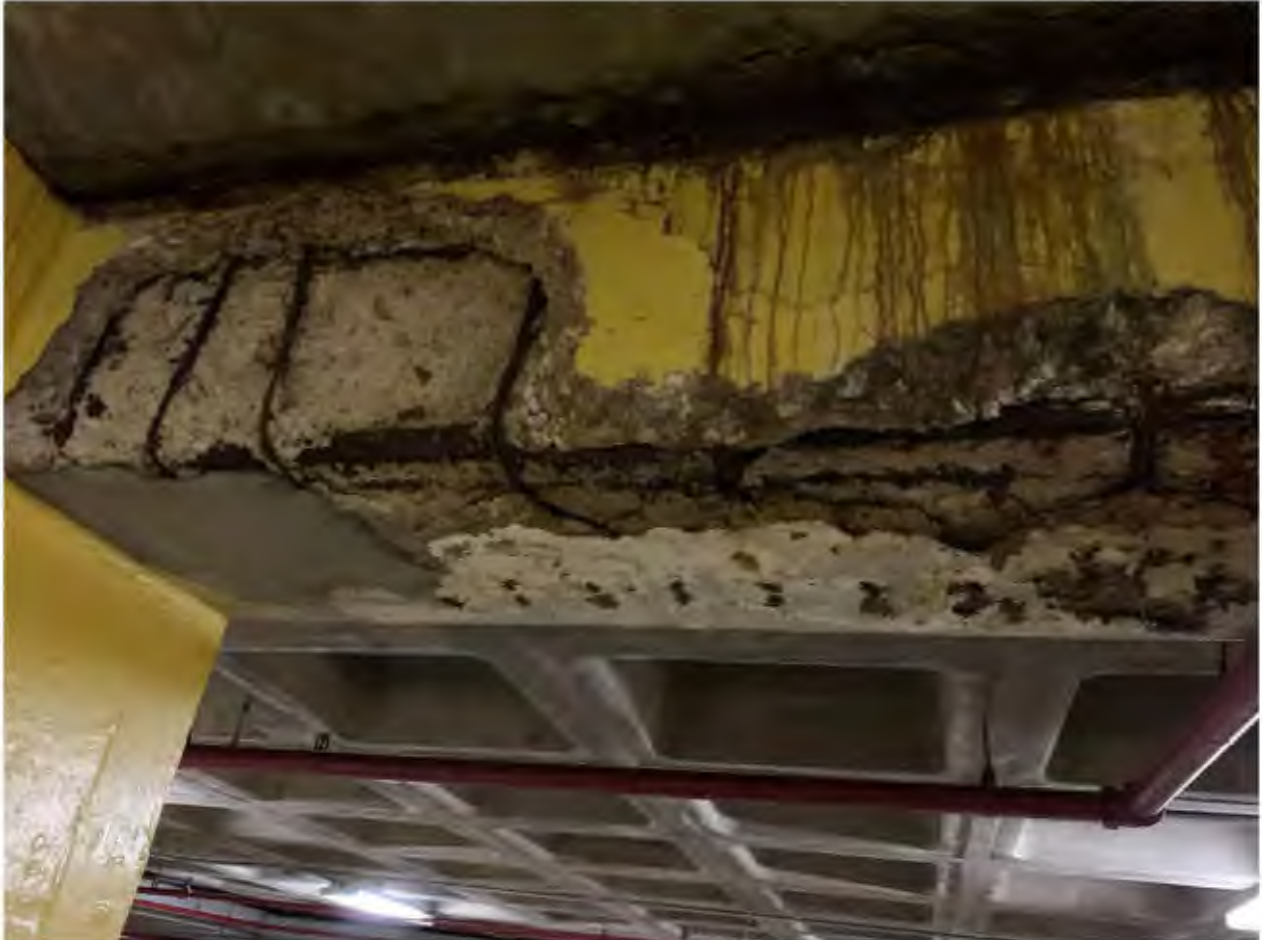
Picture 8: Deteriorated Concrete Beam

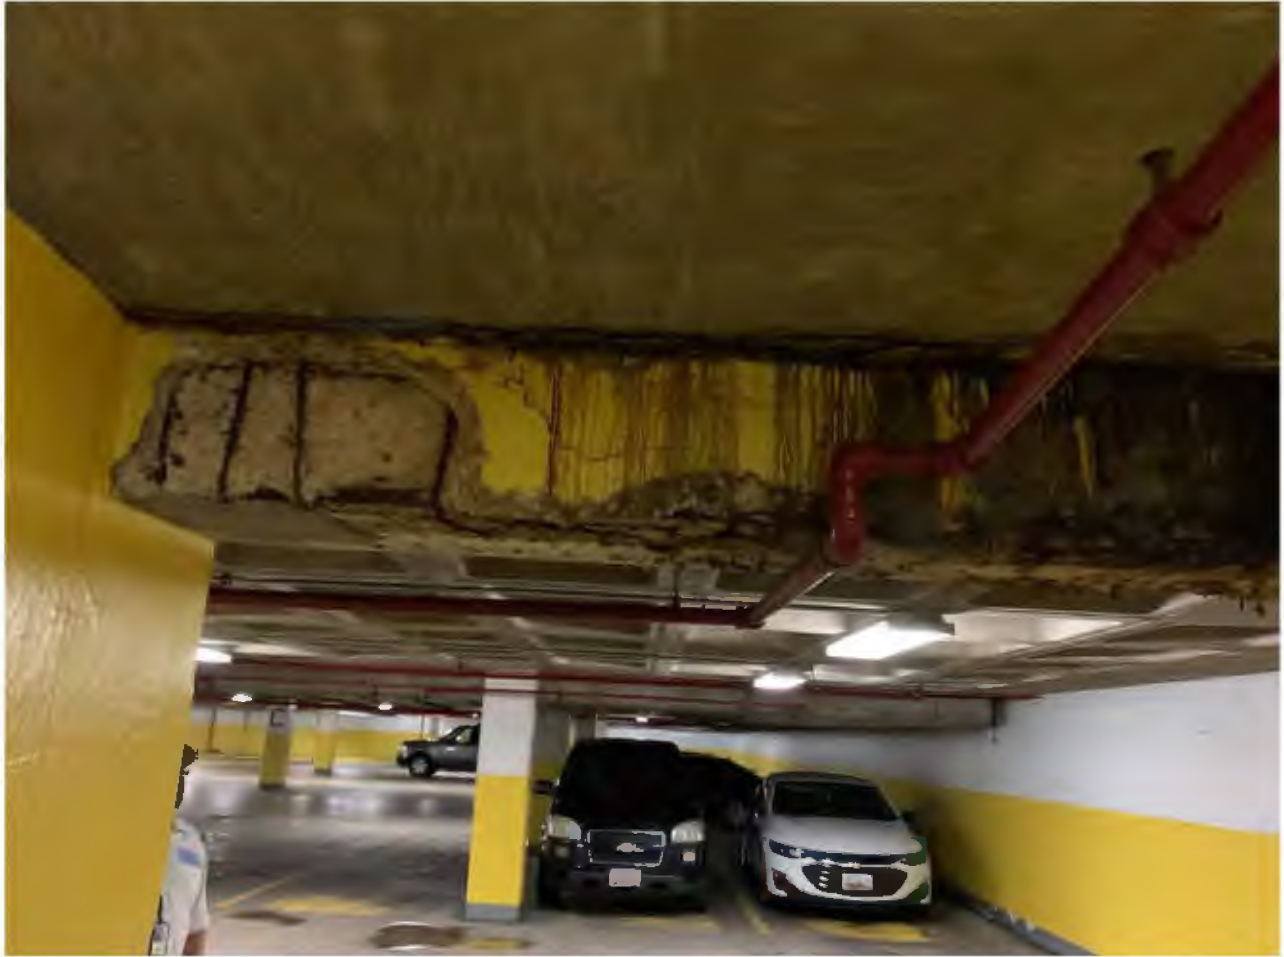
Picture 9: Deteriorated Concrete Beam

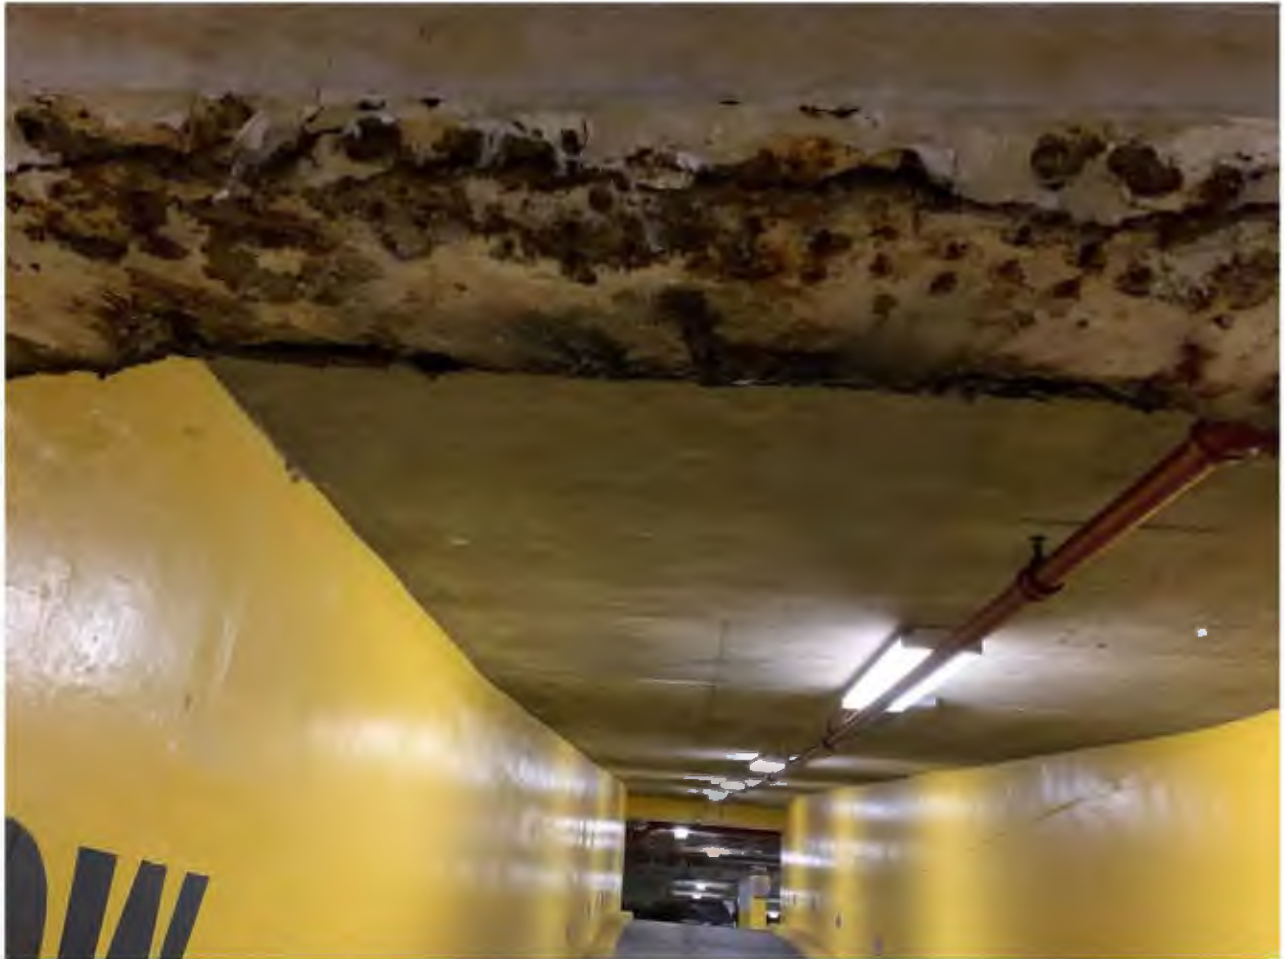
Picture 10: Deteriorated Concrete Beam

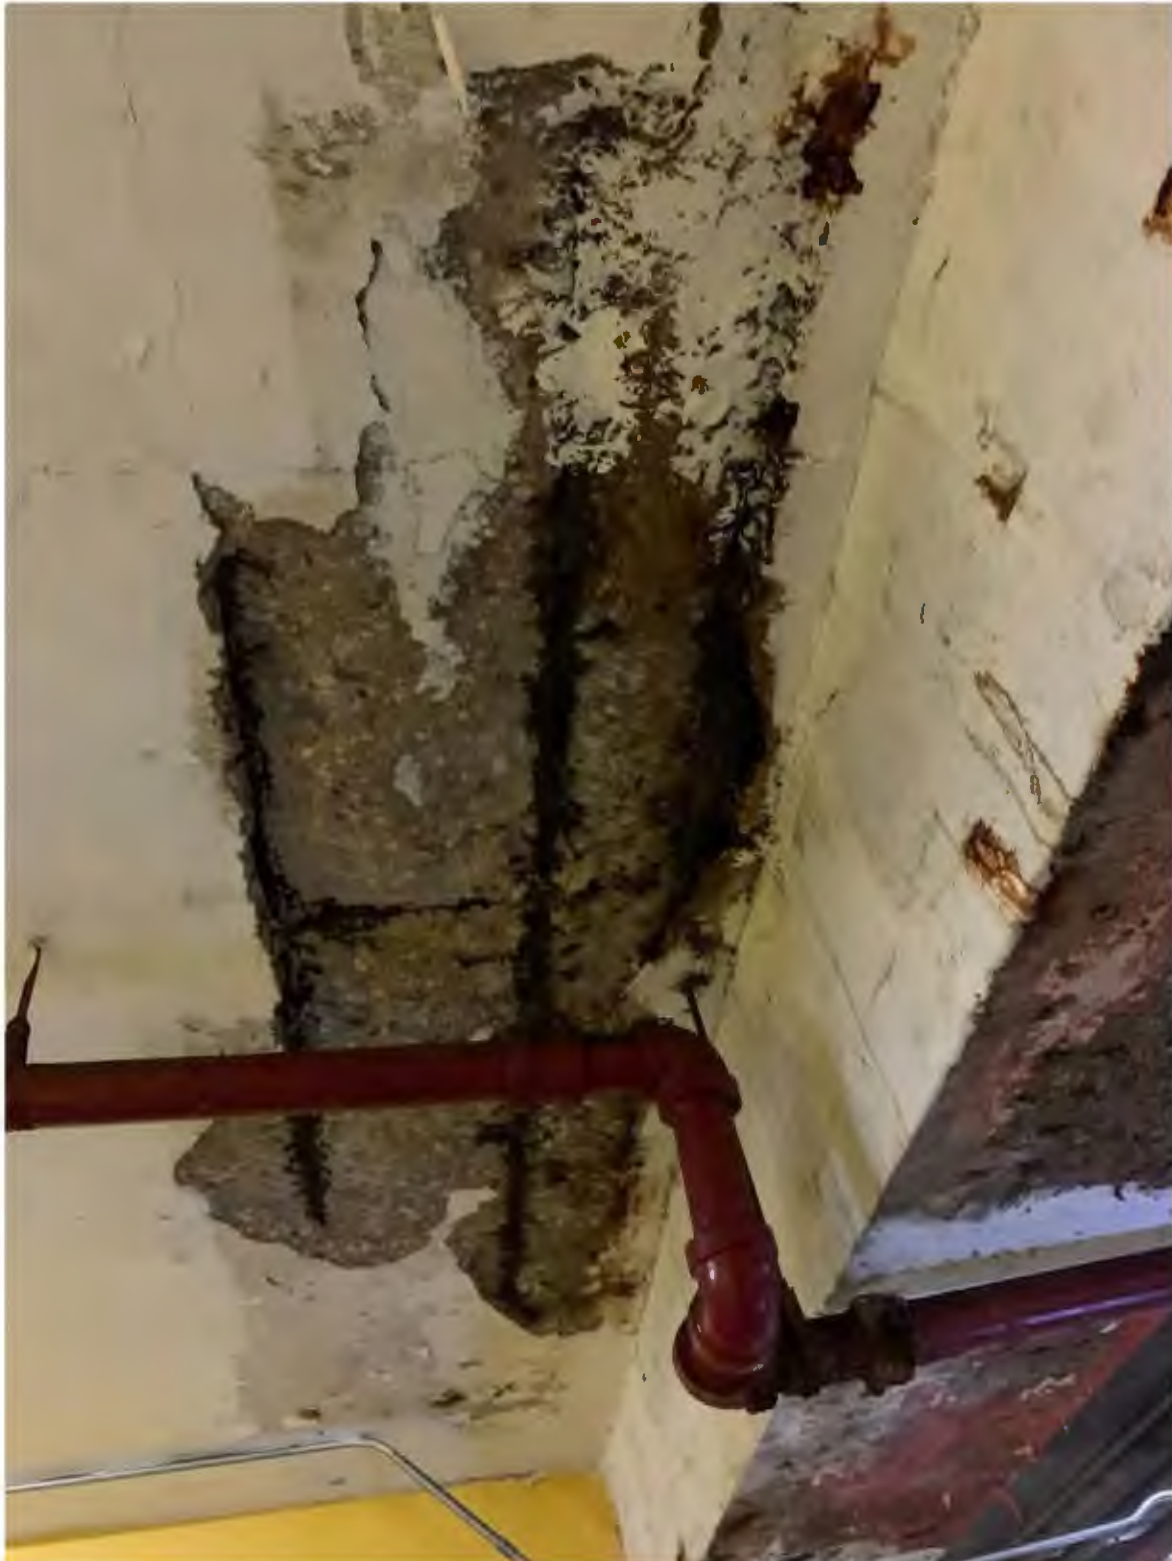
Picture 11: Deteriorated Concrete Beam

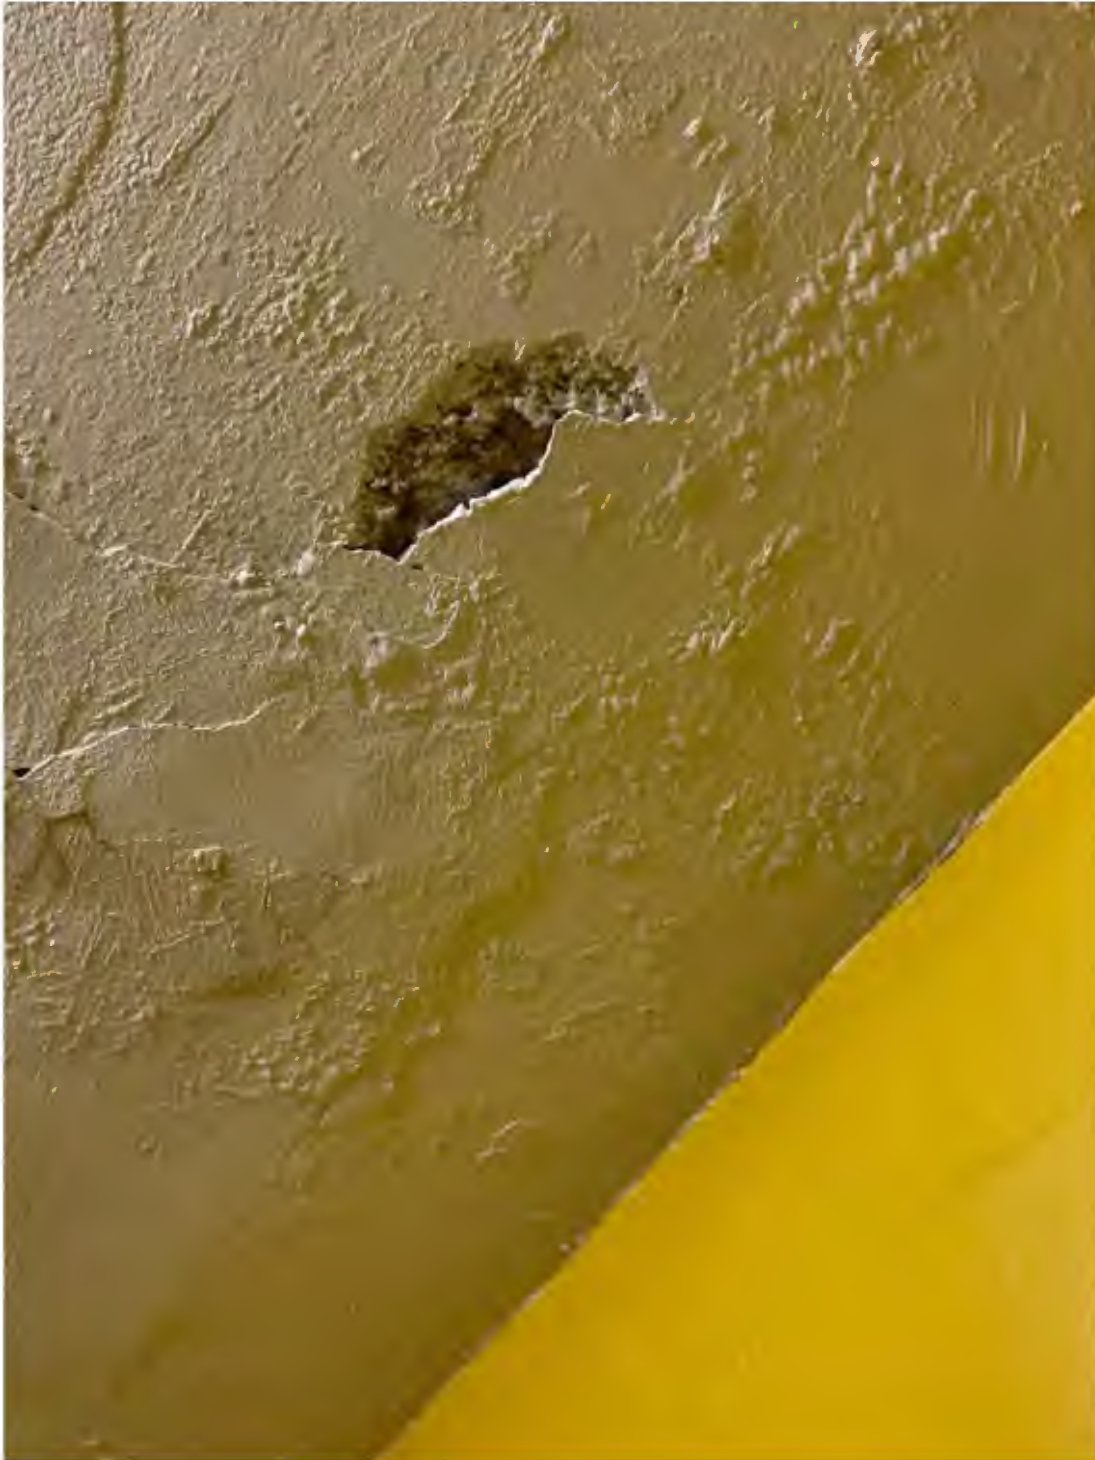
Picture 12: Deteriorated Concrete Slab at Ramp (Efflorescence & Delamination)

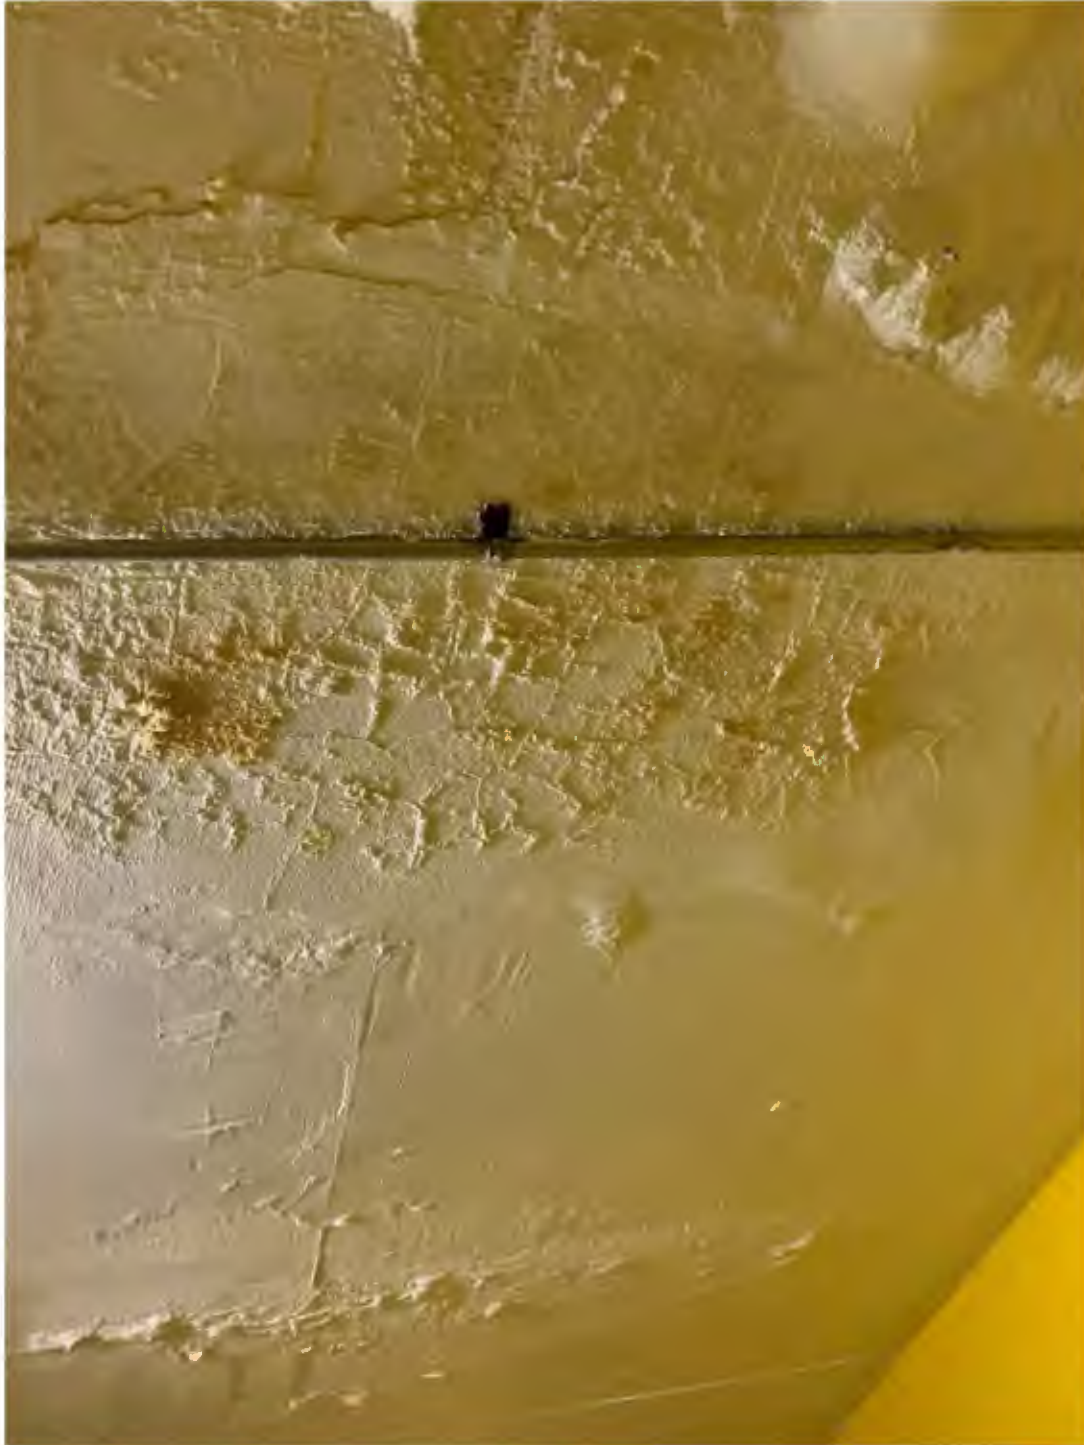
Picture 13: Deteriorated Concrete Slab at Ramp (Efflorescence & Delamination)

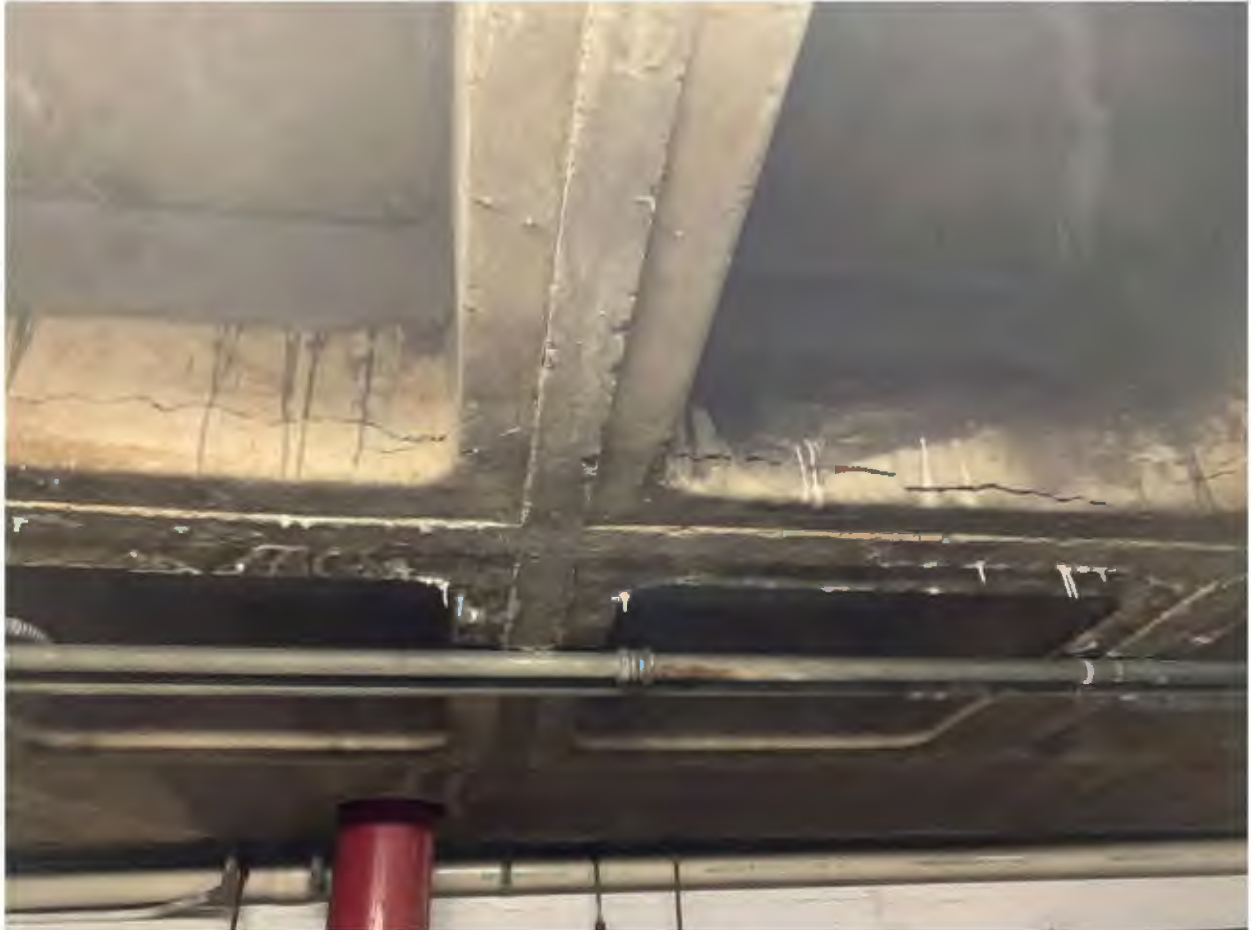
Picture 14: Deteriorated Concrete Waffle Slab (Cracks & Delamination)

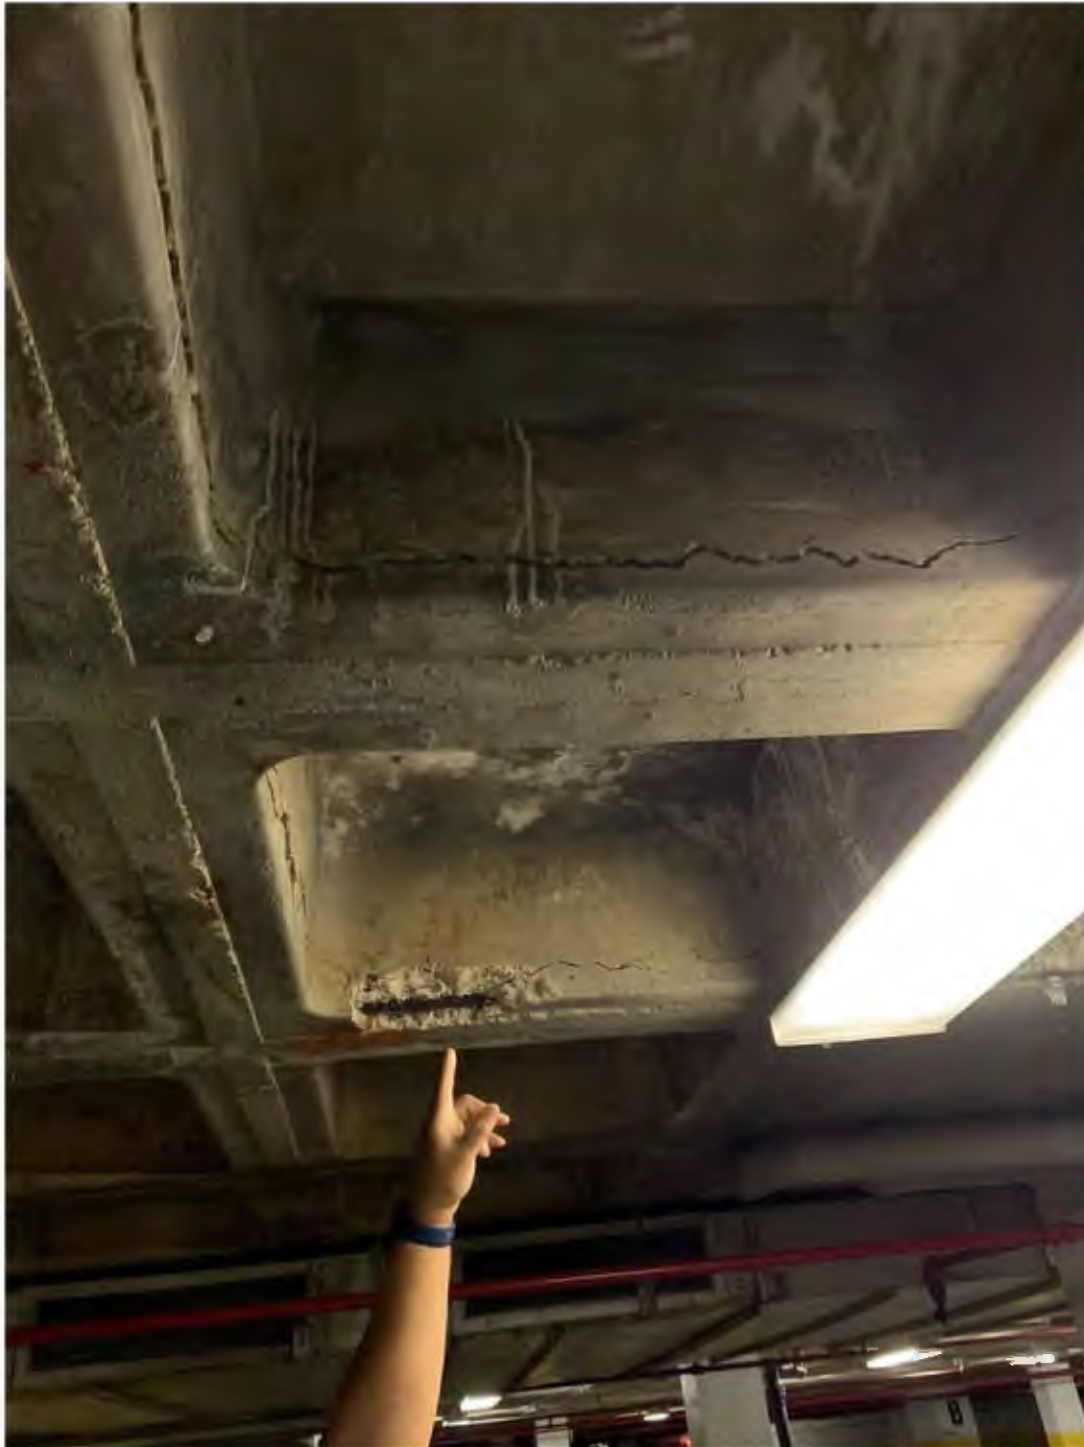
Picture 15: Deteriorated Concrete Waffle Slab (Cracks & Delamination)
