Description of document: General Services Administration (GSA) Infrastructure Assessment for the Weaver Building (the HUD Headquarters Building) 2013-2025

PROJECT: Department of Housing & Urban development (HUD) Headquarters – Weaver Building
Investigation of Deteriorated Concrete Beams, Floors & Walls

Robert C. Weaver Garage Feasibility Study Final Report Submission

ROBERT C. WEAVER BUILDING

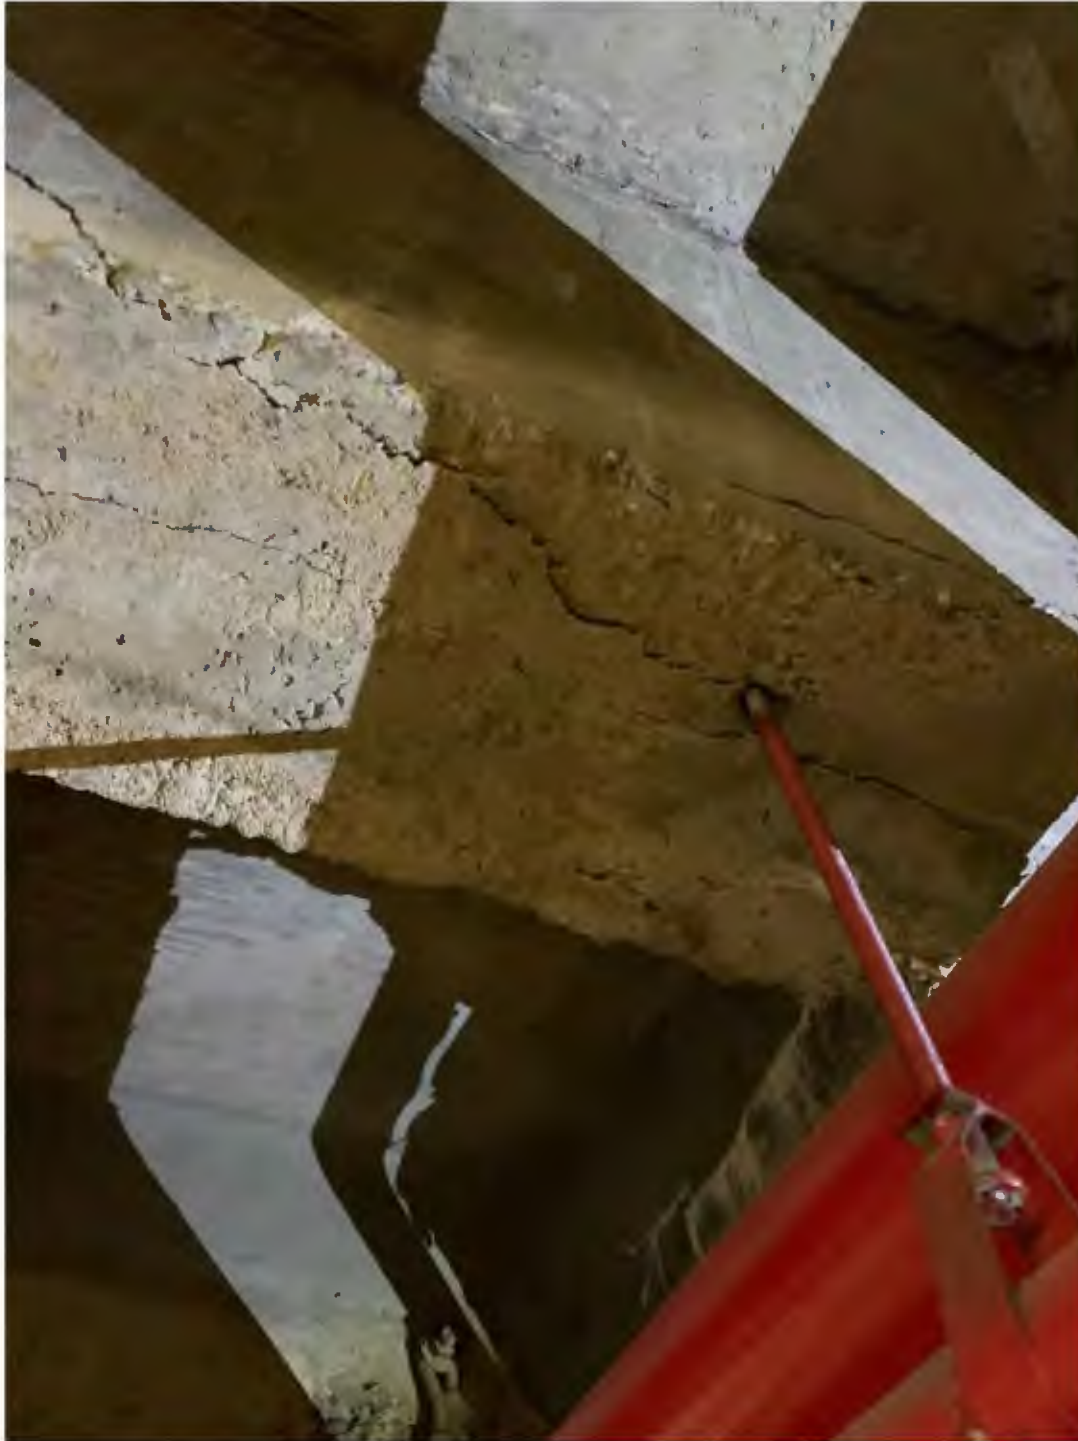
Picture 16: Deteriorated Concrete Waffle Slab (Cracks & Delamination)

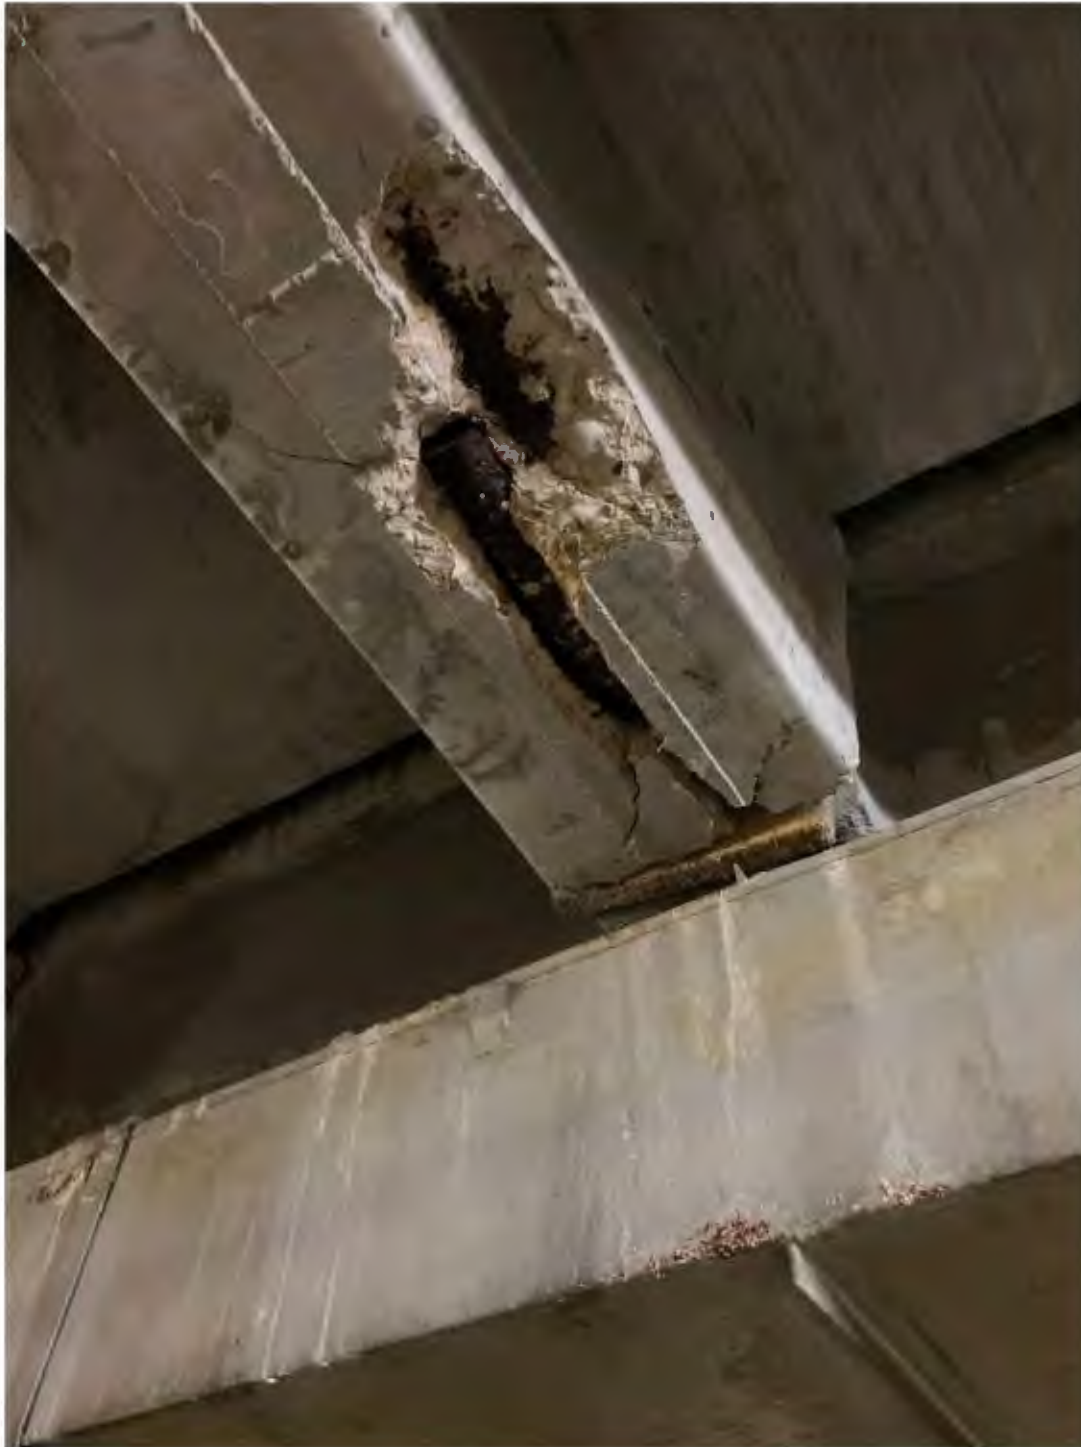
Picture 17: Deteriorated Concrete Waffle Slab (Cracks & Delamination)

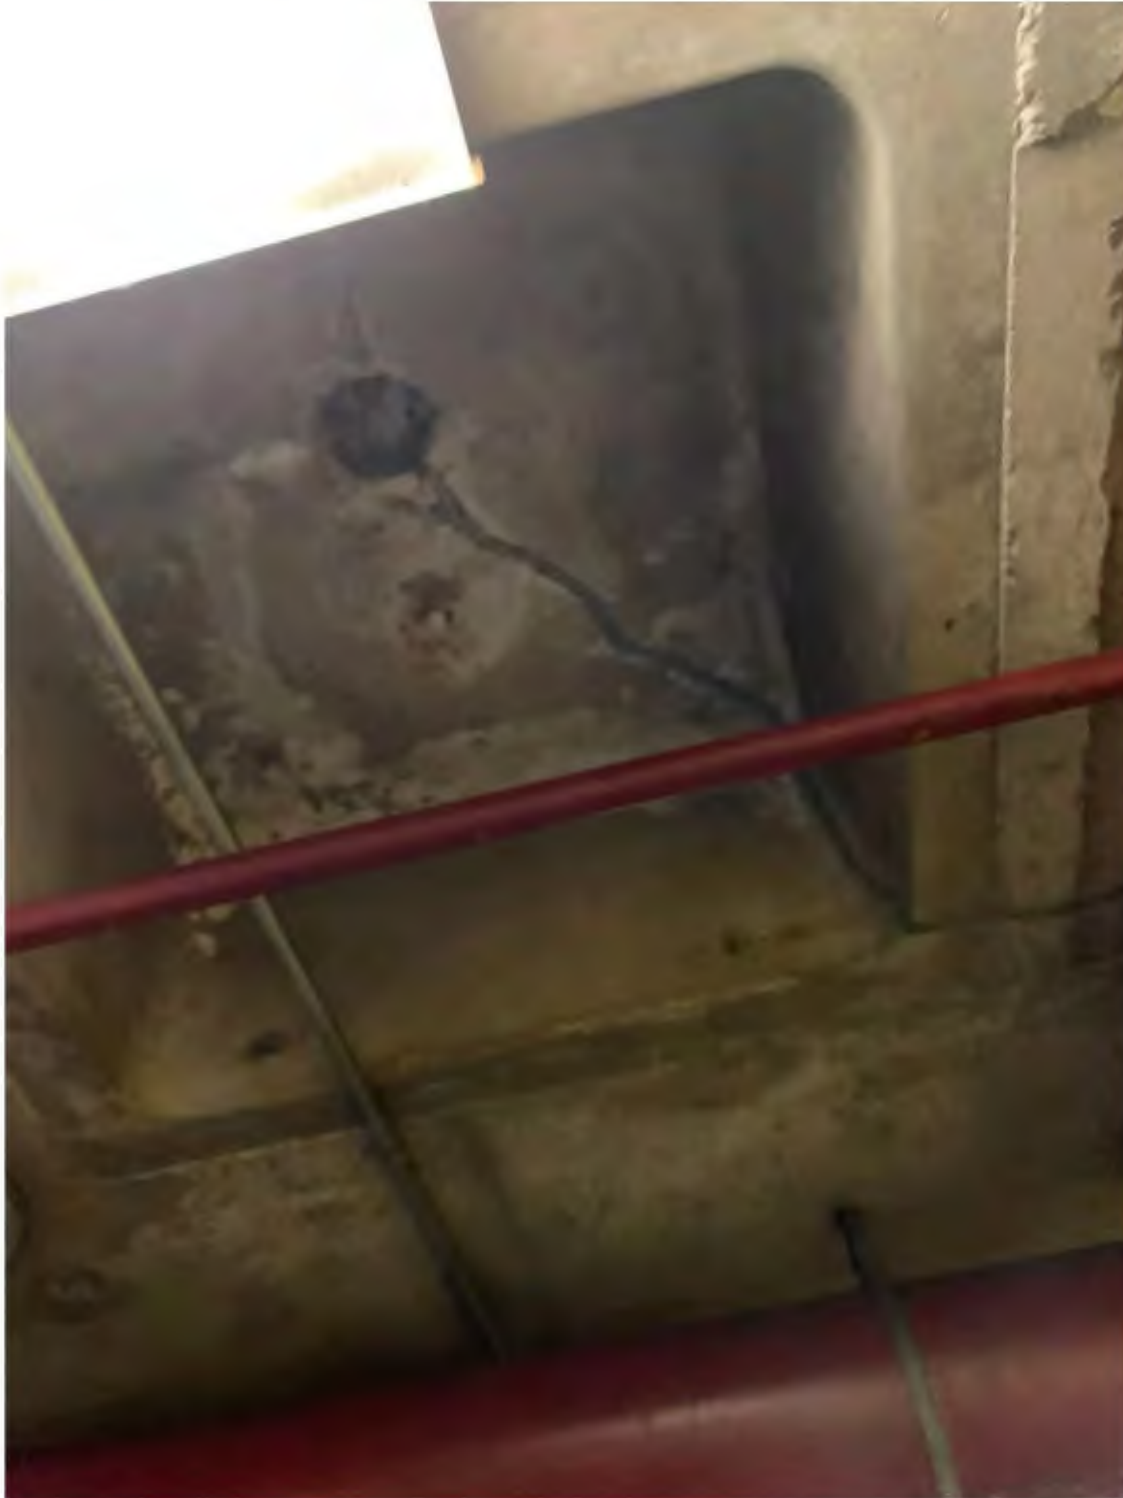
Picture 18: Deteriorated Concrete Waffle Slab (Cracks & Delamination)

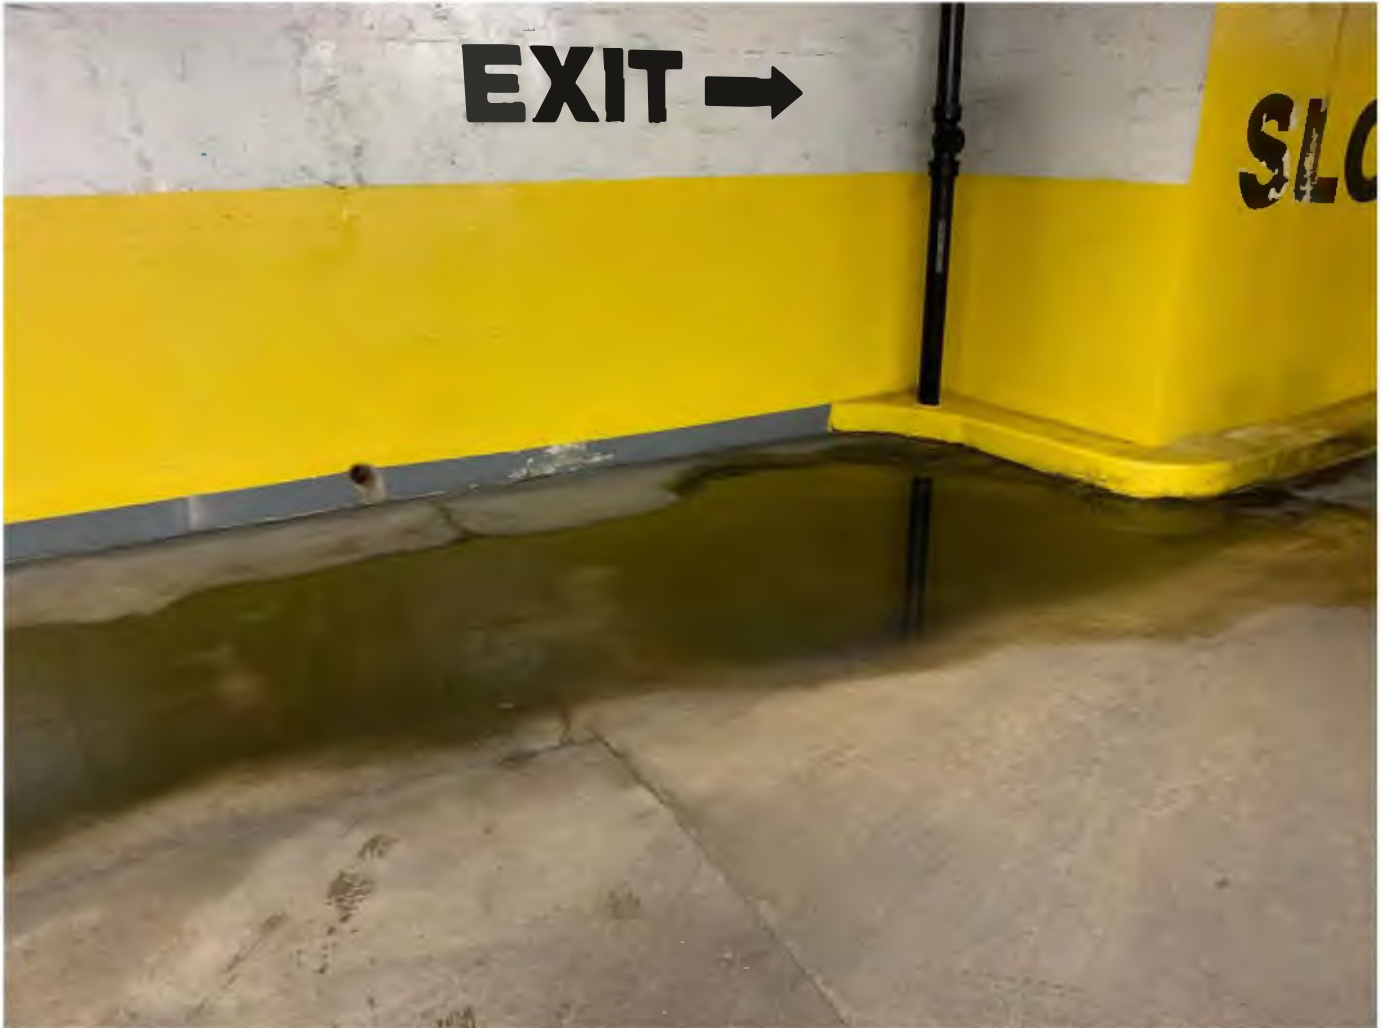
Water infiltration along expansion joints, floor trenches and piping penetrations were noted throughout the areas observed around the parking garage ramps on Levels - B and C. There is a large ponding of water at the ramp bottom corner on Level-C (see picture-19) that is not draining properly. There is only one trench drain to capture water flow on the Plaza ramp bottom and there are some cracks around the trench drain (see picture-20).

Picture 19: Large water ponding at Level-C, bottom ramp, that is not properly draining due to no slope in the slab.

- 6) Conduct a thorough study to determine the cause of the water leaks, ponding, and effectiveness of the one trench drain and drainage system at the bottom of the Plaza ramp. The study should also review the impacts of the water leaks to the structural system and provide recommendations to repair the water leaks.

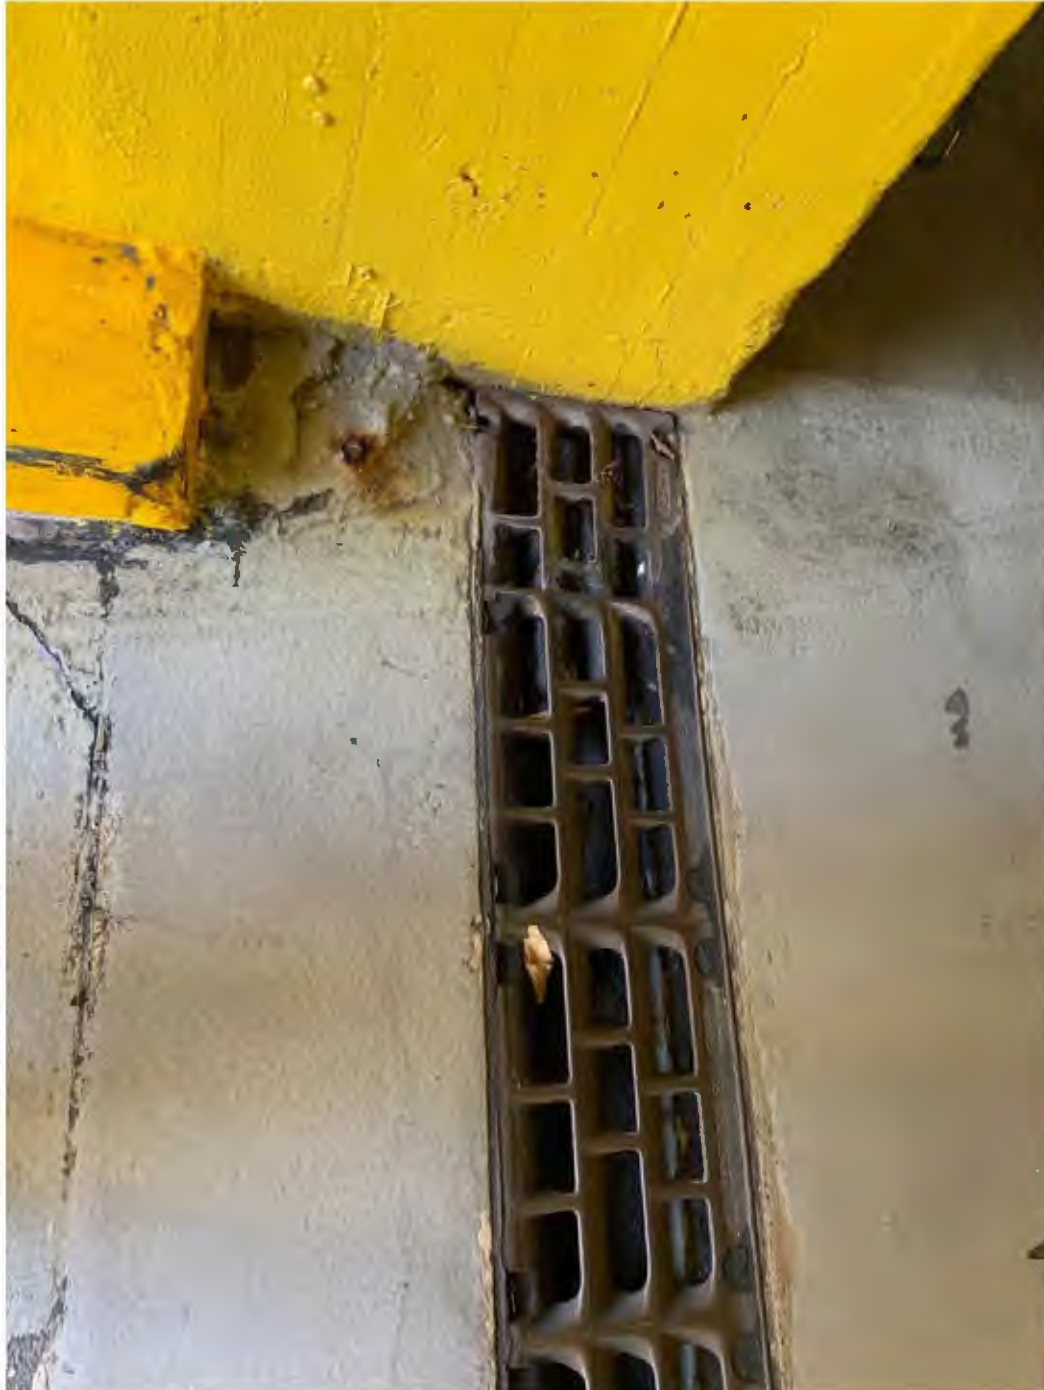
The design for the Plaza level expansion joint repairs was done in 2020. Repairing the Plaza level expansion joints, cracks, and construction joints will help mitigate the amount of water leaks. The trench drain at the bottom of the Plaza ramp on Level-B may not be capturing all of the water flow during heavy rains. It seems

water flow may be overflowing past this trench drain, which continues on Level-B and further down the ramp to Level-C. Water leaks may also be occurring along the cracks at the trench drain, seeping down to the concrete walls and levels below.

Picture 20: Trench drain at ramp bottom at Level-B. Ramp goes up to Plaza level (exterior) and is the only drain to capture flow of water from outside.

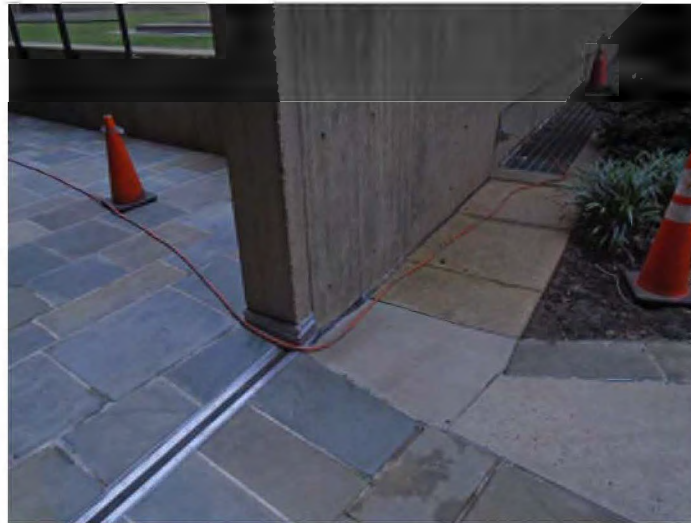
Deficiency 2-B North Wall: There are numerous active leaks along the north wall in the Loading Dock. Visual survey found much of the wall to have streaks of water damage at the east end of the foundation wall, with some limited damage to the concrete wall. Two separate controlled Water Tests (W1 and W3) were conducted on the plaza area above. W1 consisted of discharging a hose on the east end of the concrete wall at the north end of the Loading Dock. An expansion joint, not present on the design drawings provided, terminates at the end of the wall. The leak from the water test aligns with the expansion joint termination. W3 consisted of discharging a hose onto the intersection of the north end of the planter wall where it intersects the north Loading Dock wall that project above grade. Leaks began to occur immediately along the north foundation wall inside the Loading Dock. There was also an actively leaking pipe penetration at the north wall.

Photo Seal-2: Water Test Location WT1 and WT3
(on back side of wall in photo)

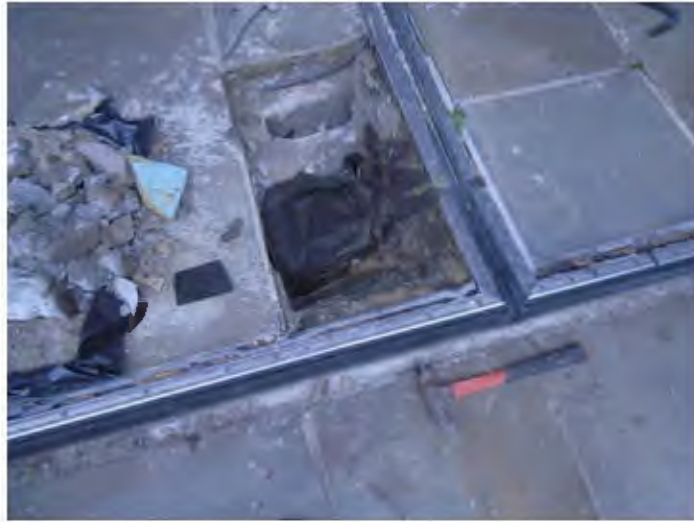
Deficiency 1-B, Expansion Joint: The expansion joint at the east end of the Loading Dock is experiencing several leaks. This water infiltration has led to several areas of concrete damage, including spalled and cracking concrete. A significant amount of damage was found at the intersection of two expansion joints between Columns Q-R. A destructive test cut (TC2) was performed at this expansion joint intersection at the West Plaza above and found that the expansion joint to fastened into an approximately 8-inch-high curb. test cuts through the membrane were not made; however, the membrane surface on the curb was sounded. The membrane is completely delaminated from the curb and the underlying curb was found to be unsound. The curb, waterproofing membrane and expansion joint have suffered damage due to failure of the expansion joint mounting bolts/curb and are allowing water to enter into the system and leak to the Loading Dock.

Photo Seal-2:
Test Cut (TC2) at
displaced
expansion joint in
Loading Dock
area. Exposed
curb was sounded
with a hammer
and found
“unsound.”

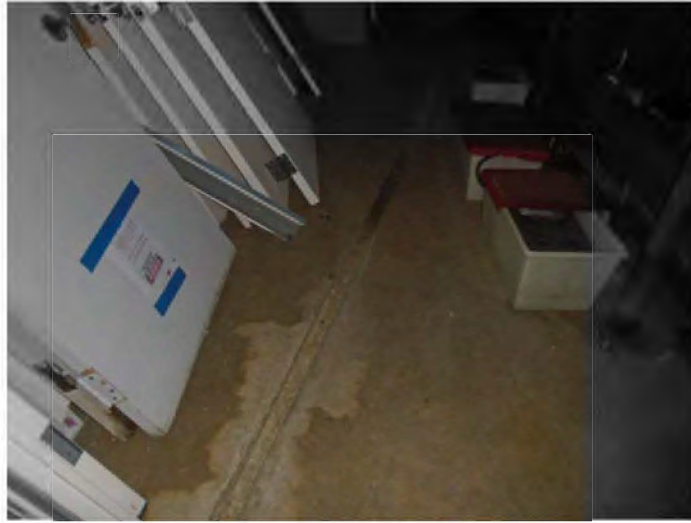
Photo Seal-3:
Trenches cut
into concrete
floor in
Generator
Room

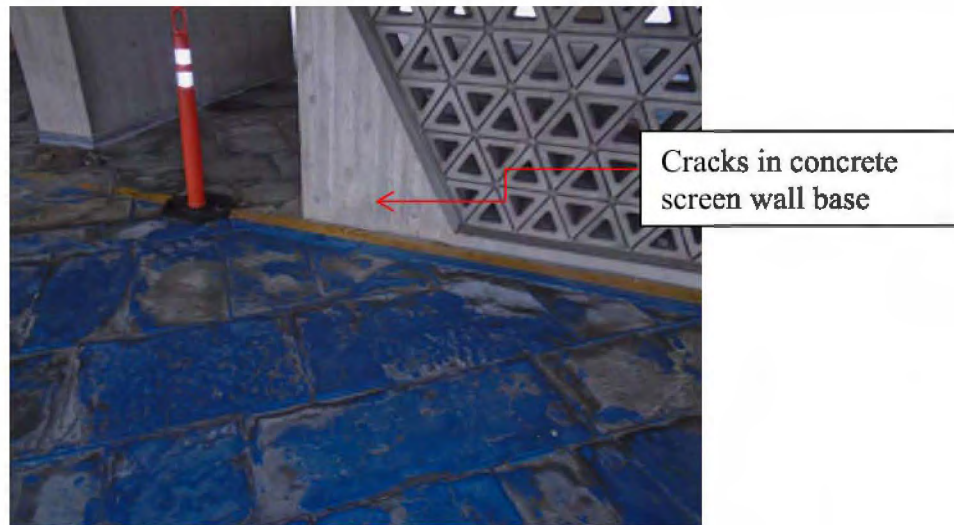
Photo Seal-5: Concrete screen wall at Southeast Wing

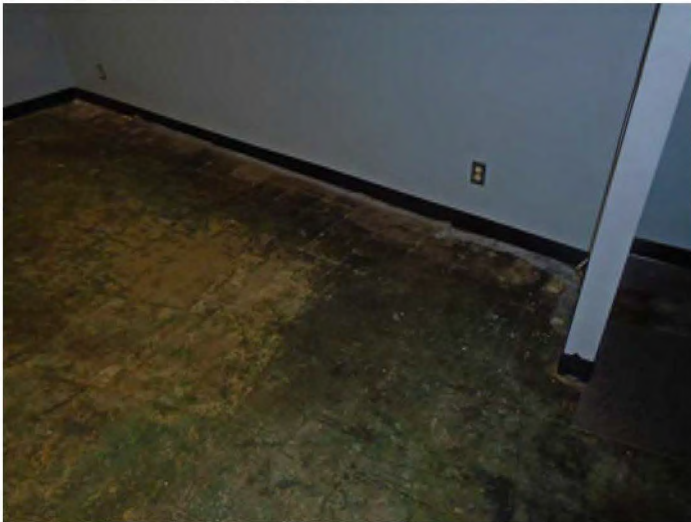
Deficiency 16-B, Room B182 Leaks: Water stains and damaged concrete were found on the northern foundation wall within Room B182. Interior finishes at the ceiling, floor and wall have been removed due to extensive water damage. There is a large cast iron pipe that penetrates the wall in the ceiling above that was reported by building maintenance to belong to the District of Columbia (sewer line). Water staining and corrosion were visible around the pipe. Building maintenance noted that leaks often occur approximately one day after a large rain event.

Photo Seal-5: Water damage in Room B182

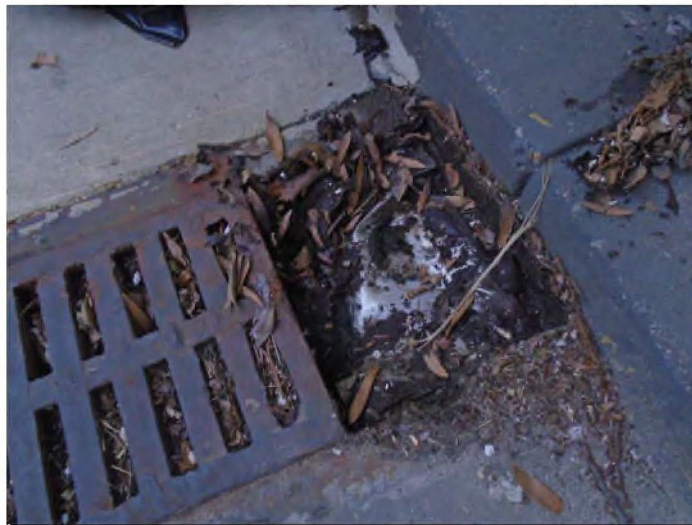
Deficiencies 10-LA, 14-LA, 10-LB, 14-LB, 10-LC and 14-LC: There are several deficiencies associated with the ramps of the garage which are addressed together in this section. Certain areas of the ceiling structure above all levels of the ramps are delaminated and spalled. One area has evidence of poor consolidation. The worst location of concrete is at the top and bottom of the garage ramps. The bottoms of some of the adjacent concrete joists in the waffle slab are delaminated but the most extreme conditions are at the concrete header beams below each trench. They are severely spalled and the existing reinforcement is exposed and corroded. This has occurred over the years due to problems in the trench drain. It is evident from the existing water stains and leaks that water migrates from the trench through the concrete beam.

Photo Seal-6: Trench drain at Parking Ramp in East Plaza

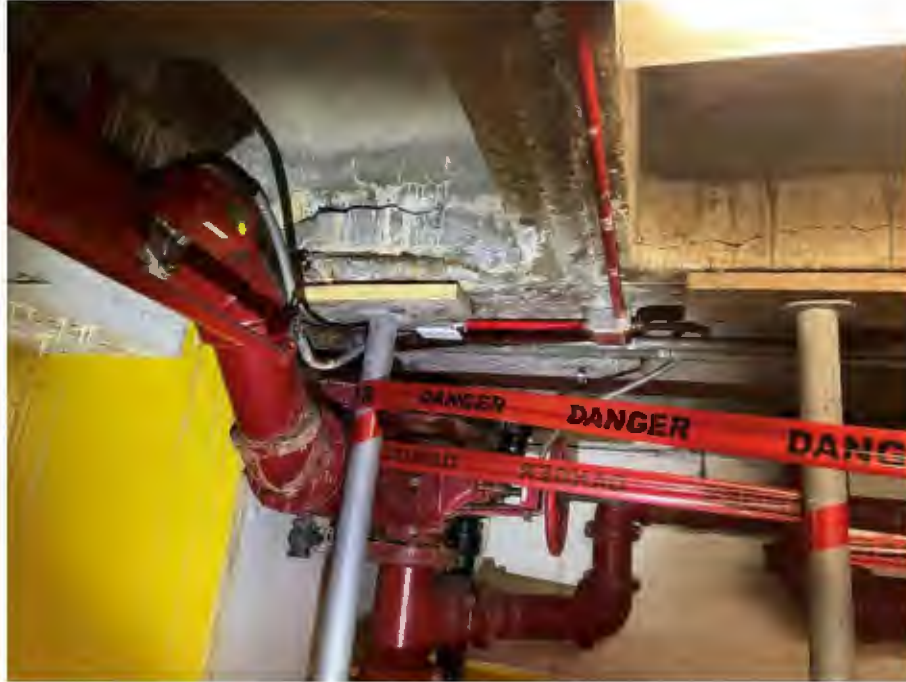
Severely damaged joists requiring full depth replacement
Estimated quantity: 200 LF of joist full replacement
Estimated quantity 100 LF of joist bottom partial repair

- Cracked joists in the waffle slab adjacent to the ramp should be repaired. These will be a mix of full depth replacement and joist bottom repair, depending on severity and whether the adjacent slabs require repair.
