The Hubble Space Telescope Optical Systems Failure Report

November 1990

National Aeronautics and
Space Administration

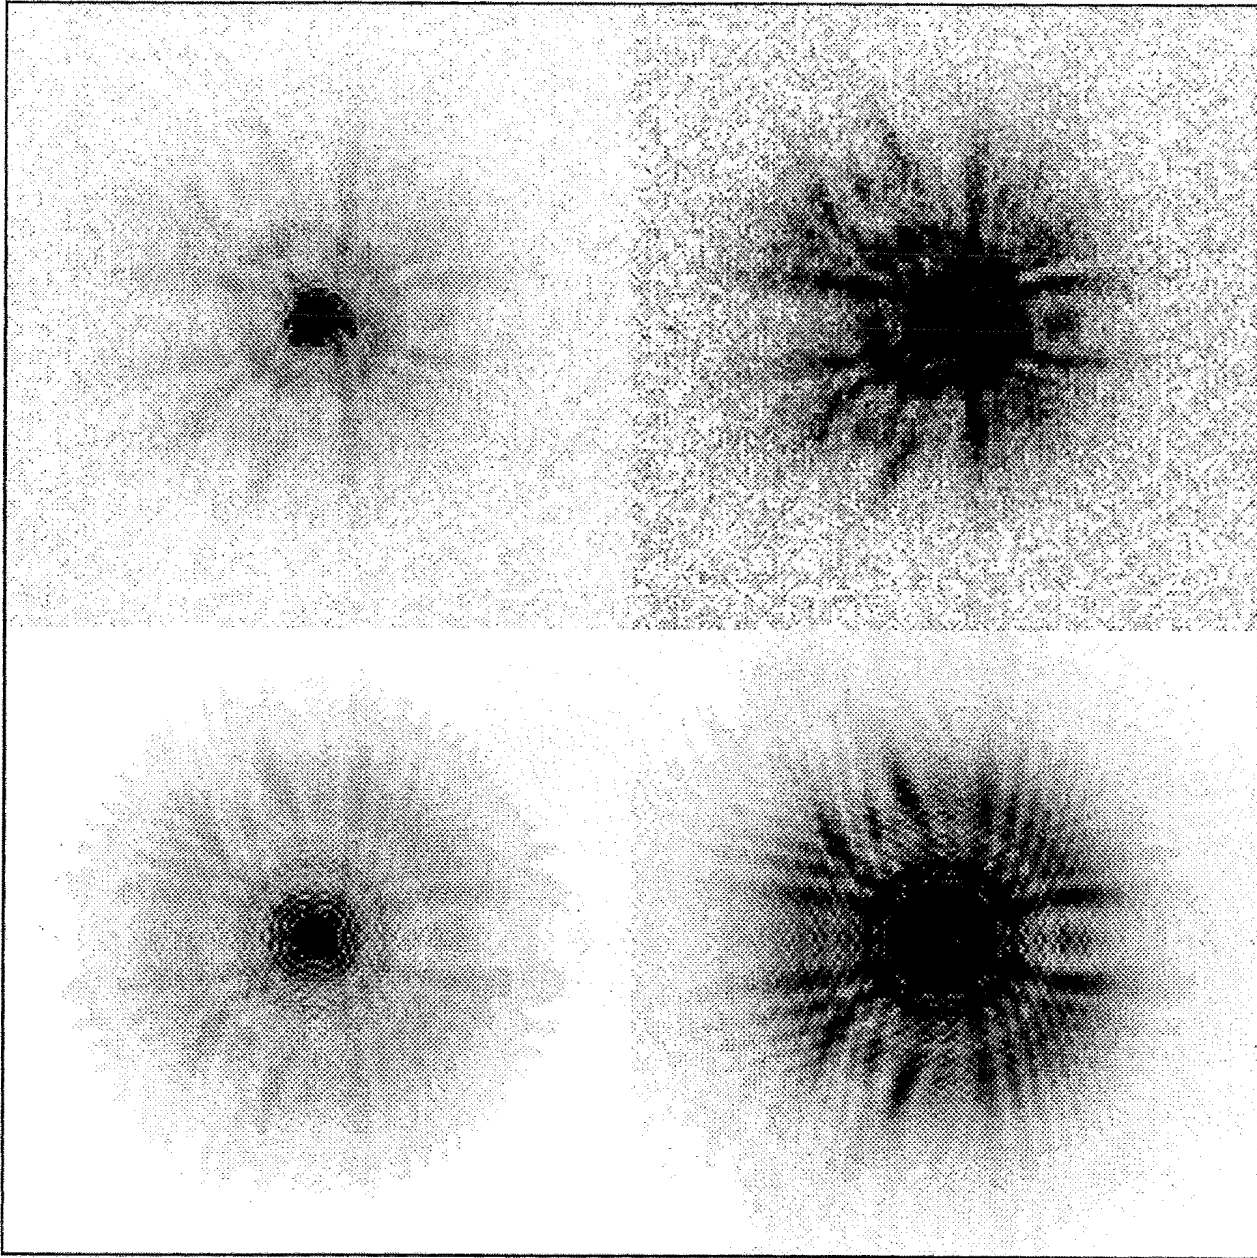
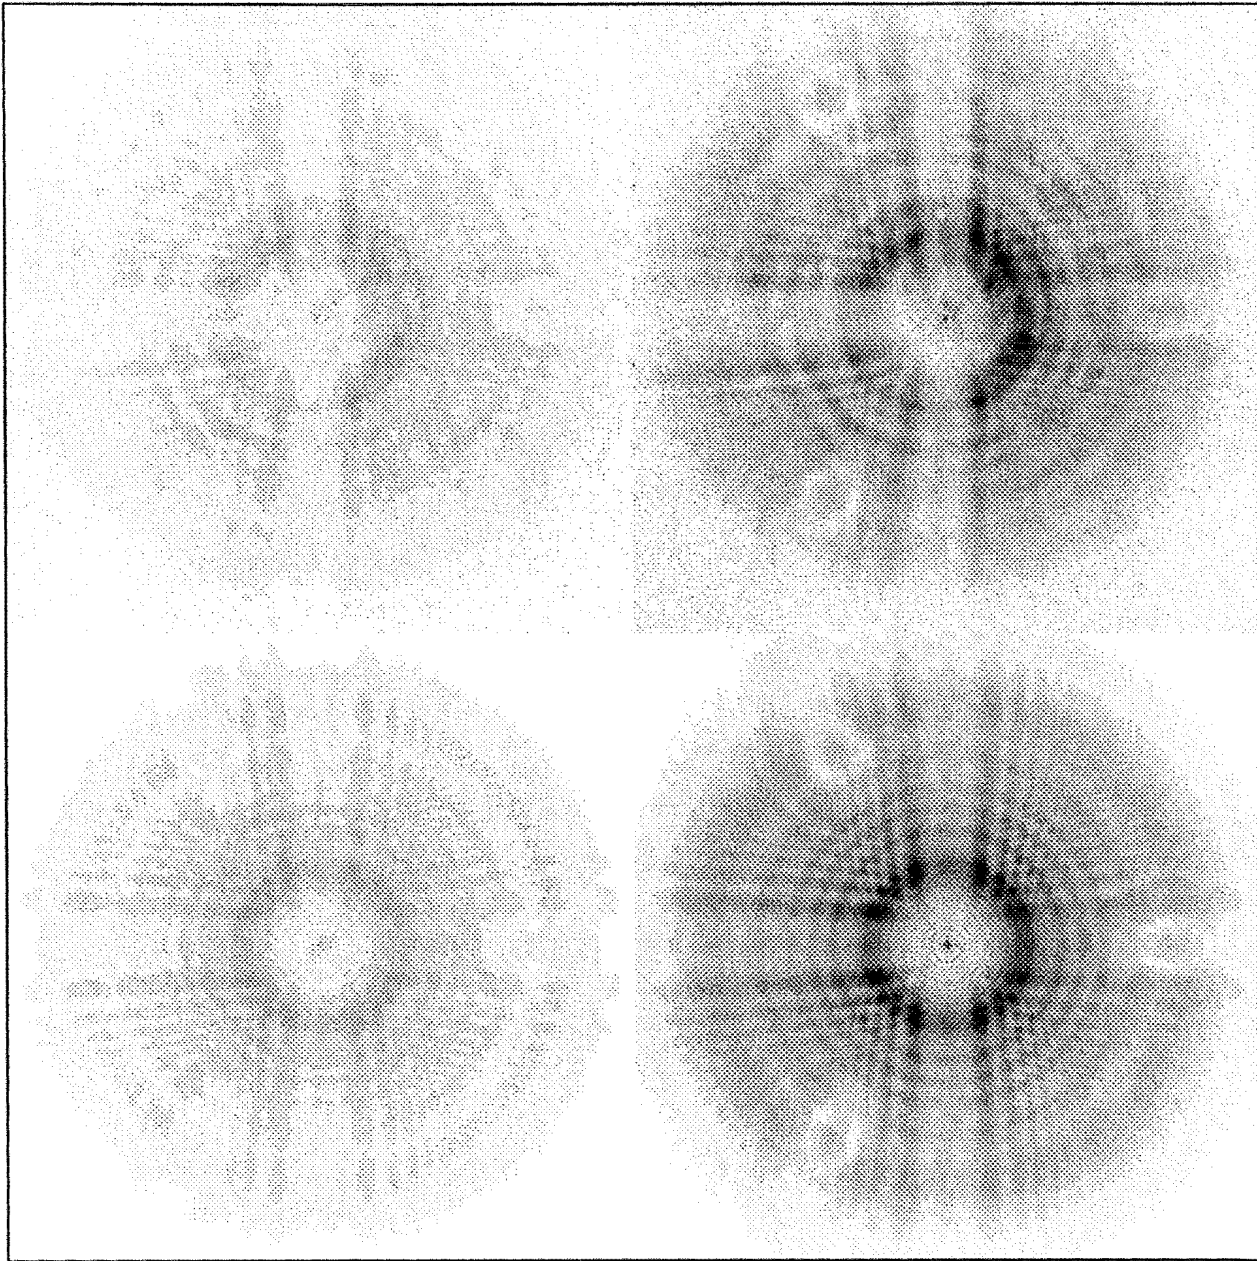
(a) Recorded image of the PC5 star taken on June 14, 1990, with a 0- μ m inside focus.

Figure 6-1. Planetary Camera images versus computer simulations. The images in the top frames were taken with the Planetary Camera; those in the bottom frames are computer simulations created using an optical model with 0.5-wave rms wavefront error at 547 nm.

(b) Recorded image of the PC5 star taken on June 21, 1990, with a -300- μ m inside focus.

Figure 6-1 (continued). The images in both (a) and (b) show a linear-intensity display on the left, and a logarithmic ("stretched") image display on the right. The focal position denotes the position of the secondary mirror. (Data were supplied by Dr. Jon Holtzman.)

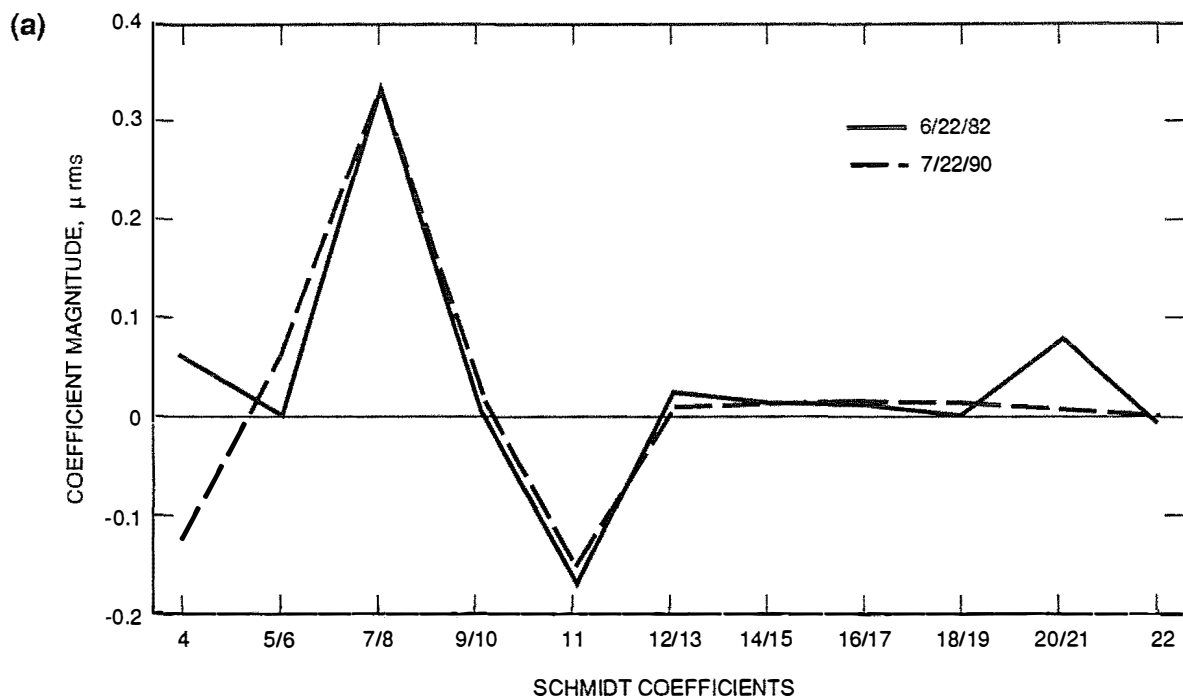
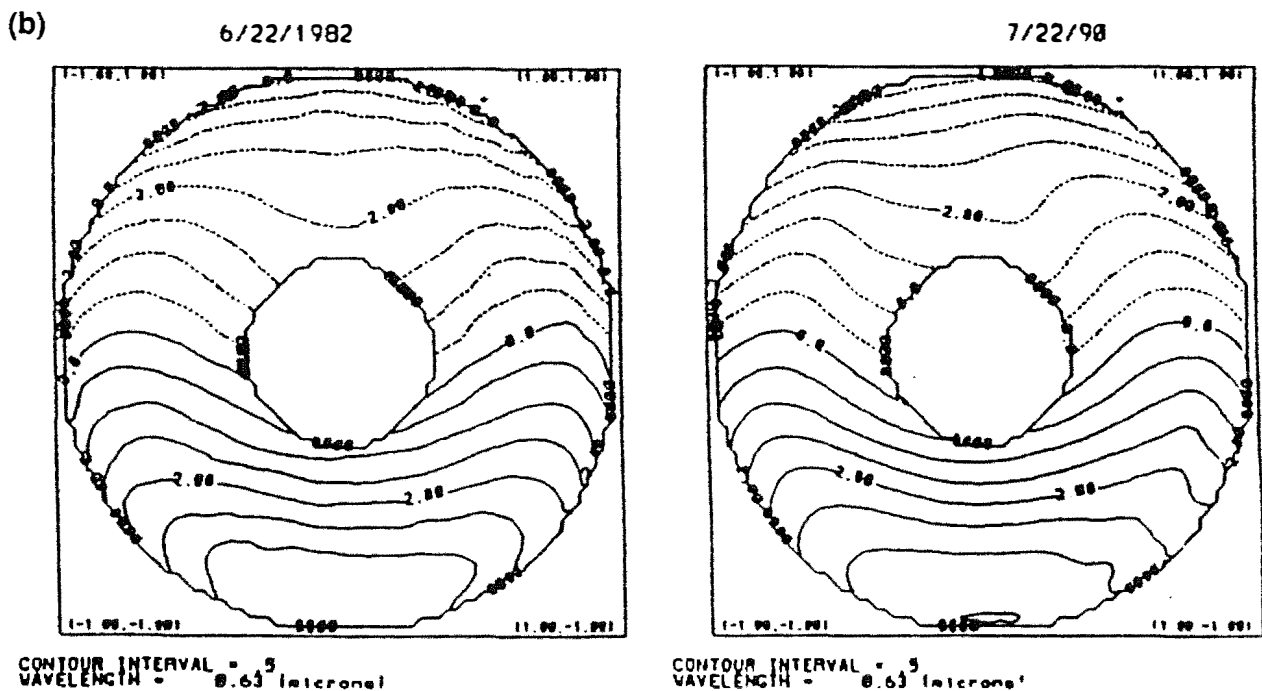
Figure 6-2. Comparison of 1982 and 1990 inverse null corrector data. (a) The coefficients which define the magnitude of various distortions to the wavefront were measured by the INC when it was inserted in front of the RNC in 1982 and in 1990. (b) The coefficient data were extracted from these plots of the interferograms.

The amount of spherical aberration introduced by the INC error is only a small amount compared to the amount of spherical aberration actually measured.

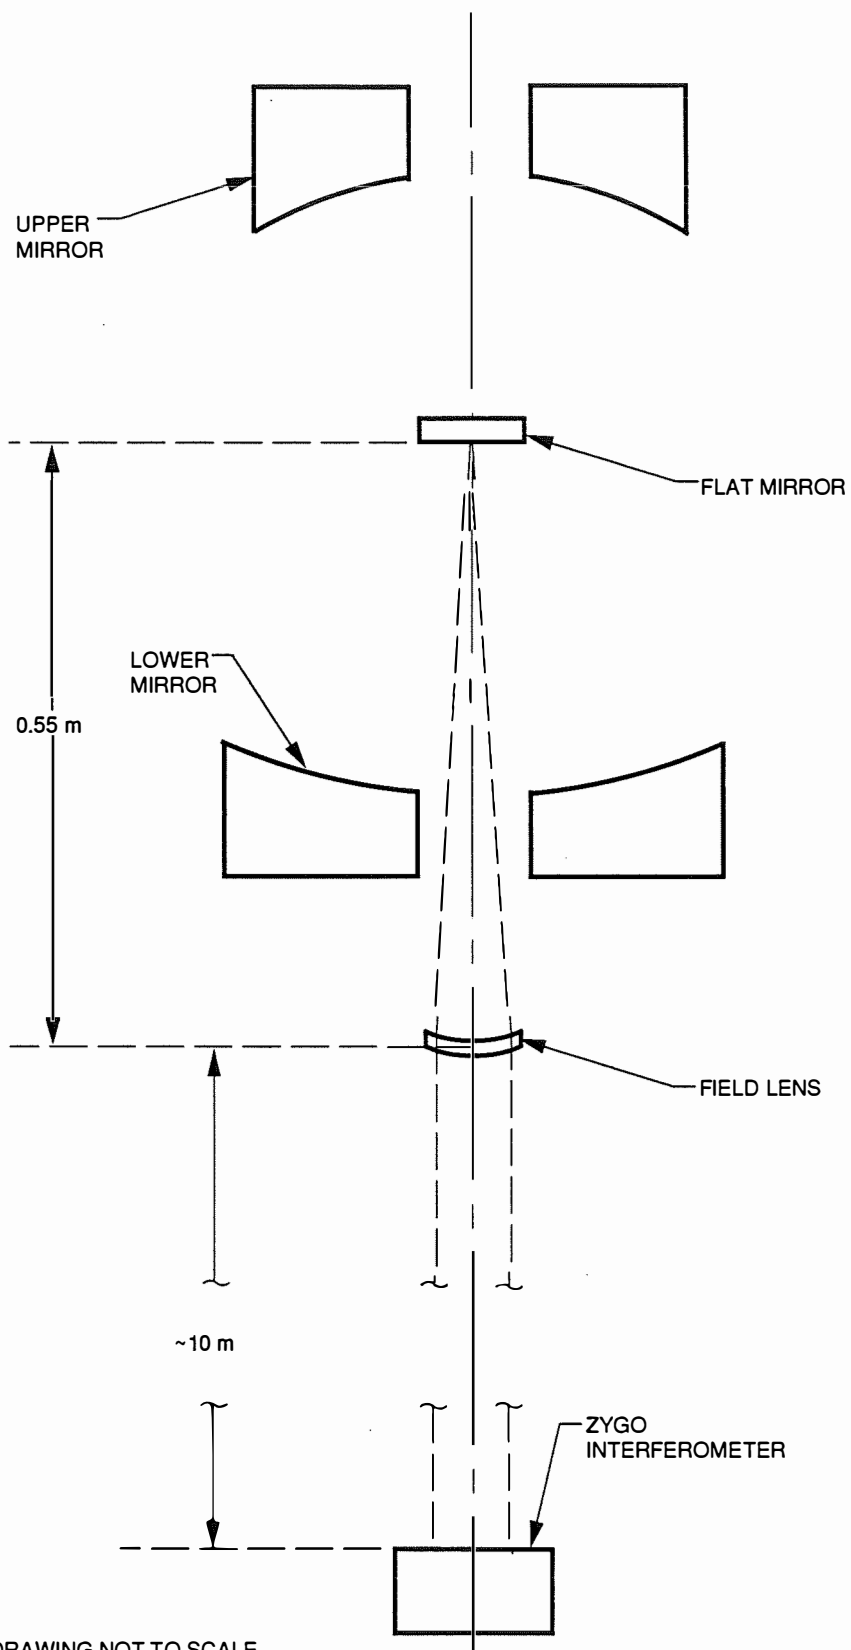
The optical element spacing was measured in 1990 by shining collimated light up through the field lens using a Zygo interferometer as the source, and by placing a flat mirror at the focus of the field lens (a distance of about 0.55 m above the lens). The correct position of the mirror was determined by using the interferometer to find the best focus (Figure 6-3). The distance from the flat mirror was then measured down to the vertex of the lower mirror using a fixture in the mirror hole for a reference. This measurement showed that the field lens was about 1.3 mm too far from the lower mirror. Both the direction and the magnitude of the spacing error correctly explained the spherical aberration observed in the HST image data. The spacings of the other optical elements in the RNC were measured and were found to be correct.

Figure 6-3. The 1990 spacing measurement between the field lens and the lower mirror of the reflective null corrector, using an optical test.

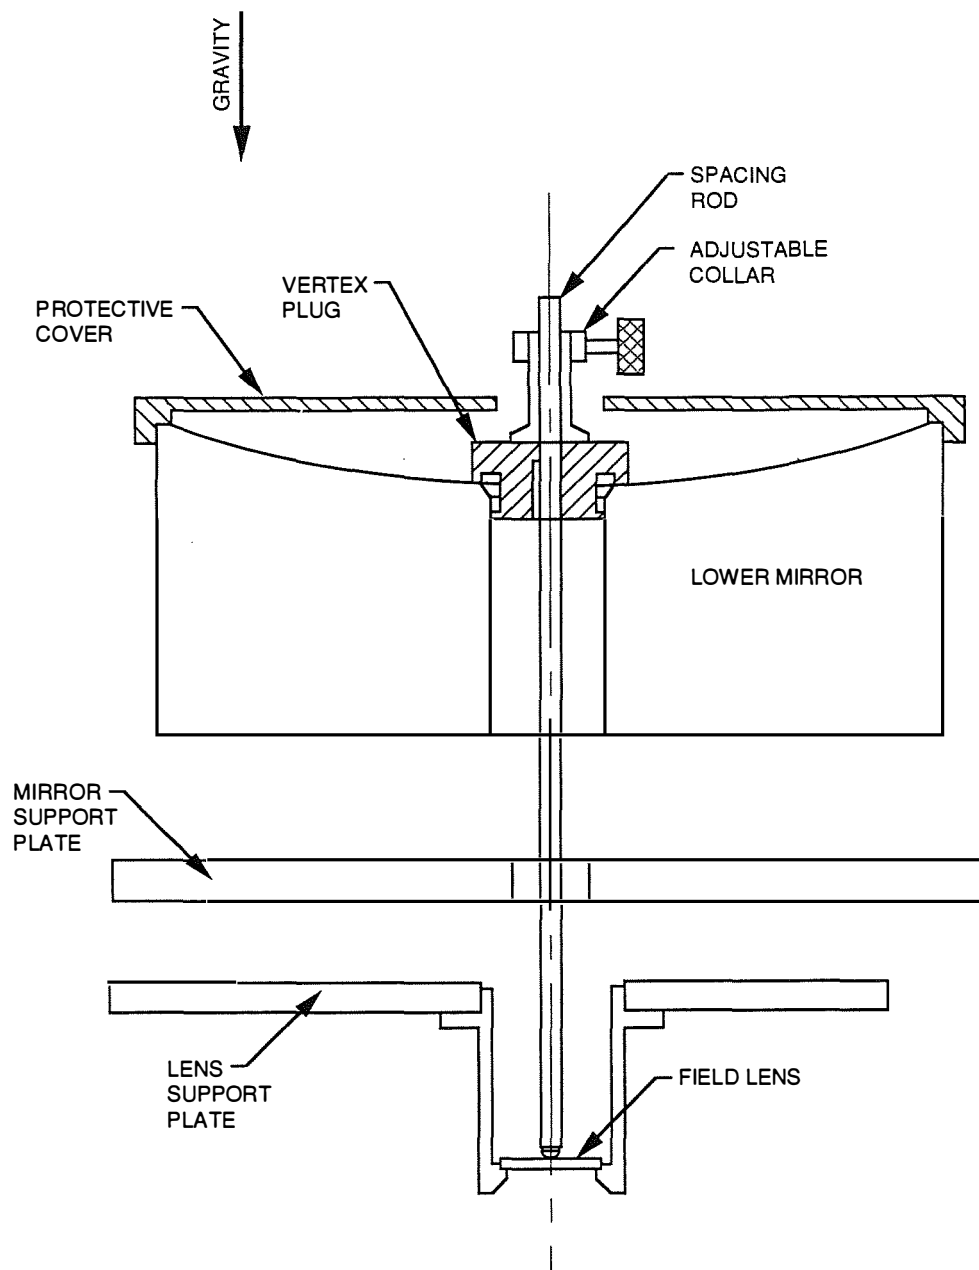
In addition to the optical test used to detect the field-lens spacing error, a direct physical measurement was made from the field lens to the vertex of the lower mirror (Figure 6-4). A lightweight spacing rod and a new vertex plug were made. The results verified the previously measured spacing error to ± 0.1 mm. More accurate measurements of the displacement error will be done at a later time, as this information is necessary for an accurate determination of a prescription for the recovery optics.

When the field lens position error (FLPE) is taken into account and applied in correcting the data taken with the RNC, it results in a mirror shape that would account for most of the error observed in the HST images. Also, the interferograms taken with the RvNC were reprocessed and corrected for the as-built data available for the RvNC. This independent set of data yields a mirror shape very close in value to the RNC/FLPE data. These data led the Board to conclude that the predominant source of error had been found and was caused by the field lens position error. (See Appendix E for the HST performance based on the as-built data.)

Figure 6-4. The 1990 spacing measurement between the lower mirror vertex and the field lens of the reflective null corrector, using a mechanical technique.

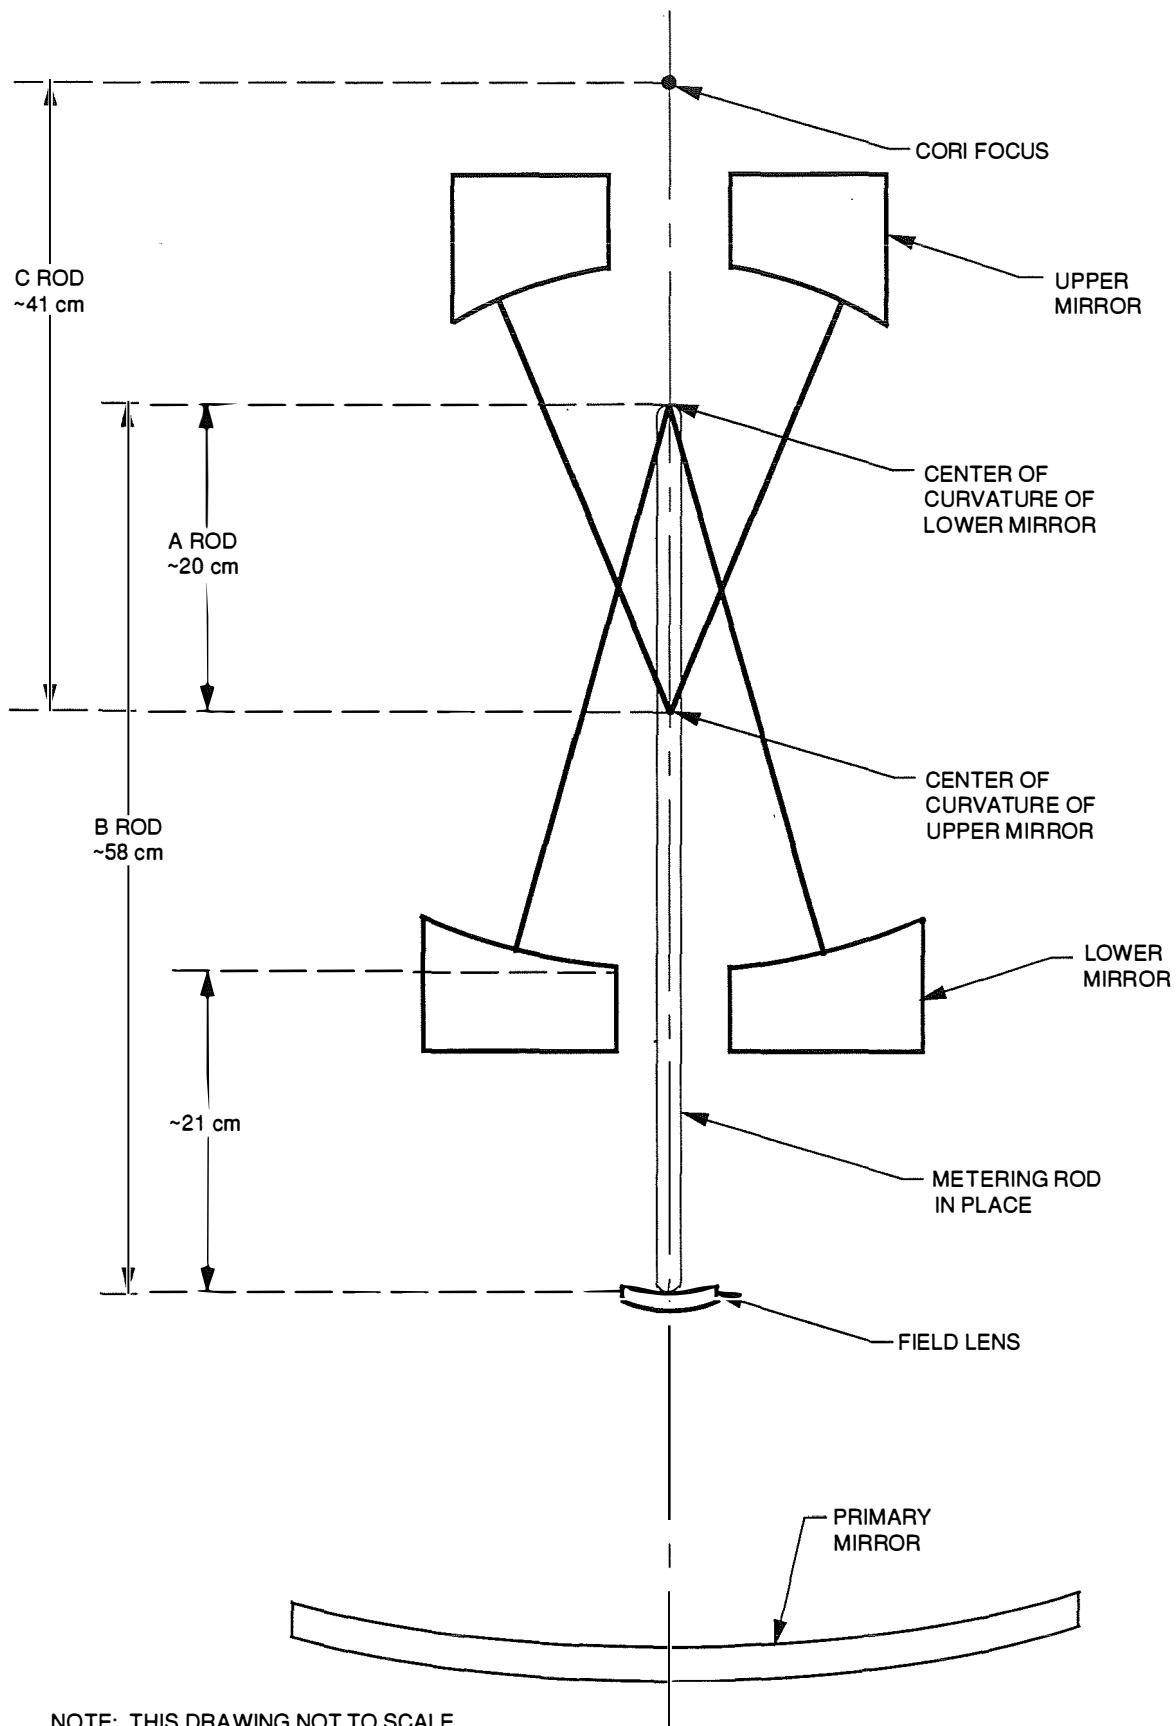
There were three metering rods (labeled A, B, and C) made of Invar, a metal with a small temperature expansion coefficient. The ends of the metering rods were rounded and polished because the very precise positioning of the optics in the RNC used an interferometer, rather than a mechanical measurement. This procedure involved auto-reflecting a focused beam of light off the end of a rod and observing an interference pattern from the beam that came back on itself. Centering the light beam on the rod end was essential for the measurement. To prevent the metering rod from being misaligned laterally with respect to the interferometer axis, P-E decided to attach "field caps" to one end of the rod (Figures 7-2 and 7-3). The field caps were fitted over the rod ends and had a small aperture in the center to ensure centering of the rod on the beam.

Figure 7-1. Position of metering rods used to space optical elements in the reflective null corrector.

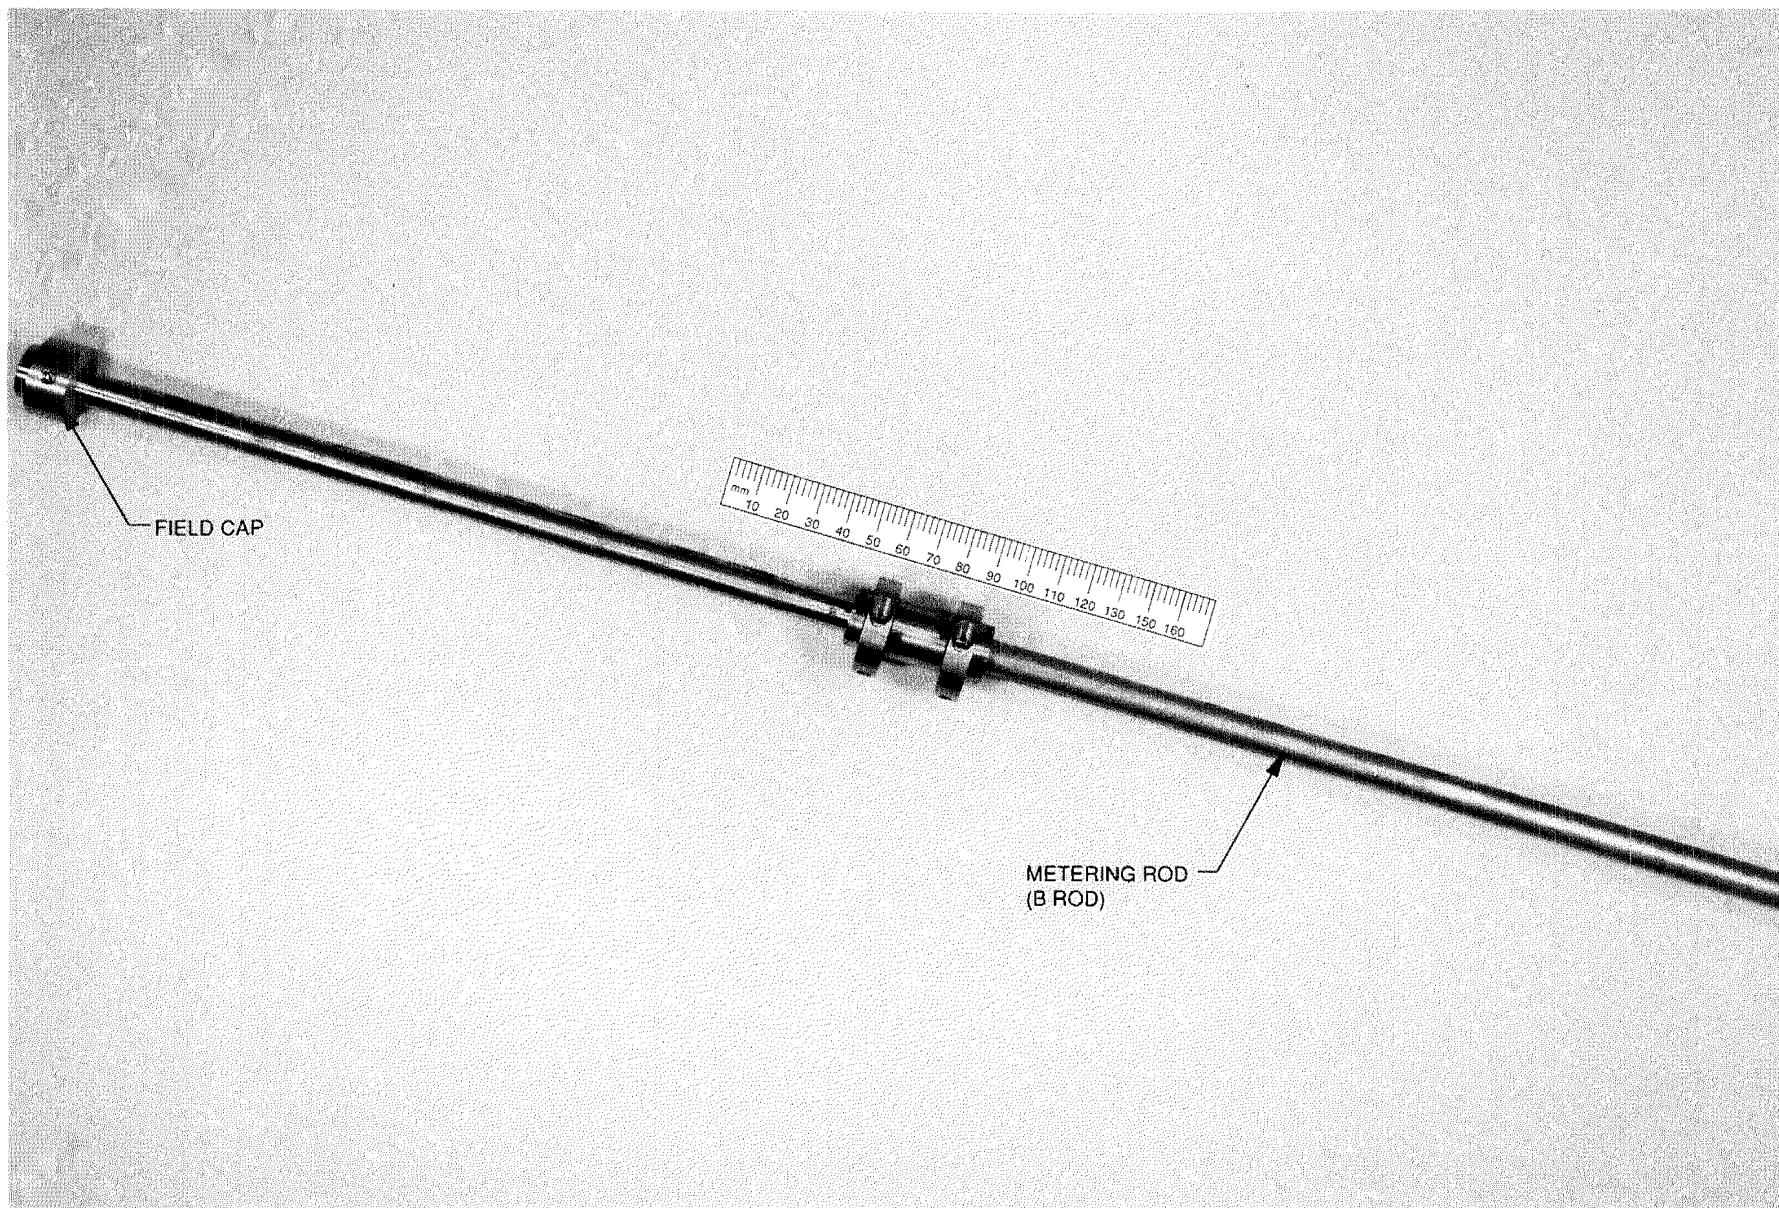
Figure 7-2. Metering rod (B rod) used to space the field lens and the center of curvature of the lower mirror in the reflective null corrector.

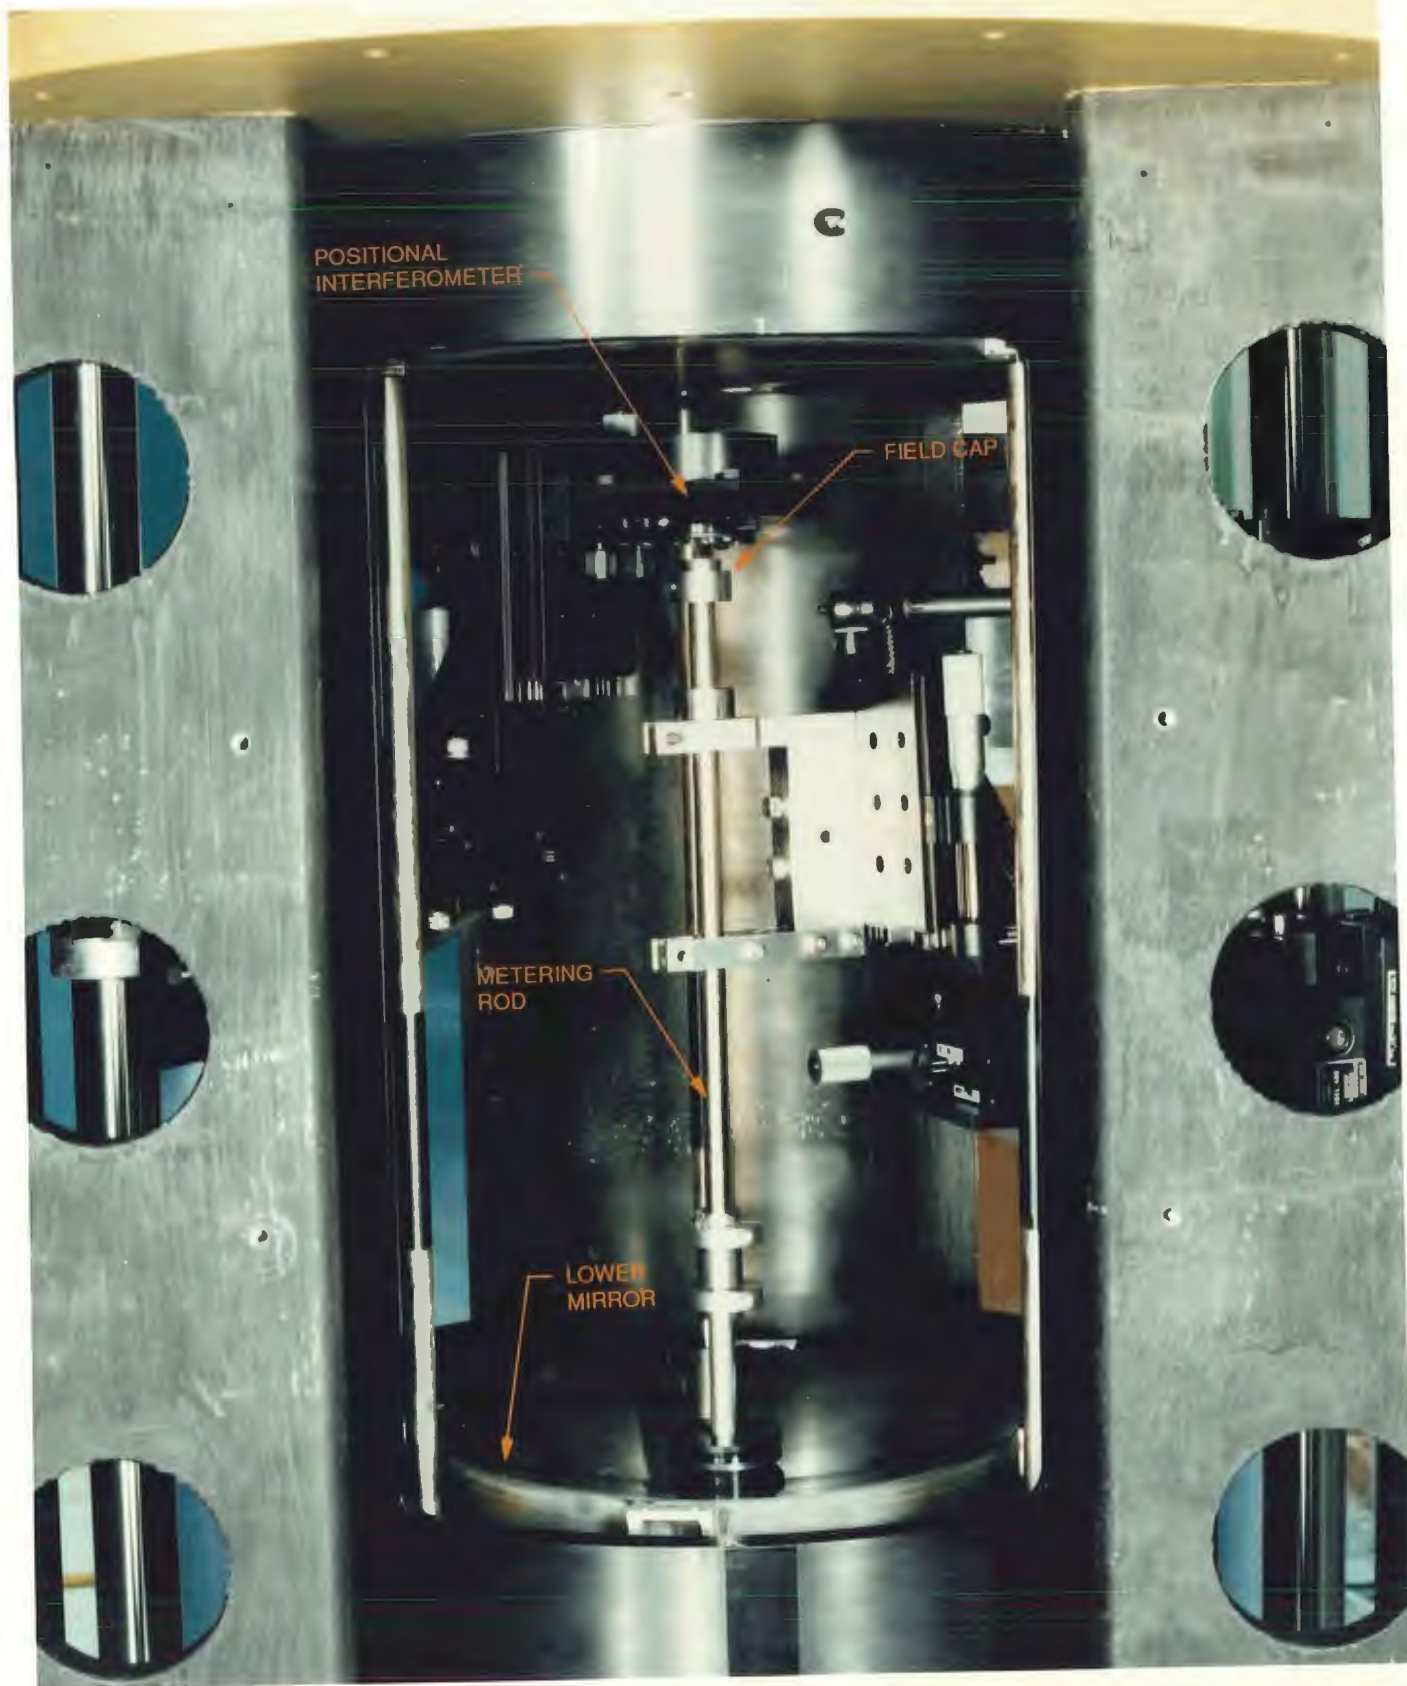
Figure 7-3. Metering rod in position between the field lens and the center of curvature of the lower mirror in the reflective null corrector.

With one end of the metering rod presumably located at the center of curvature of the lower RNC mirror, the field lens was then brought up to the end of rod B, but there was no adjustment left in the screws used for this positioning. More adjustment room was made by inserting spacers between the field lens and the lower mirror mounting plate. The adjustment mechanism was found not to be staked. Staking, i.e., securing the mechanism to prevent inadvertent movement, was a specified procedure. The final location of the field lens was then set with the addition of the spacers. As a result, the field lens was about 1.3 mm too far from its correct position relative to the lower mirror.

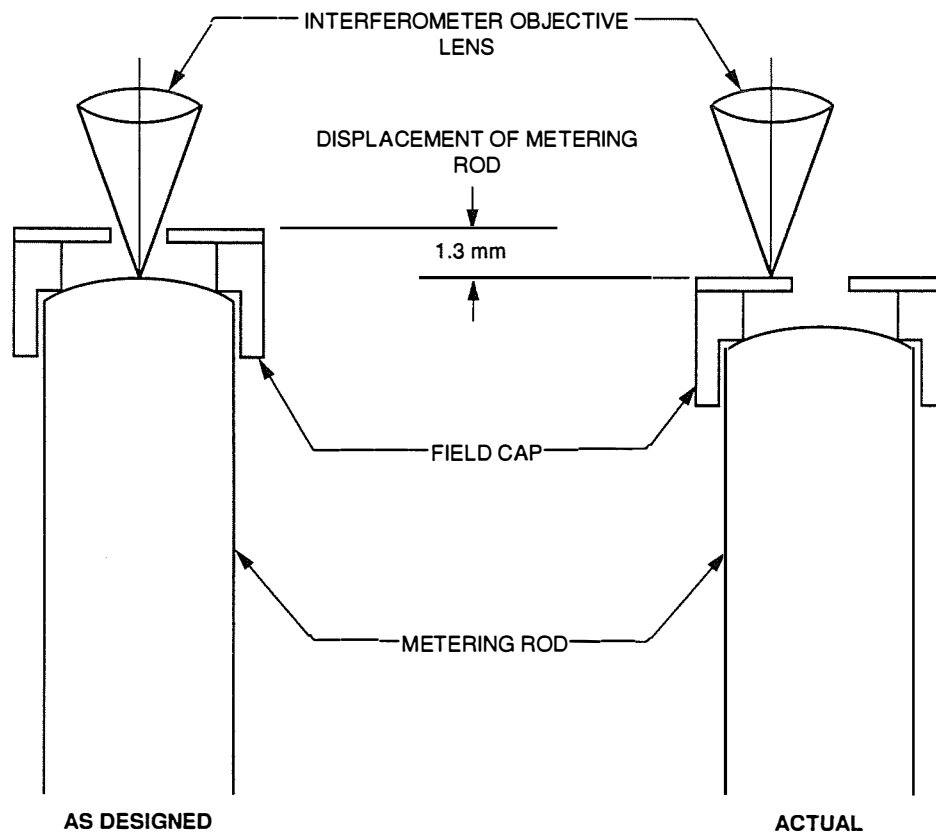
Figure 7-4. Displacement due to the interferometer focusing on the field cap instead of the metering rod.

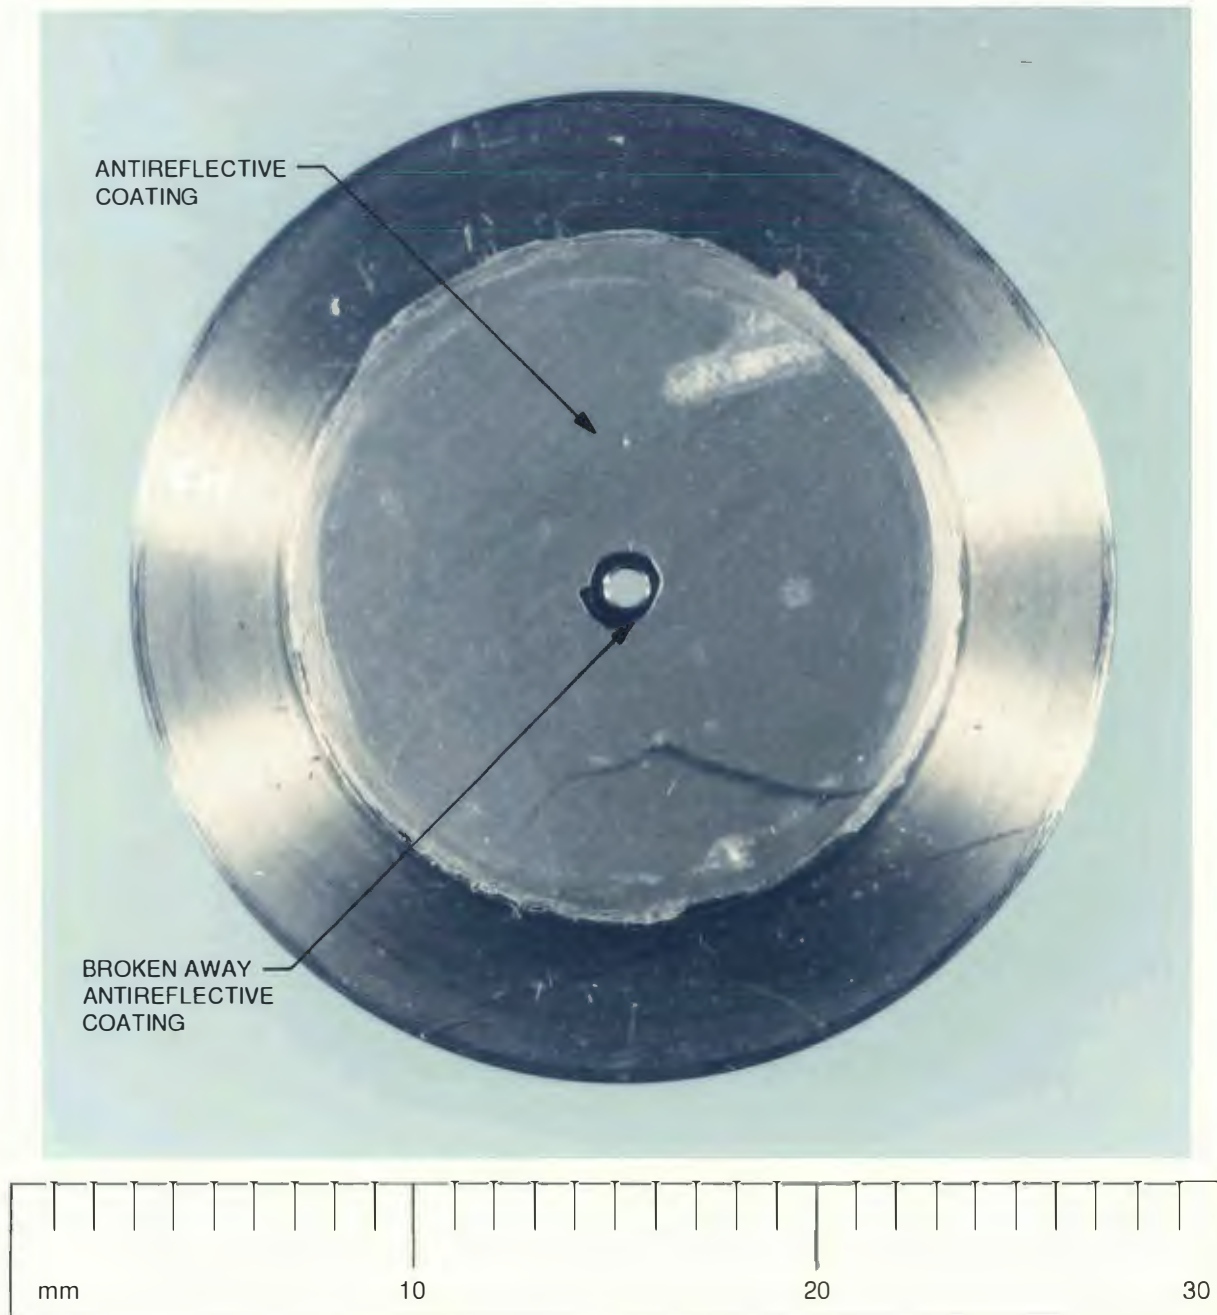
The top surface of the field cap was covered with nonreflecting material; however, some of this material had, apparently inadvertently, broken away from a small area around the field cap aperture. It appears that the operator obtained reflection from the field cap where the nonreflecting material was absent, rather than the rod end, causing the 1.3-mm misspacing. A test performed in 1990 with the equipment showed that it was quite easy, even probable, to make this error with the configuration used. Figure 7-4 indicates how the displacement error occurred by reflecting light off the field cap, rather than the rod end, as designed. Figure 7-5 is a photograph of the field cap and shows the specular region around the aperture. (In this photograph, the broken-away coating appears darker than the surrounding region.)

Figure 7-5. Top view of the field cap, showing the aperture and the area where the antireflective coating had broken away.

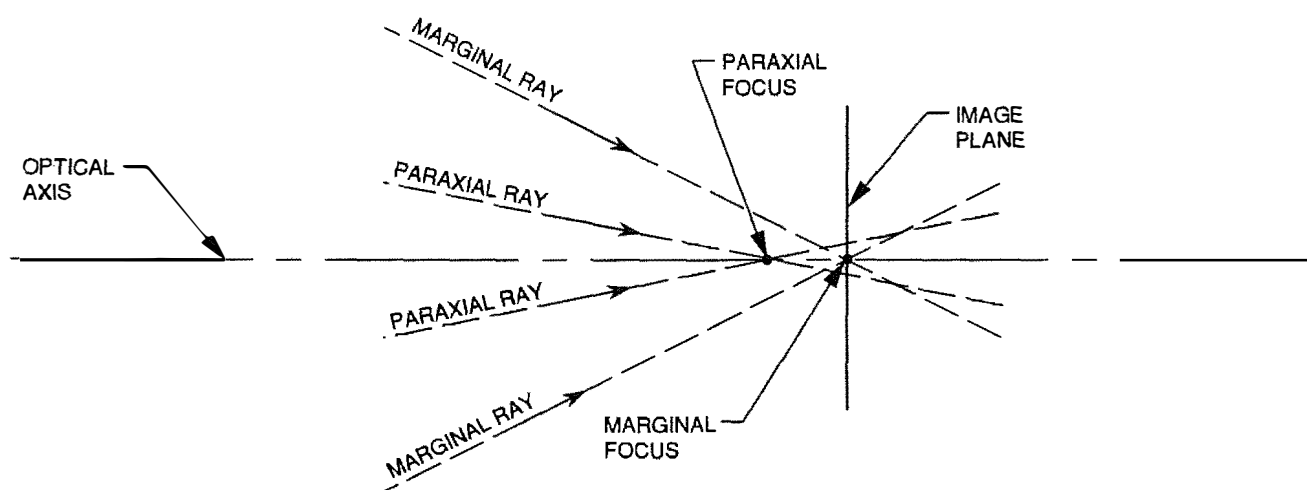
In the case of the HST, the "template" (the reflective null corrector) used to provide the reference surface for figuring the primary mirror, was not correct. In Figure C-4, we show an enlarged view of the marginal and paraxial rays as they converge in the vicinity of the vertex of the HST. Figure C-1 was used to show how the marginal focus could be superimposed on the paraxial focus by removing material. In the HST, too much material was removed from the outer edges of the primary mirror, and the marginal focus was moved to the right, past the paraxial focus. Since the marginal focus is to the right of the paraxial focus, the sign on the error is negative. Since more material than necessary was removed, the opticians call this situation "overcorrected" spherical aberration.

Figure C-4. Image-plane enlargement of the HST Ritchey-Chretien optical system. In the HST, too much material from the edges of the primary mirror was removed, and the marginal focus was moved past the paraxial focus. This is characteristic of an optical system overcorrected for spherical aberration.

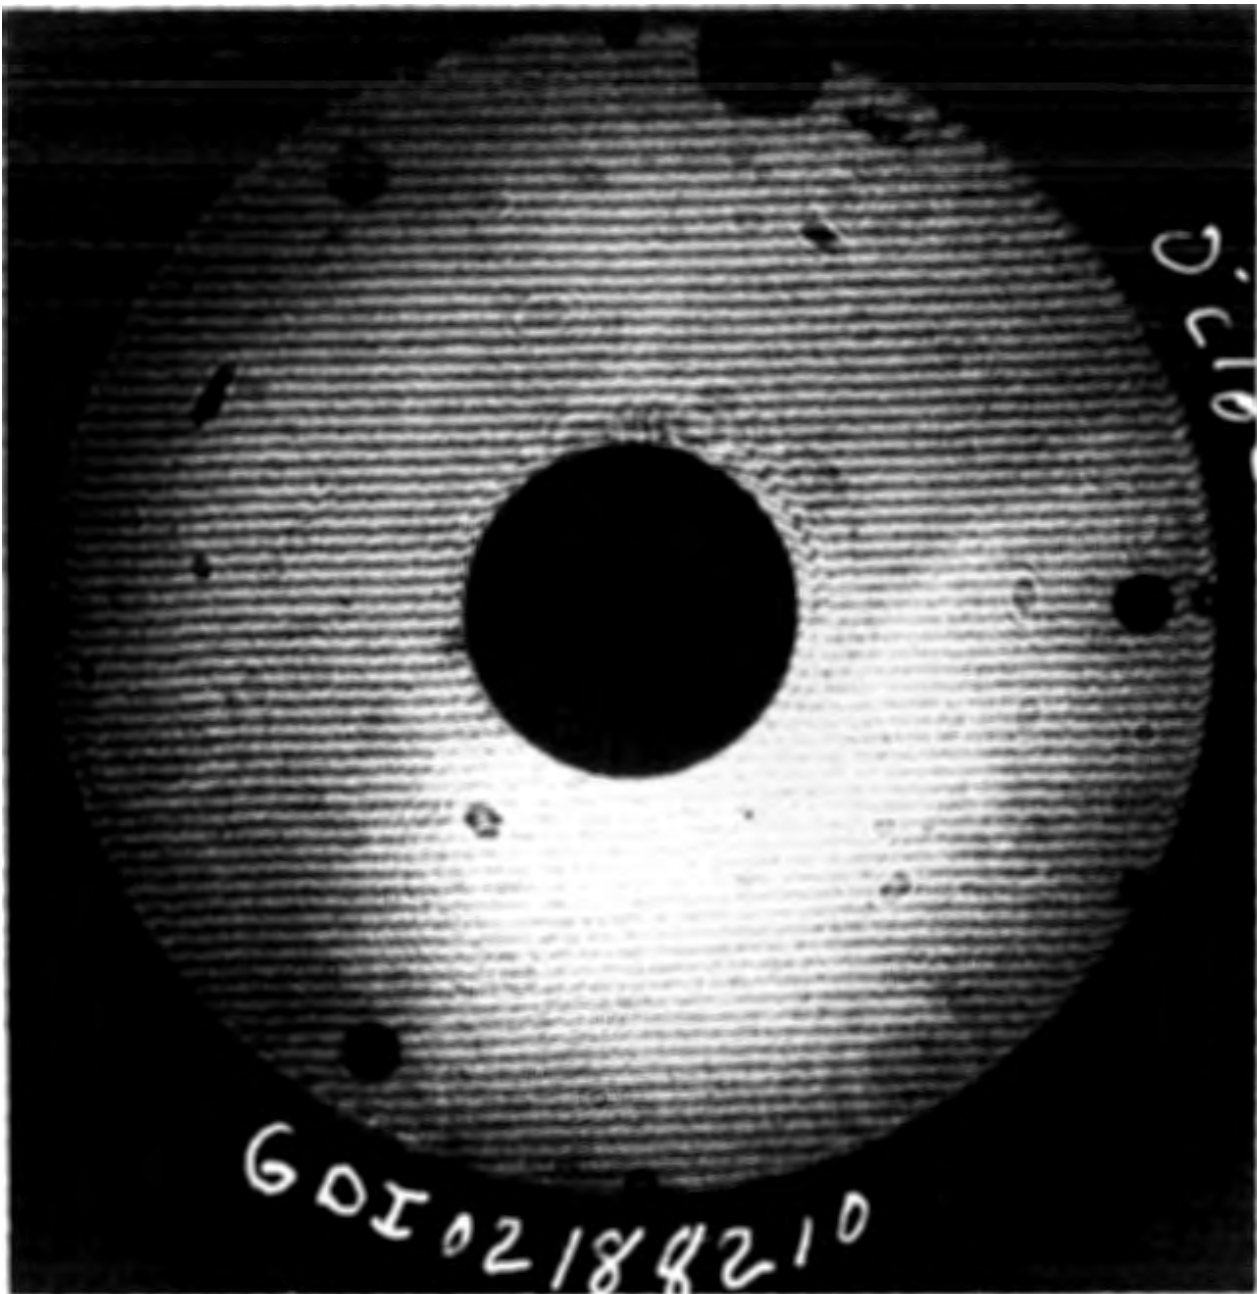
This interferogram shows three circular obscurations that cover penetration holes in the mirror surface. The obscurations were not directly part of the mirror support system, but they covered catch plates that would keep the mirror from breaking loose of the mount and damaging portions of the space shuttle orbiter, should the shuttle have had to abort the flight and return to Earth in an emergency landing. The fringe pattern also indicates the presence of local, sharp surface errors that actually fall outside of the clear aperture being used in the telescope. The semicircular marks at the periphery are fiducials used to locate the aperture in the fringe digitization process. The other defects indicated in the picture are glass chips and marks attached to components in the reflective null corrector.

Figure D-1. RNC interferogram of the primary mirror, taken in February 1982.

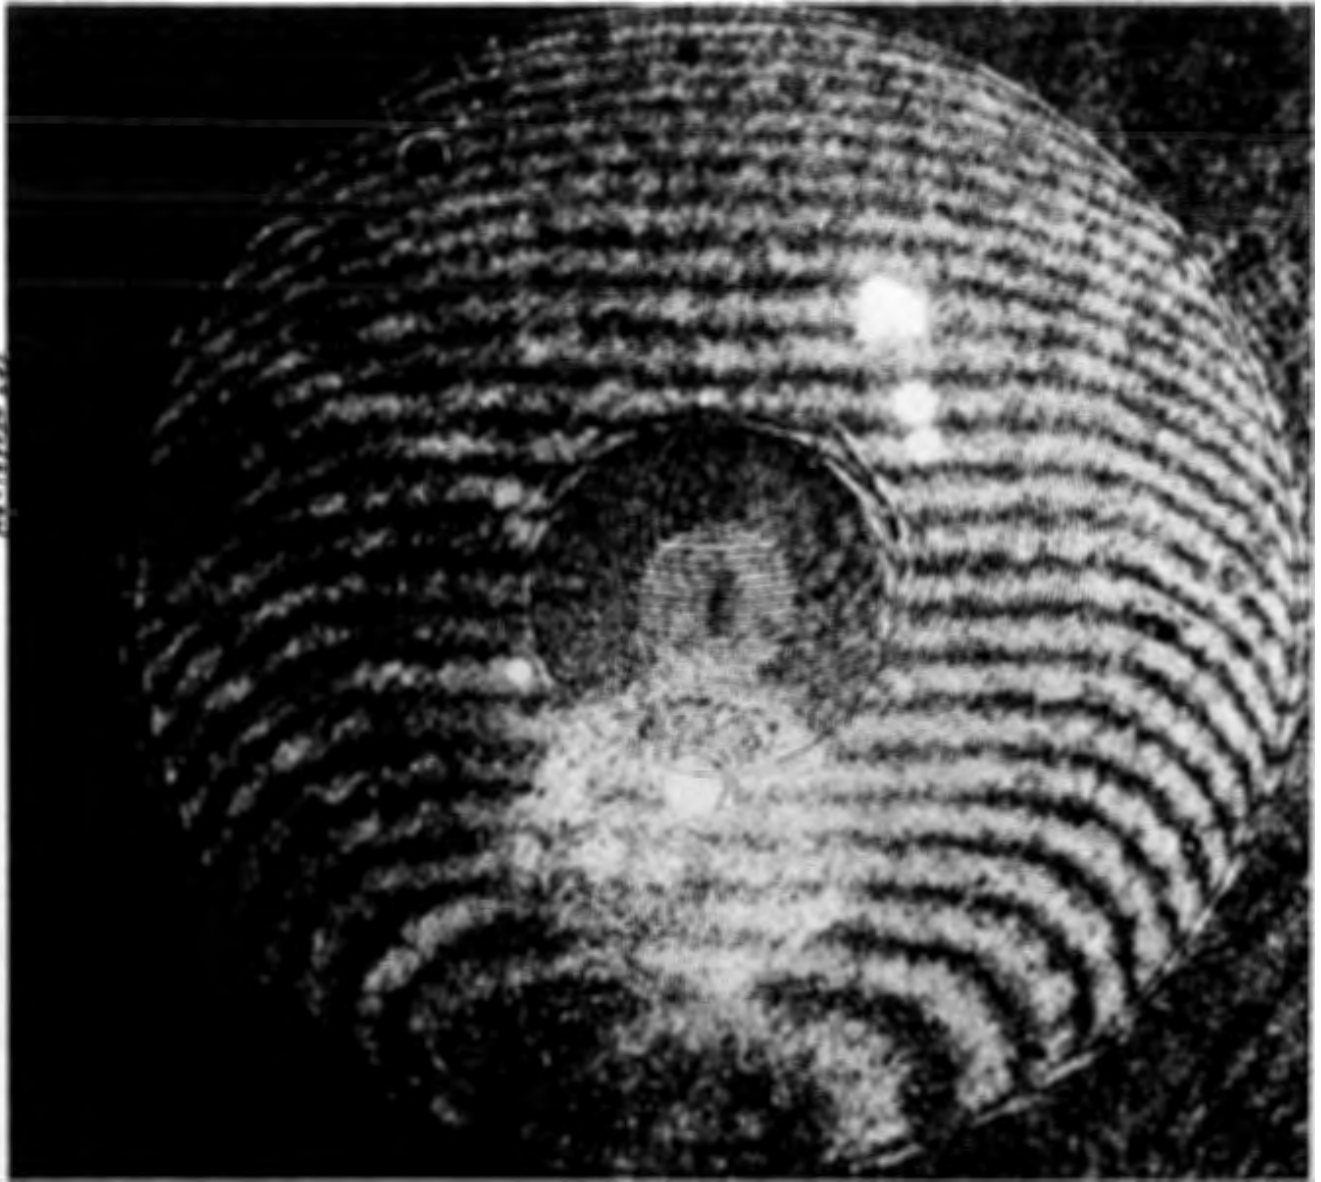
Figure D-2. RvNC interferogram of the primary mirror, taken in May 1981.
