The Hubble Space Telescope Optical Systems Failure Report

November 1990

National Aeronautics and
Space Administration

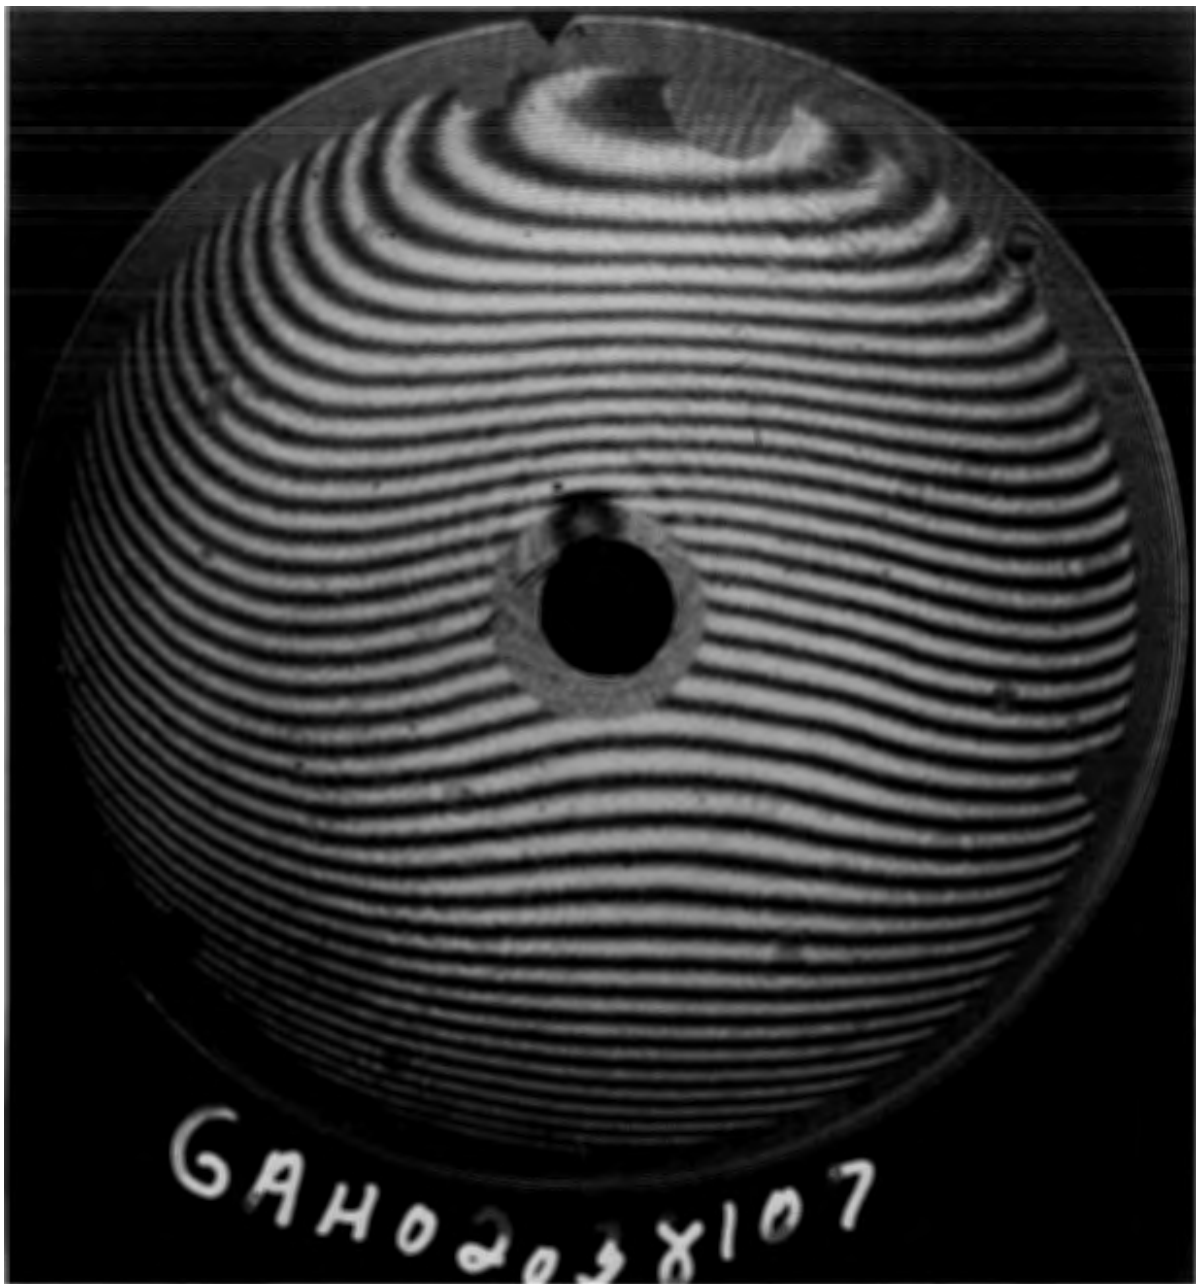
The consistency of the data from the INC and the RvNC indicates the presence of the error in the RNC. The excellent agreement of the INC data taken in 1981 and similar data taken in 1990 indicates the excellent stability of the RNC.

Figure D-3. INC interferogram of the reflective null corrector, taken in February 1981.

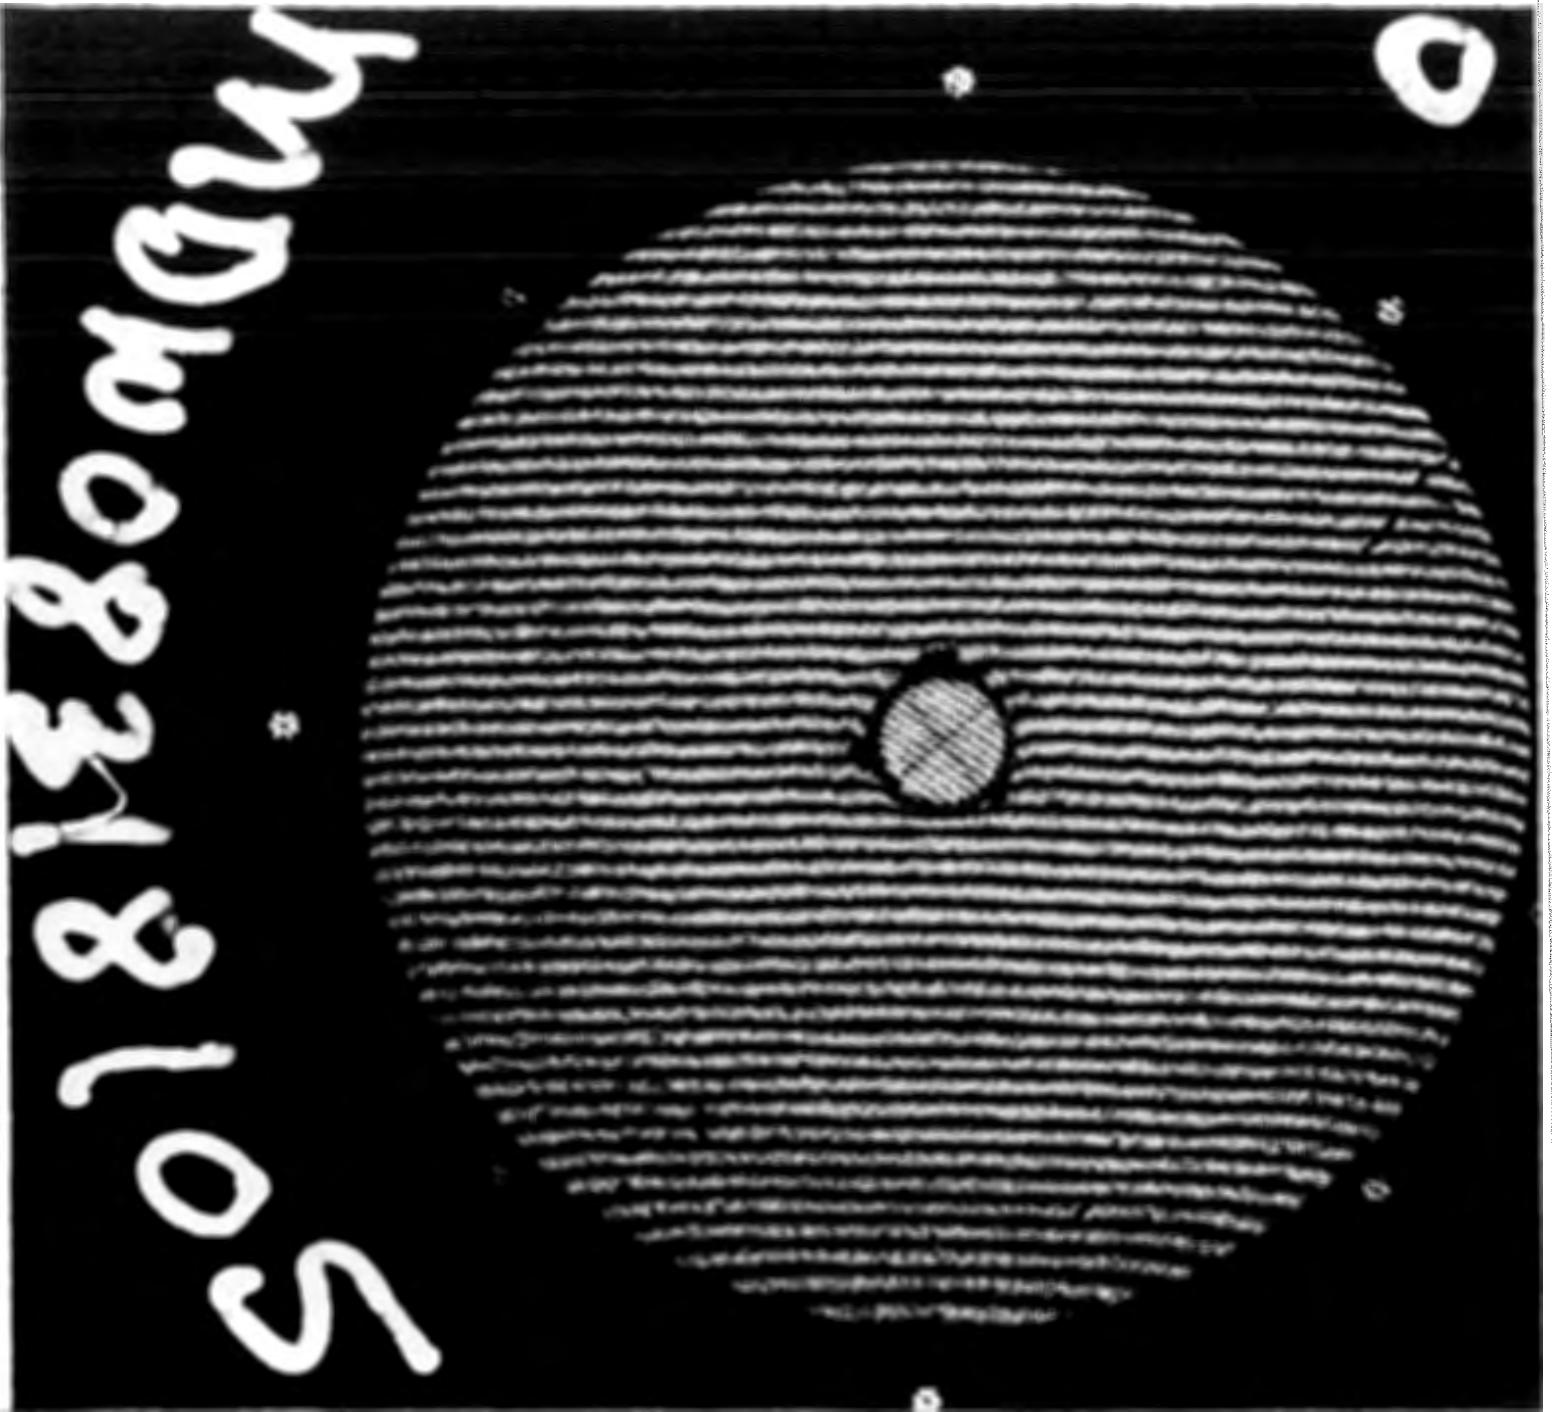
Analysis of this interferogram in 1990 supports, with only minor differences, the predicted quality of the surface shape.

**Figure D-4. Hindle Shell interferogram of the secondary mirror, taken
August 31, 1981.**
