National Aeronautics and Space Administration (NASA)
Selected Apollo & Shuttle Lessons Learned 2014

Lesson 4: Selected Apollo & Shuttle Lessons Learned (Part 1)

Lesson 10: Selected Apollo & Shuttle Lessons Learned (Part 2)

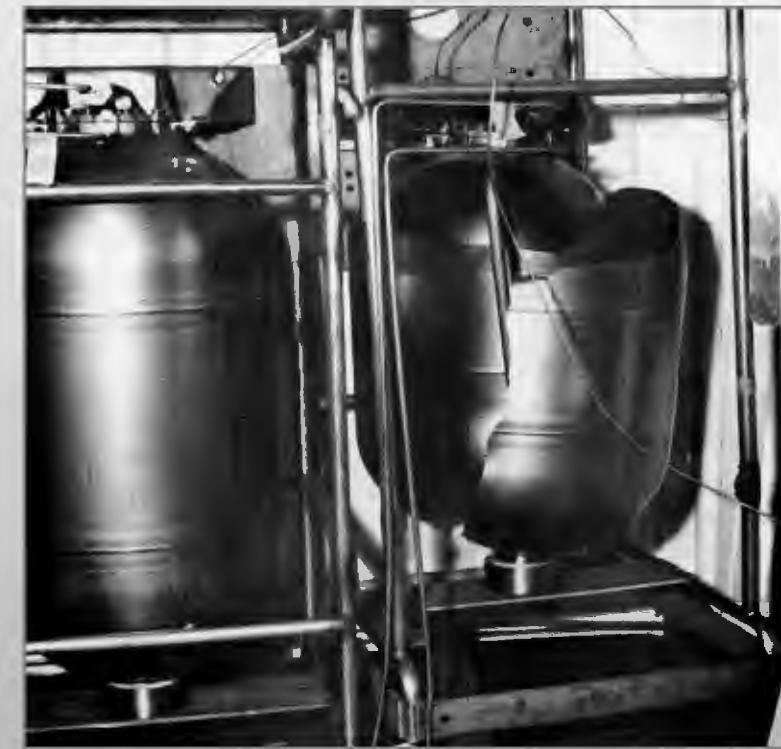
- RCS oxidizer tank exploded in test, January 1965
 - Occurred on 23rd day of 30-day creep test
 - Failure analysis indicated SCC
 - Fingerprint
 - Surface contamination
- 10 additional oxidizer tanks in test, July 1965
 - 4 exploded in first 42 hours
 - 4 others leaked
 - SCC indicated
- All prior experience indicated compatibility
 - Gemini, Lunar Surveyor, Titan missile
 - No contrary historical data
 - Other recent specimen & tank tests verified compatibility
- Confusion reigns
 - Previously compatible system now incompatible
 - Large inventory of tanks already on hand

RCS Tank Failure Solutions

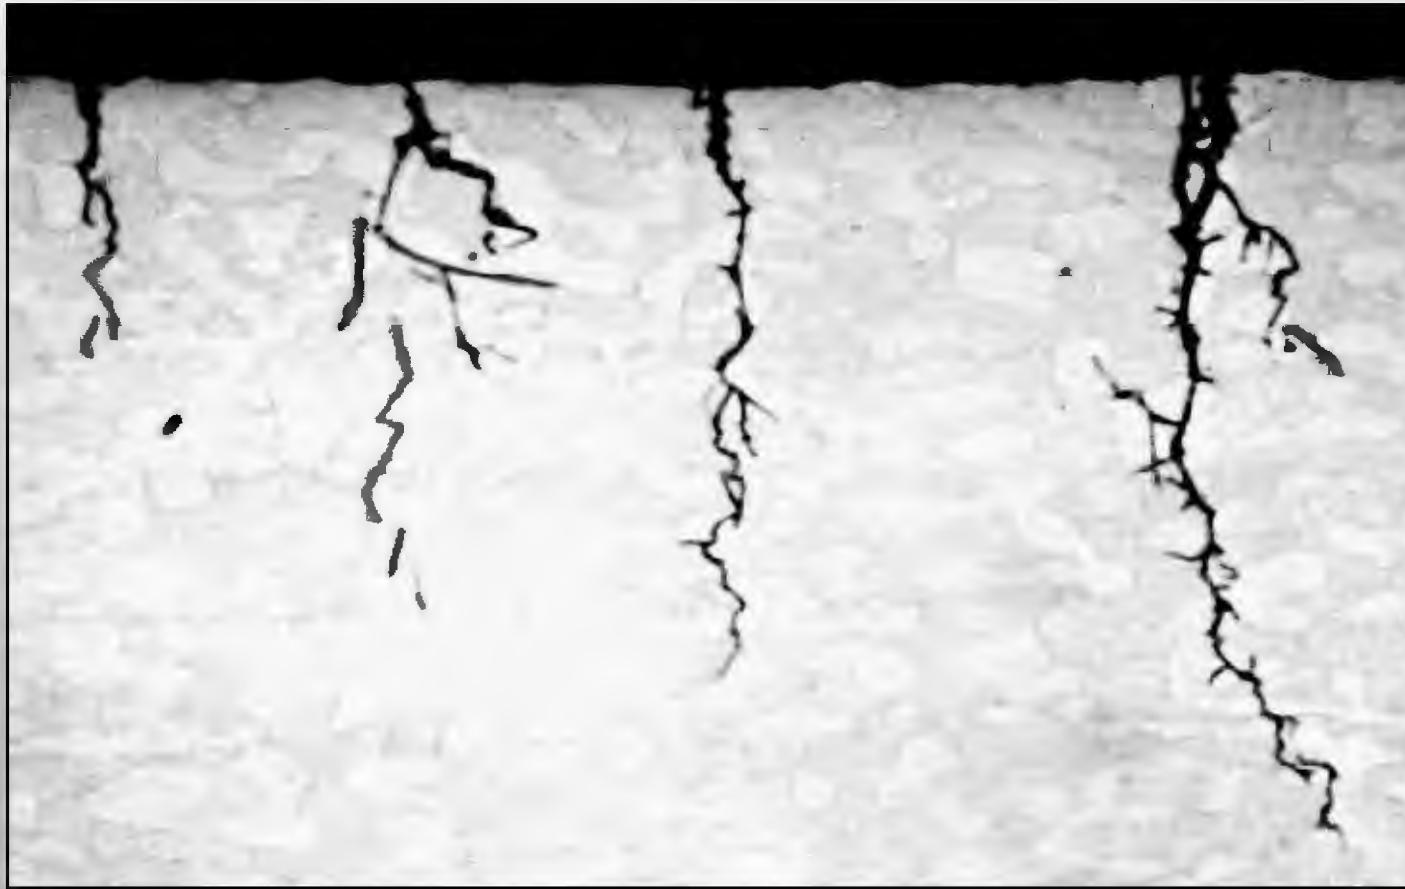
Damage Mode

Stress Corrosion Cracking

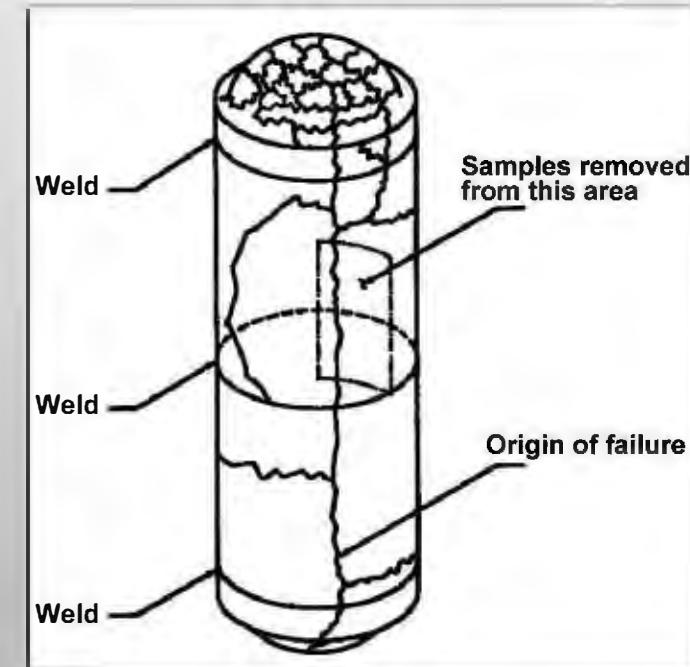
- Oct. 1, 1966: SC-101 fuel tank leaked during cold flow test
 - Methanol used in place of Aerozine 50
 - Suspected stress corrosion cracking
 - Weld contamination also suspected
- Additional tank testing instituted to sort out SCC & weld contamination possibilities
 - Tanks to be tested in place
 - Tank considered to be a leaker
- Oct. 25, 1966: SC-017 fuel tank exploded during test
 - Tank installed in Service Module when tank exploded
 - SC-017's Service Module completely destroyed in explosion

- Stopped using methanol as referee fluid
- Scrapped all tanks that had been through cold flow test
- Applied fracture mechanics methodology to all pressure vessels in remainder of Apollo Program
 - Proof-test logic principally used
 - Many tanks already in inventory
 - Low number of cycles involved
 - Measured fracture toughness, fatigue & environmental crack growth properties of all tank materials
 - Parent, weld & HAZ
 - Measured K_{th} of actual flight propellants before each lunar mission

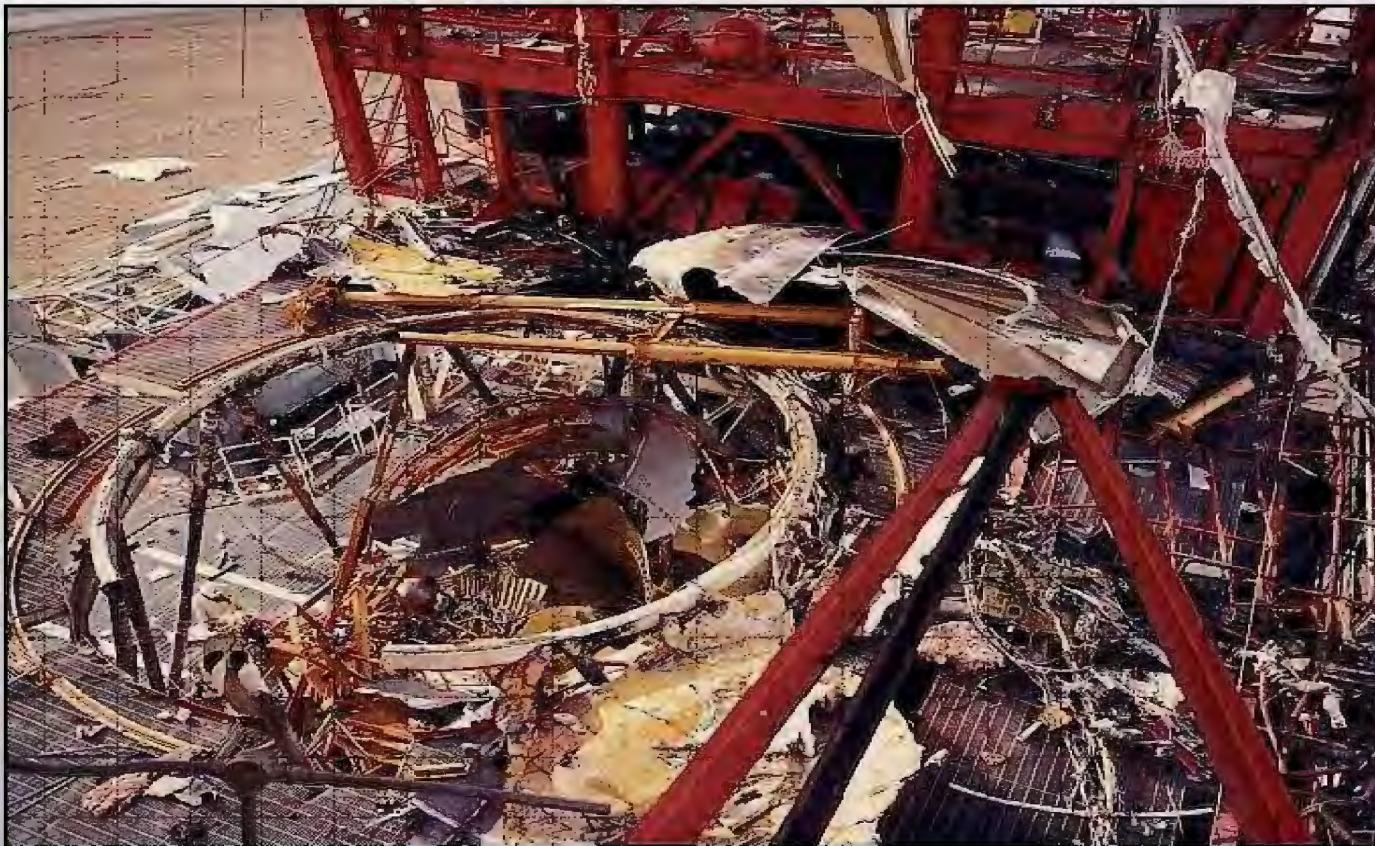
Explosion destroyed entire S-IVB stage & severely damaged static firing test stand

- Remove all helium tanks welded with CP weld wire
 - 5 on S-IVB 503 stage
 - 4 found on other stages
- Spacecraft 6Al-4V tanks implicated by problem
 - Welded on purpose with CP weld wire
 - JSC cut up many tanks looking for hydrides
 - No hydrides were found
 - Hydride problem peculiar to thick multipass welds
 - Spacecraft 6Al-4V tanks were thin-walled single/double pass welds

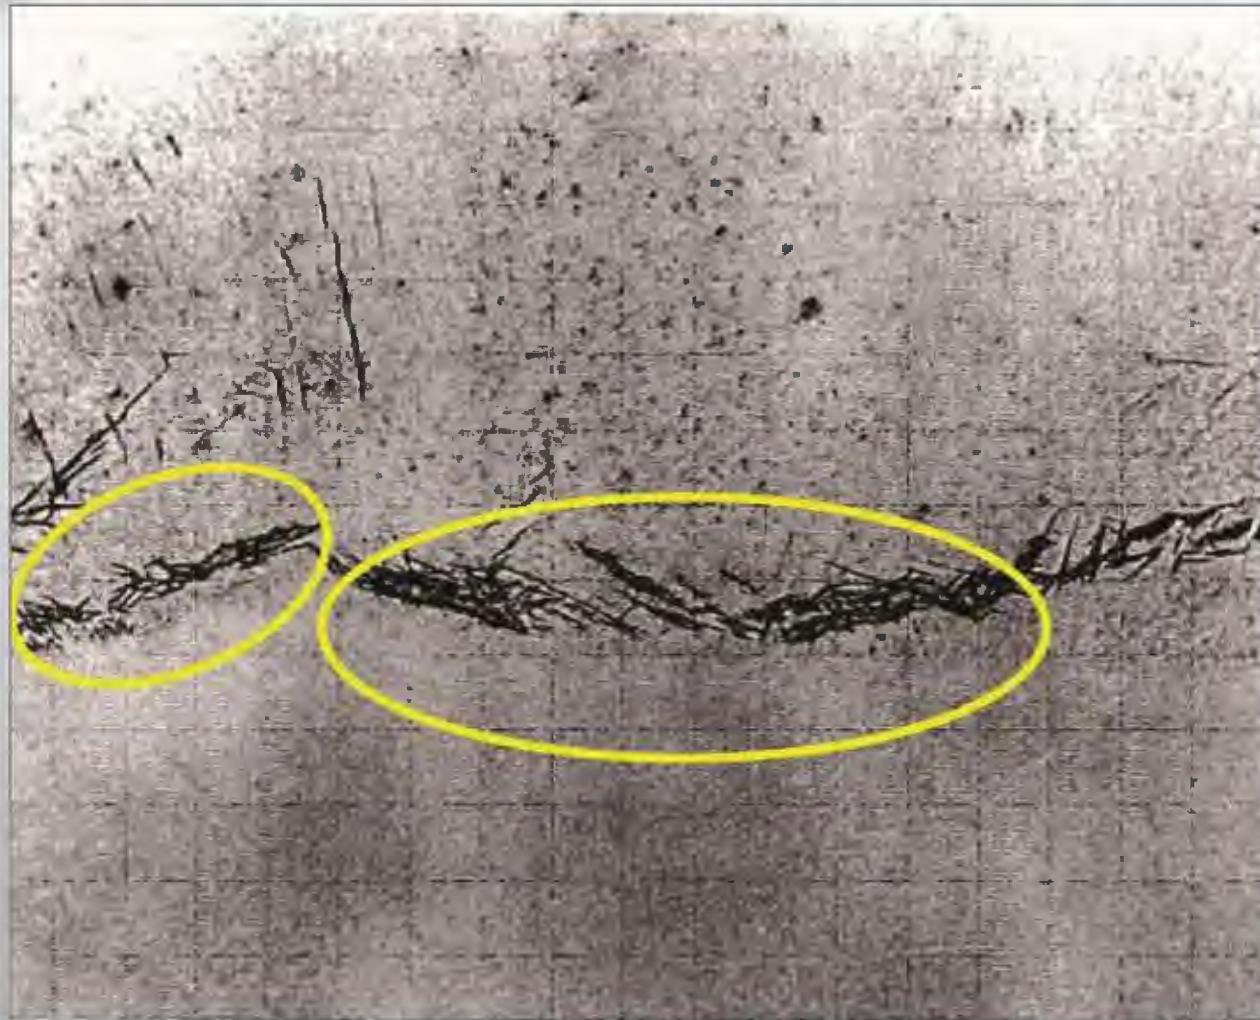
Wrong Weld Wire

- Tank welded with wrong weld wire
 - Commercially pure (CP) titanium weld wire used
 - One spool of CP wire was mislabeled/misshelved
 - Specification called for titanium 6Al-4V weld wire
- Wrong wire resulted in low alloy content in the weld
 - Much lower hydrogen solubility in weld
 - Hydrogen diffused to weld via a stress gradient
 - Hydrogen precipitated as titanium hydride needles at fusion line
 - Over time sustained load cracking occurred
- Very-low-alloy content resulted from multipass weld
 - 10–12 passes required
 - Each pass further diluted weld deposit

Titanium hydride needles

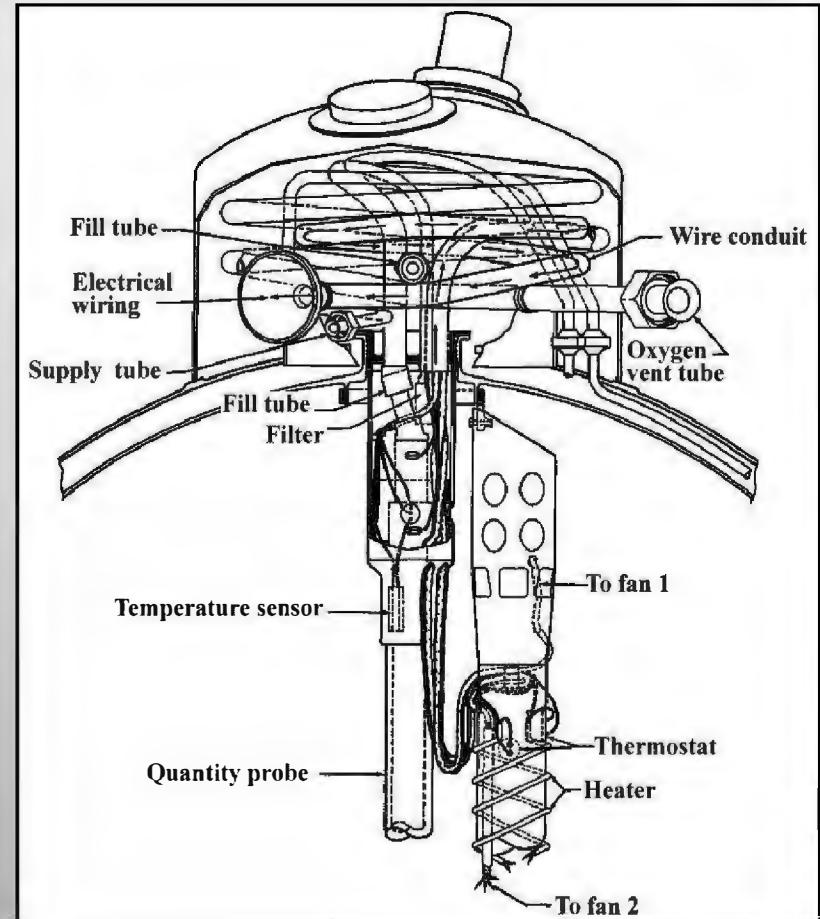
- Tank contained:
 - Pure-oxygen environment
 - Flammable materials
 - Ignition sources
- Thermostatic switches underpowered
- Switches not tested under power
- Tank dropped in manufacturing
- Could not detank after CDDT
- Improvised detanking procedure
 - No test/verification
 - Very high internal temperature occurred
 - Wire insulation severely degraded

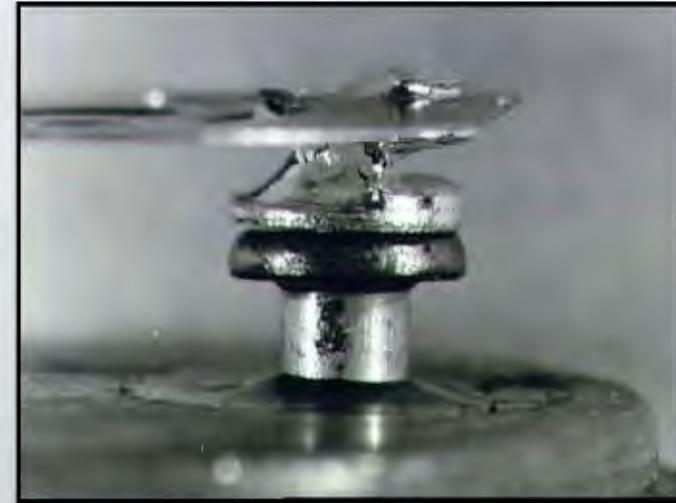
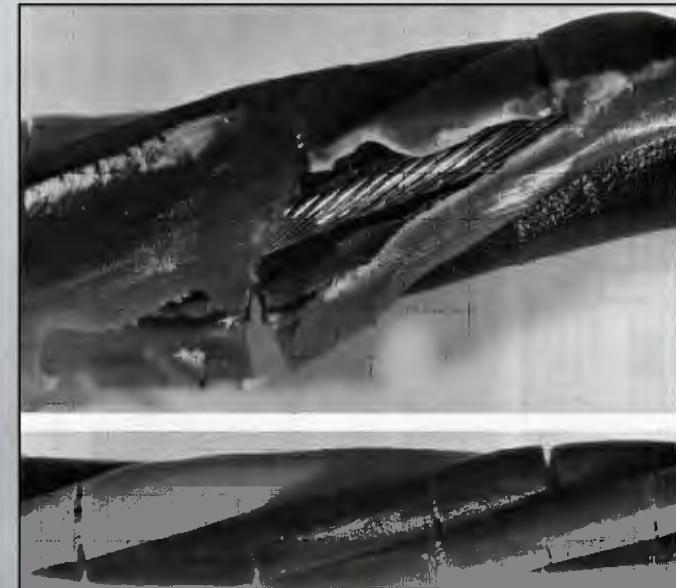
- Improvised detanking procedure required prolonged heating of tank contents
 - Thermostatic switches set at 80 °F
 - Prolonged heating requires switches to open
 - First time ever with 65 VDC
 - 28 VDC switches opening with 65 VDC power applied weld shut
 - Opening arc persists too long
 - Contacts melt & bridge 0.015" gap
 - Power to heating element on for 8 hours
 - Temperature near heating element 1,000 °F
 - Teflon insulation on nearby wires severely degraded

- Major tank redesign
 - Removed all wiring & motors from contact with oxygen
 - Minimize use of flammable materials inside tank
- Some felt installing correctly rated switch would be sufficient
- Implemented rigorous requalification test program
- Revised KSC prelaunch anomaly resolution procedure
- Reassessed all subsystems & responsible organizations

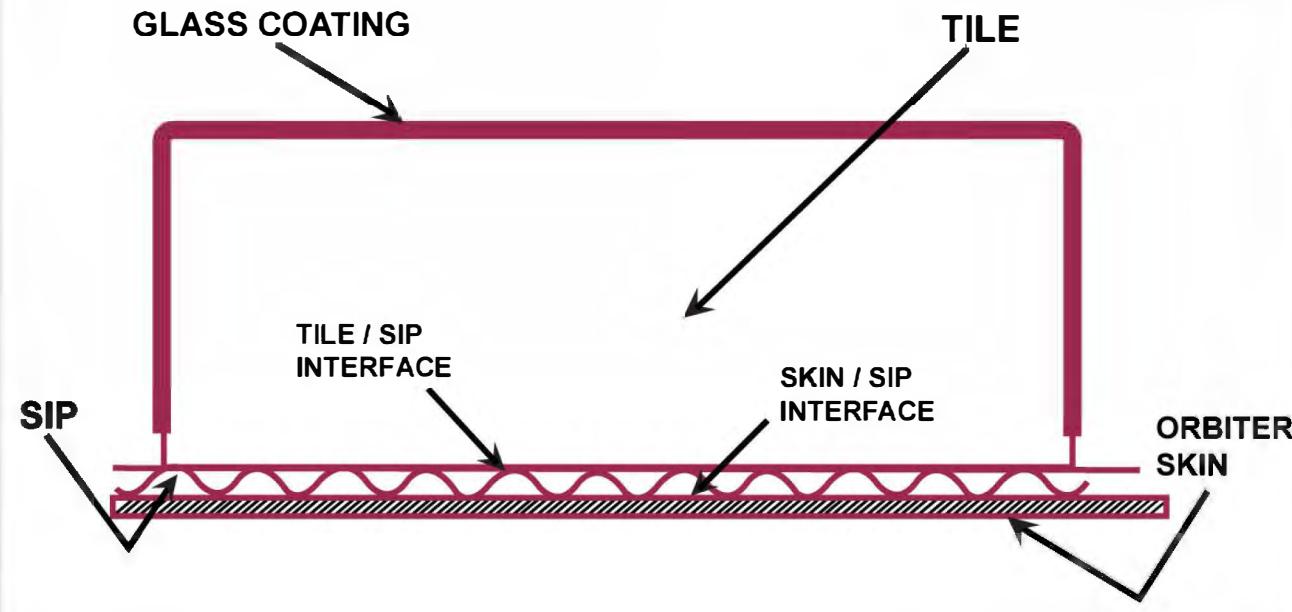
- May 1979—
Several tiles
fell off Orbiter
when it was
ferried by 747
aircraft to
Kennedy
Space Center
- Tiles vital to
protection of
Orbiter during
reentry

- Tiles were glued to Orbiter skin with room-temperature vulcanizing (RTV) silicon adhesive & Nomex strain isolation pad (SIP)
 - SIP “needling” caused localized stress concentrations along bondline interface with tiles
 - Concentrations resulted in low bond strength
- Original tests of bond strength conducted on small (2"×2") flatwise tensile specimens, not full-sized tiles
- Dynamic testing had not been started

- Densification of tile's bottom surface:
 - Eliminated voids
 - Exposed denser, stronger surface to RTV at bond
 - Allowed stress concentrations to be “neutralized” & not a performance factor
- 2 densification methods developed:
 - LUDOX process, which added silica to tile surface
 - Tetraethylorthosilicate (TEOS) process, which also added silica to tile surface

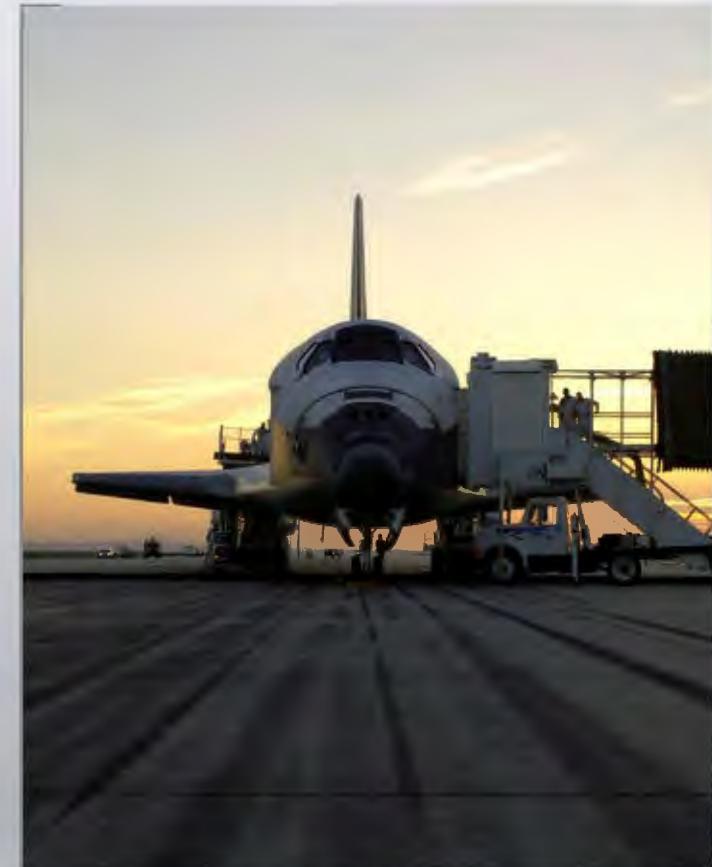
- TPS tiles coated with thin film of borosilicate glass
- Coating prevents tiles from absorbing water
- Coating easily damaged
- Initial repair method only certified for thermal environments

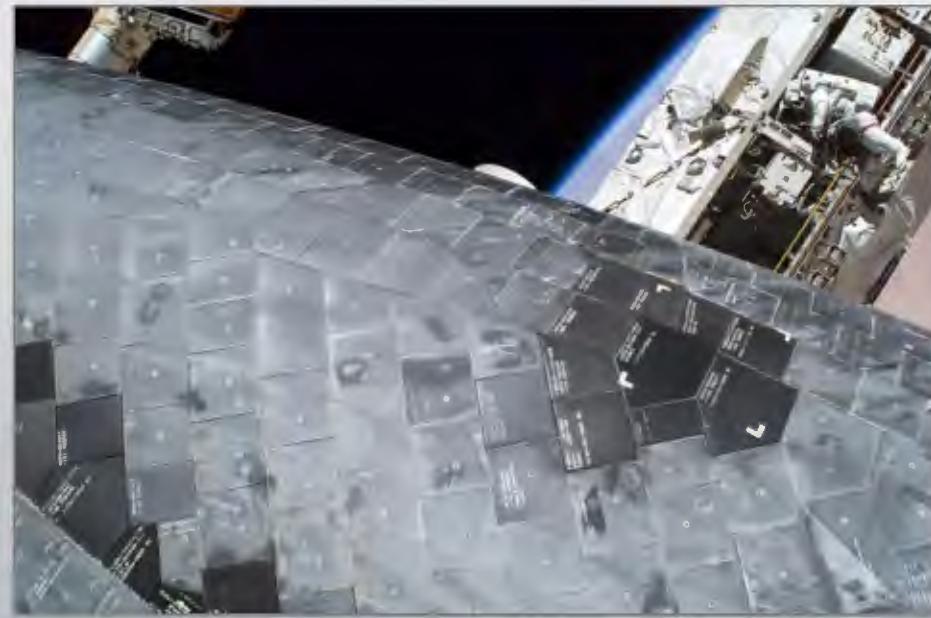
- Tile material very soft & lightweight
- Repair material very hard & heavy
- During dynamic movement, hard repair material damaged surrounding soft tile material
- Repair popped out
