Description of document:	National Science Foundation (NSF) Documents Concerning the Arecibo Radio Observatory Response Plan
Requested date:	19-November-2020
Release date: Additional release date:	26-February-2021 14-April-2021
Posted date: Update posted date:	15-March-2021 11-April-2022
Note:	Material released 14-April-2021 begins on PDF page 18
Source of document:	National Science Foundation Attn: FOIA Officer 2415 Eisenhower Avenue Alexandria, Virginia 22314 Fax: (703) 292-9041 Email: <u>foia@nsf.gov</u>

Response Plan for the Arecibo Observatory Cable Failure

RESPONSE PLAN FOR THE AUXILIARY CABLE FAILURE AT THE ARECIBO OBSERVATORY

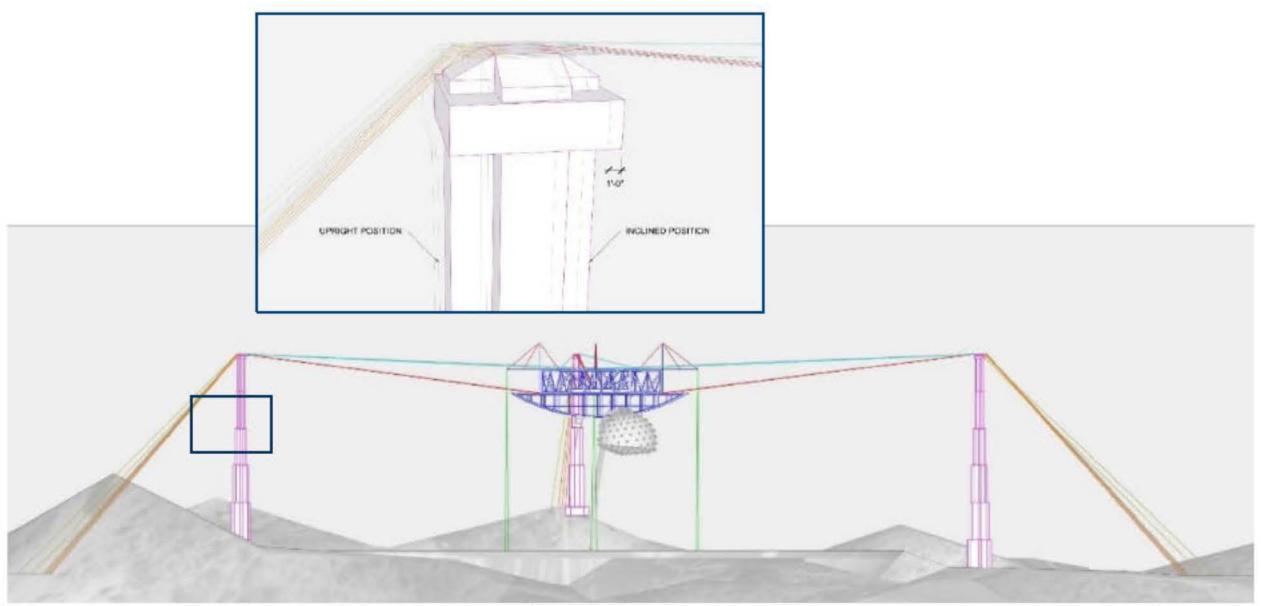
Figure 2. One-foot horizonal translation of tower from backstay lengthening.

Although much more time-consuming than relieving hold-down cables, lengthening the backstays on the towers would provide additional, quantifiable reduction in key element demands, and it could be done without personnel working within the tower perimeter. Lengthening backstays will allow the tops of the towers to move inward. This will, in turn, cause the Feed Platform to drop, which will relieve the remaining tension in the hold down cables and increase the slopes of the suspension cables. Both of these actions will reduce suspension cable tensions. We performed some rough preliminary analyses using as-designed dimensions and material properties which indicated that allowing the top of each tower to move inward one foot (a very small and very tolerable amount of movement) would have the following beneficial effects:

The combination of the initial post-event hold down cable release and allowing the tower tops to move inward as indicated above would add a significant, quantifiable margin of safety to the already stable conditions.

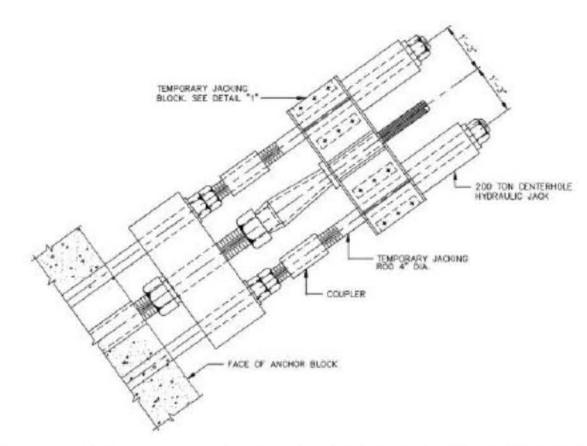
TENSIONING AUXILIARY BACKSTAYS - MK 302, MK 303 & MK 304

Figure 4. Auxiliary cable backstay anchorage

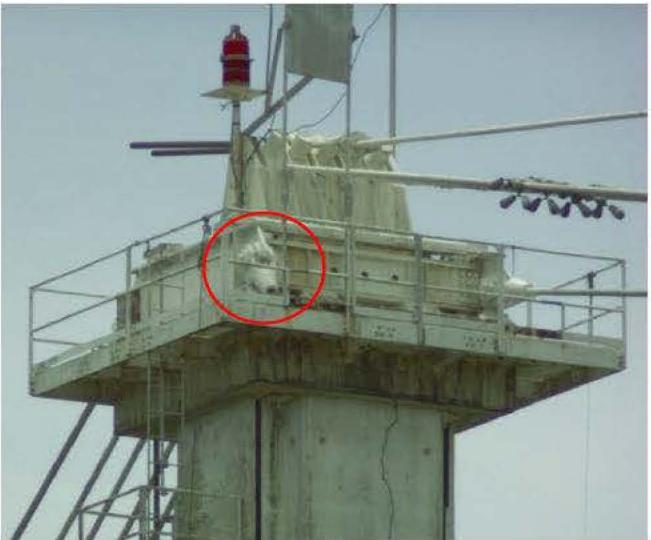
Once Step 1.1 is complete, recovery of the failed clevis can commence. Removal of the clevis will require personnel to climb Tower T4, secure the clevis to the tower, remove the pin, and then lower the clevis to the ground. This work will be done during low wind conditions and in accordance with a task-specific safety plan. All personnel will have appropriate PPE and will be tied off to proper anchorages during their ladder accent/decent and while working on the top platform. Personnel working on the top platform should remain next to the failed socket and avoid positioning themselves in front of or below any other live cable socket. Figure 5 is a long-distance view of the failed clevis.

Figure 5. Failed clevis (circled). Photo from AO.

Risks associated with failure of another cable and any ensuing collateral damage during this activity will be low. As previously indicated, demands on the intact cables are less than the demands sustained during and shortly after the failure. In addition, in the unlikely event of a future cable failure, the failed unit will not be able to contact personnel positioned on or at the base of the tower. The tower will remain stable should a backstay cable failure occur. The recovered clevis, once lowered to the ground, should be stored indoors in an environmentally controlled space.

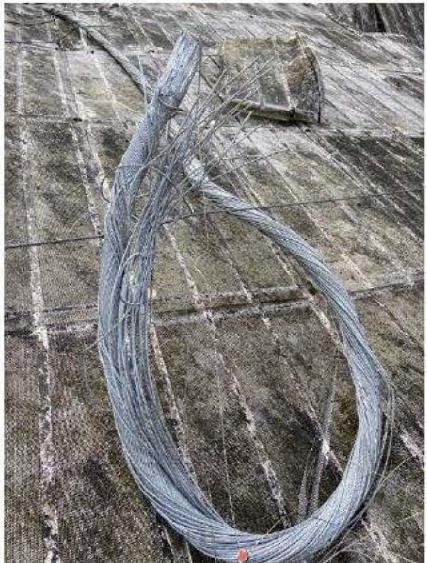
Figure 6. Cable end to be recovered. Photo from AO.

Approximately 10 feet of the failed cable including the failed end should be recovered (see Figure 6). This will require accessing the lower portion of the primary reflector, securing the individual wires using steel clamps (hose clamps or similar), holding the segment of cable with a material handler, cutting the cable with an electric saw, and lowering the material to the ground. This work will be done during low wind

conditions for the site and in accordance with a task-specific safety plan. All personnel will have appropriate PPE. The recovered cable end should be stored indoors in an environmentally controlled space.

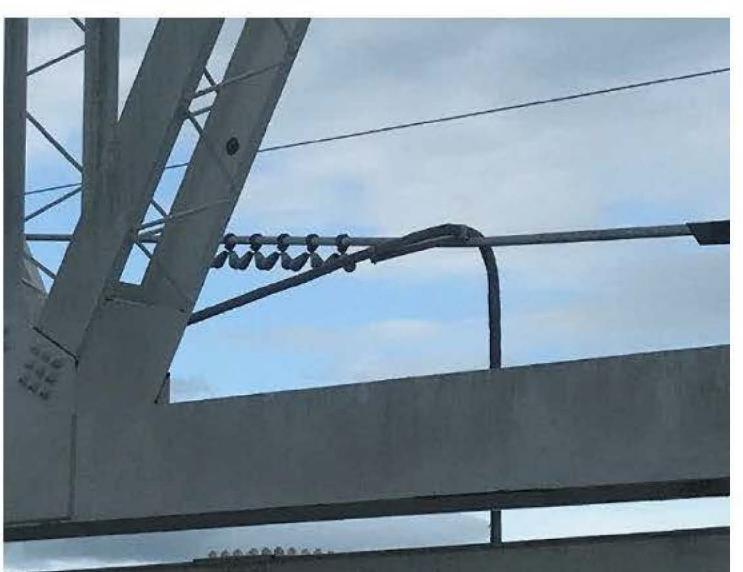
Figure 7. Failed cable draped over T12 auxiliary cable. Photo from AO.

Removal of the remaining attached socket and draped length of cable can proceed after the monitoring and socket bypass retrofits of Steps 1.3 and 1.4 have been installed. These steps will provide further assurance that work on and below the platform will be reasonably safe. Removal of the still-connected socket and cable must avoid damaging the auxiliary cable from Tower T12 over which the failed cable is draped (see Figure 7 above). Because it is advantageous to save the socket and cable for testing, the retrieval effort will need to secure the socket and adjustment rod connection, detach the connection assembly, lift and rotate the assembly away from the supporting cable, and lower it to the ground.

This work will be done during low wind conditions for the site and in accordance with engineered and task-specific safety plans. All personnel will have appropriate PPE.
