**S0300-BJ-RPT-010**

# **COMMERCIAL AIRCRAFT SALVAGE OPERATIONS**

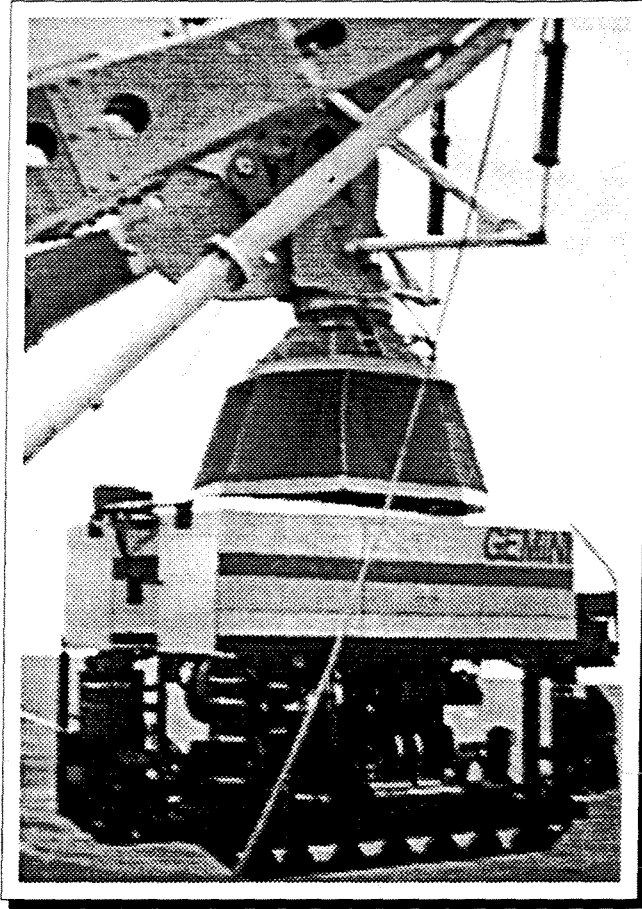
Figure 4-4. Launching GEMINI.

- A-frame for launch and recovery. A hydraulically operated, aluminum A-frame designed to launch and recover GEMINI was installed over the starboard wing wall of STENA WORKHORSE. Although the design was similar to other proven recovery devices, this system was used for the first time during actual ROV launch and recovery on site. The A-frame proved satisfactory after considerable structural and vehicle housing alignment problems were overcome.
