Description of document: **US Navy Naval Sea Systems Command Report on the Salvage of the Space Shuttle Challenger Wreckage**

Title of Document Space Shuttle Challenger Salvage Report, T9597-AA-RPT-010/SUPSALV, 0910-LP-140-9100, Published By Direction of Commander, Naval Sea Systems Command

Date/date range of document: 29-April-1988

SPACE SHUTTLE CHALLENGER SALVAGE REPORT

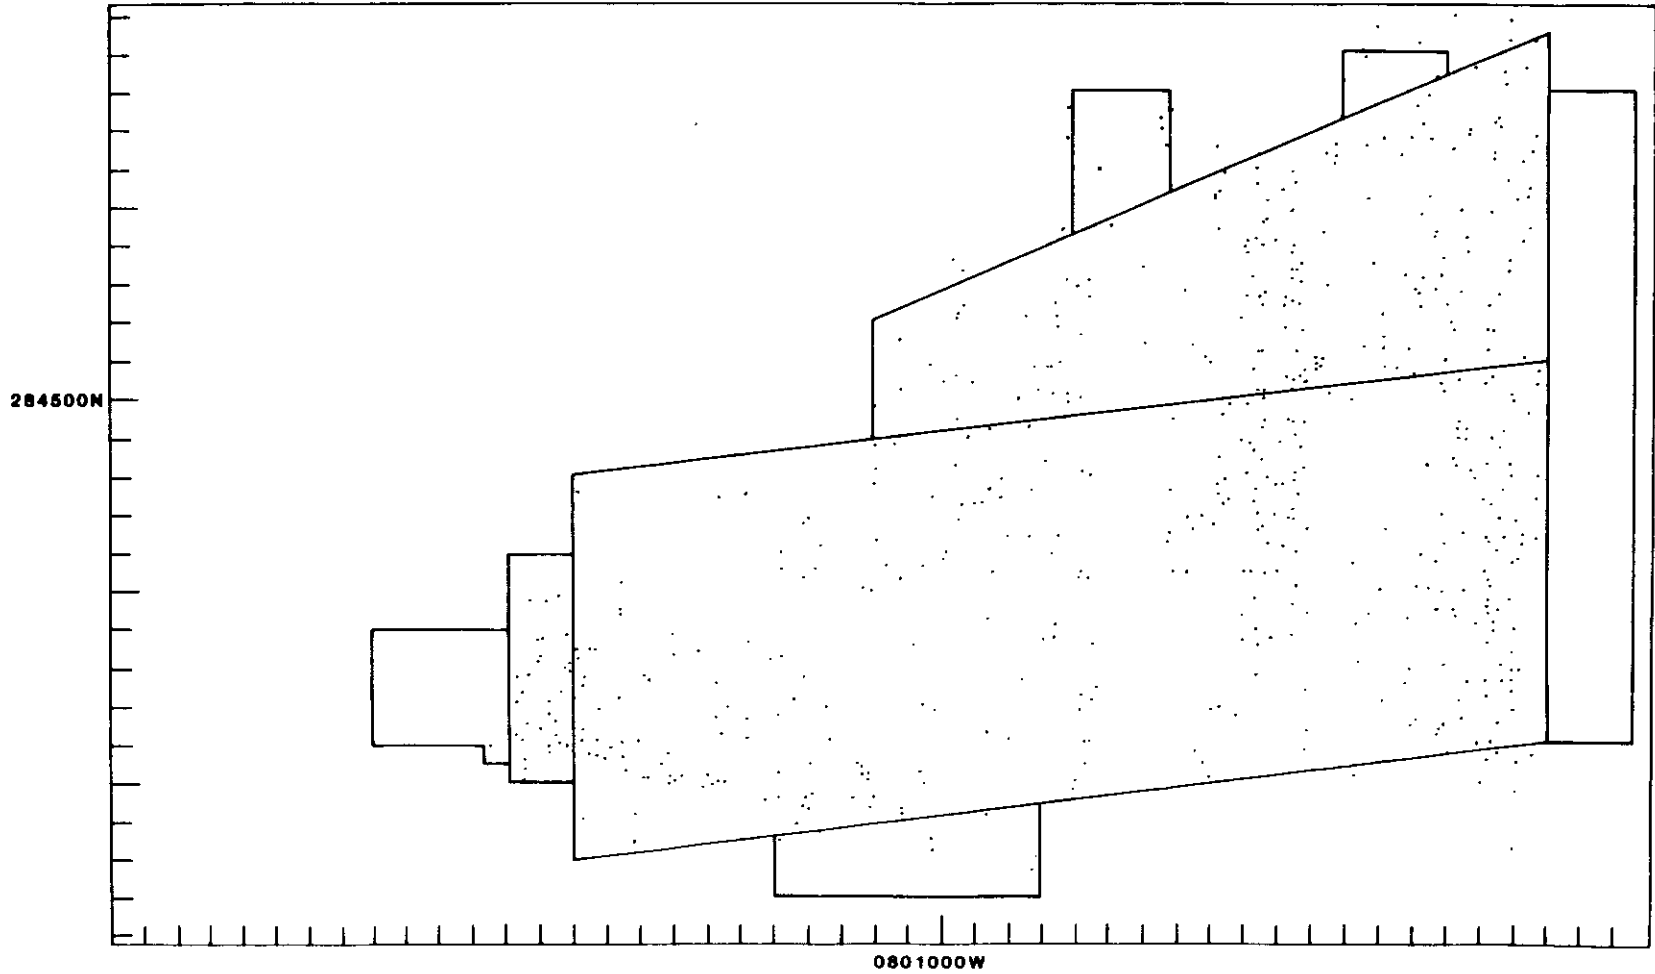
Exhibit 13. Distribution of 881 Designated Sonar Contacts

4.2 Contact Summary. From 8 February through 29 August 1986, a total of 881 contacts were designated from the sonar traces during the search, of which 711 were ultimately investigated using divers, ROV's, or manned submersibles. Of these 187 were confirmed to be shuttle-related, two were identified as aircraft, thirteen were shipwrecks, and another thirteen were determined to be debris from previous launches at the Cape. Some 112 contacts were miscellaneous scrap such as sinks, 55-gallon drums, old buoys, and rigging from cargo or fishing vessels. The remaining contacts were either geological in nature or nothing conclusive could be

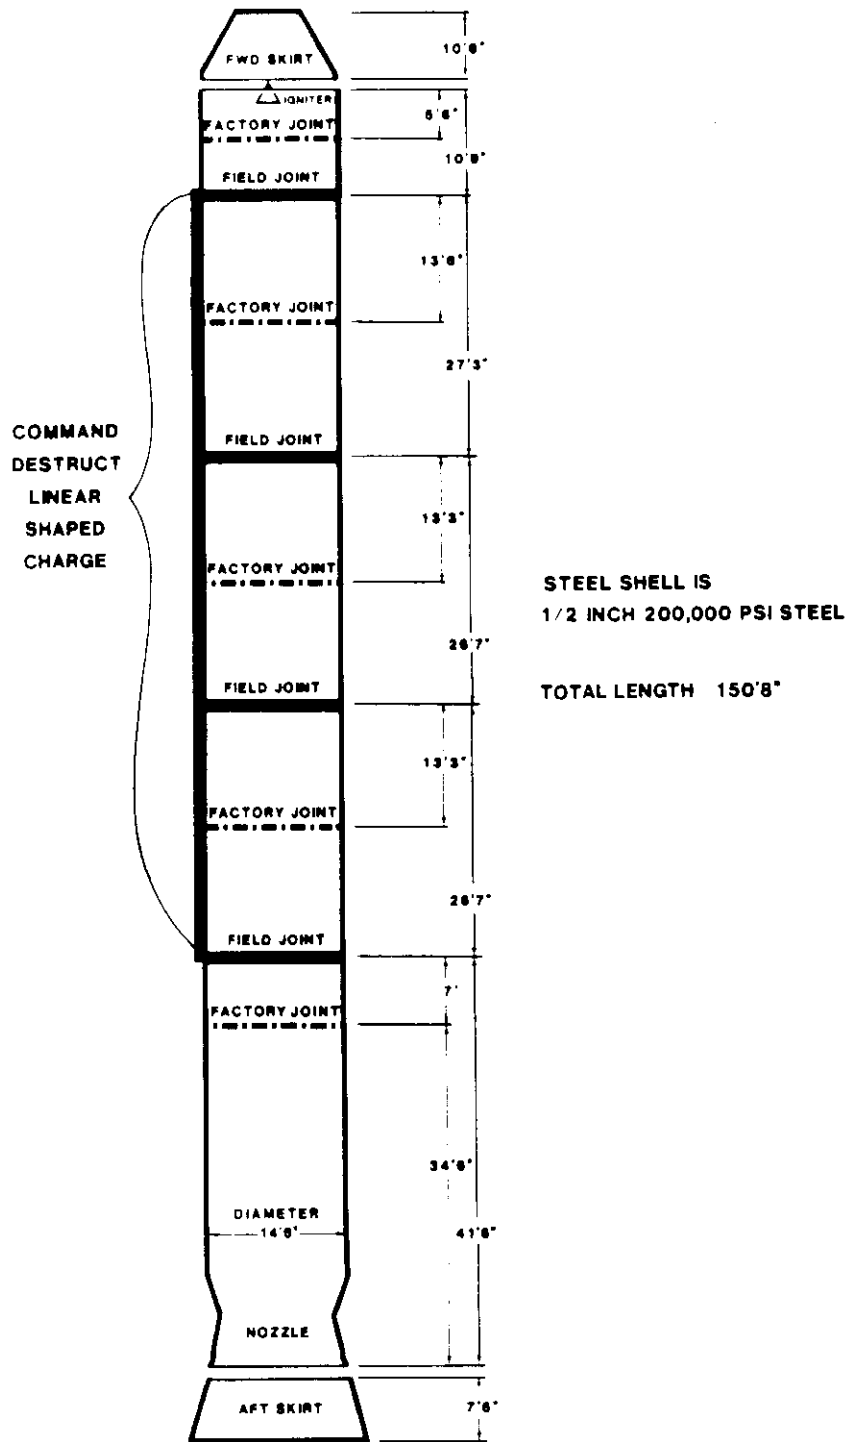
Exhibit 15. Arrangement of Typical SRB

5.1 SRB Configuration. The primary mission of the deep water salvage operation was the recovery of the critical sections of the suspected burned-through joint of the right SRB. NASA had reviewed the shuttle design and photographic evidence from the launch and had concluded that the most probable cause of the CHALLENGER mission explosion was a failure of the right SRB lowermost field joint. At 0.678 seconds into the flight, photographic data and analysis showed a strong puff of grey smoke spurting from the vicinity of this joint at the 270 to 310-degree sector of the circumference. NASA believed that the lower field joint on the right SRB had failed, releasing burning gasses which ignited the liquid hydrogen-oxygen fuel in the External Tank and caused the catastrophic explosion. Exhibit 15 shows the arrangement of a typical SRB. Exhibit 16 shows the geometry and nomenclature of a typical SRB joint. NASA required physical evidence for proper evaluation of the failure. Another objective was recovery of other sections of the SRB for additional analysis. The salvage mission was successful in that the critical sections of the right SRB were retrieved and the majority of other SRB debris was recovered. Success did not come, however, without significant challenge from the environment and the SRB targets themselves.

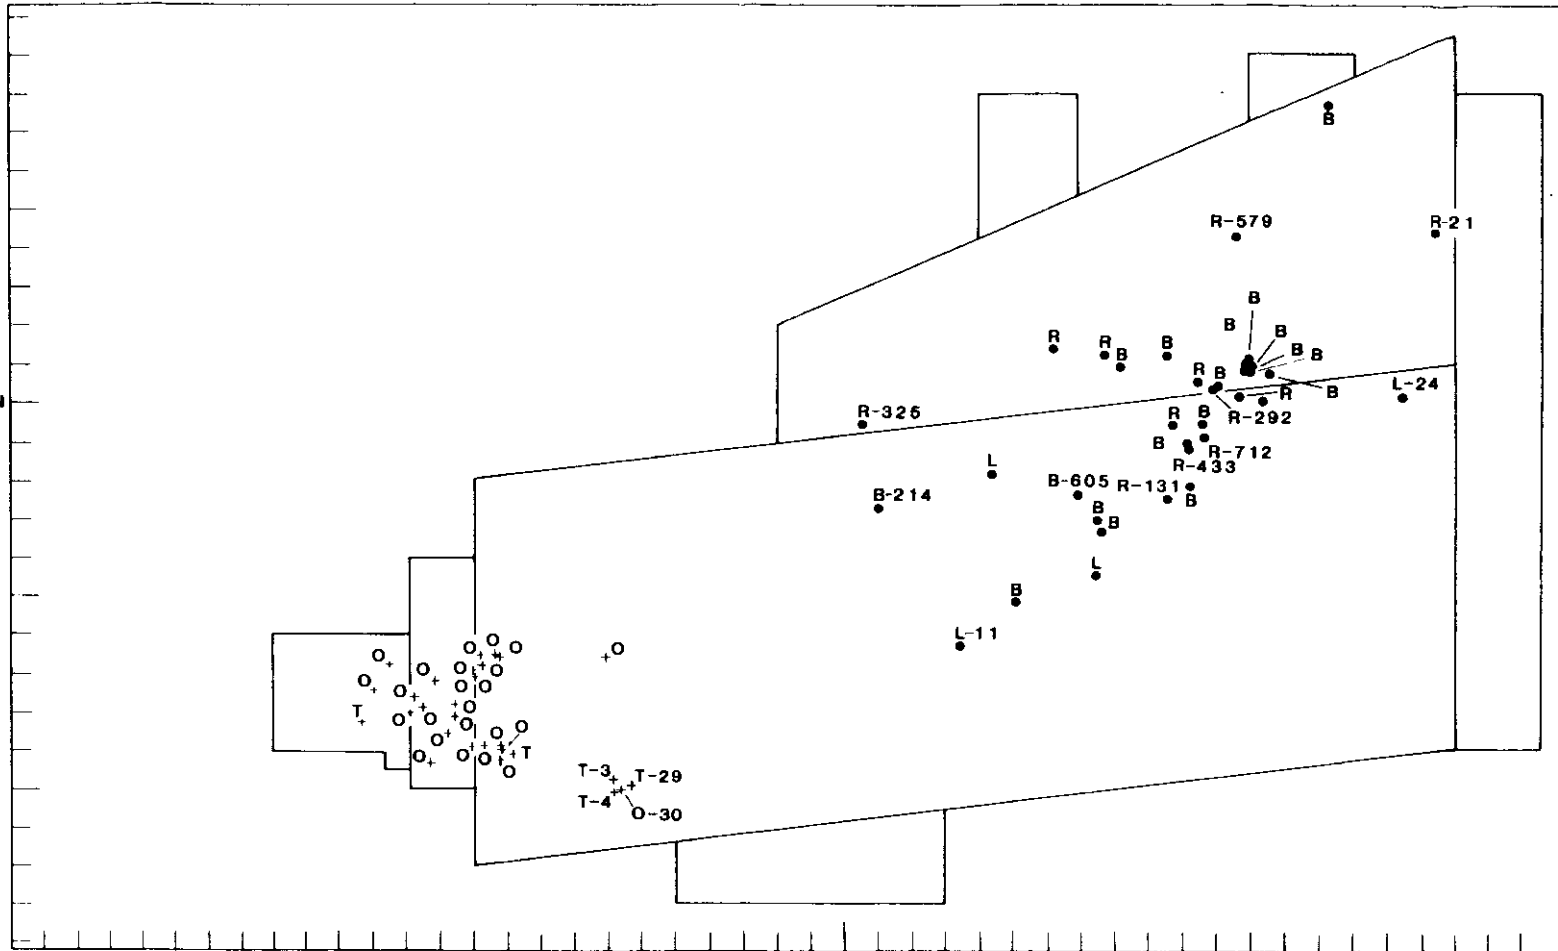
Exhibit 17. SRB and Orbiter Debris Areas

5.2 Distribution of SRB Debris. Fragmentation of the SRB's at high altitude resulted in many small pieces being dispersed over a wide area. Exhibit 17 shows the overall dispersion of shuttle debris. The right and left SRB debris fields were co-mingled but were exclusive from the Orbiter, external tank and payload debris field. It must be emphasized, however, that this tremendous SRB debris dispersion was not initially known or even suspected. At first the debris fields found at Contacts #21 and #24 were suspected to contain the entire right and left SRB's respectively. Only after much later radar, visual and structural data analysis, supported by an emerging pattern from recovered debris of random SRB dispersion over vast areas, was the true nature of SRB disintegration correctly determined. In point of fact, when the range safety officer detonated the linear shaped charges, each of the nine joints (four field joints and five factory joints) on each SRB failed catastrophically. Six of the resulting ten "cylinders," already open at the 0° location due to the linear shaped charge cut, opened up and failed at 180° and in most cases again at approximately 90° and 270°, thus dispersing a "checkerboard" of steel plating from an altitude of 13 miles and at an initial relative rate of 100 to 250 miles per hour (mph) transversely and in excess of 2,000 mph axially. The two SRB sections aft of the rearmost factory joint, having the greatest mass, impacted the sea intact at the eastern most sites at Contacts #21 and #24. Structurally adjacent components of the right SRB were found separated by over seven miles. Exhibit 18 shows the distribution of SRB contacts along the failed field joint circumference.

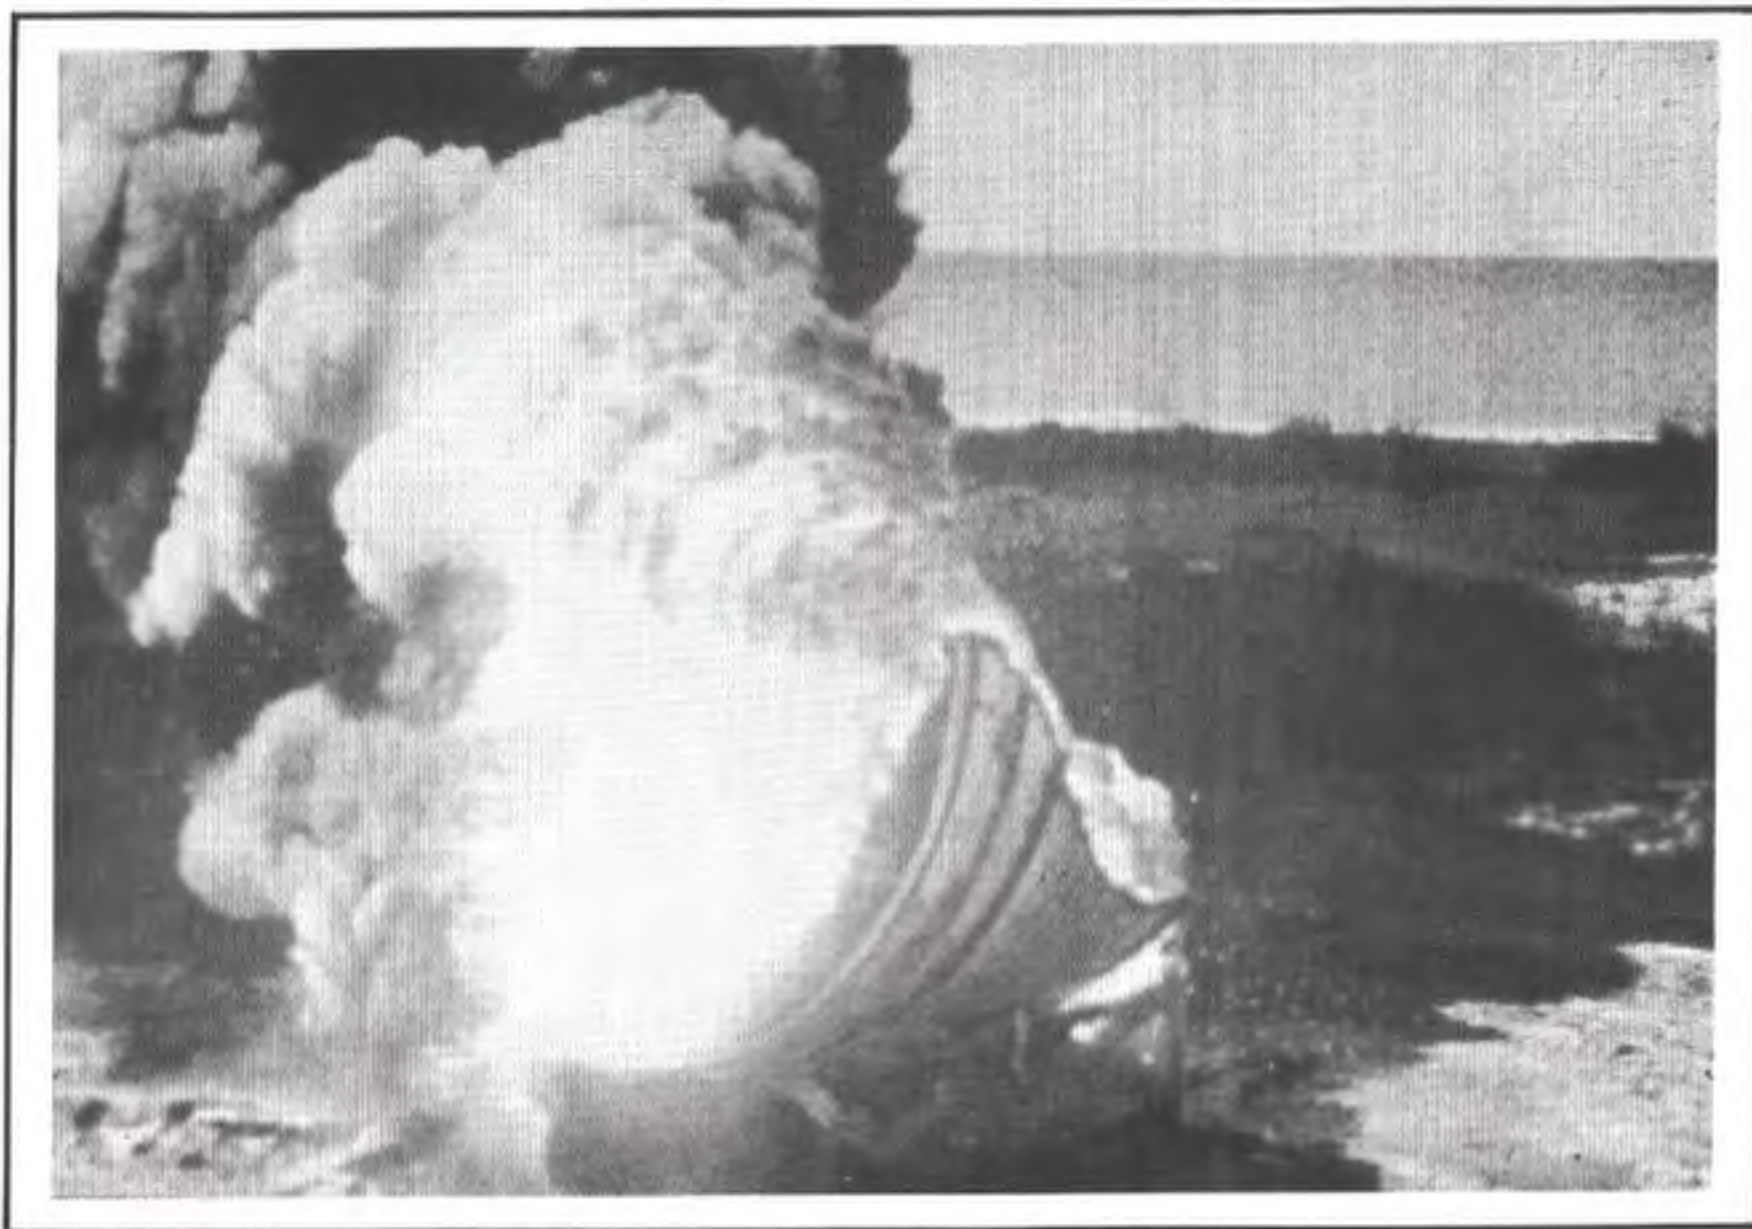
Exhibit 22. Propellant Burning from a Booster Piece

5.6.2 Propellant. Unexpended solid rocket propellant was extremely hazardous and required precautions to prevent ignition. The SRB propellant burns at temperatures in excess of 5,000° F and tended to become unstable with emersed time. Recovered parts containing propellant were kept wet and care was taken to avoid shear or sparking between hard surfaces while handling. Open flames and direct heat were kept away. Once offloaded ashore SRB parts containing propellant were taken to an ordnance burn area where the propellant was safely ignited before the part was taken to the reconstruction area for analysis. Exhibit 22 shows the burning of propellant from a booster piece.

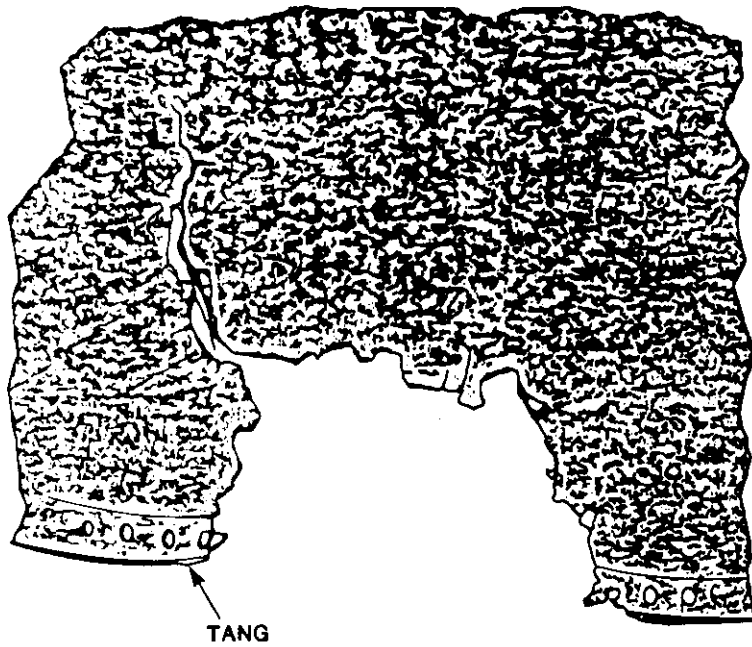
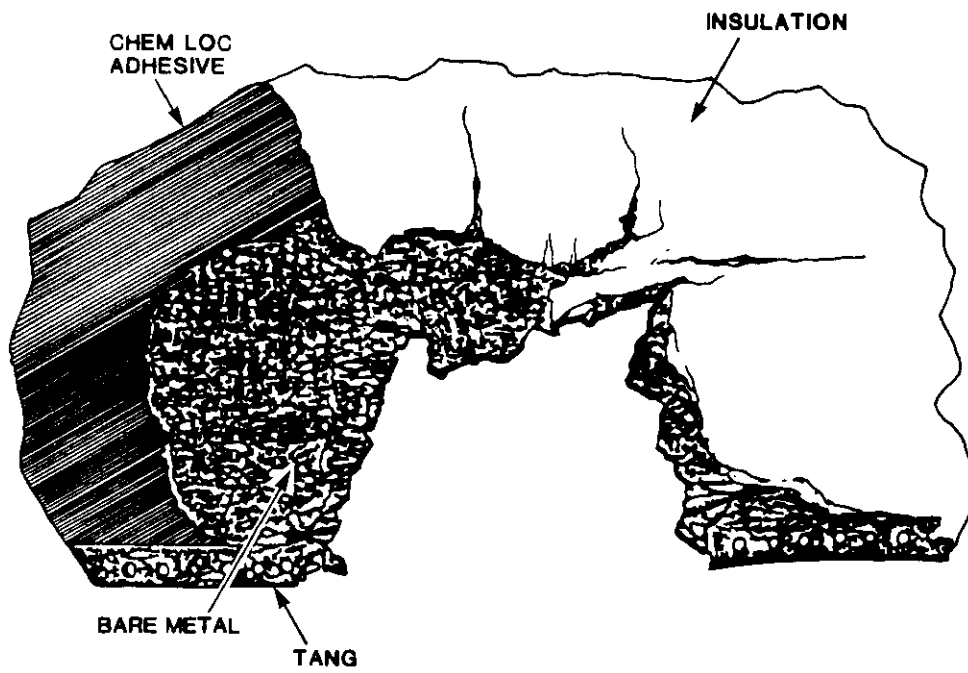
Exhibit 23. Contact #131 Interior and Exterior Surfaces

5.9 Recovery of the Right SRB Critical Joint. The recovery of Contact #131 typifies the successful result of the concept of operations wherein several major assets were sequentially utilized to locate and recover the target. Contact #131 was the right SRB aft center segment containing the tang portion of the joint burn through area, Exhibit 23. This contact was initially located on 1 March 1986 by LIBERTY STAR in 560 feet of water using side scanning sonar. At that time the magnitude of SRB dispersion was not known and its location was in the left SRB trajectory area. Thus it was assigned a low priority for classification. NR-1 operated at the site of Contact #131 on 5 April, classified the contact as probable STS 51-L debris and videotaped the contact. After a review of the NR-1 videotape by SUPSALV and NASA engineers, visual evidence of possible burned areas raised its priority markedly and the manned submersible SEA-LINK I, operating from EDWIN LINK, was assigned to investigate the contact. On a dive conducted on 12 April 1986, SEA-LINK I onboard observers verified that Contact #131 was badly burned and scarred. A wire pendant was attached to a tang section and a pinger

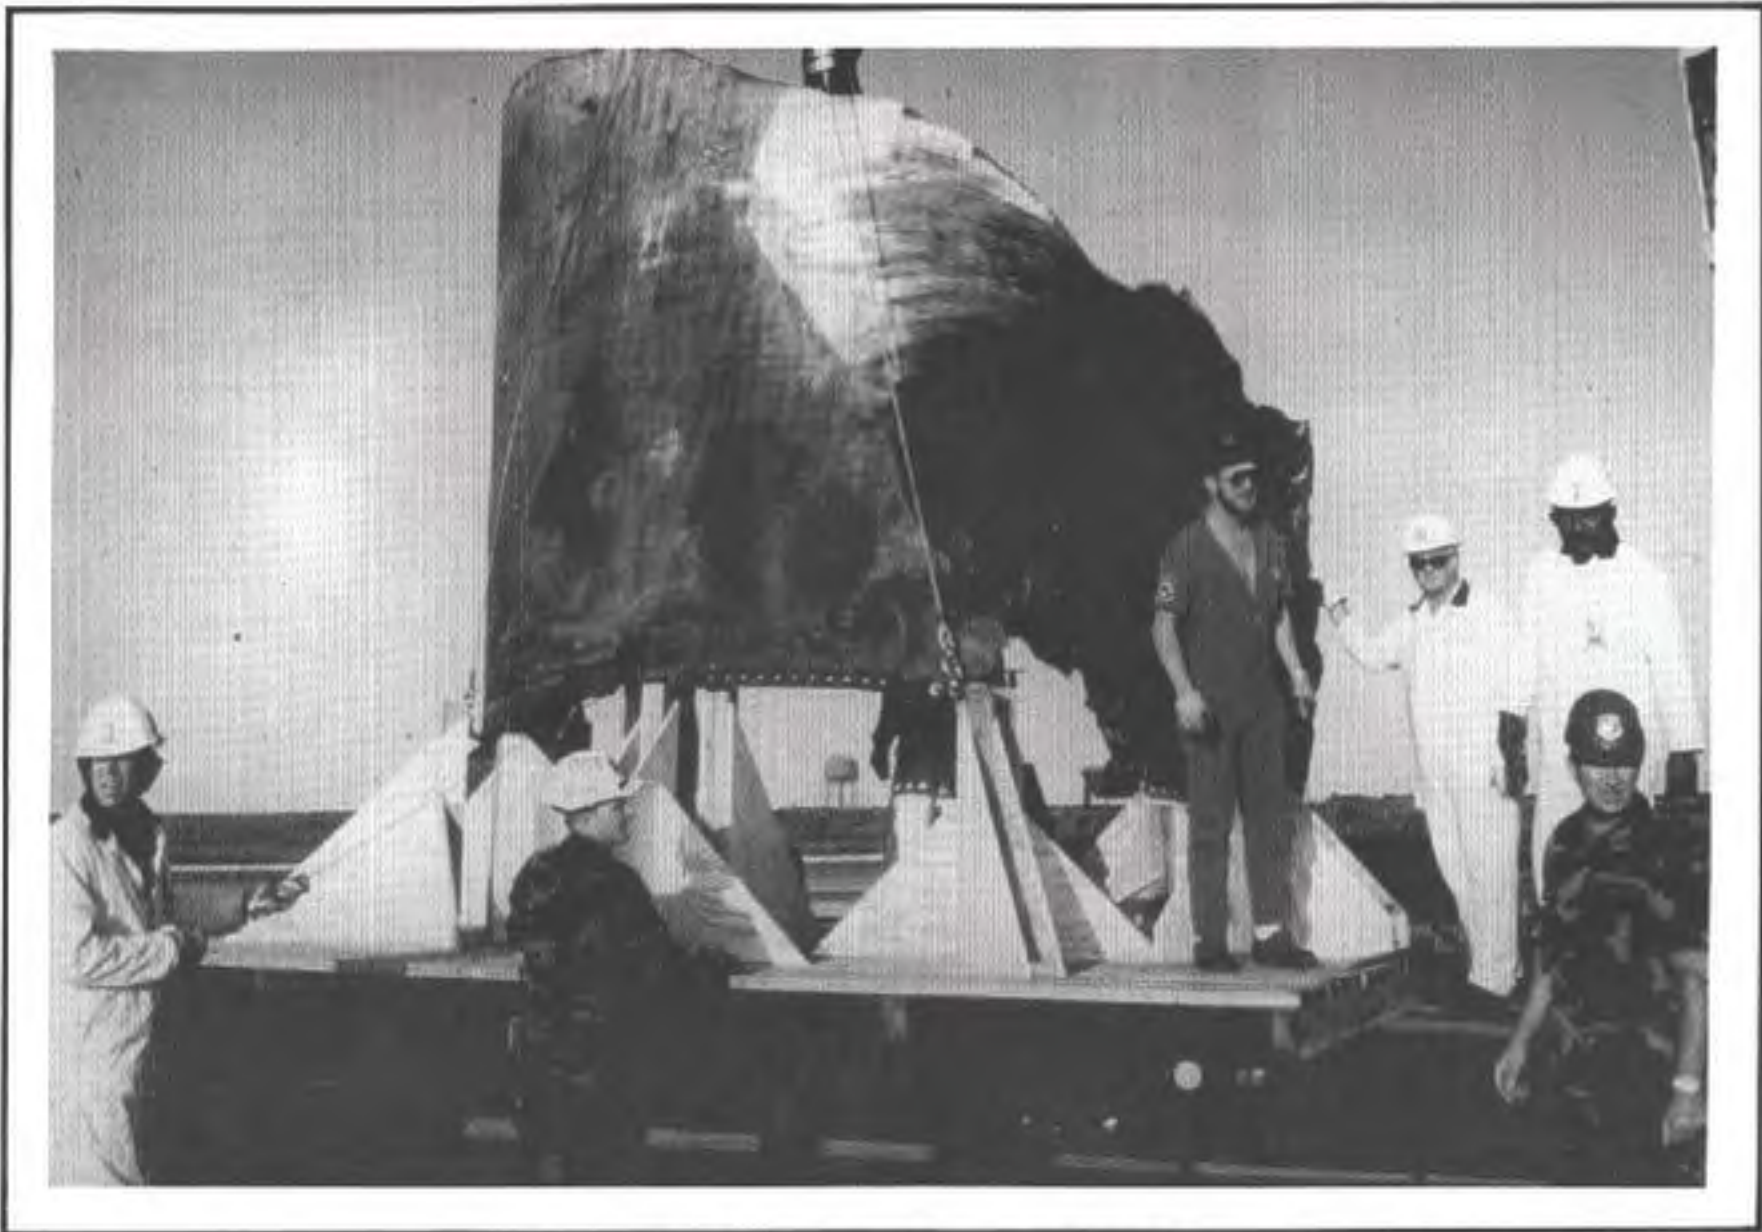
Exhibit 24. Contact #131 Recovery Right SRB

deployed. STENA WORKHORSE was immediately assigned to conduct recovery. Using the ROV GEMINI, STENA WORKHORSE attached a lift line and recovered the piece on 13 April 1986, Exhibit 24.

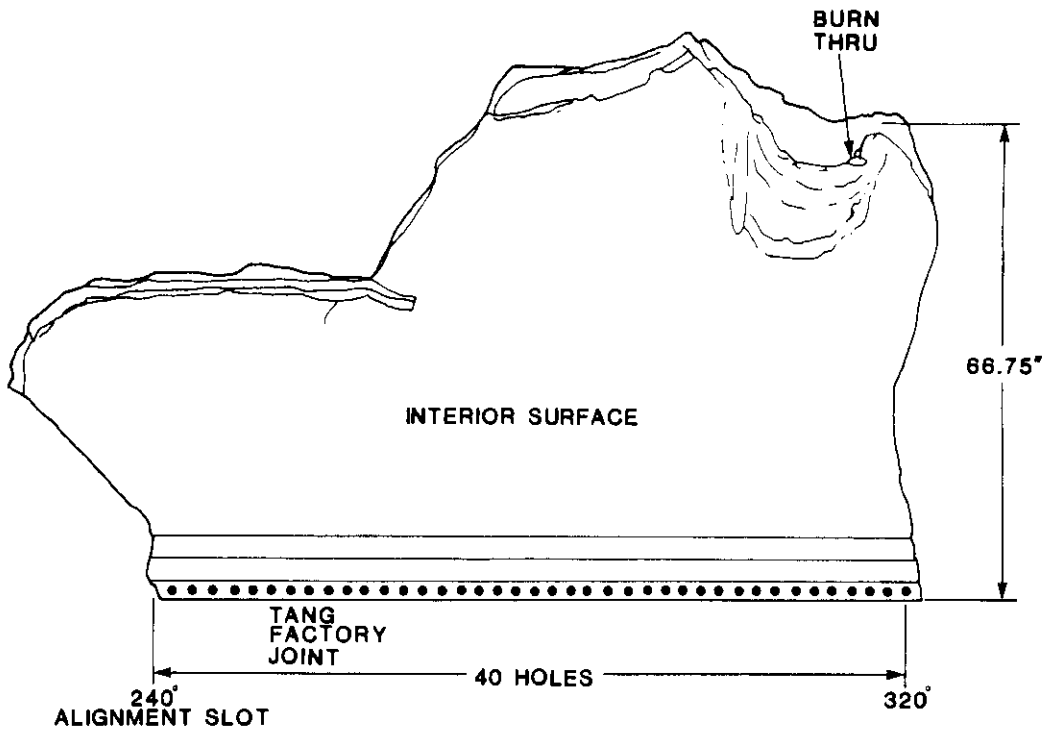
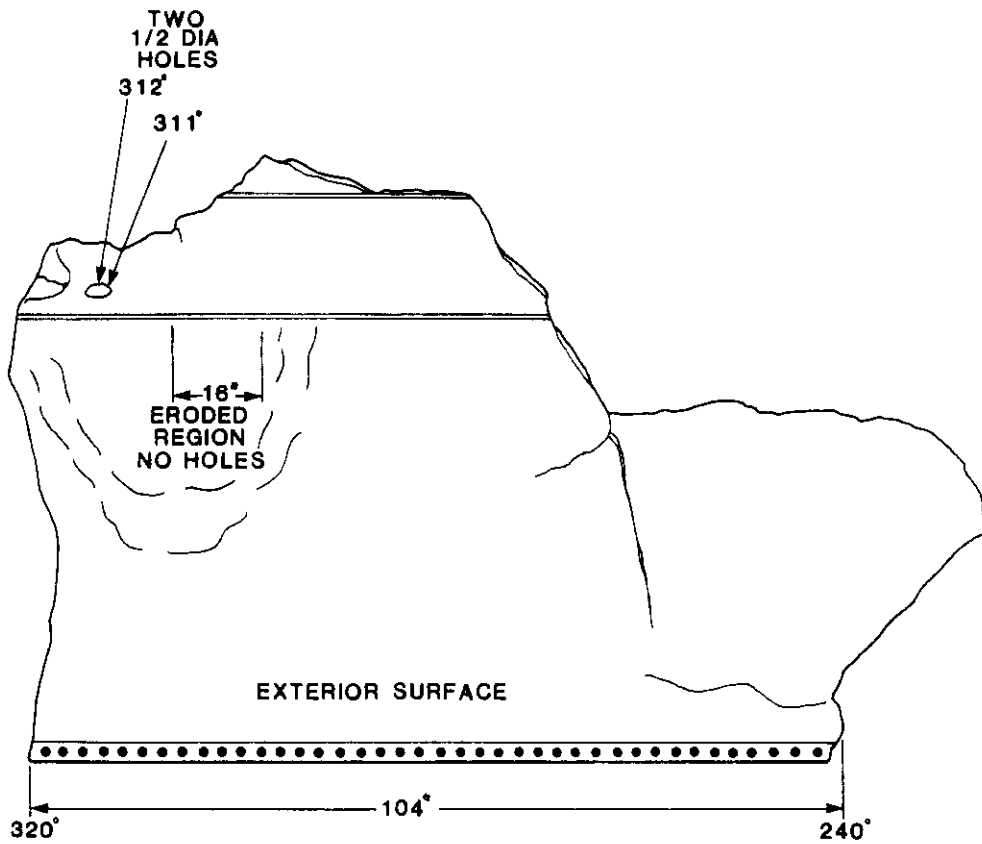
Exhibit 25. Contact #712 Interior and Exterior Surfaces

5.10 Completion of SRB Recovery Operations. With the recovery of Contact #131 the primary objective of the deep water SRB salvage operations had been satisfied. Nonetheless NASA requested that the lower or companion piece containing the other half of the burned through joint also be recovered for investigative purposes. However detailed visual classification and recovery efforts of all designated sonar contacts in the known SRB debris field confirmed that the companion piece had not yet been found. An initiative to research with side scan sonar the most probable area was abandoned by SUPSALV in favor of reanalyzing existing sonar traces. A 72 sq nm area bounded by lat 28° 50 min - 28° 42 min and long 79° 55 min - 80° 04 min was defined. By exercising greater discrimination, the sonar trace evaluation team designated 15 additional contacts within this box, two of which were subsequently found to be SRB related. Contact #712 had been located by side scan sonar on 11 March. However, because it was considered marginal, it had not been designated as a contact at that time. On 18 April it was designated along with 14 other contacts. STENA WORKHORSE positioned herself over Contact #712 on 26 April and the GEMINI ROV classified it as SRB. Tang holes were not accessible so a plate grabber was rigged. During recovery the plate grabber slipped off and the target fell to the bottom. In its new attitude, a tang section was exposed, a shackle attached, and the piece was successfully retrieved and landed on deck. This entire operation required four ROV dives over a 22-hour period. STENA WORKHORSE recovered two final SRB targets and proceeded into Port Canaveral the afternoon of 28 April to offload debris and commence demobilization. Exhibit 26 shows a composite of the major pieces recovered along the failed joint. Exhibit 27 shows a full size reconstruction of the booster shell from one inch styrofoam templates patterned from the recovered pieces. The two pieces, Contacts #131 and #712, as shown fitted together, reveal a 28-inch diameter circular burnhole, portions of which looked as if they had been cut by an oxy-acetylene torch. The exact cause of the space shuttle CHALLENGER explosion was confirmed.

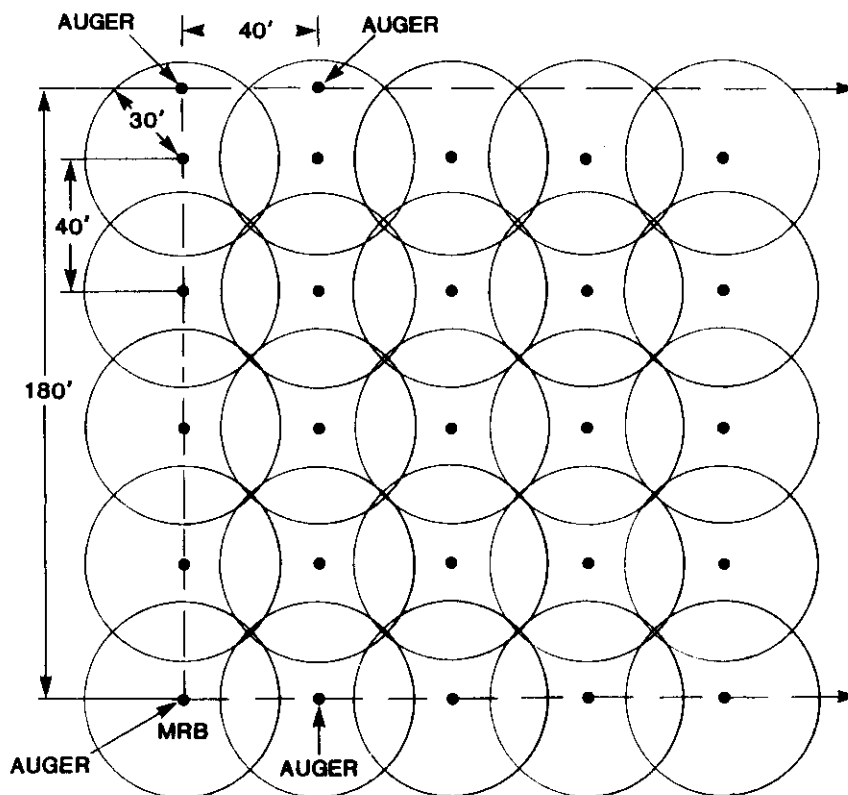
Exhibit 32. Combined Jack-stay and Circle Method

6.3.2 Combined Jack-stay Search Methods. The combined jack-stay and circle search method employed for locating buried debris with metal detectors purposely included significant overlap to eliminate the possibility of missing very small objects. Exhibit 32 shows the search pattern. A reference buoy was initially dropped on datum at the intended search area. Divers then placed an auger anchor on the sea floor at datum and established a north-south base line 180 feet long by compass swim. The base line was knotted every 40 feet and fixed at the ends with auger anchors. Similar base lines were placed parallel to the first and 40 feet apart. Divers then conducted a series of circle searches along each base line with metal detectors. Each circle had a 30-foot radius from an auger at one of the knots on the base line. Divers covered the area by searching a series of 5-foot wide concentric circles. One diver would swim the circling line around the auger while the second searched along the line with the metal detector. When a buried object was detected it was dug up and placed in a central location for recovery at the dive's end. The areas were prioritized for search by the debris pattern detected during the earlier search with a towed metal detector and visual searches of the sea floor by divers using diver propulsion vehicles.

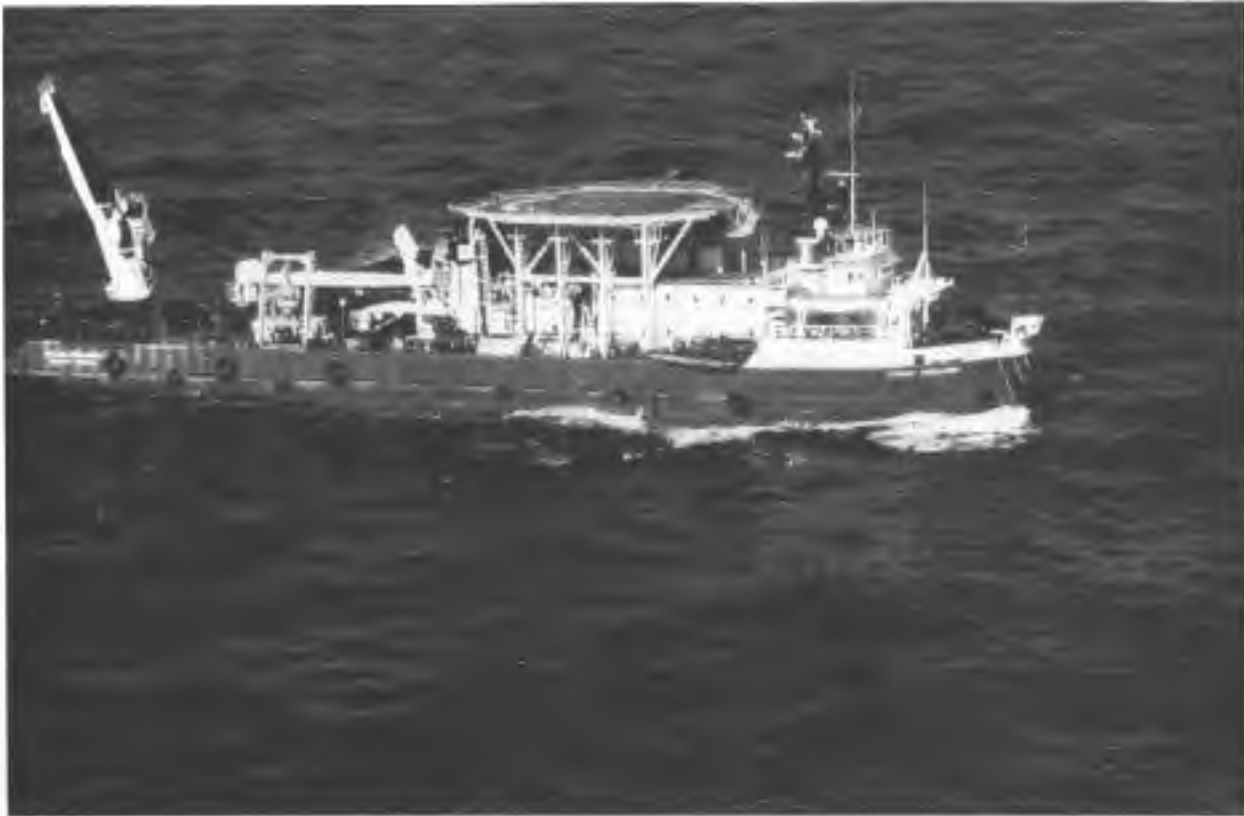
STENA WORKHORSE

Description: General purpose heavy work vessel

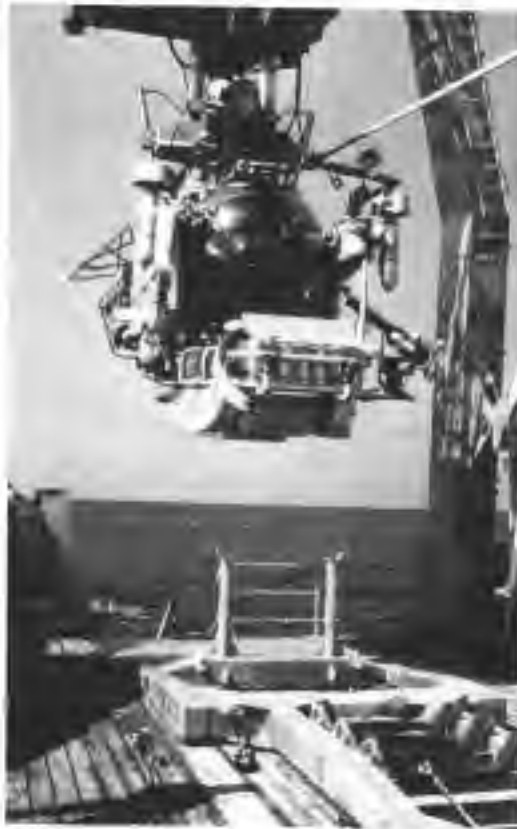
JOHNSON SEA-LINK I AND II

Description: Manned submersibles designed for deep diving in depths to 2,640 feet

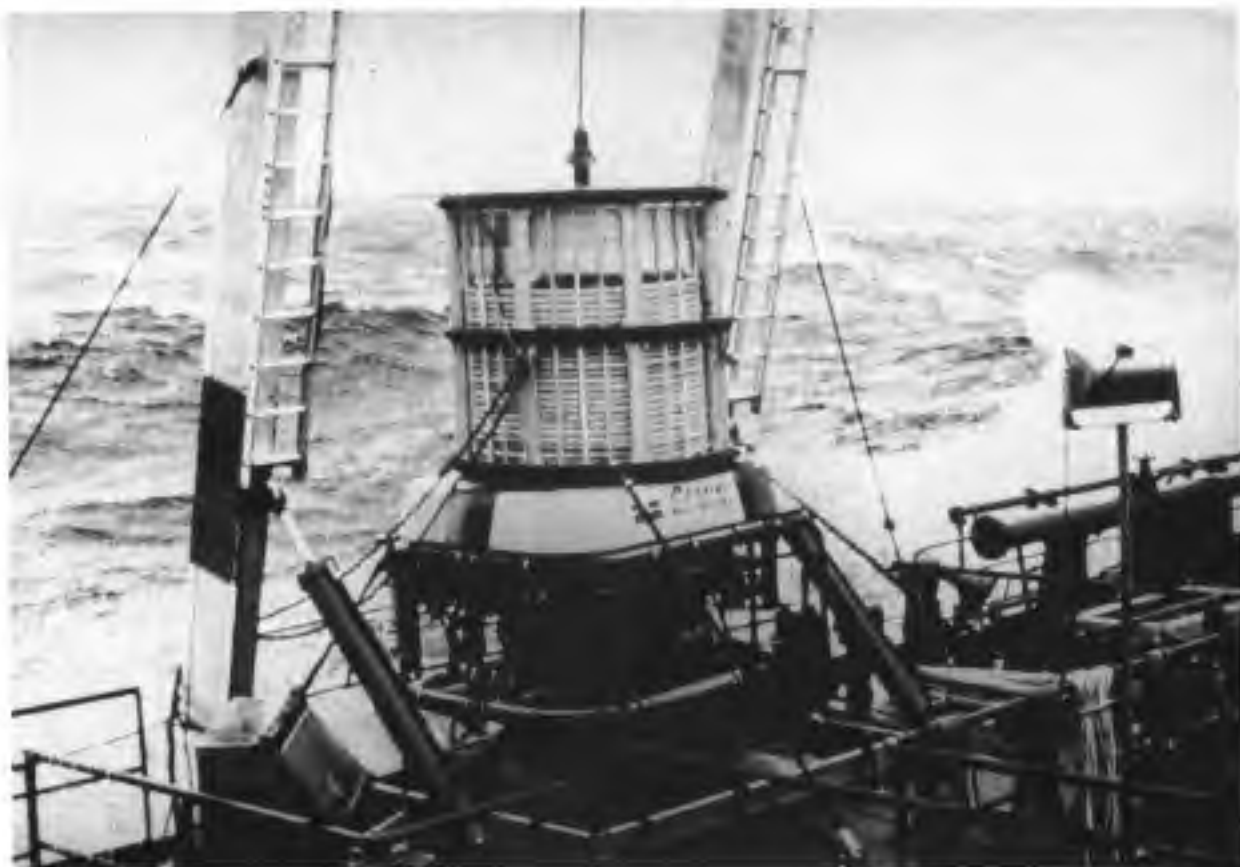
GEMINI

Description: A remotely operated, open frame highly adaptable subsea work system (depths to 10,000 feet)

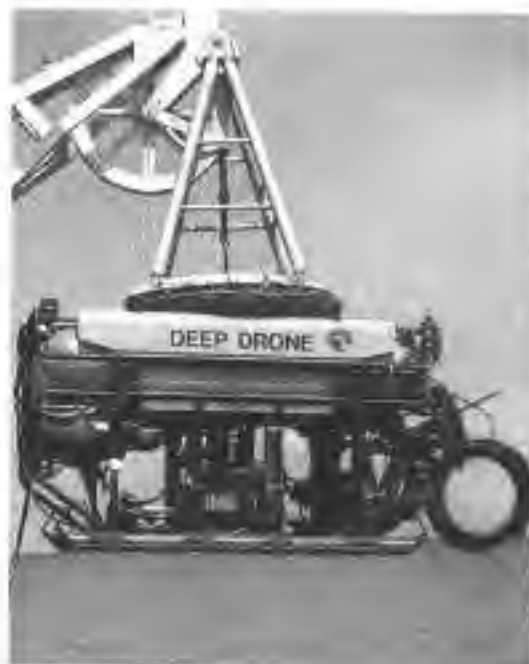
DEEP DRONE

Description: State of the art tethered unmanned vehicle designed to perform search and salvage to 6000 feet

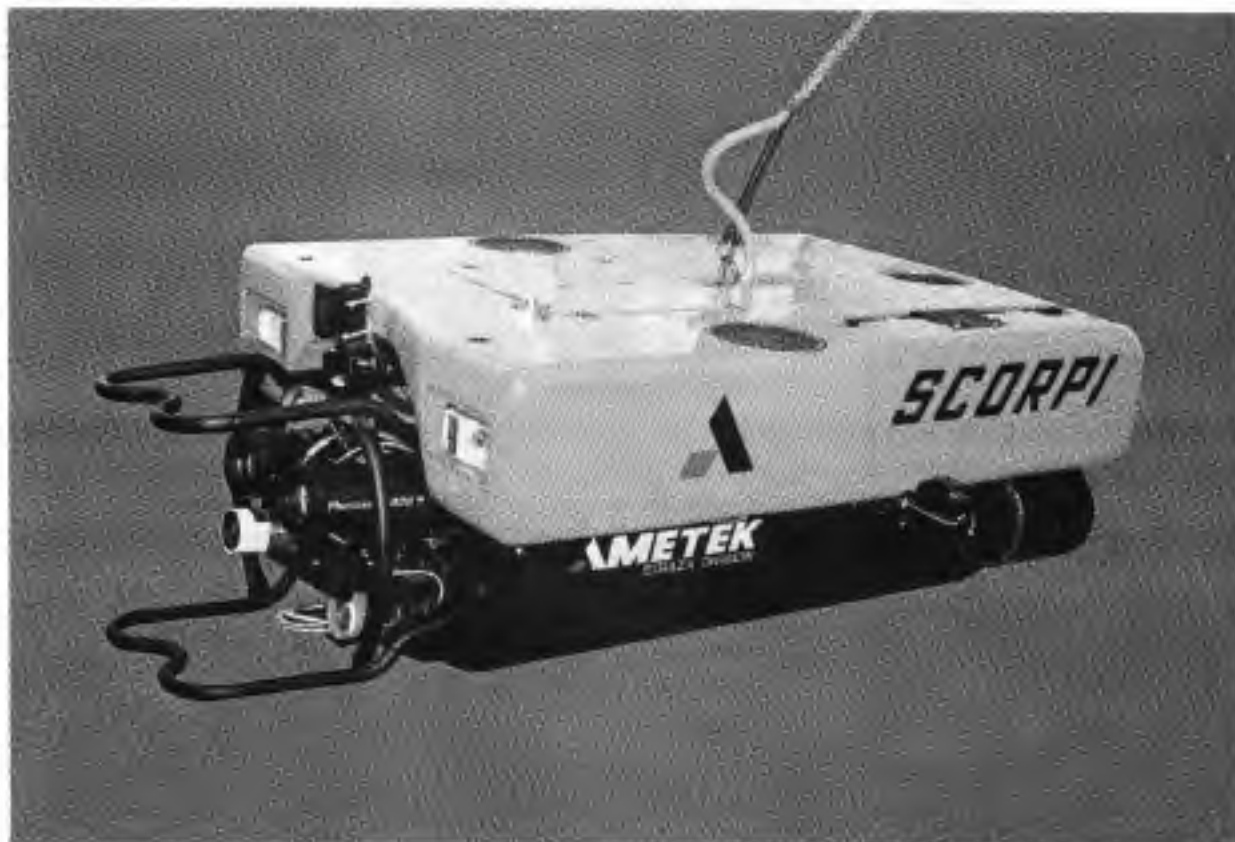
SCORPI

Description: A versatile and reliable remotely operated underwater work system designed primarily for inspection and non-destructive testing at depths to 3,000 feet
