Description of document:	Curriculum and Presentation Slides for the National Transportation Safety Board (NTSB) training class Survival Factors in Aviation Accidents (AS302) 2004
Requested date:	2021
Denied date:	12-October-2022
Appealed date	13-October-2022
Released	04-November-2022
Posted date:	12-December-2022
Source of document:	FOIA Request National Transportation Safety Board Attention: FOIA Requester Service Center, CIO-40 490 L'Enfant Plaza, S.W. Washington, DC 20594-2000 Fax: (240) 752-6257 <u>NTSB's FOIA Online Submission Website</u>

AS320: Survival Factors in Aviation Accidents

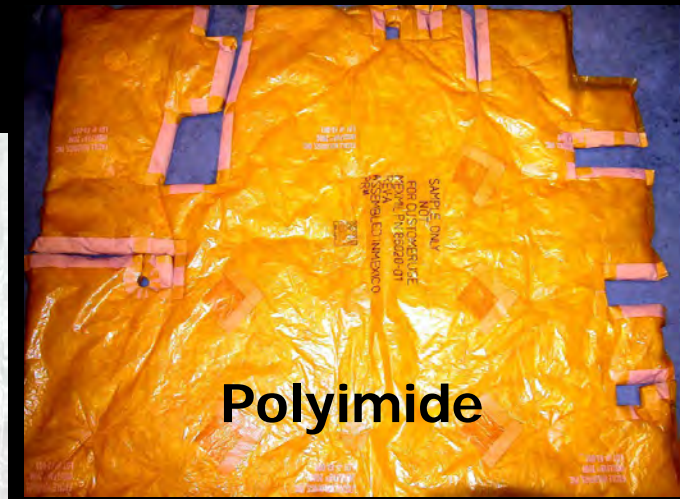
Plain Mylar

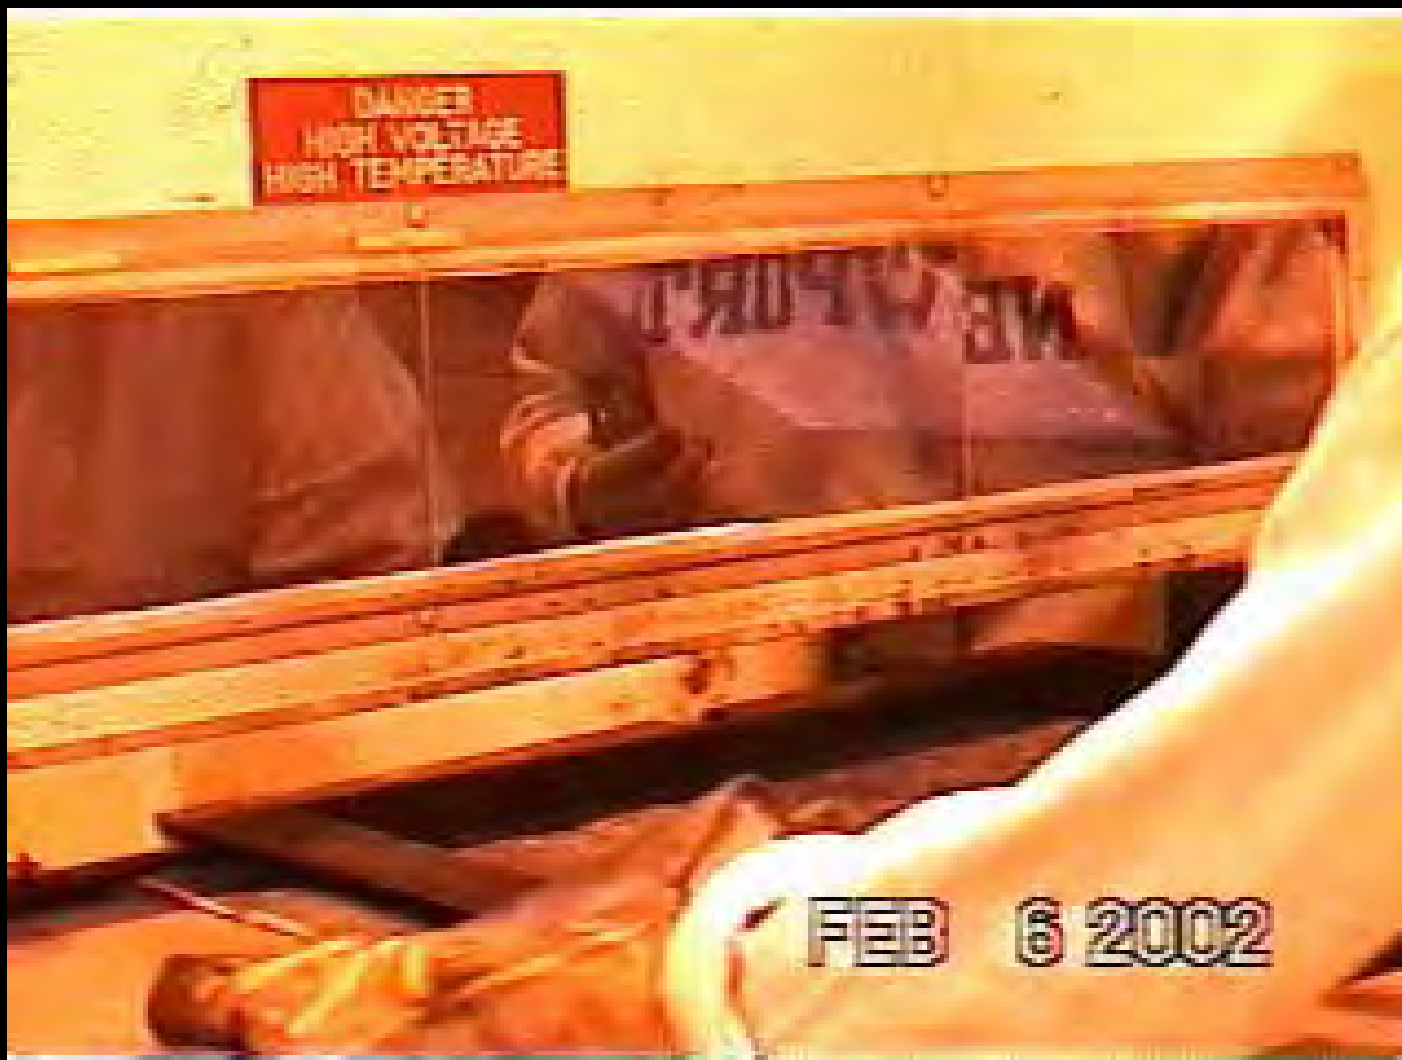
Fuselage Burnthrough

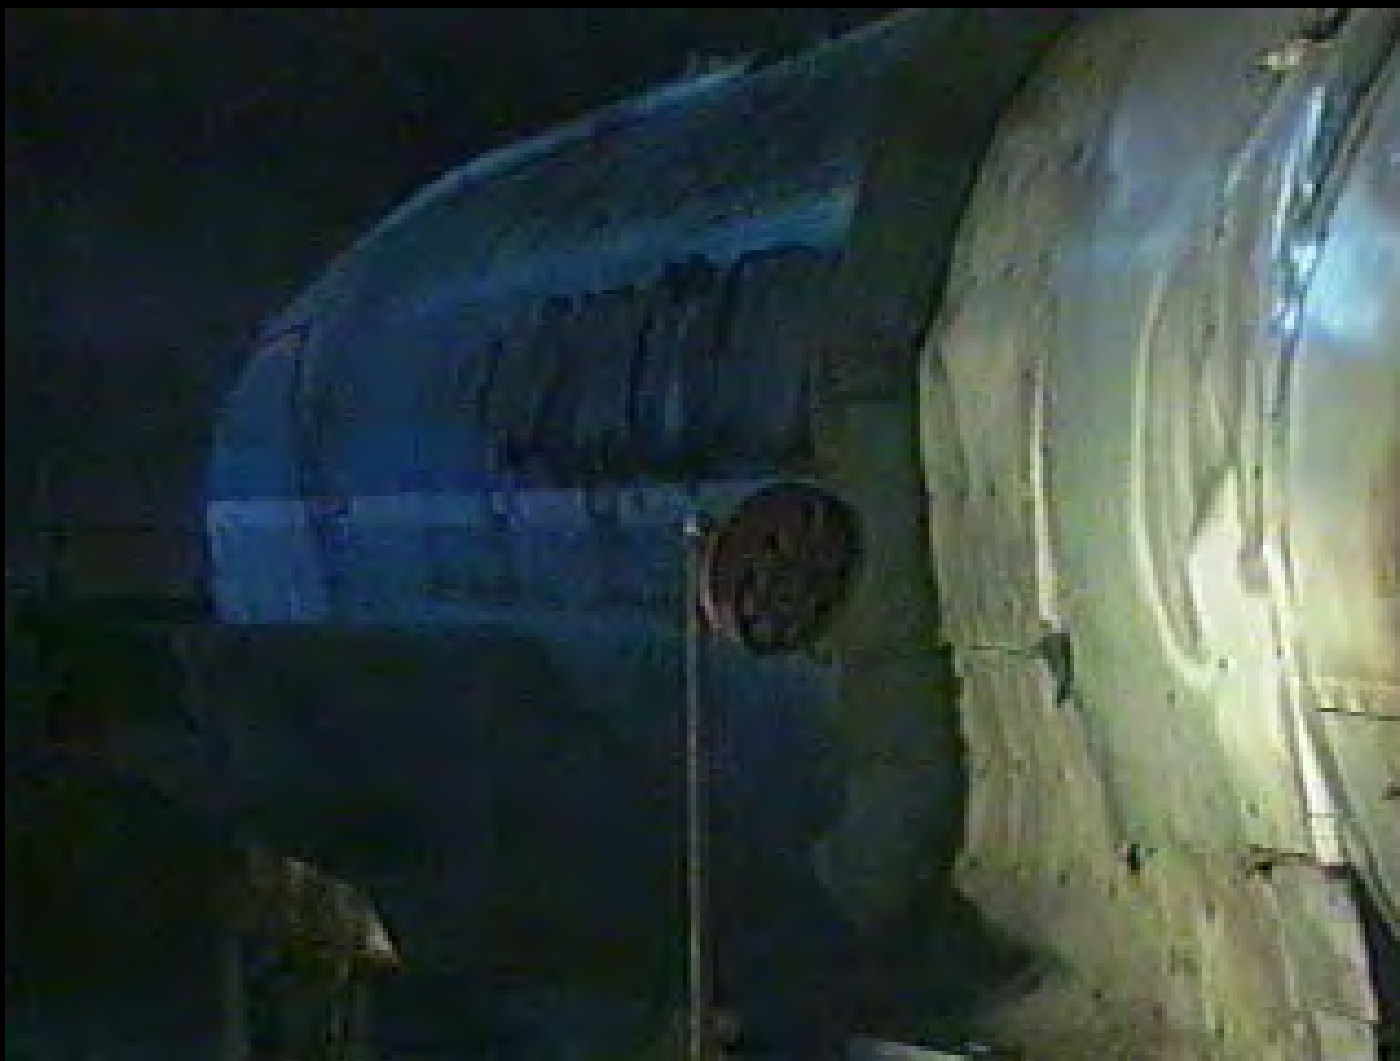
Full-Scale Test Results Using Various Materials

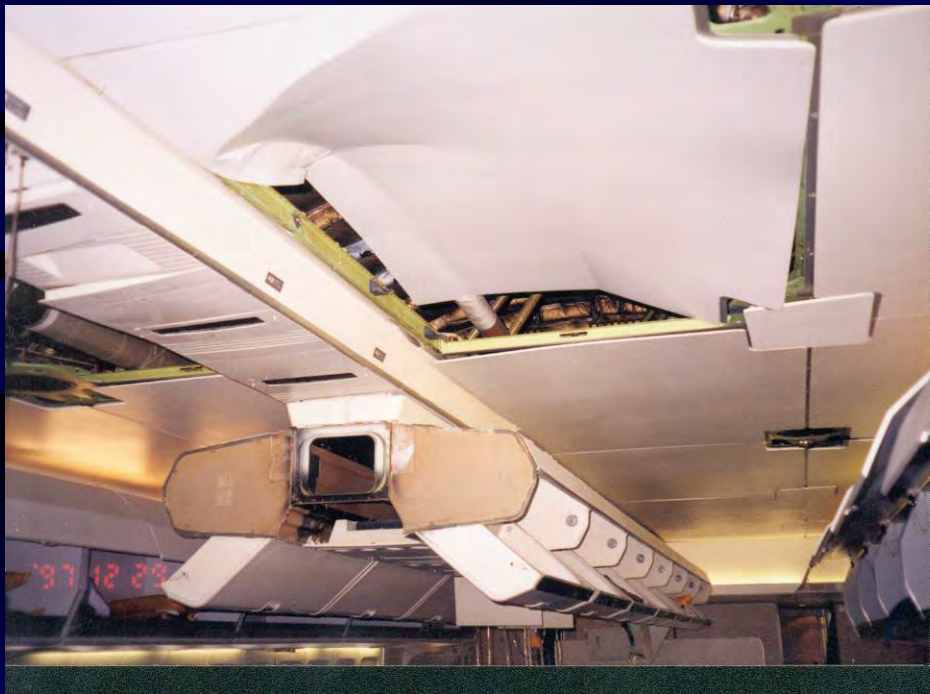
E Zone – Damaged and Missing Ceiling Panels.

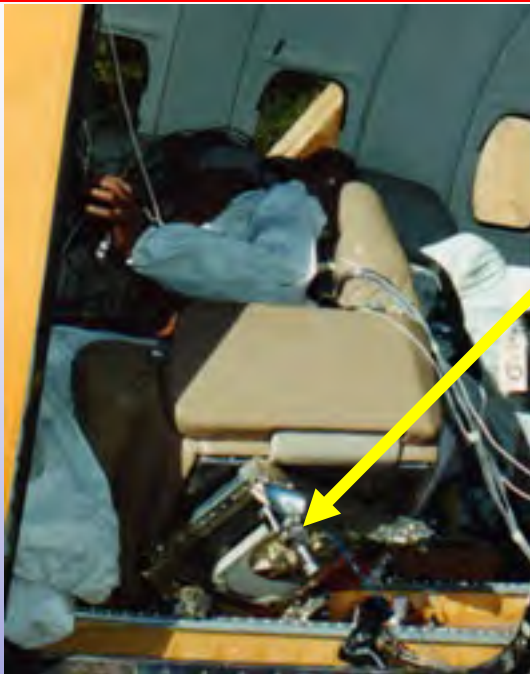
Seat attachment failure

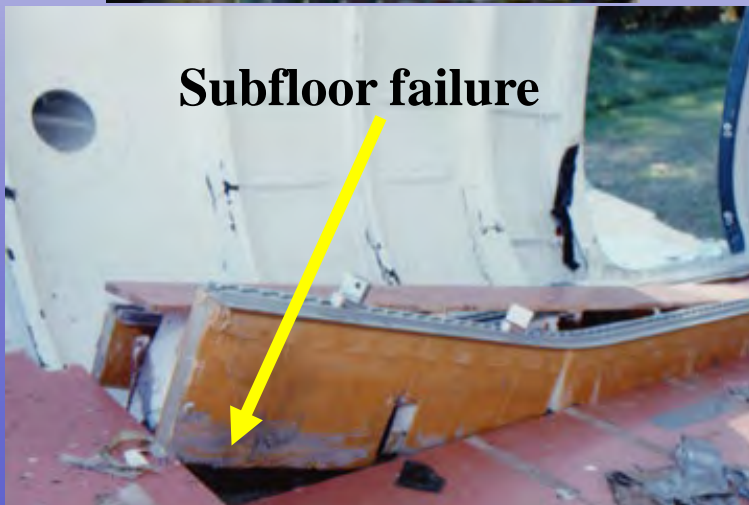
Subfloor failure

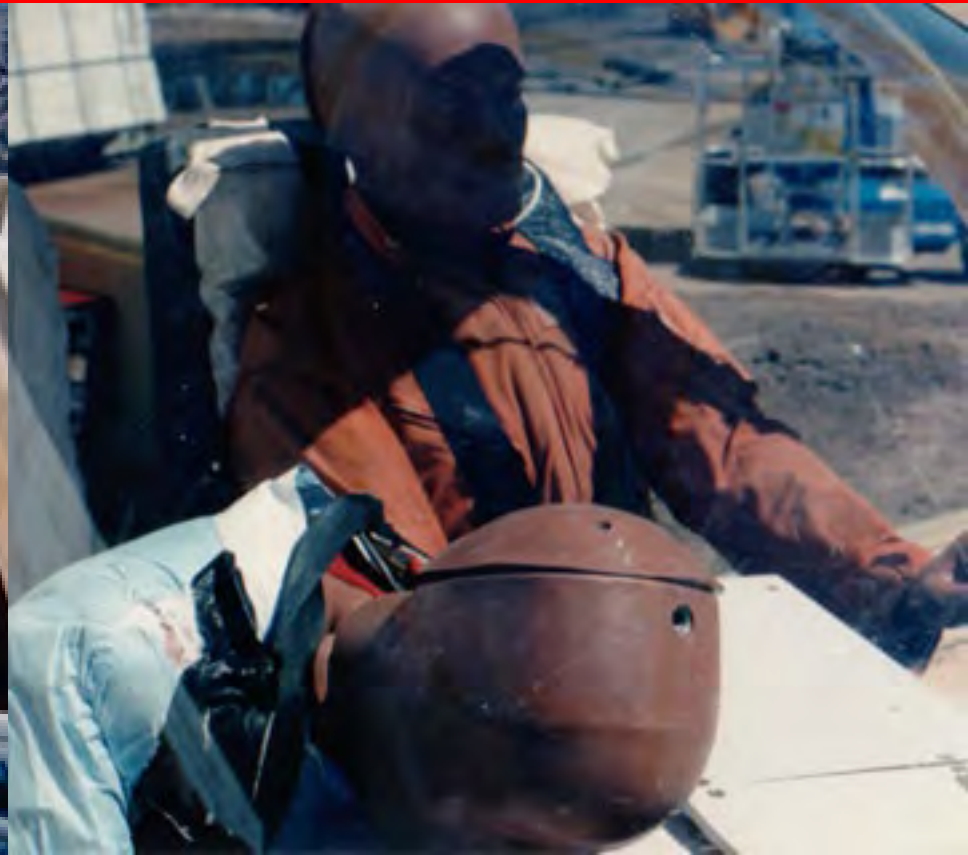
**Attachment to aircraft structure
fails allowing head strike**

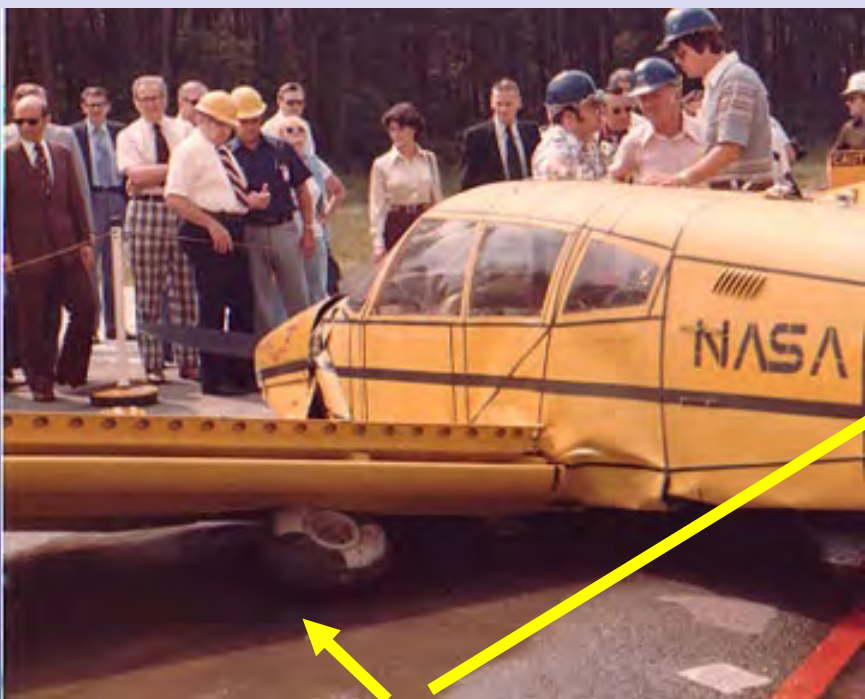
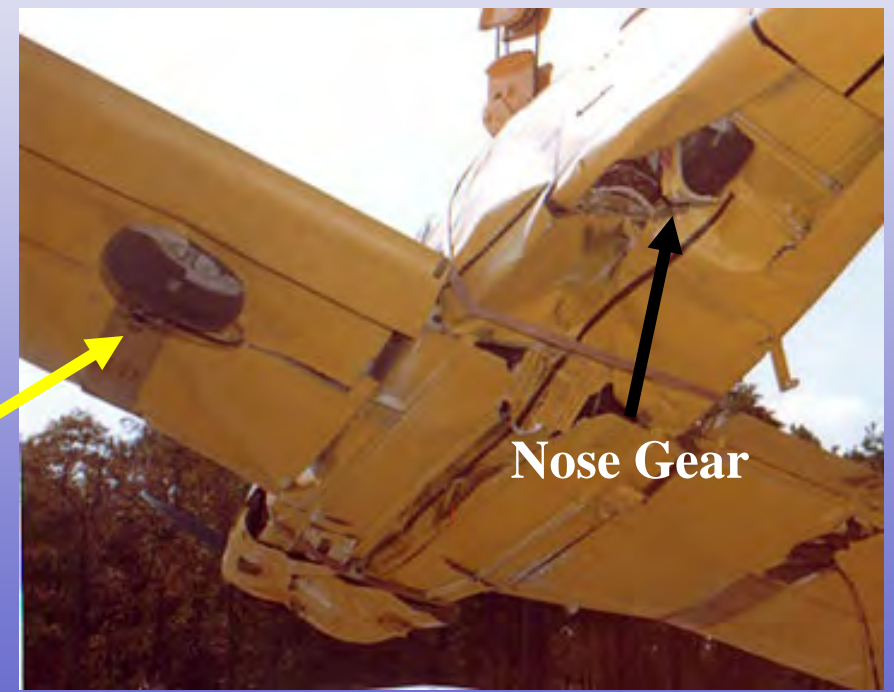
- Fuselage structure should be reinforced to resist penetration.
- Wing struts, external accessories, and landing gear should be designed/modified to ensure that if these parts fail, they fail safely.

Fuel spillage due to gear penetrating wing tank

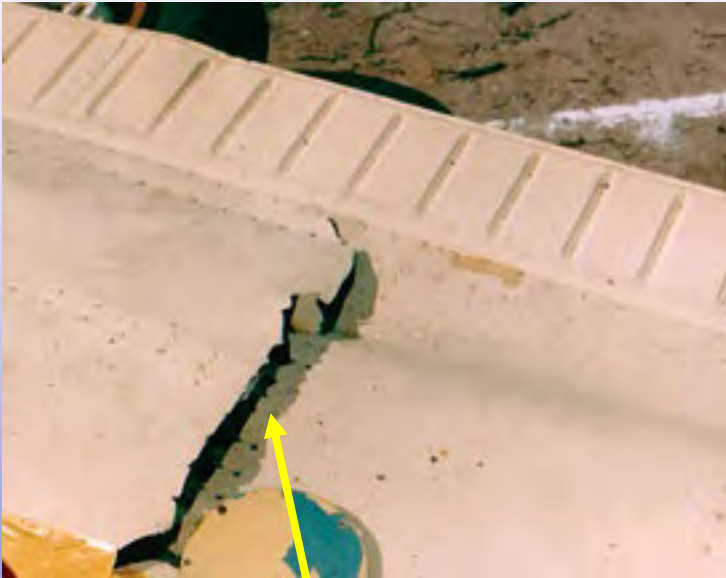
Rivet Line Skin Failure

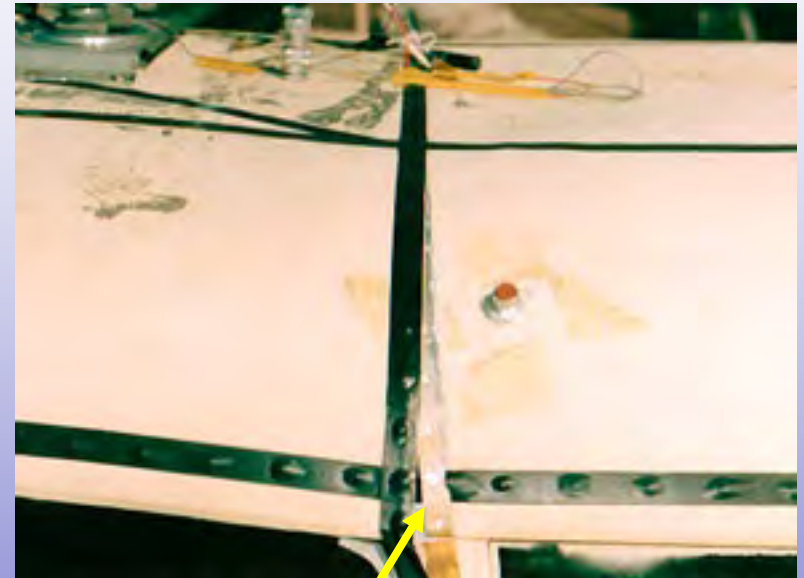
Rivet Shear Failure

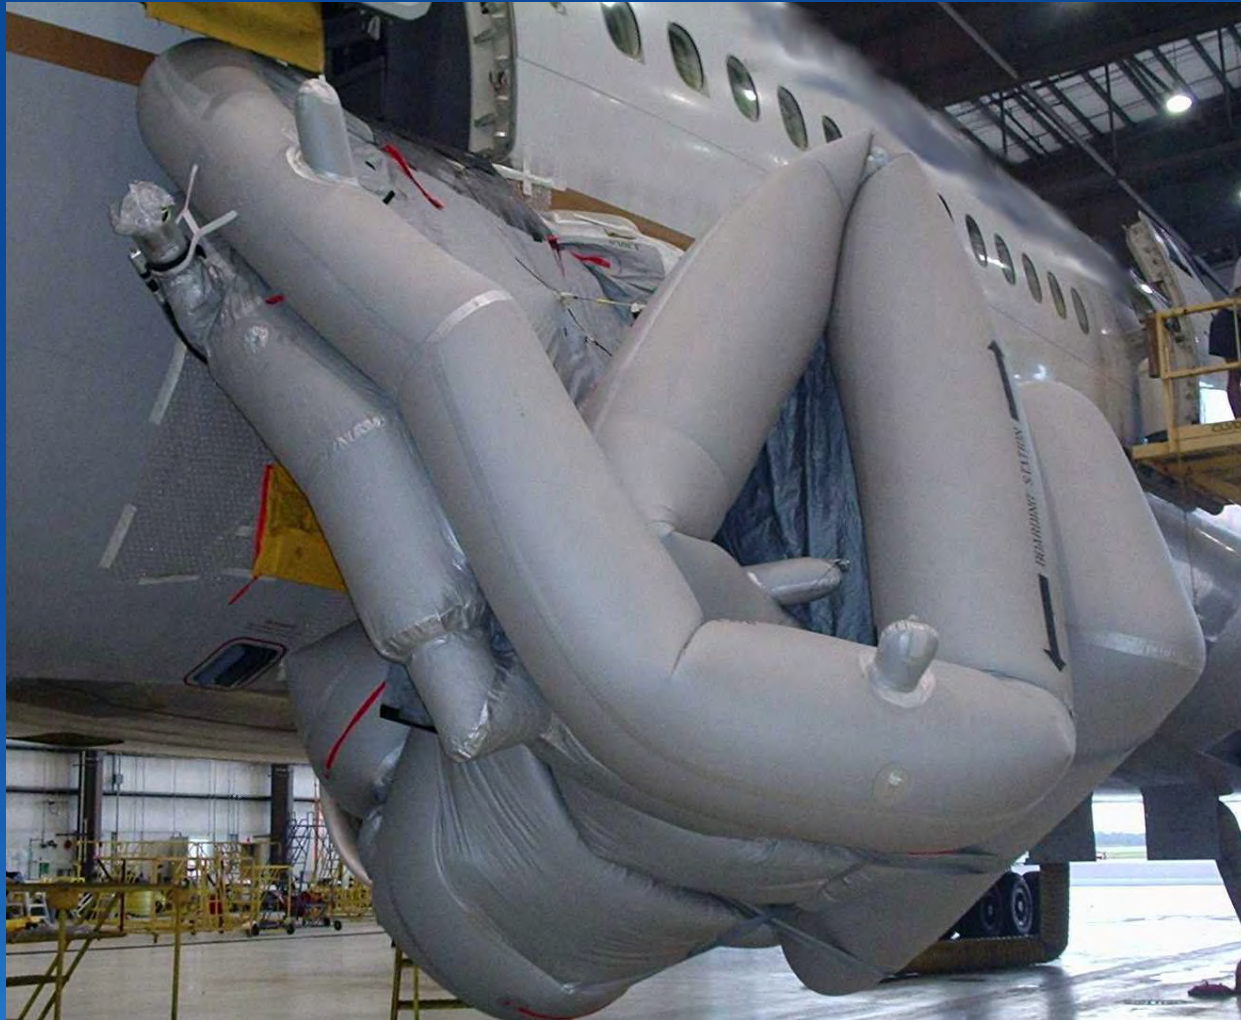
“Design Geometry not Obtained”

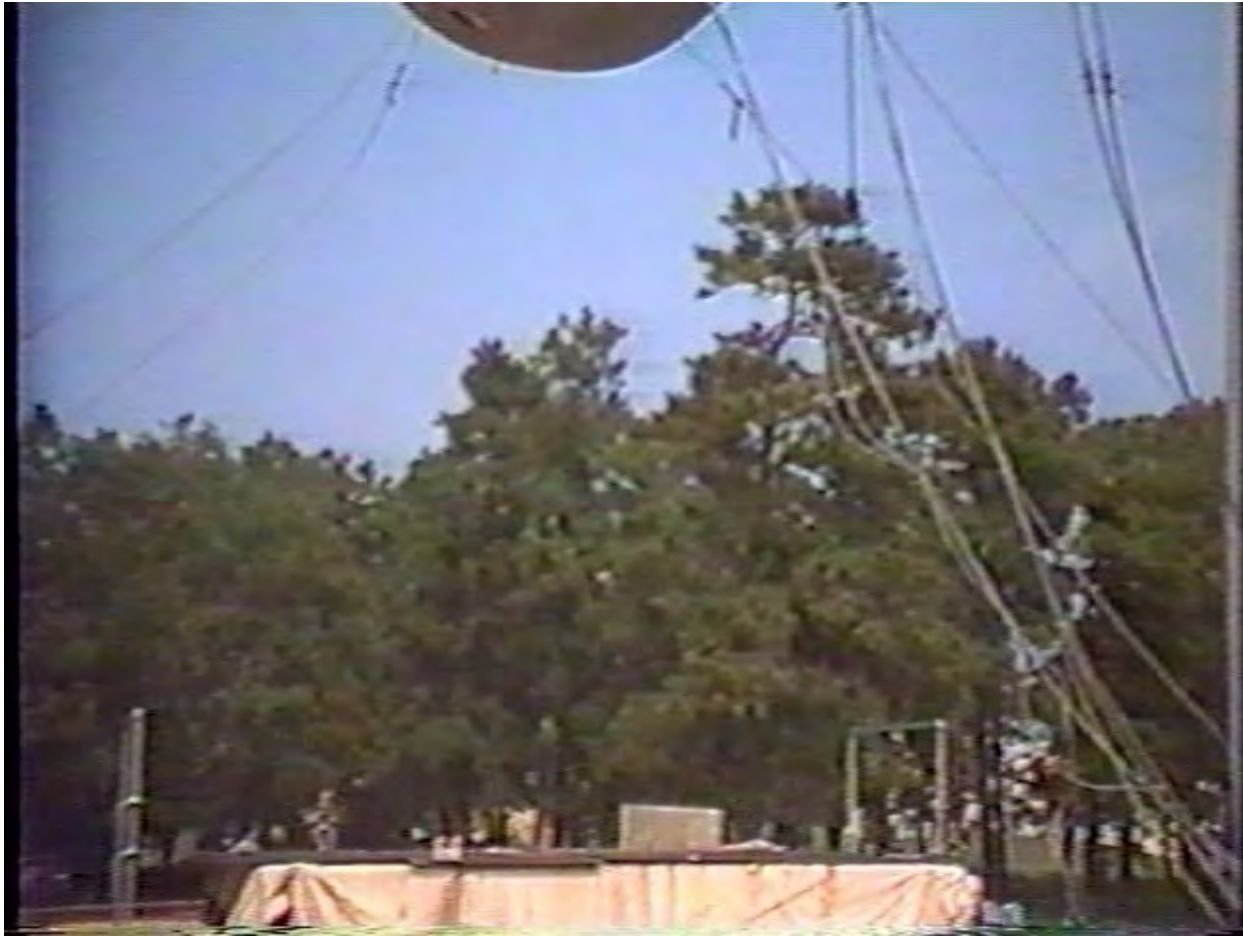
Example of a fuselage absorbing energy

- The remaining energy is transmitted through the fuselage to the aircraft floor.
 - The resulting floor-level deceleration is transmitted to seats
 - This floor-level deceleration is the impact condition replicated in seat sled tests.

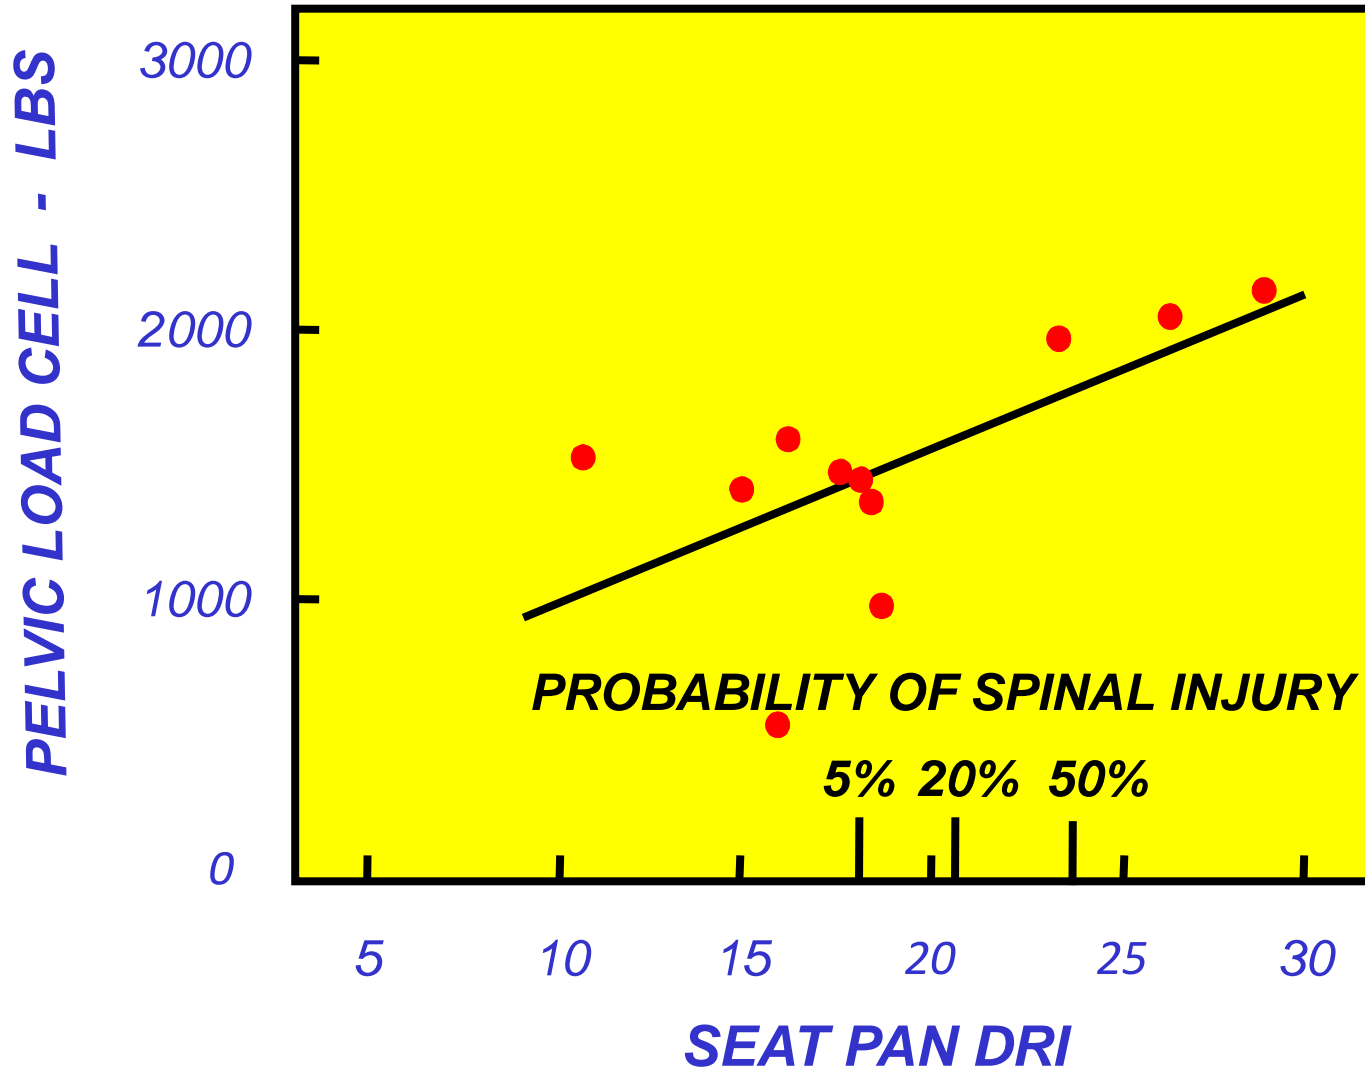
- Lumbar Spine
 - In vertical loading the bottom-most segment of the spine (lumbar) is the most vulnerable to injury. The military had derived a relationship between seat pan acceleration and spinal injury called the Dynamic Response Index (DRI). It was based on cadaver tests and accident data from helicopters and ejection seats.
 - To be more useful for civilian applications, a relationship between DRI and the load measured at the lumbar spine of a test dummy was developed. The limit of 1500 lb chosen corresponds to a 15% chance of spinal injury.

Probability Of Spinal Injury Is Related To The Load Measured In The Part 572B Dummy 's Pelvis
