# **EX-USS TORTUGA (LSD 26) SALVAGE REPORT**

**14 SEPTEMBER 1989**

**SUPERVISOR OF SALVAGE  
U.S. NAVY**

The June - August 1989 removal and scuttling of the ex-USS TORTUGA (LSD 26) from San Miguel Island was a unique off-shore salvage operation for several reasons: the entire hull was fully flooded and open to the sea; complex salvage computer programming was utilized on-scene for the first time; and the effect of on-board hazardous substances at times dictated the salvors' actions.

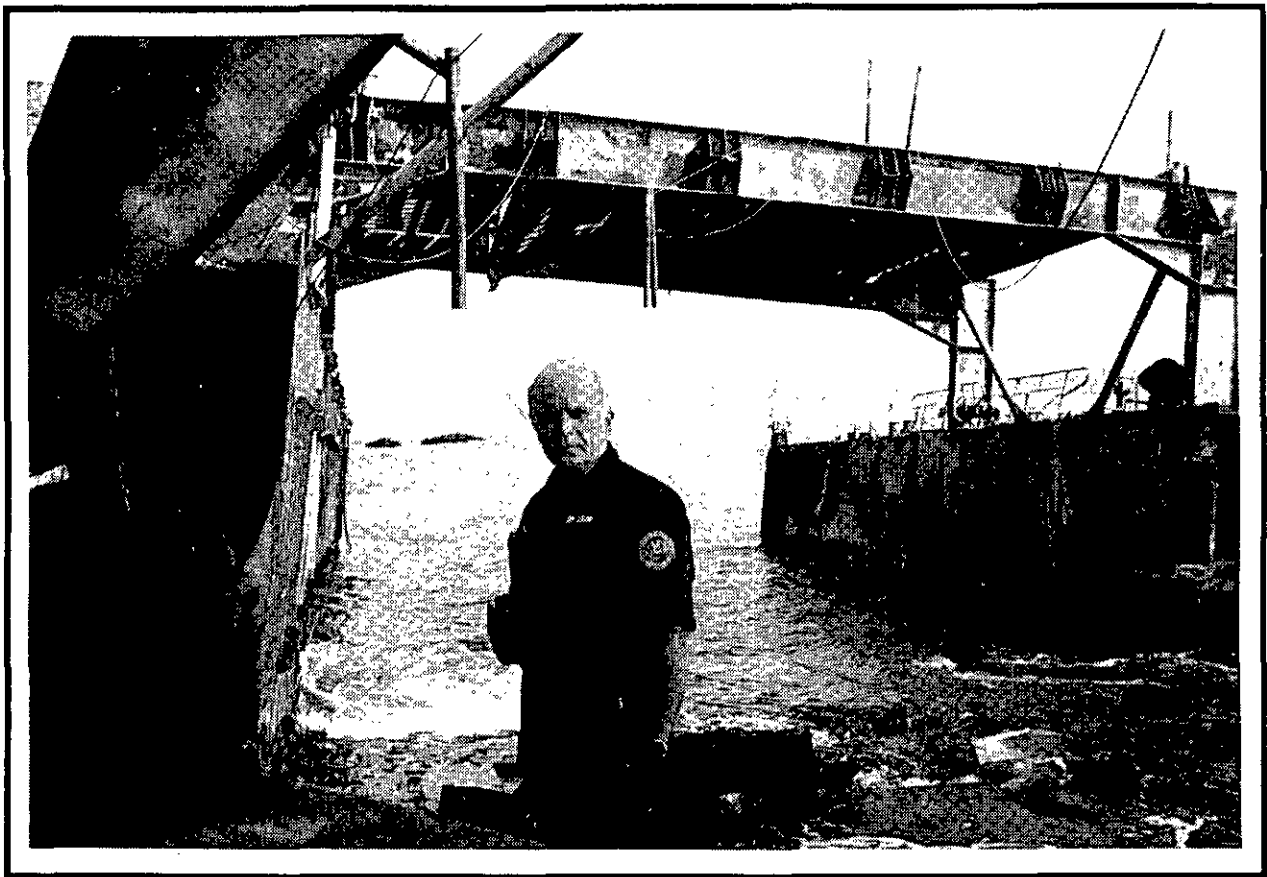
**FIGURE 3-1. "Not much to smile about as Jim Bladh surveys TORTUGA."**

**3-1.1 SURVEY RESULTS.** On 2 and 3 February 1988, the salvage contractor and a salvage engineer (Figure 3-1) conducted a survey for the purpose of developing an estimate for removing TORTUGA. The fore section, measuring 355 feet and weighing approximately 4,390 long tons, was hard aground by approximately three feet.

All fuel and ballast tanks and engineering spaces below the third deck (well deck), with no observed exceptions, were open to the sea. Mechanical systems within these spaces were disrupted. The ship appeared to be impaled by rocks in several locations along the starboard side amidships, and the hull appeared as though it may have sustained a fracture across the bottom at Frame 41. It was estimated that any plan to remove the fore section intact would have to include careful and selective topside weight removal in order to prevent further weakening of the hull girder and possible breaking of the ship at this frame. The detached 100-foot stern section, weighing approximately 400 long tons, appeared to be readily removable by breaking, refloating or a combination of the two.

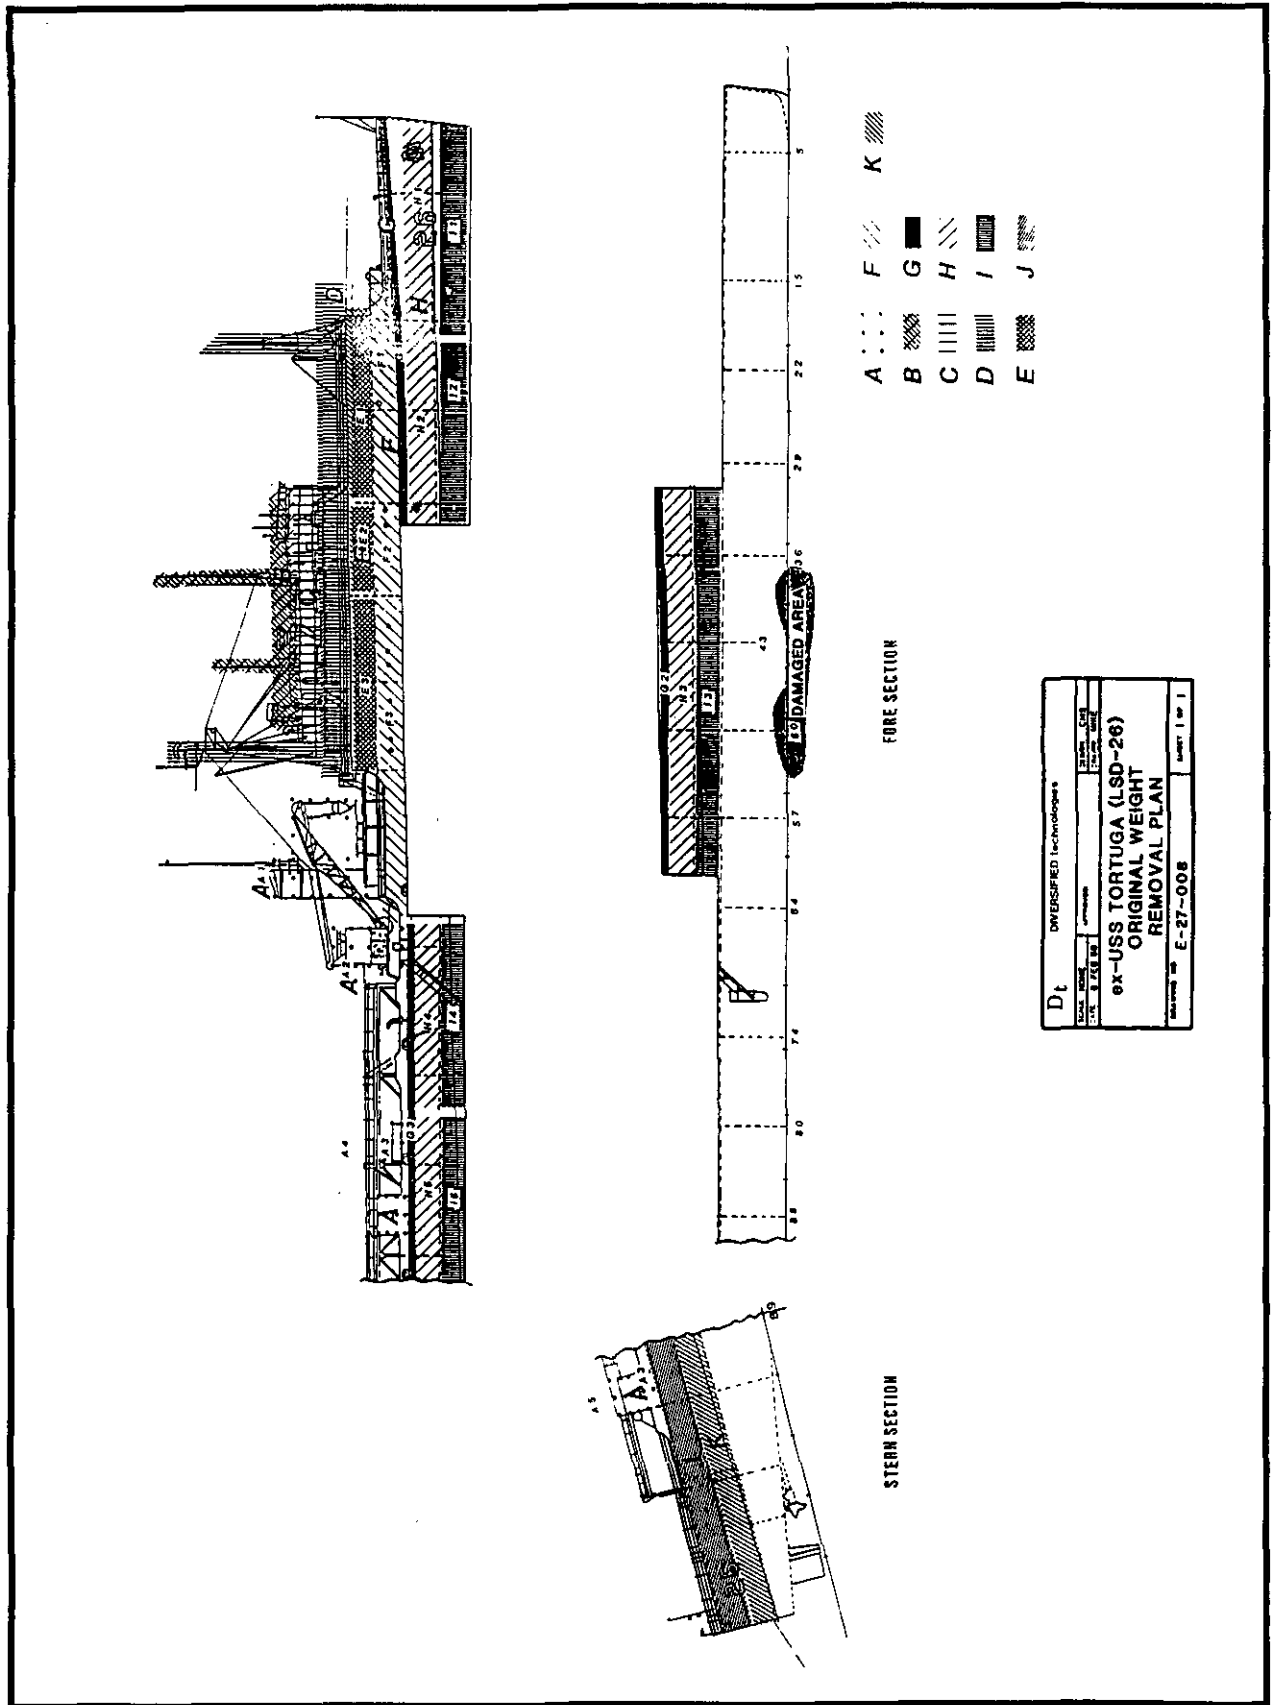
FIGURE 3-2. Original Weight Removal Plan.

**3-1.5 WRECK REMOVAL PLAN.** The plan for removing the fore section of TORTUGA consisted of a combination of breaking and refloating. The breaking phase would entail cutting the structure and outfit down to the well deck forward of Frame 31 and aft of Frame 62, removing approximately 1,300 tons of steel. The structure up to the main deck between those two frames would be retained to offset the effect of the suspected fracture near Frame 41. Loads of scrap, totaling 300 to 400 tons each, would be hauled by barge to Long Beach. Figure 3-2 shows the initial weight removal plan.

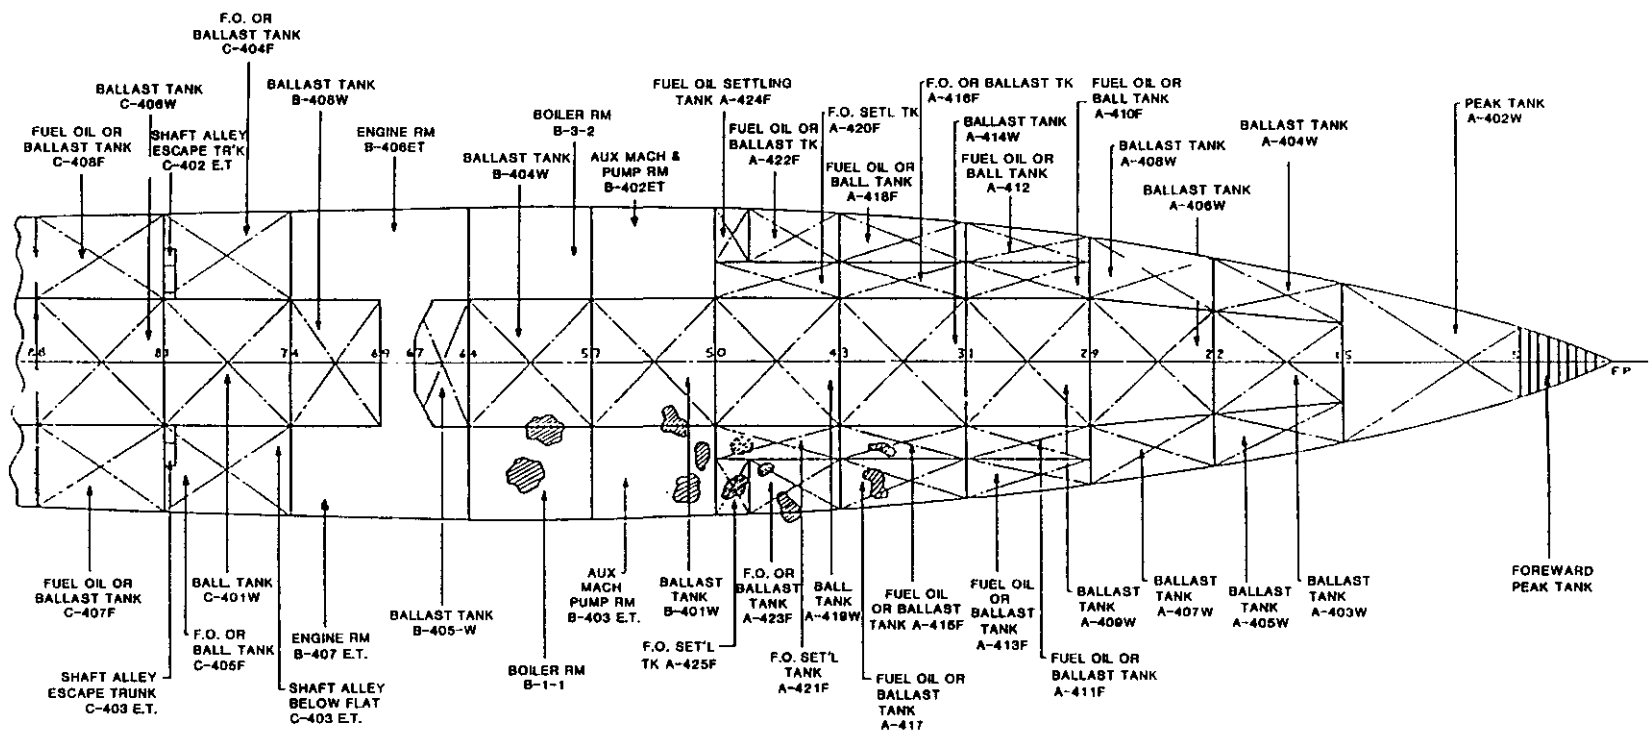
FIGURE 4-1. Plan View of Spaces Below the Well Deck in the Fore Section.

Figure 4-1 shows a plan view through the well deck of the fore section of TORTUGA, detailing the numerous spaces available for dewatering. A graph of the water level and corresponding static head necessary to achieve a given increase in buoyancy was prepared for each ballast tank and engineering space. Figure 4-2 shows a sample plot for wing tanks A-412-F and A-413-F. Based on a conversion of one foot of floodwater displaced (literally pushed out the bottom) for every 0.445 psig of air pressure introduced and retained in the space, the maximum static pressure achieved corresponded directly to a specific increase in buoyancy. Calculations for all tanks and engineering spaces were done in this manner. (A permeability factor of 0.85 was used for the six engineering spaces and 1.00 for all tanks). The water level within each space in the stranded condition prior to dewatering was established by interpolating between measured drafts for the fore section. Observed drafts were as follows:

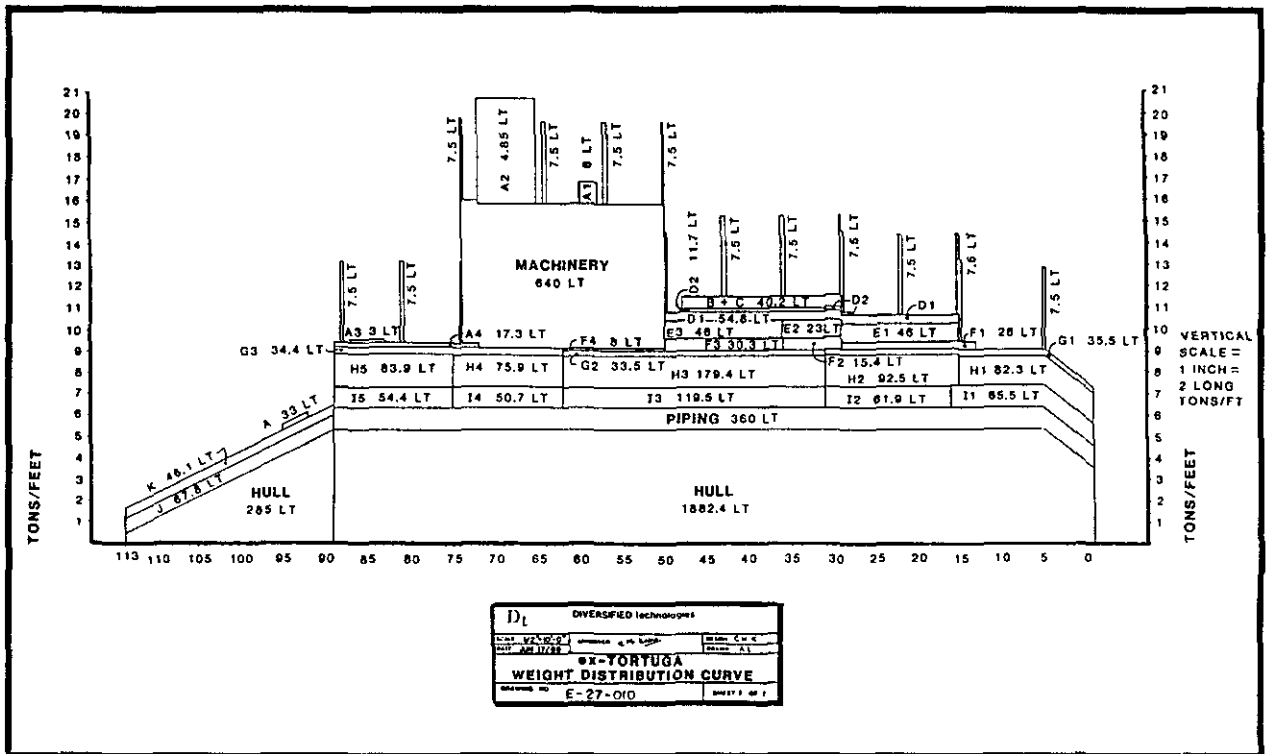
FIGURE 4-4. Weight Distribution Curve (Before Weight Removal).

Due to extensive damage, it was suspected that the strength of the hull had been significantly reduced. Maximum stresses were computed to compare with the yield stress of the remaining structure. Figures 4-4 and 4-5 show the weight distribution for the entire fore section before and after the topside weight removal phase. The weight distribution of Figure 4-5 was used to generate the weight curve in Figure 4-6 which, when combined with the buoyancy curve generated from Bonjean areas, yielded the load curve. Second integration of this load curve, in turn, yielded the bending moments (M) which were computed for eleven evenly-distributed stations 35.2 feet apart. Figure 4-7 shows the summary of moments for both a stillwater condition and worst-case conditions of hog and sag. The worst-case scenarios are based upon a standard L/20 wave, where it is assumed that the fore section is supported amidships or at both ends on the crests of a 352-foot long, 17.6-foot high wave. As can be seen in Figure 4-7, the maximum bending moment predictably occurs in the midships area.

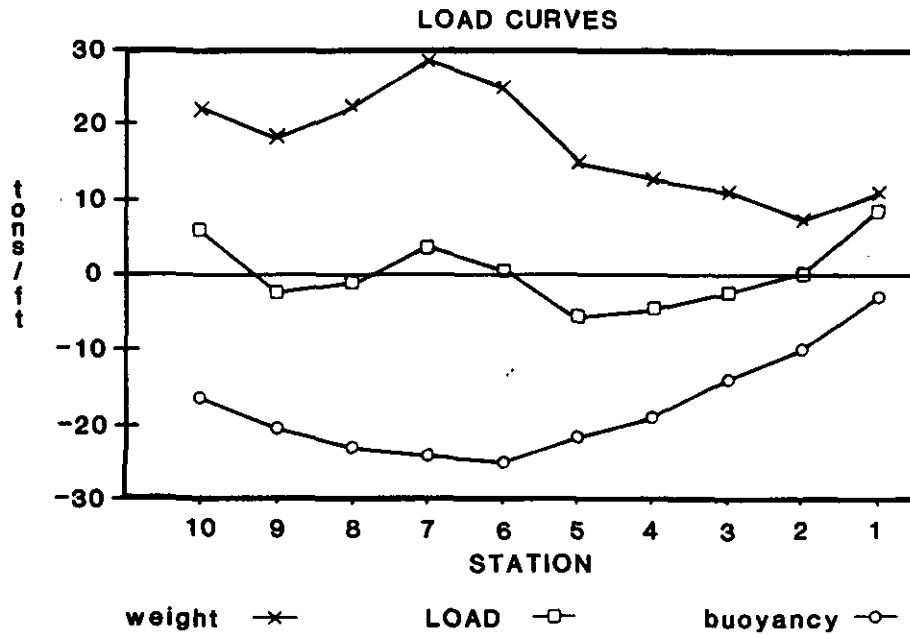
FIGURE 4-6. Weight, Buoyancy and Load Curve Values from "AFLOAT" Subprogram.

Although the maximum bending moment occurred at Station 5, the reduced section modulus located at Station 6 produced the largest stresses: 12.3 and 10.2 tons per square inch (TSI) at the keel and well deck, respectively, in a hogging condition. Figure 4-9 lists composite bending stresses for all eleven stations.

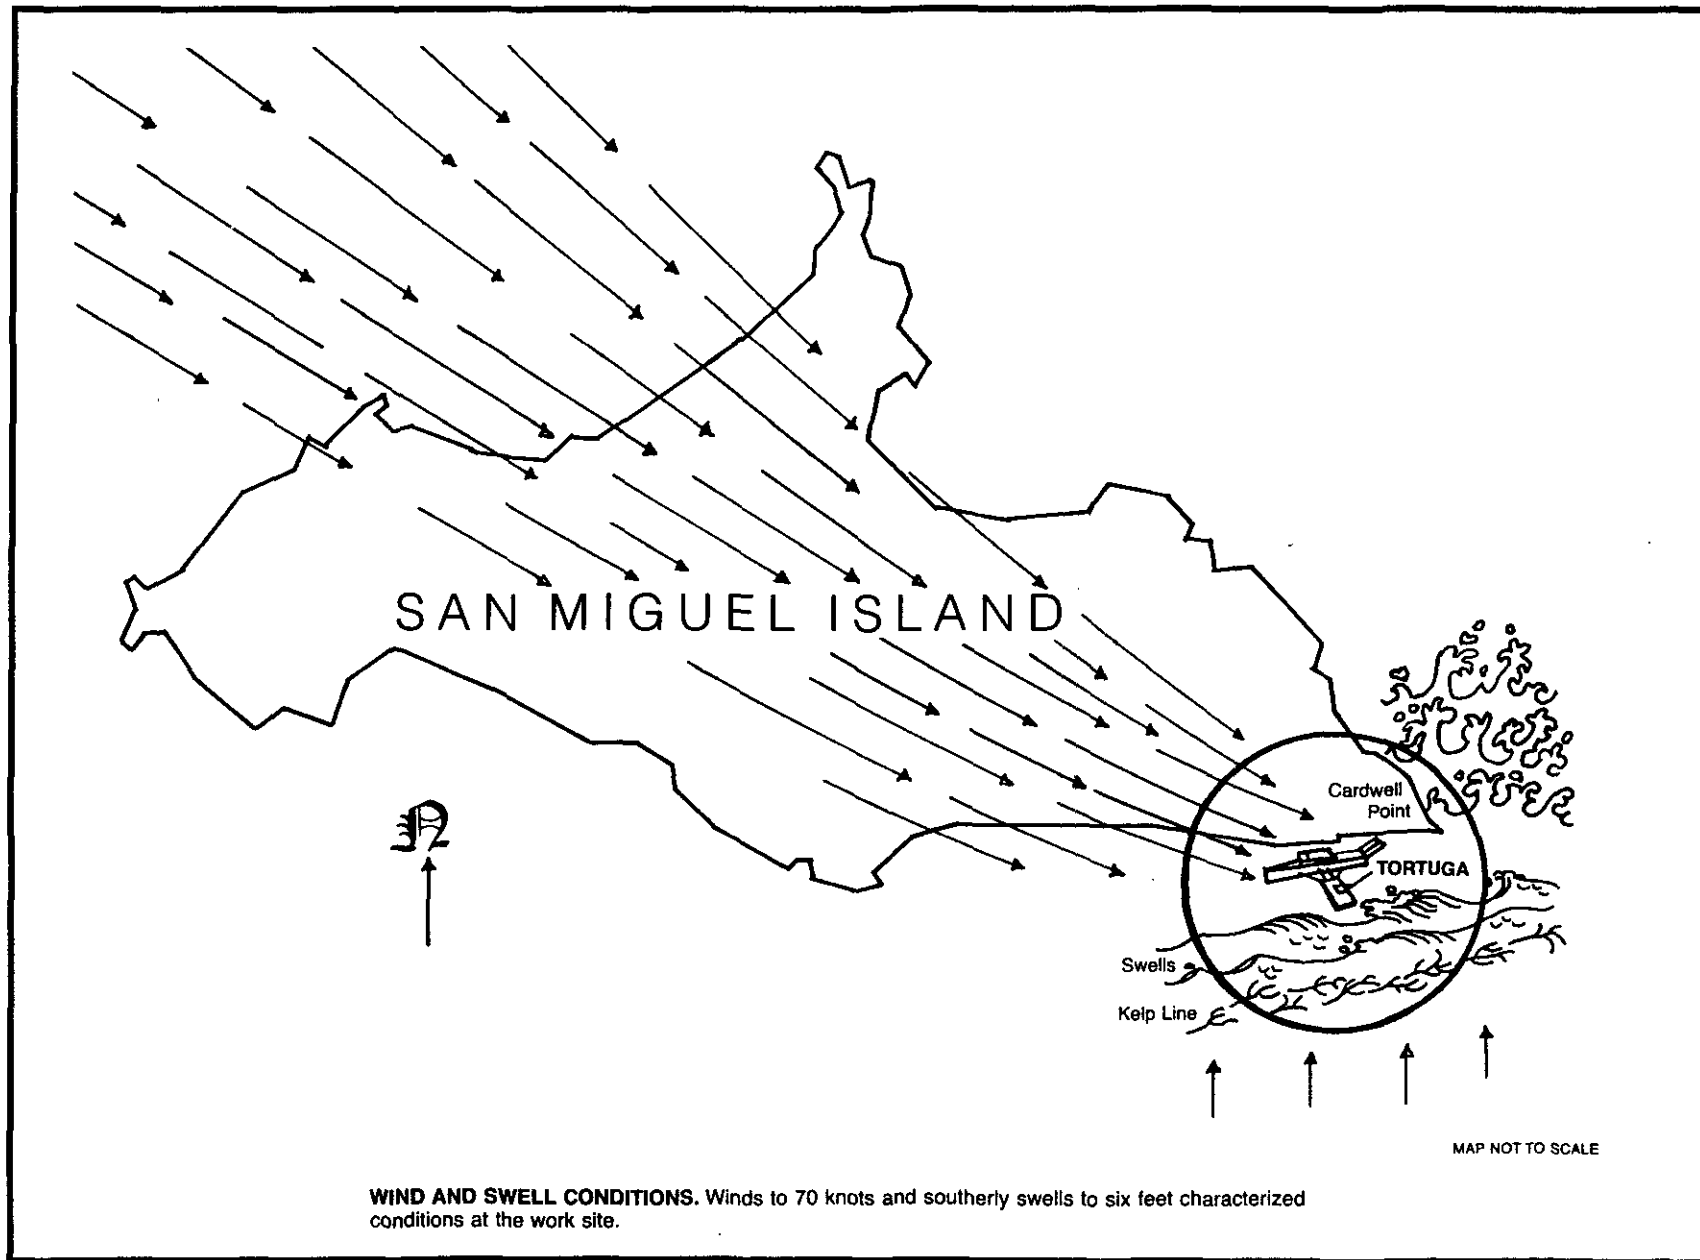
FIGURE 5-6. Wind and Swell Conditions.

**Impact of Weather Conditions.** Wind and swell conditions (Figures 5-6 and 5-7) were a major factor throughout the TORTUGA operation. The south side of the island experiences wind conditions unlike those on the rest of the island, with the result that actual wind velocities at the work site were significantly higher than those projected for the area by the U.S. Weather Bureau. As a typical daily pattern, winds would lessen around 0100 or 0200 and stay in the 25- to 30-knot range until 1200 or 1400, at which time they would steadily increase until late in the afternoon when they would hit their maximum sustained velocity of 60 to 70 knots. These unexpectedly high winds were thought to be caused by a venturi effect created between Cardwell Point on San Miguel Island and Sandy Point on Santa Rosa Island, about three miles to the southeast. Winds of these velocities, compounded by consistently high southerly swells created conditions alongside TORTUGA which were often too rough to get personnel on or off the wreck by boat. As a result, a daily helicopter operation was adopted shortly after the start of the operation for personnel transportation.

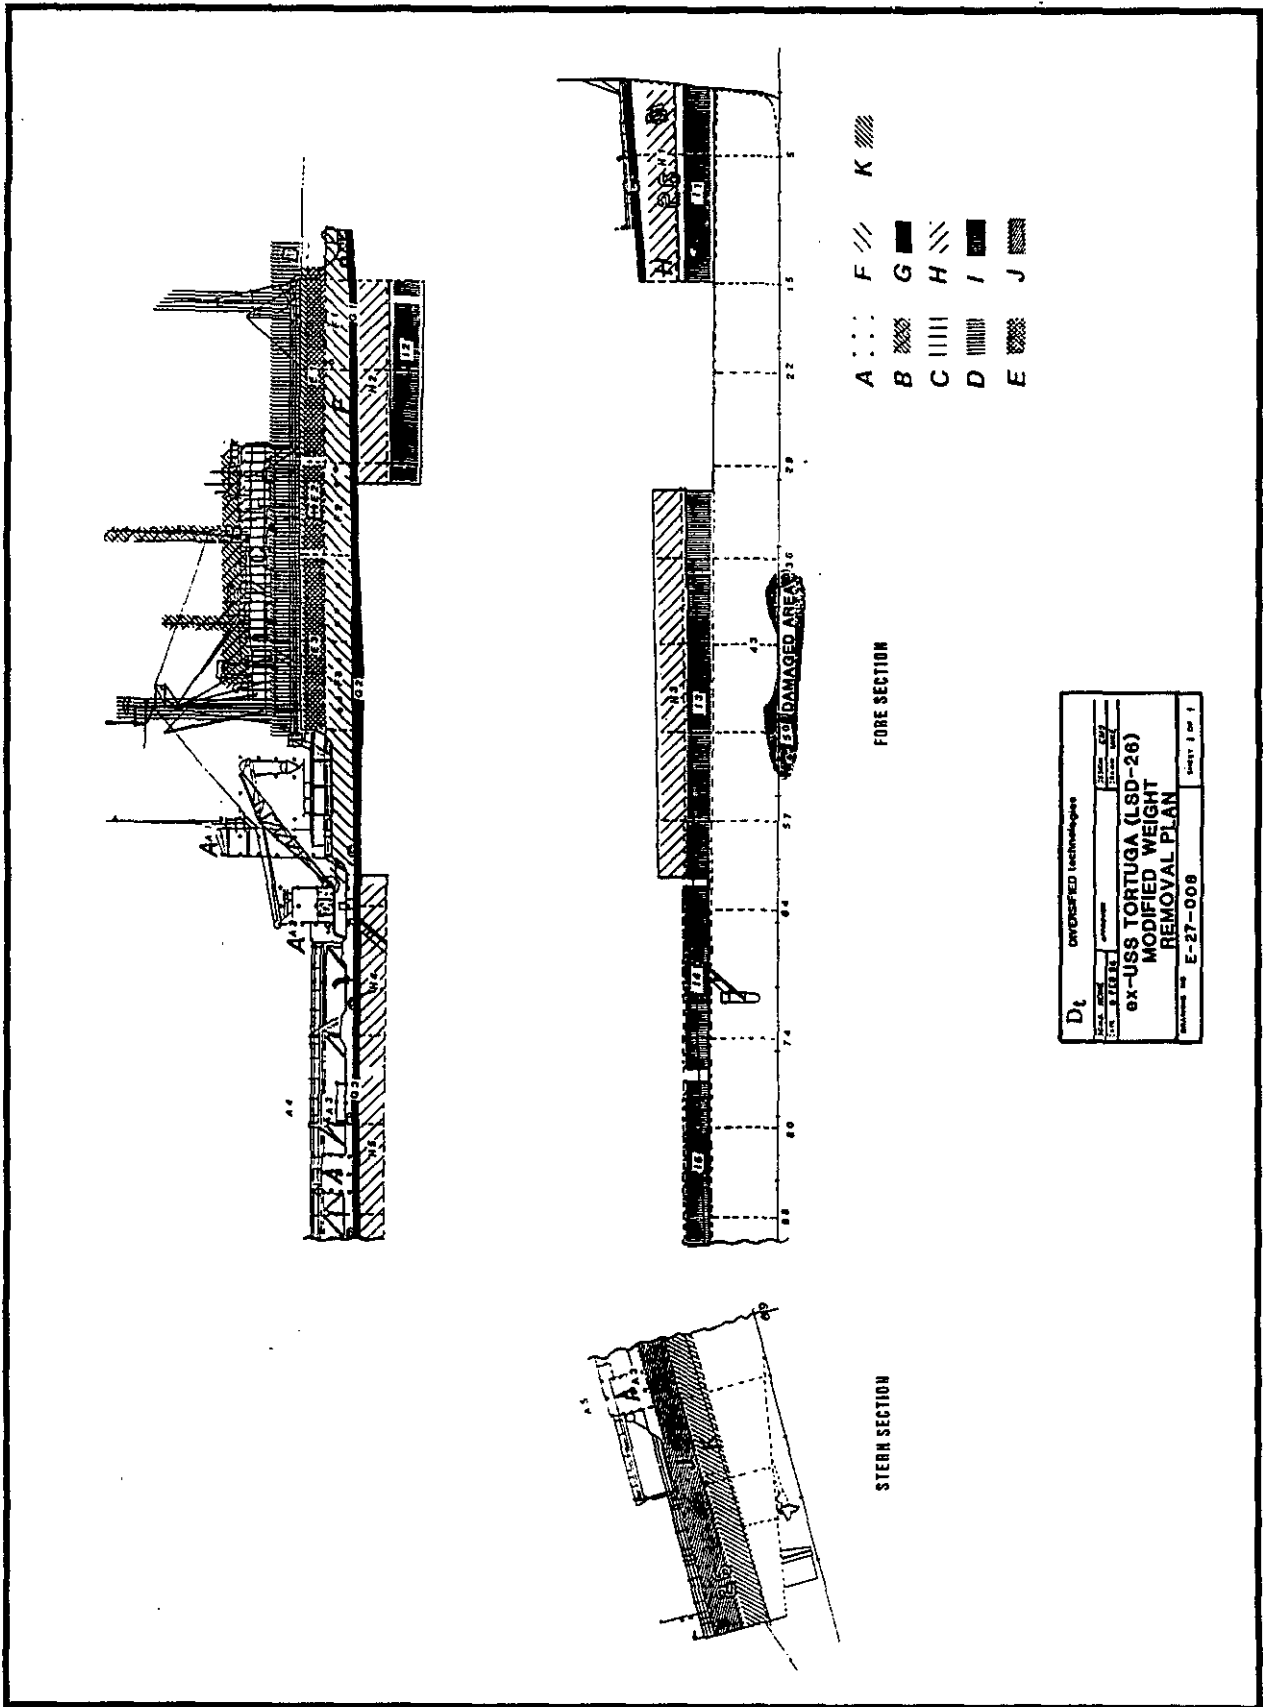
FIGURE 5-11. Modified Weight Removal Plan.

The original plan proposed by the contractor had recommended removing the raised fo'c'sle along with the rest of the superstructure. In the actual cutting operation, this part of the vessel was left intact to provide points for attachment of pulling lines. Removal of the fo'c'sle would have required considerable time and effort to burn the thick steel, and proper pulling points would then have had to have been welded to the bow. Figure 5-11 shows the revised weight-removal plan with the bow left in place. Steel was removed from the superstructure down to the well deck except as indicated, providing a weight reduction of nearly 1,200 LT, as discussed in Chapter 4.

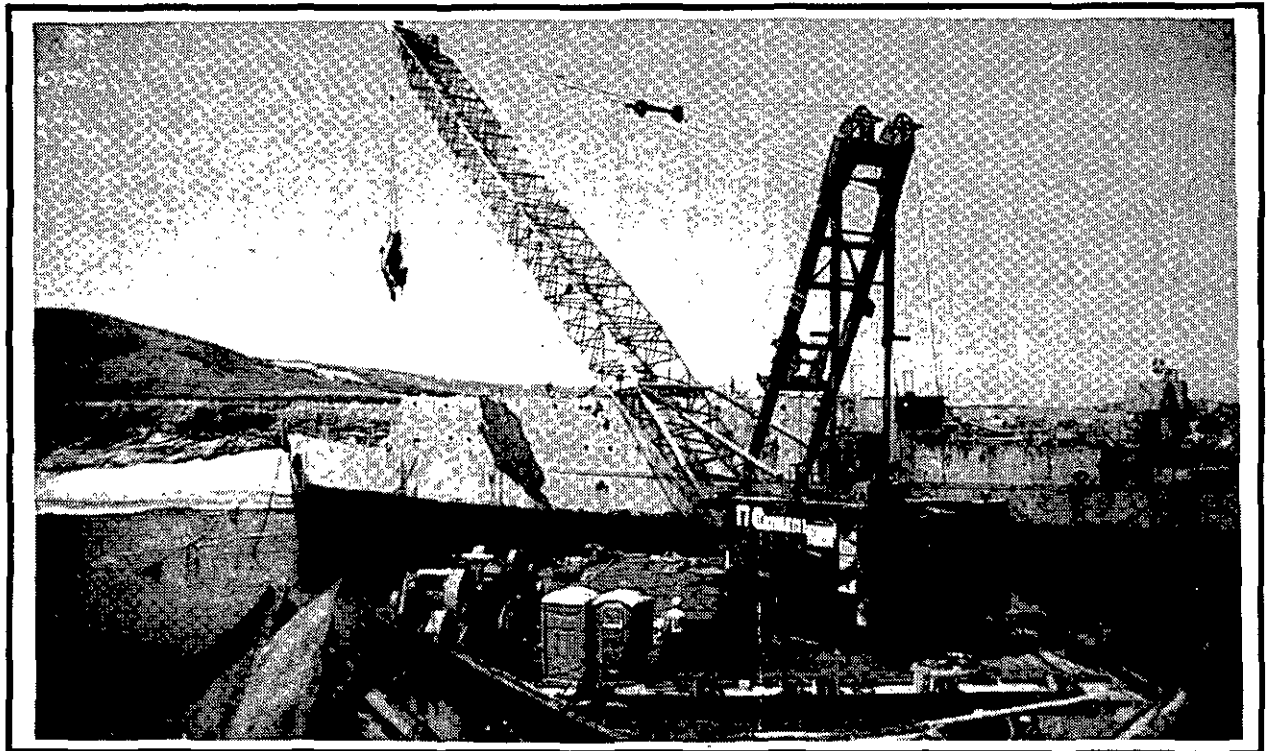
**FIGURE 5-14. Offloading Scrap.**

When 300 to 400 tons of cut steel had accumulated in the well deck, the ATB-99 was brought to the job site from Long Beach, and moored into position to crane-lift the scrap aboard the barge for transport to Long Beach (Figures 5-14 and 5-15). The crane barge ATB-99 was outfitted with six-foot stanchions down each side as a containment fence for the scrap steel. Larger pieces of steel were positioned against the stanchions to add to the containment so that scrap could safely be piled higher. In addition to the ship's pedestal-mounted cranes, the heaviest units lifted were the grating sections of the helicopter deck and the two stacks, weighing eight to 10 tons each.

To enable the scrap steel to be lifted by crane, holes were burned into two corners, then long-link lashing chain was run through the holes and made up to a shackle pin and wire pendant which connected to the crane hook. Several lighter pieces could be picked at once, and heavier or odd-shaped pieces often required four points rather than just two for the pick. Small pieces of scrap from the living spaces, such as bunks, desks, and sinks, were piled by hand into 20 x 20-foot cargo nets, then the four corners of the net were picked up for the crane lift.

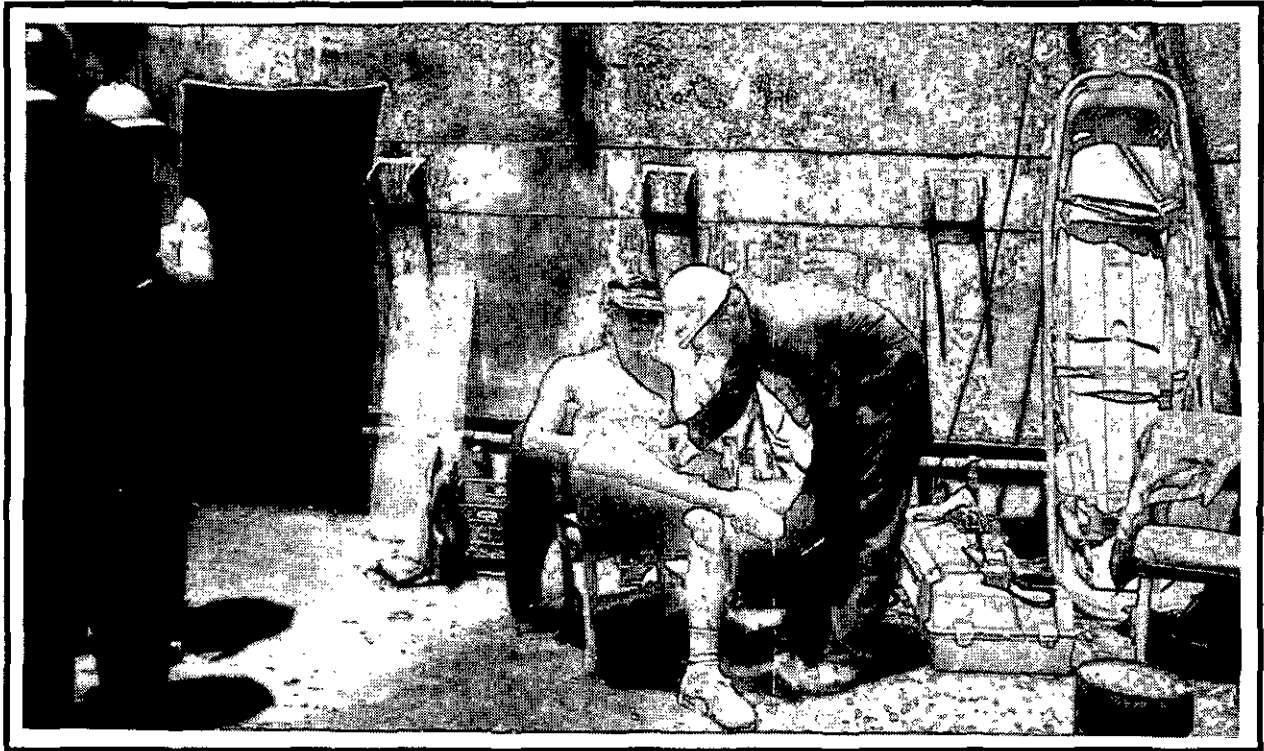
**5-3.1 TANK SURVEYS.** Every ship tank was surveyed for leaks and to assess the extent of damage. Initial dry surveys were completed by Fleet personnel. Subsequently, the salvage contractor used two of its own salvage divers to perform the remaining underwater surveys and ballast tank repairs. Figures 5-16 through 5-19 depict reviewing of the salvage plan and tank repairs.

**FIGURE 5-16. LCDR Jack Strandquist Reviewing the Salvage Plan.**

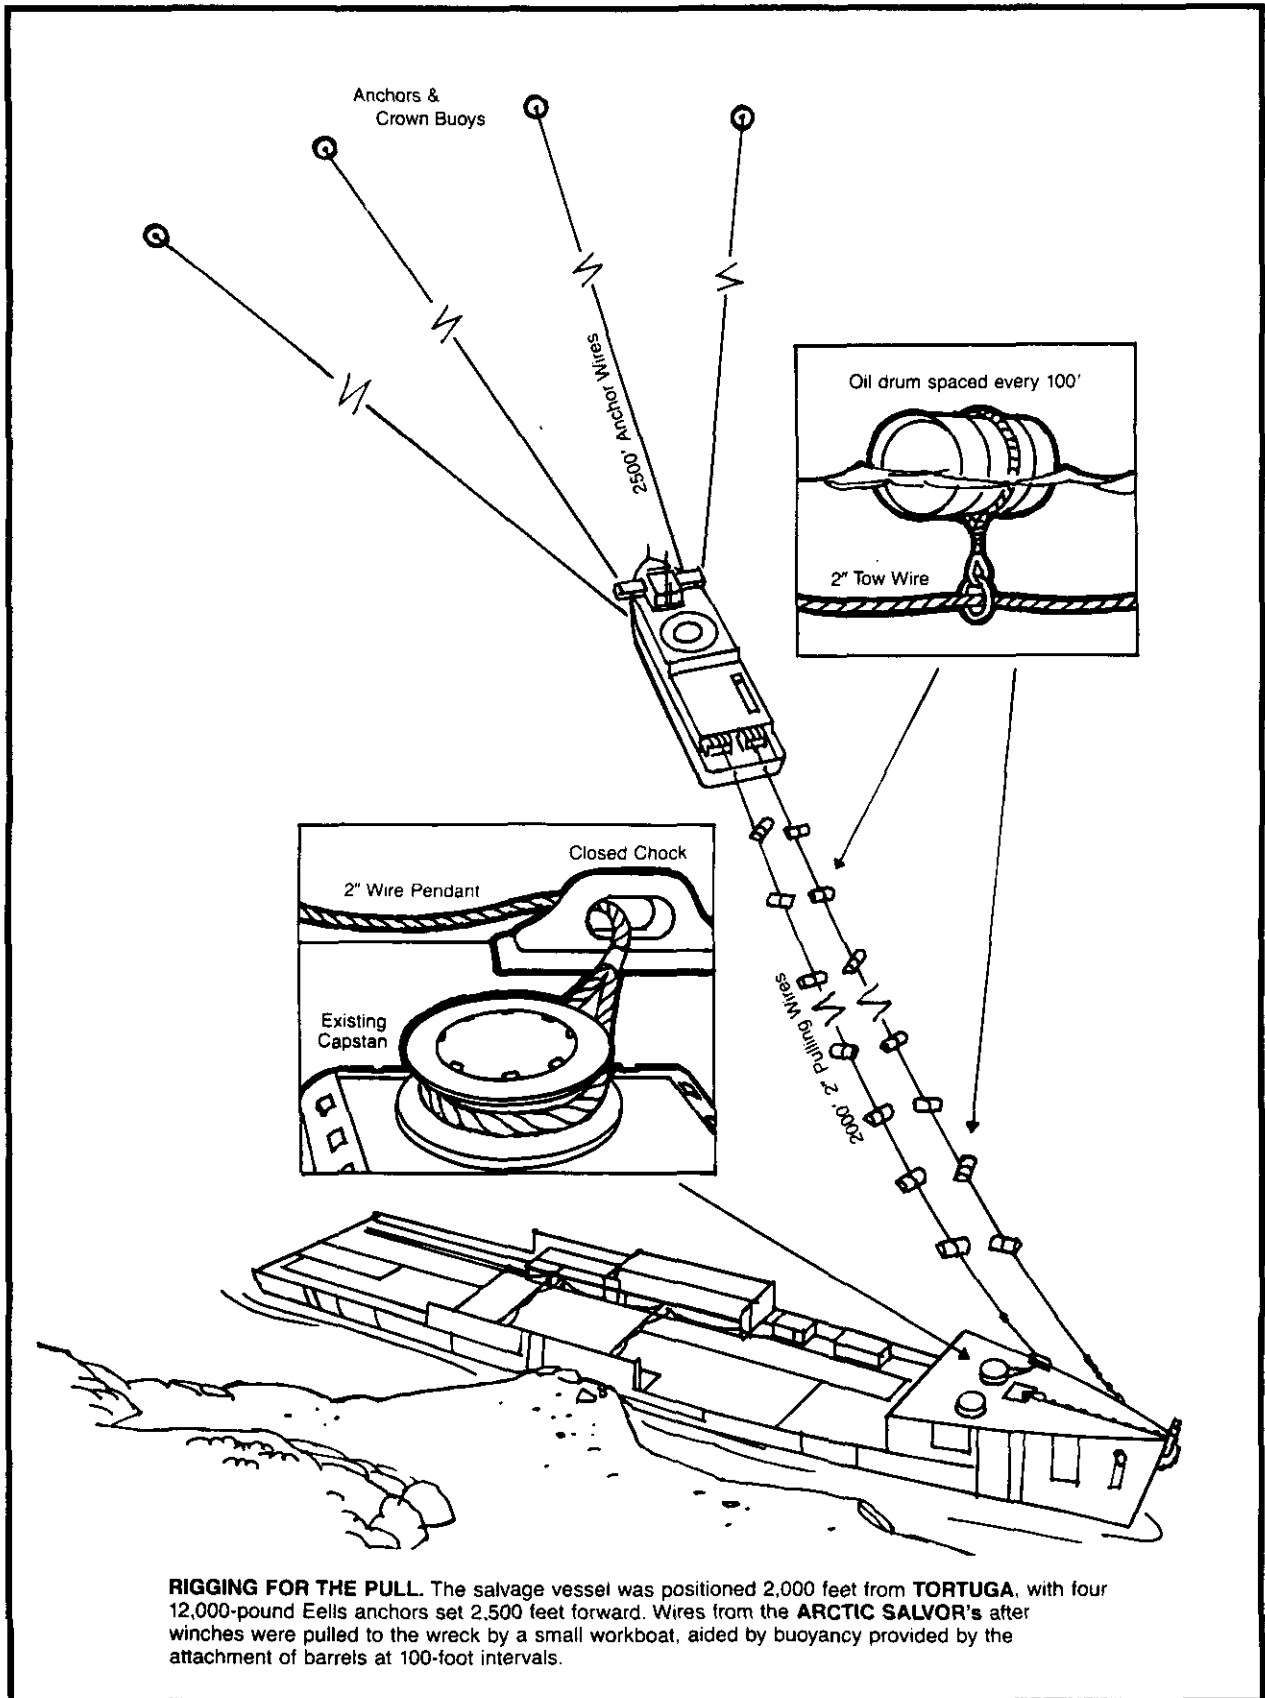
**5-4.1 RIGGING FOR THE INITIAL PULL ATTEMPT.** (Figure 5-21) TORTUGA was aground broadside to the beach. Freeing a vessel from this condition can best be accomplished by pulling from one end rather than from the middle or along the side. A lever action is created, and greater results can be achieved for a given pulling force. In this case, the bow was the initial choice because of easier hawser attachment and potential interface from the stern section if an aft pull were selected. In addition, when the vessel was first dewatered for test, it was found to be afloat at the bow but not at the stern. Pulling the bow enabled the salvors to swing the wreck to a position nearly perpendicular to the beach so that the sea itself could assist in the refloating as swells rolled down the length of the ship and helped lift the stern.

**FIGURE 5-21. Rigging for the Pull.**

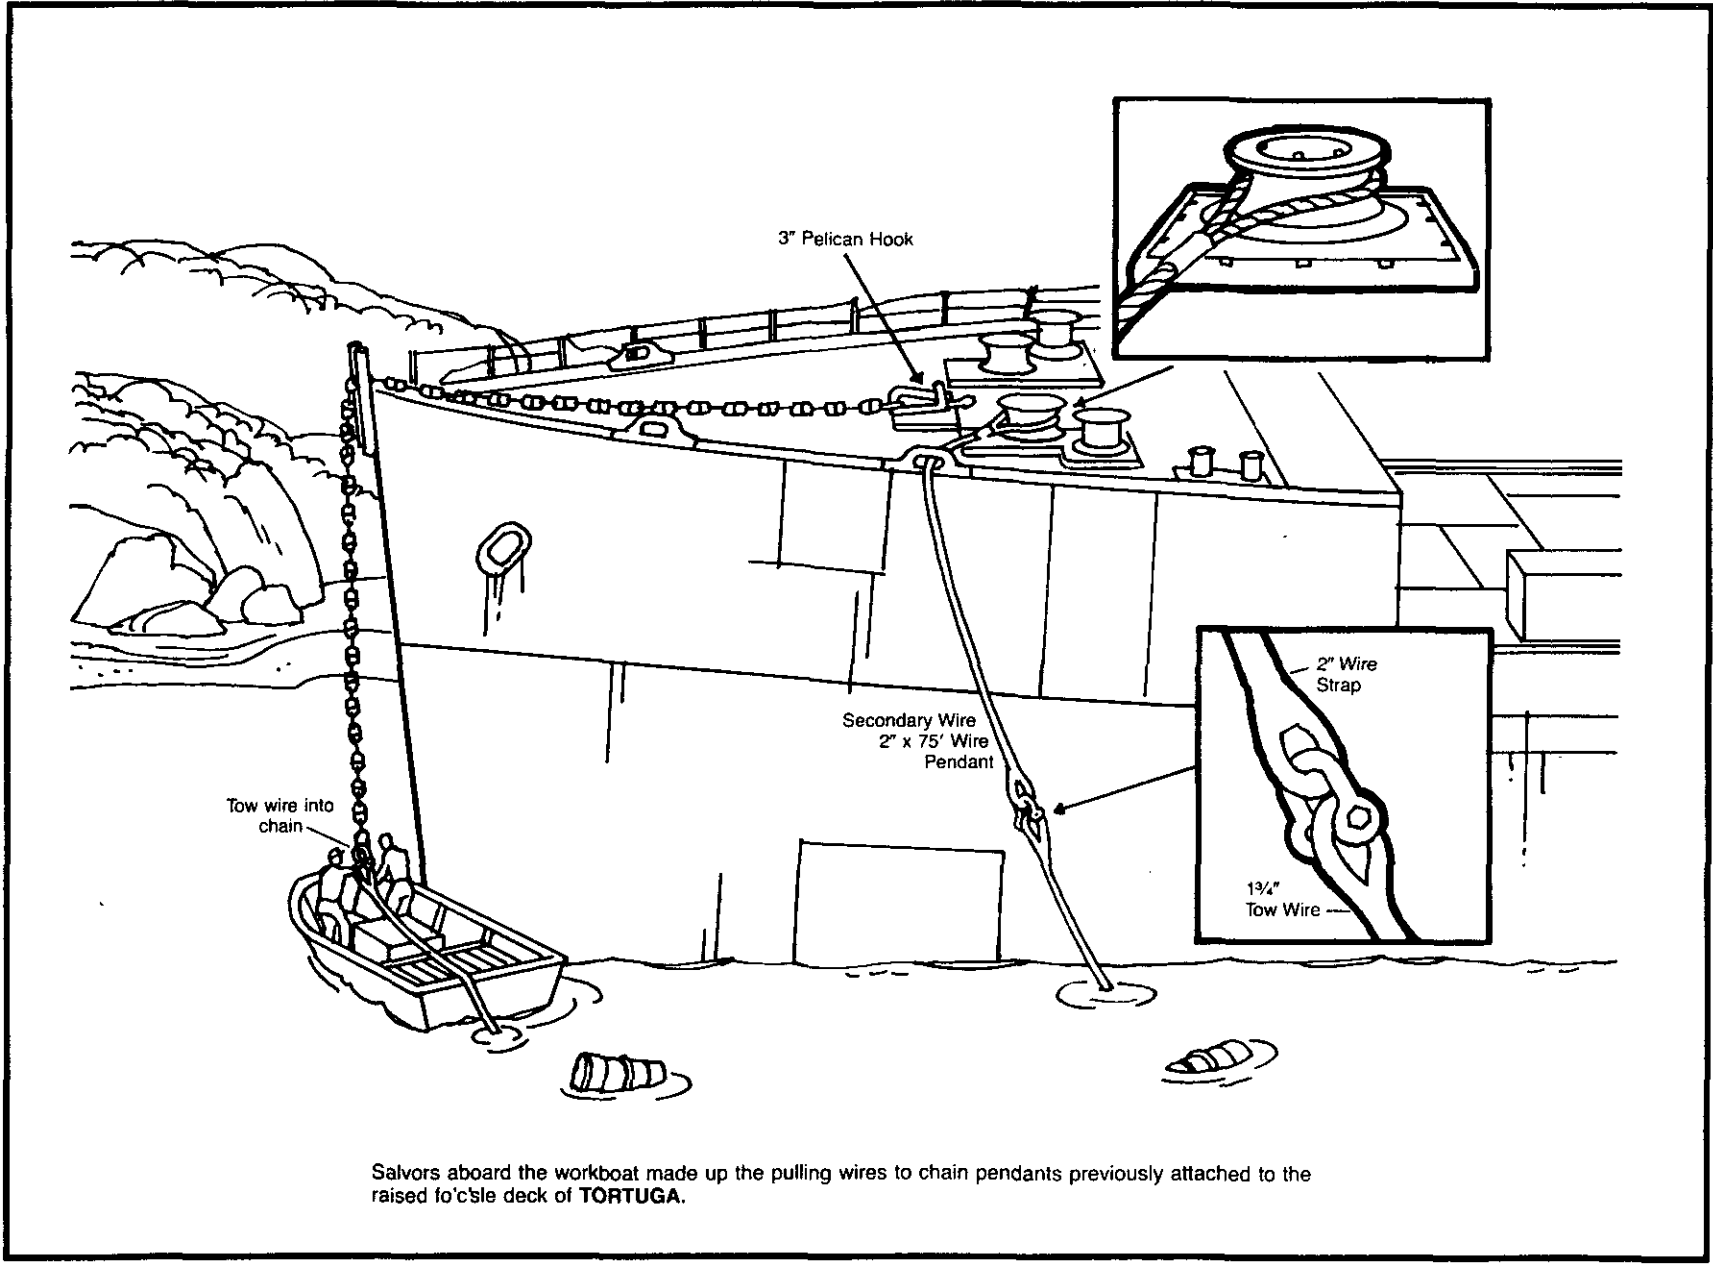
As a common practice in refloating and wreck-removal operations, wires from the salvage vessel to the stranded vessel are flown by a helicopter in order to complete the hook-up as quickly and efficiently as possible. In the refloating of TORTUGA, however, time was not a critical factor, and sea and swell conditions were such that a helicopter was not necessary, so the two wires were pulled ashore utilizing the ARCTIC SALVOR's 300-HP workboat. Barrels were placed at 100-foot intervals to provide buoyancy to the wires. Already attached to the raised fo'c'sle deck of TORTUGA were pendants with wires hanging almost to the waterline. Salvage personnel aboard the workboat made connections between the pendant wires and the paid-out wires (Figure 5-22). Though a whole day had been allowed for this

FIGURE 5-22. Connections Between Pendant Wires and Paid-Out Wires.

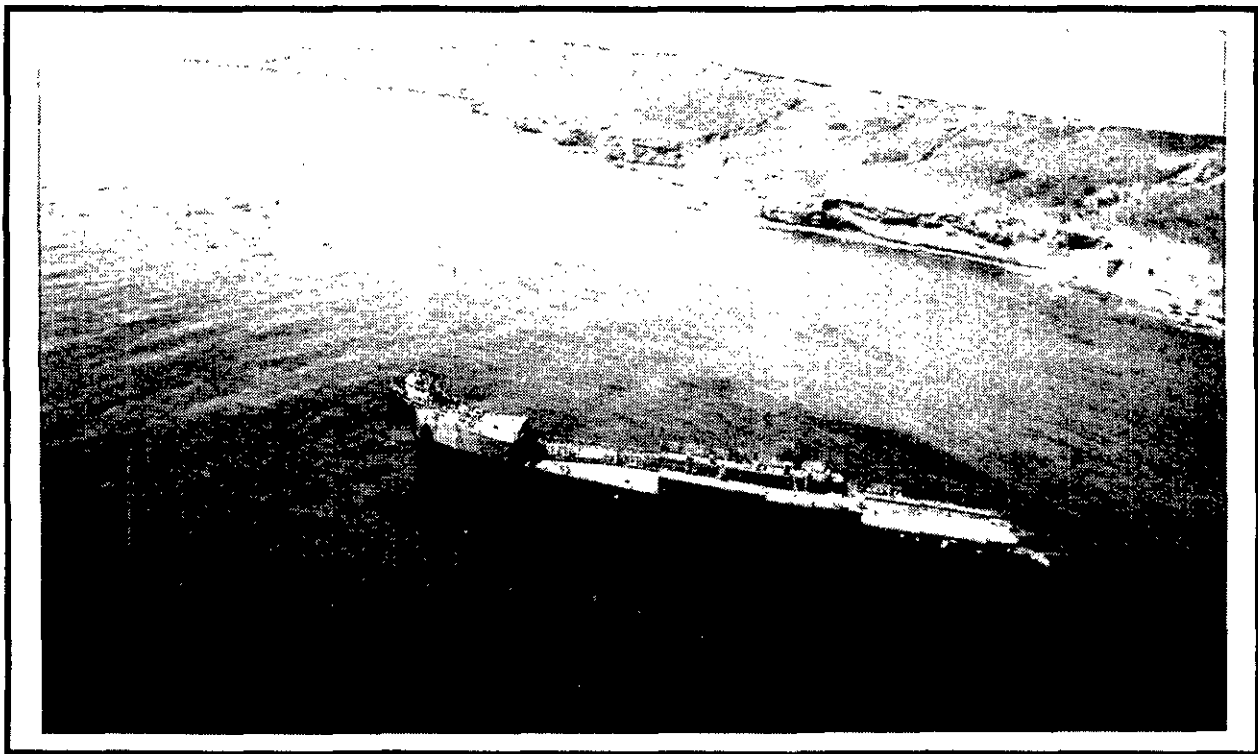
**5-4.3 TOWING TO SEA AND SCUTTLING.** A 2400-HP SPARTAN-class tug was at the scene when TORTUGA was freed from strand and immediately secured a towing line to the refloated vessel (Figures 5-24 and 5-25). Aboard TORTUGA were four salvage personnel, who cut the two wires connecting the wreck to the salvage vessel. The towing phase of the operation got underway at once (Figure 5-26) while the ARCTIC SALVOR remained at the site long enough to pull in wires, pick up the four anchors and remove kelp.

**FIGURE 5-24. Tug Securing Towing Bridle for Tow to Disposal Area.**

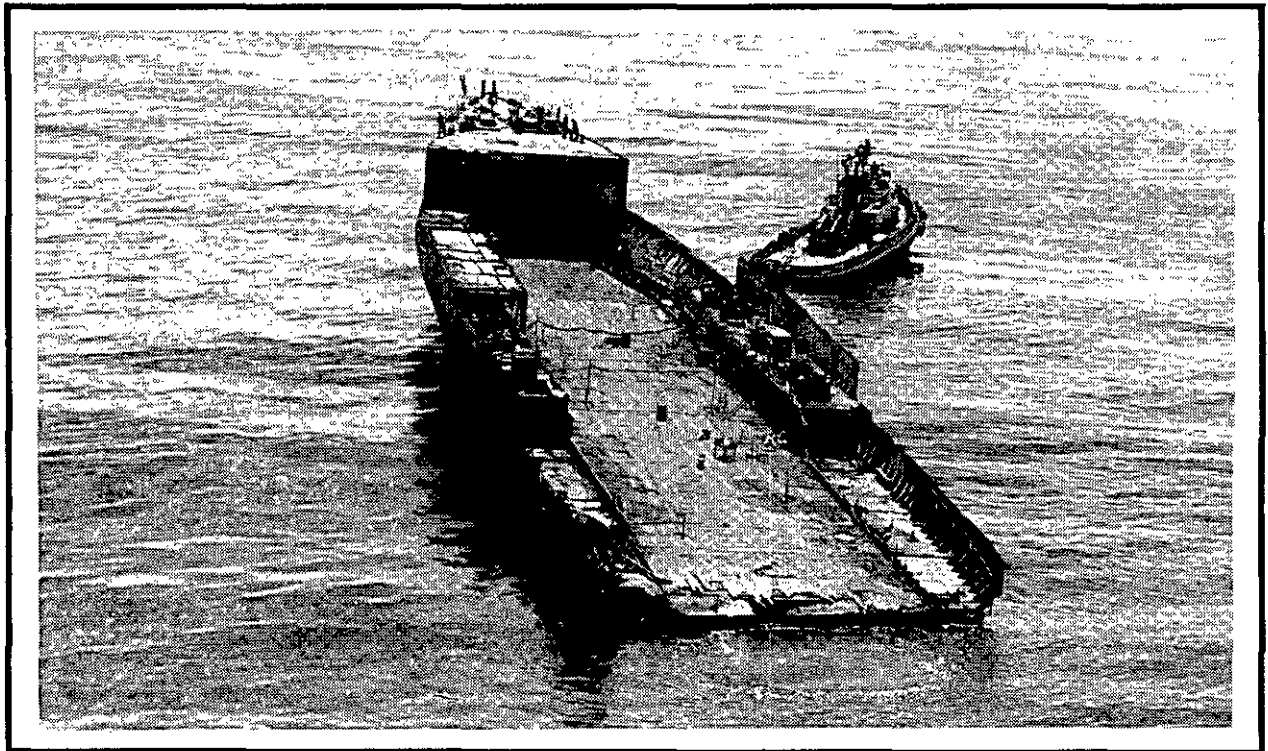
**FIGURE 5-25. TORTUGA Ready for Tow to Disposal Site.  
(Note Compressors and Manifolding)**

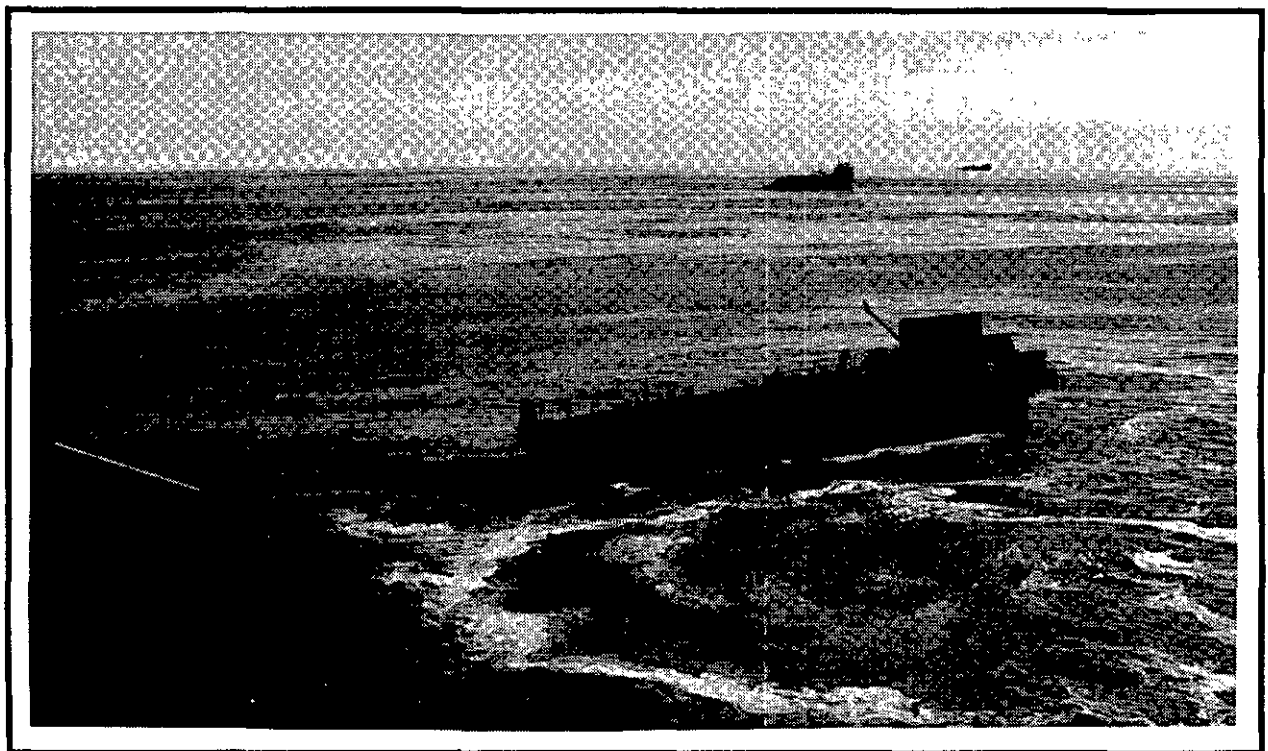
**FIGURE 5-26. TORTUGA Hulk Under Tow. Remainder of Stern Section in Foreground.**
