# **EX-USS TORTUGA (LSD 26) SALVAGE REPORT**

**14 SEPTEMBER 1989**

**SUPERVISOR OF SALVAGE  
U.S. NAVY**

The June - August 1989 removal and scuttling of the ex-USS TORTUGA (LSD 26) from San Miguel Island was a unique off-shore salvage operation for several reasons: the entire hull was fully flooded and open to the sea; complex salvage computer programming was utilized on-scene for the first time; and the effect of on-board hazardous substances at times dictated the salvors' actions.

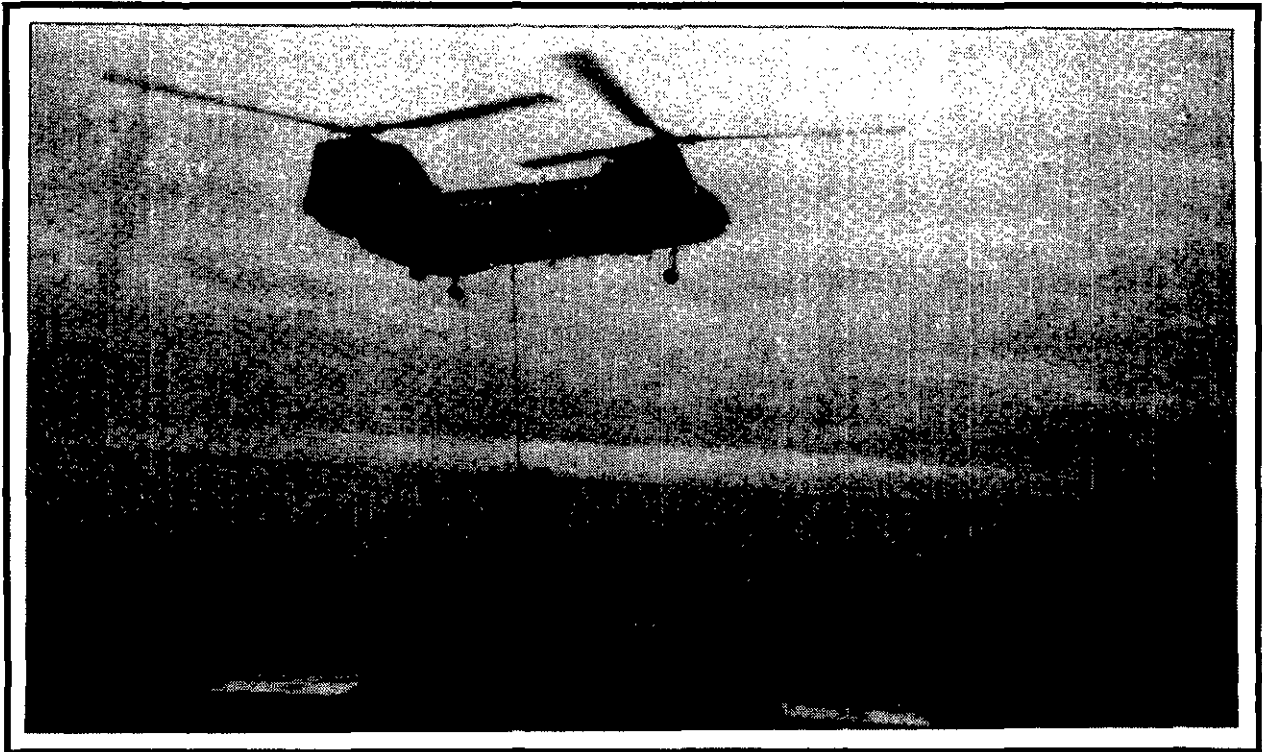
On the morning of 21 August, the helicopter arrived at 0814 and began lifting the compressors off the wreckage, completing the equipment lift-off at 0850 (Figures 5-27 and 5-28). A rubber Zodiac was dispatched from the ARCTIC SALVOR to come alongside the wreck. Two persons left TORTUGA at this time and two remained aboard, one positioned at the bow and the other at the stern. At 0910, lines from the tug to TORTUGA were released. Moving rapidly toward the middle of the vessel, the two remaining salvage personnel opened the valves to let the air bleed off from the tanks. As soon as all valves were open, the final two salvors boarded the Zodiac and pulled away from the wreck. At 0925 the ex-USS TORTUGA (LSD 26) disappeared below the surface of the Pacific Ocean forever.

**FIGURE 5-27. Compressor Being Air Lifted Off TORTUGA Prior to Scuttling.**

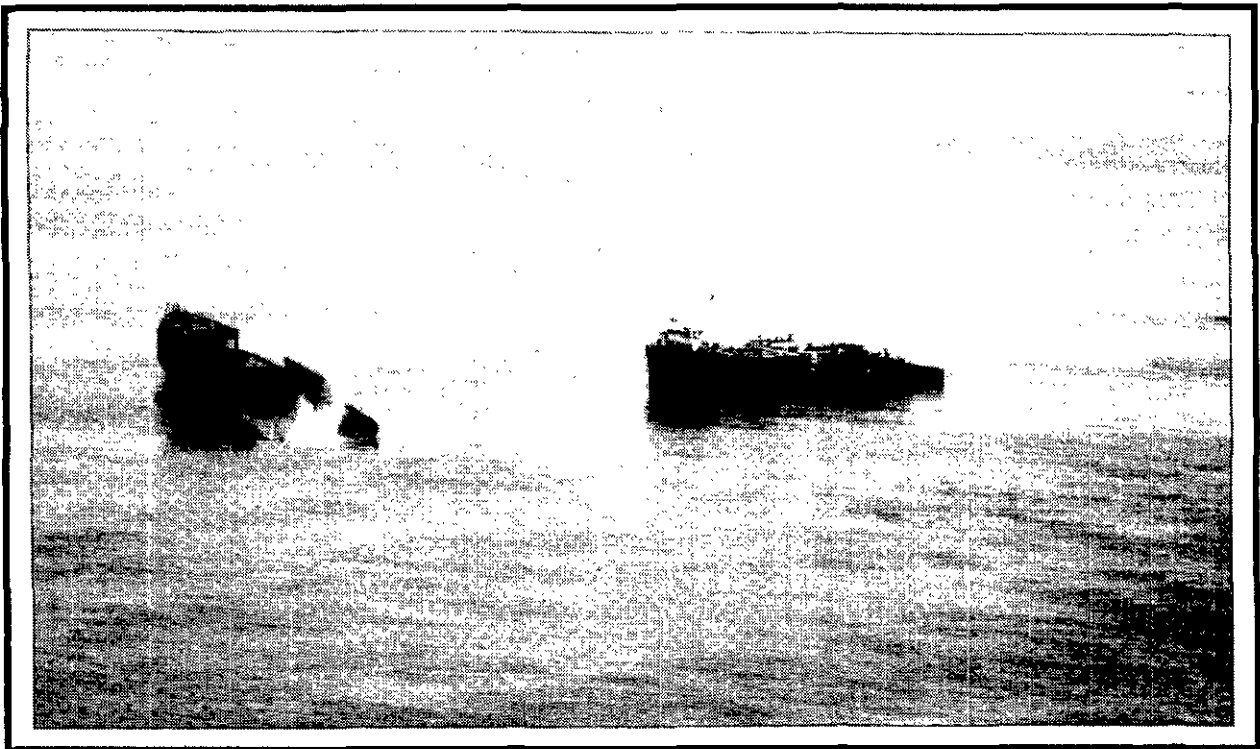
**FIGURE 5-28. TORTUGA Just Prior to Sinking. Note That Compressors and Manifold Have Been Removed.**
