Description of document:	US Navy Salvage Report: Suez Canal Salvage Operations in 1974
Requested date:	20-December-2007
Released date:	17-December-2008
Posted date:	05-May-2009
Title of document	Suez Canal Salvage Operations in 1974
Source of document:	Department of the Navy Naval Sea Systems Command NAVSEAFOIA@navy.mil

SUEZ CANAL SALVAGE OPERATIONS IN 1974

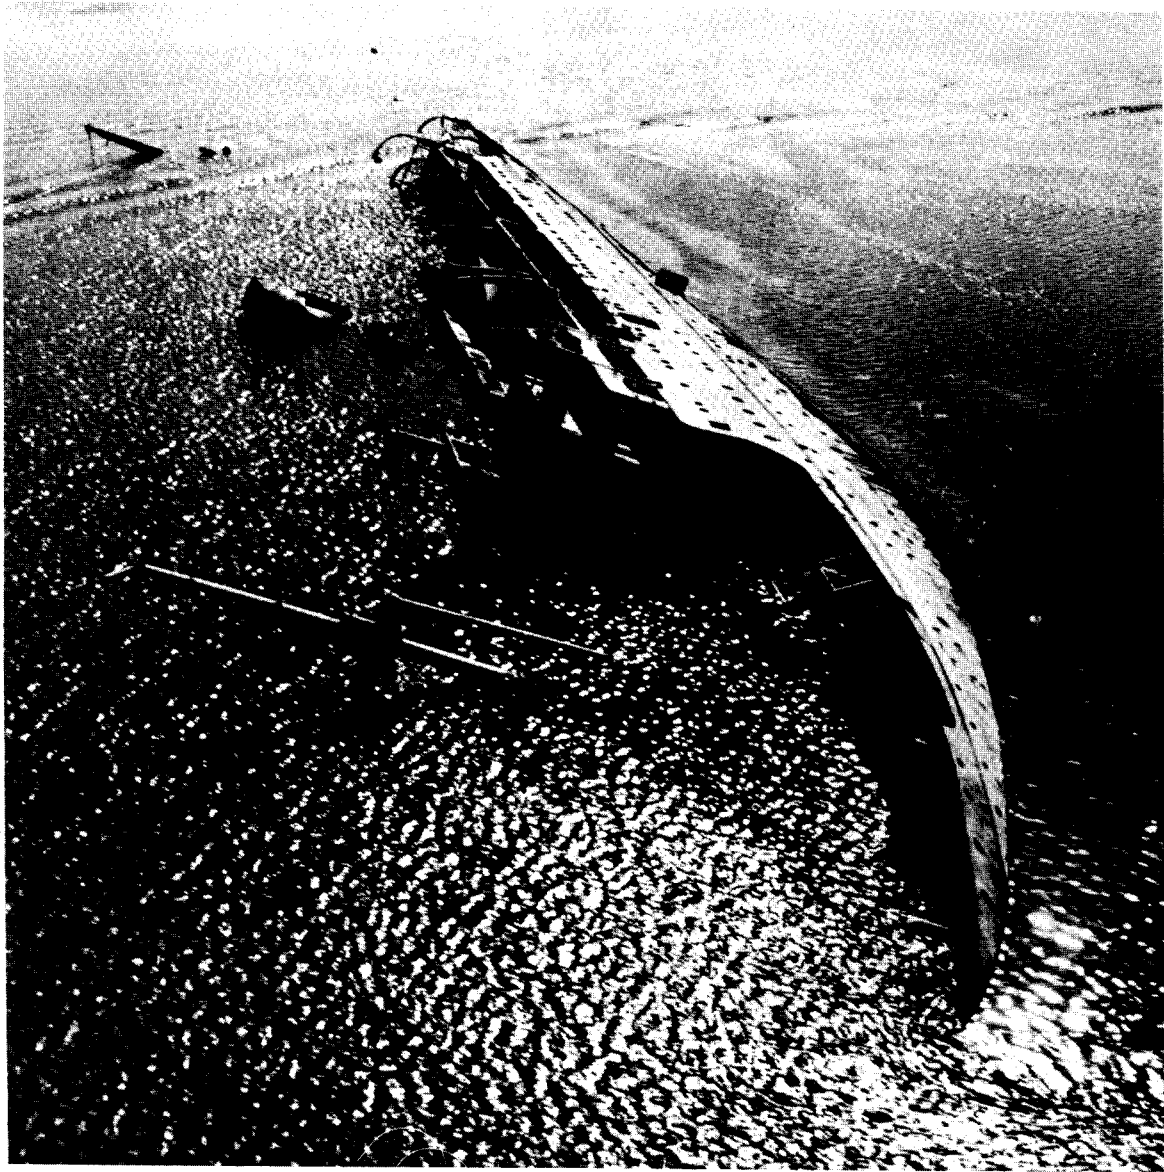
FIGURE II-3
MECCA Shortly After Sinking in 1967

MECCA, a 438-foot long, 7300-ton steam-powered passenger cargo ship, was built in England during 1929-34. MECCA was owned by the United Arab Maritime Company and had been converted from a passenger ship to a passenger cargo ship especially designed to carry pilgrims to Mecca. At the outbreak of the 1967 war, MECCA had been involved in a collision and was undergoing repair in the SCA shipyard at Port Fuad. From there, it was towed to a point in the Canal about 7 kilometers south and positioned across the Canal, bow to the west bank. Explosive charges were detonated. MECCA rolled over to starboard and sank, blocking the Canal to all but small ships and craft. Figure II-3 is a photograph of MECCA shortly after sinking.

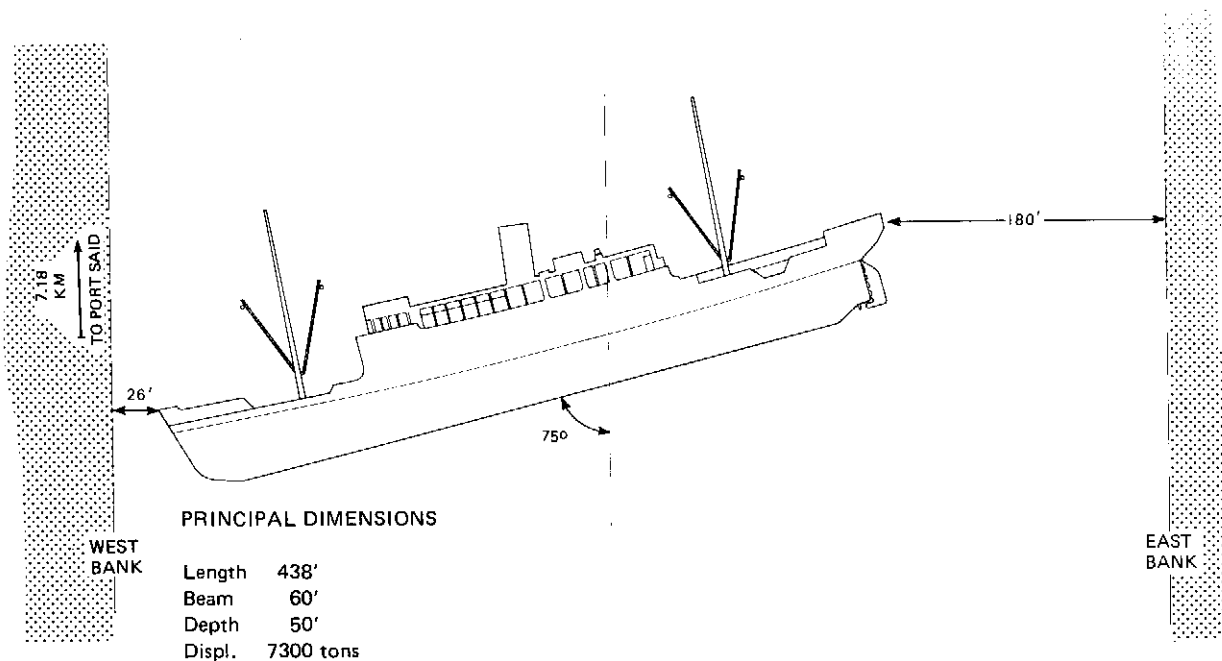
FIGURE IV-3
Location of MECCA in Canal

MECCA, the other wreck in the Northern Zone, was a passenger/cargo ship reportedly displacing about 4,600 tons. This estimate was raised to 6,500 to 7,300 tons after inspection. MECCA was resting on its starboard side with a 75-degree list at an angle of 75 degrees on the Canal centerline, as shown in Figure IV-3. The bow of the wreck was only 26 feet from the west bank in 13 feet of water, with a significant portion of the bow and superstructure out of the water. The stern rested in 65 feet of water about 180 feet from the east bank.

Currents, often exceeding 2 knots, hindered diving operations around the ends of the ship. The hull of MECCA was found to be essentially intact and supported by mud over more than 80 percent of its length. Since the starboard side was buried in the mud, there was no evidence of the collision damage under repair at the time of sinking or of the damage which caused the sinking. The ship had been outfitted to carry pilgrims to Mecca; thus, living accommodations were cramped, which resulted in the interior being cluttered with debris.

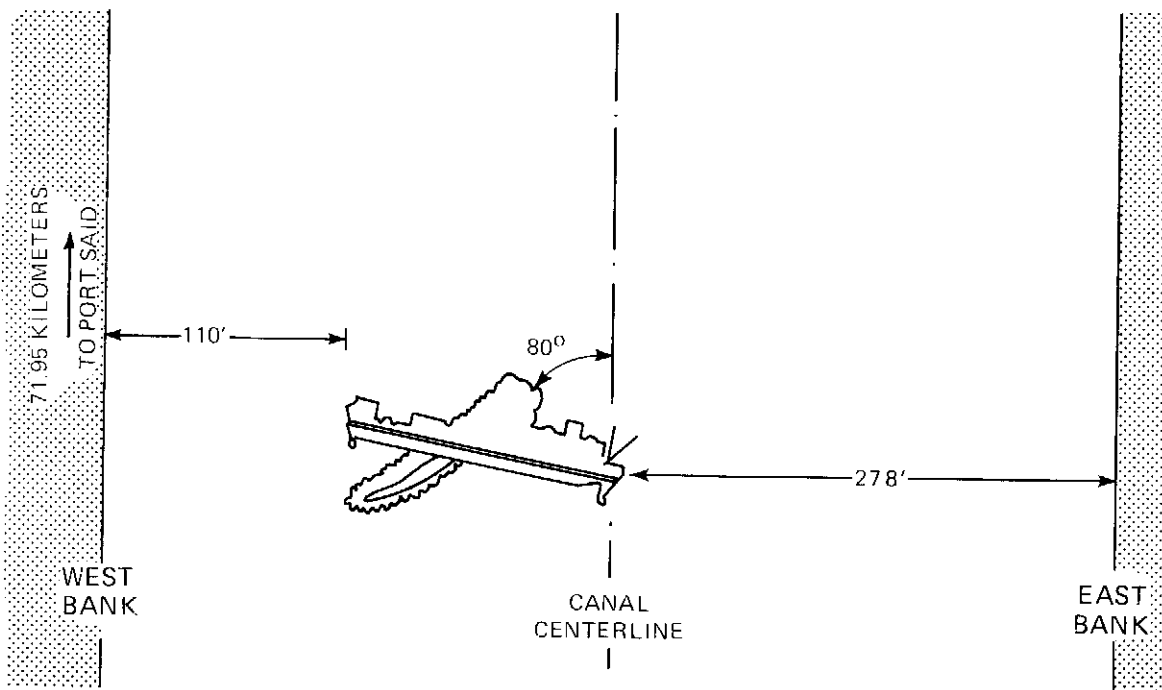
FIGURE IV-4
Location of DREDGE 23 in Canal

starboard side at 80 degrees to the Canal centerline with a 130-degree list. It was supported by the starboard deck edge and the dredging gantry, with 1 foot of water over the stern and 17 feet over the bow. Figure IV-4 illustrates the location of DREDGE 23 in the Canal.

The hull of the dredge had deteriorated. The wooden shelter deck above the main deck had been carried away, leaving only a few pipe stanchions for roof support. The dredge buckets were still attached to the ladder but had slipped off their tracks. The boom protruded about 15 feet beyond the bow, hanging 8 feet below the hull but clear of the bottom. The hull was supported at the ends and the Canal bottom had scoured to a maximum depth of about 9 feet in the center one-third. The dredge was silted in the machinery spaces to a maximum depth of approximately 2 feet. Figures IV-5 and IV-6 illustrate the condition of DREDGE 23 at survey.

There were two holes in the engine room apparently created by scuttling charges. These holes were approximately 2 feet wide and were located port and starboard about 20 feet forward of the stern at the turn of the bilge. A third hole, 1-1/2 by 2 feet, was located on the port side 40 feet forward of the stern.

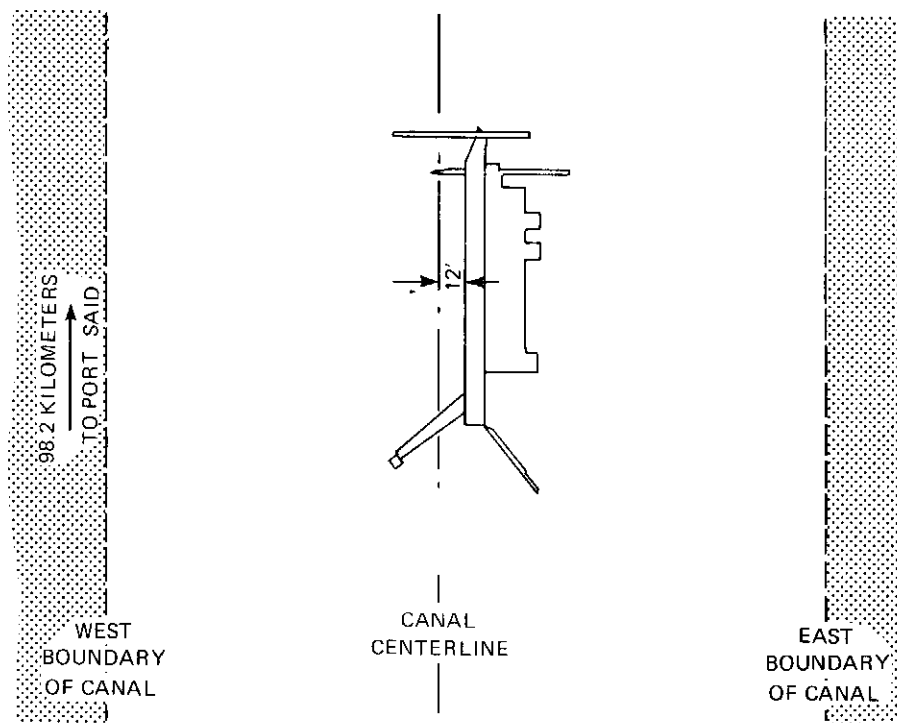
FIGURE IV-14
Location of Dredge 15 SEPTEMBER in Canal

and 12 feet east of the Canal axis in an average water depth of 52 feet as shown in Figure IV-14. The hull was supported by the Canal bottom along its entire length.

The centerline spud (a walking spud) and the starboard quarter spud each 90 feet long and the spud supports appeared undamaged. The centerline spud extended 6 feet below the bottom gate and lay horizontal 34 feet below the surface. The starboard spud extended 70 feet below the bottom gate and lay horizontal 22 feet below the surface. The dredge ladder was secure in its trunnions, and the ladder topping lift was still reeved with the hauling part still on the winch. The gantry was in place with four backstays intact. Both ladder and gantry were clear of the bottom. The sea chest on the starboard side appeared intact, and the main sea suction valves appeared to be open. Starboard storage and ballast tanks contained air pockets varying from 3 to 5 feet deep. Residual oil was found in seven of the nine wing tanks.

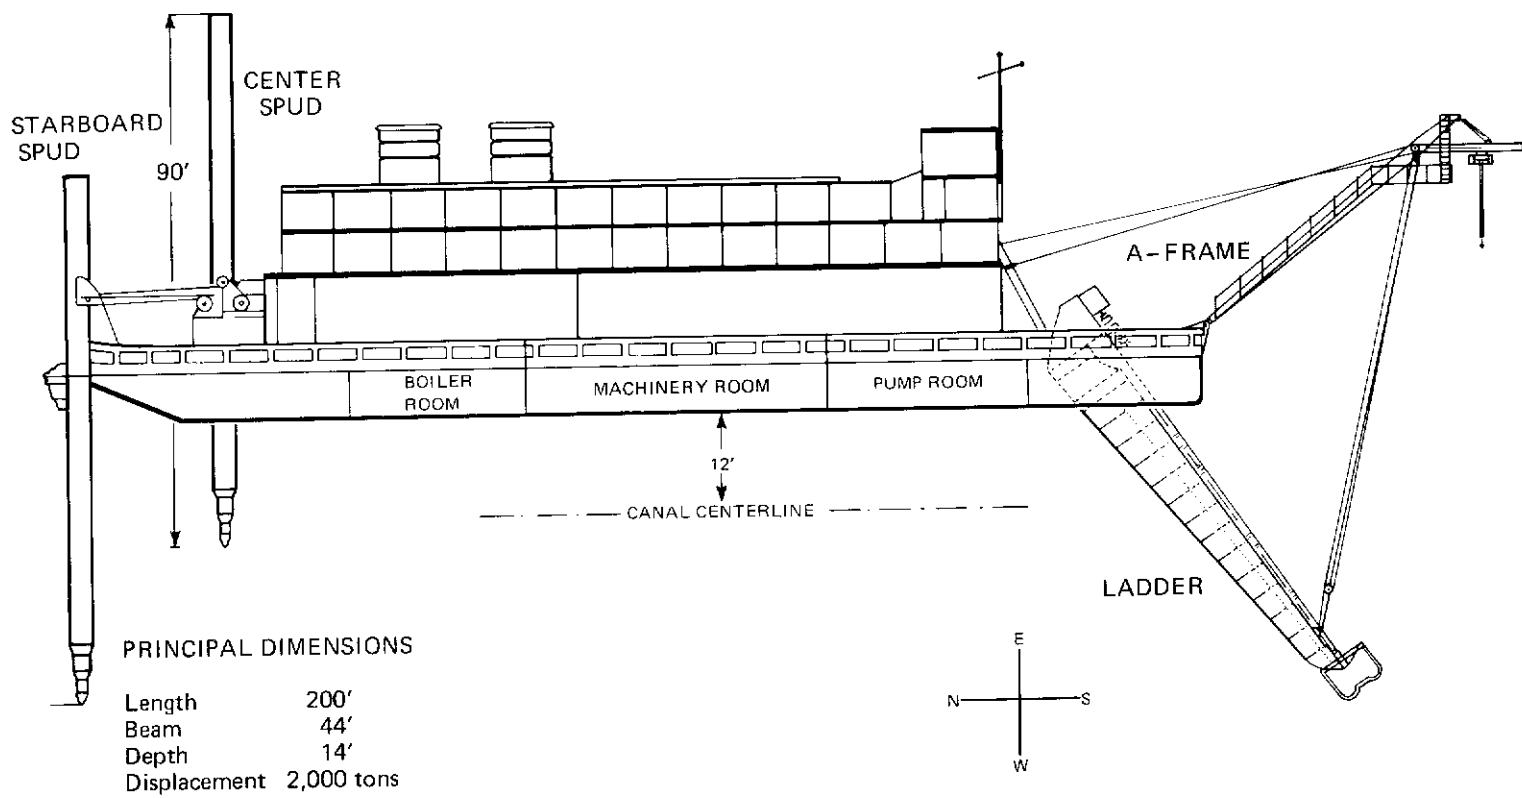
FIGURE IV-15
Condition of Dredge 15 SEPTEMBER at Survey

The hull plating appeared to be in sound condition and the hull suitable for further use. Some of the wooden superstructure had carried away, leaving only the steel framing. The hull was dished on the starboard side 60 feet aft of the bow and 3 feet from the turn of the bilge to a depth of 8 inches over an area of 2 square feet. Plating in the way of the dishing had been split along a riveted seam. There was no damage to the bottom of the dredge. That reported sinking was caused by removal of an inspection plate on the main dredge suction line could not be verified. Soft mud varying between 1 and 2 feet in depth covered the main deck edge on the port side. There was silting 2- to 4-foot deep in the pump room and machinery spaces and 6 inches deep in the port bow storage space. The sketch of the dredge 15 SEPTEMBER in Figure IV-15 shows an inboard profile and its location in the Canal.

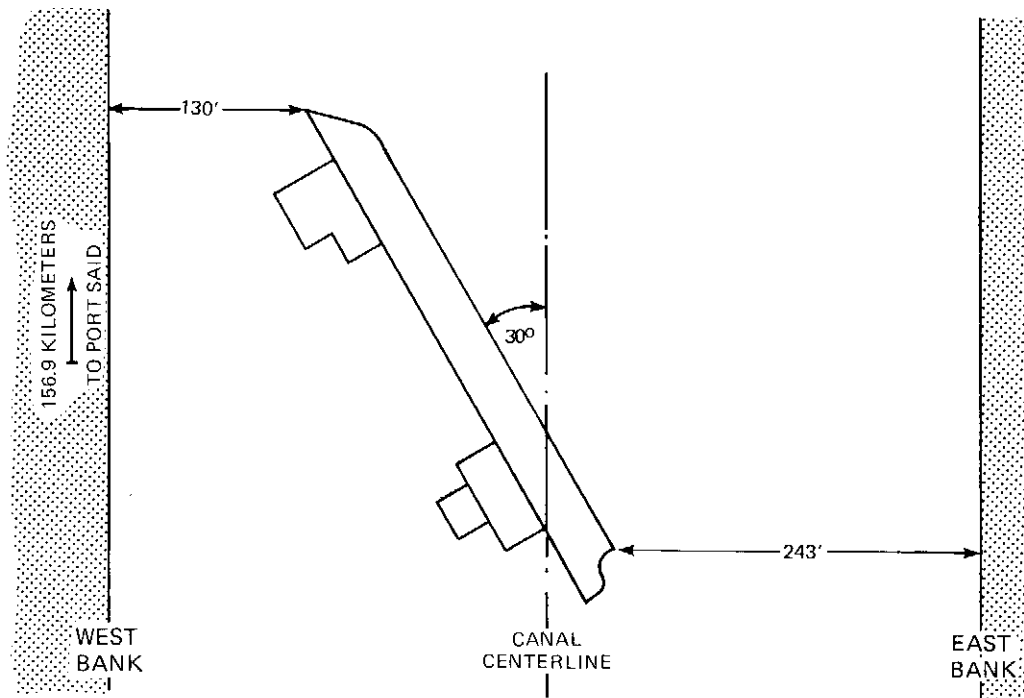
FIGURE IV-16
Location of Tanker MAGD in Canal

The hull was in generally poor condition; cargo tank tops were buckled, and plating and rivets were missing. Some plating appeared to have been scarfed out. The superstructure was intact, but damage in the tankage, summarized in Table IV-4, was widespread. The wreck was silted to a depth of 2 to 4 feet

in the starboard and center tanks and 4 to 6 feet in the port tanks. Mud was pocketed throughout the entire room with depths varying between 3 to 10 feet. The sketch of MAGD in Figure IV-17 indicates the plating removed and the damage found during the survey.

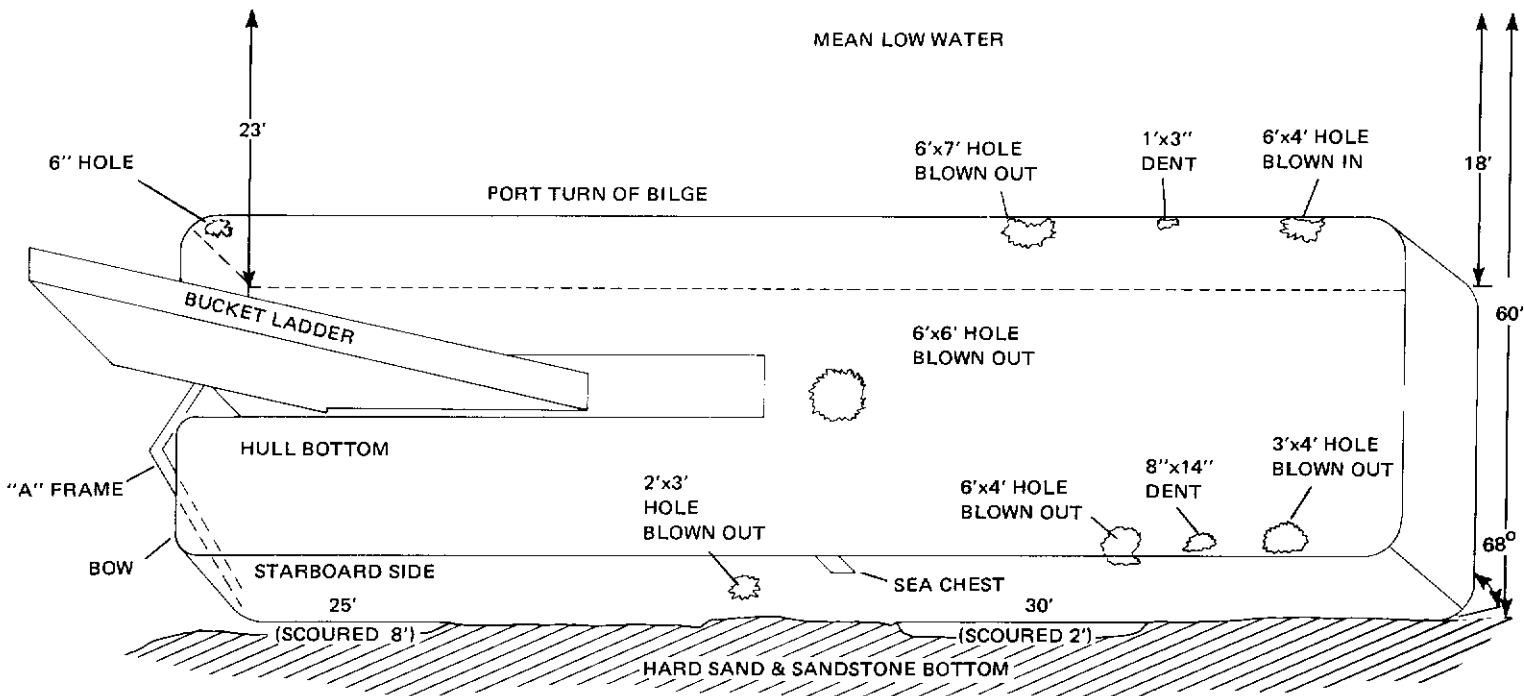
FIGURE IV-19
Condition of DREDGE 22 at Survey

The hull was in a generally deteriorated condition as a result of damage from scuttling charges and rusting. The bucket conveyor system had dropped below the hull at an angle of about 40 degrees with the ladder 24 feet below the surface and clear of the Canal bottom. Two holes, approximately 6 by 7 feet, were located in the port turn of the bilge. Three holes, 4 by 6 feet, 2 by 3 feet, and 3 by 4 feet, were located in the port turn of the bilge. One hole, 6 by 6 feet, was blown through the bottom amidships. There were three other minor dents or holes. All damage was apparently caused by scuttling action. The shelter deck of the dredge had carried away, leaving only steel framing. Sections of the main deck had been blown open and rusted through. Mud was found 3 to 6 feet deep in pockets between the main deck and longitudinal bulkheads. The sketch of the DREDGE 22 in Figure IV-19 indicates the support of the hull and the damage found in the wreck.

CONDITION OF DREDGE 22 AT SURVEY

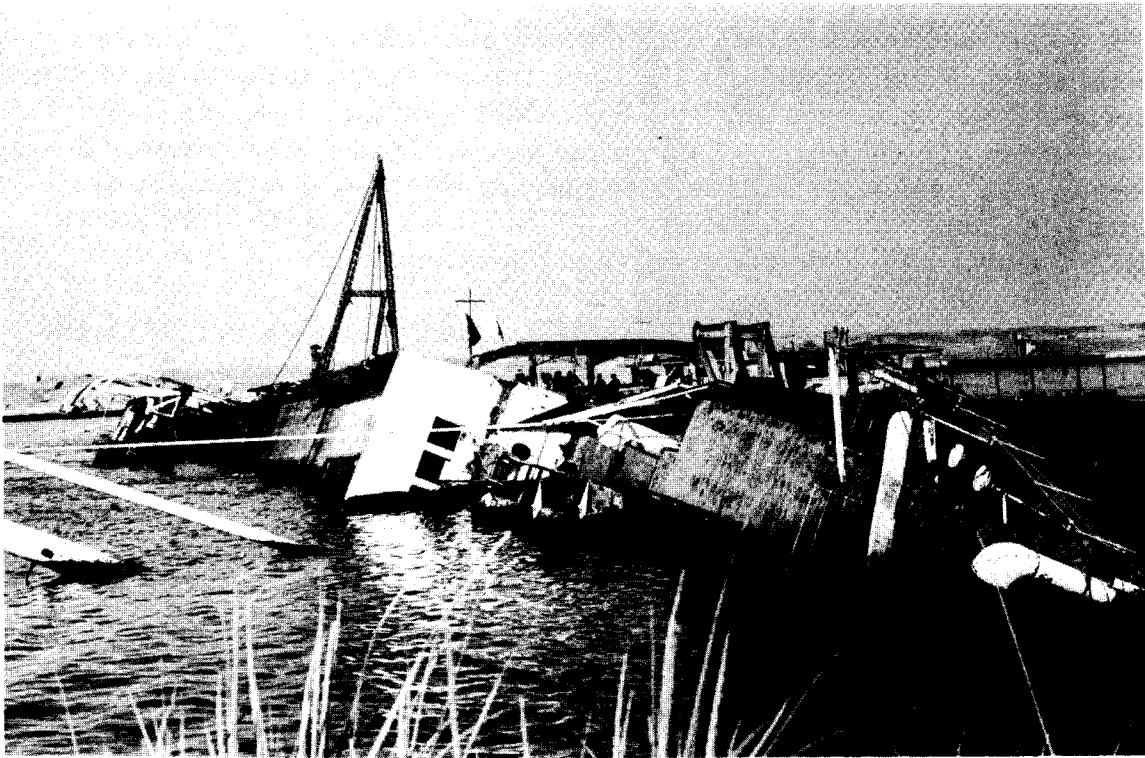
FIGURE V-12
MECCA at Commencement
of Salvage Operations

Salvage operations on MECCA commenced on 29 May 1974 as soon as practicable after the first contingent of salvage personnel had arrived in the area and outfitted Suez Canal Authority barges as work platforms. To improve access to the wreck, the SCA had installed a foot bridge from the Canal bank to the bow of MECCA and walkways with lifelines around the waterline of the wreck. Figure V-12 shows MECCA at commencement of salvage operations.

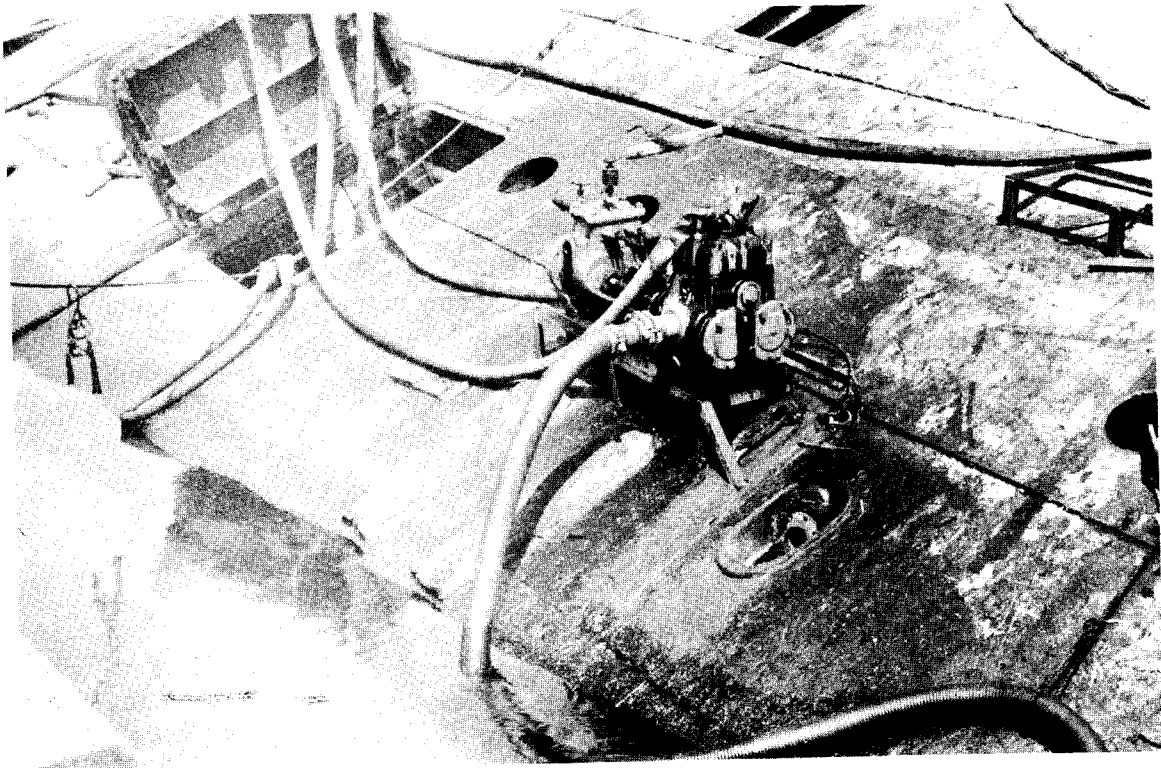
FIGURE V-13
Oil Removal Pumping
Amidships in MECCA

outside for removal of the oil without spillage. Accordingly, the first two hot-tap flanges were put in place in the midship tanks during the first week of salvage operations. Pumps and fittings arrived from the United States a week later, and pumping operations commenced shortly thereafter. Figures V-13 and V-14 show a hot-tap flange in place and an oil removal pump in operation.

Less than 50,000 gallons of oil were found and removed from the midship tanks. A negligible quantity was found in the after group of tanks. During removal operations the SCA installed a boom around MECCA to protect against accidental spills.

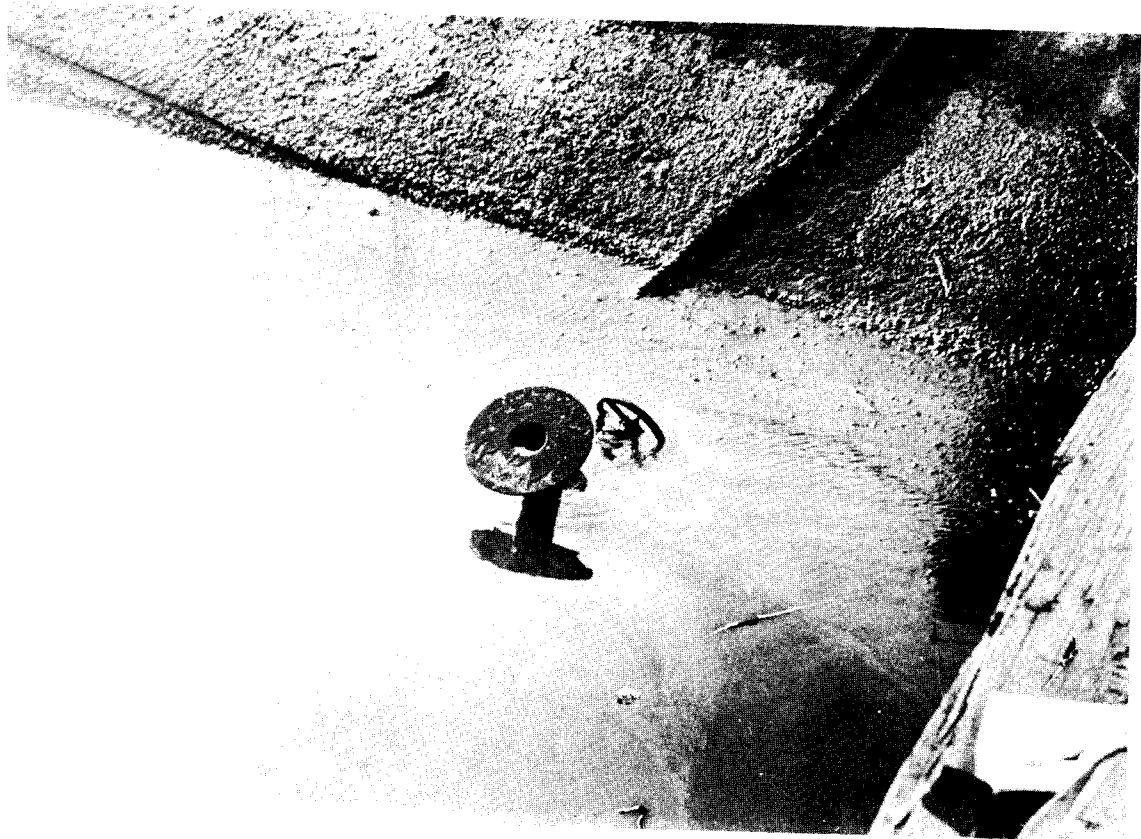
FIGURE V-14
Hot-Tap Spool in Way
of Midship Tanks on MEC. A

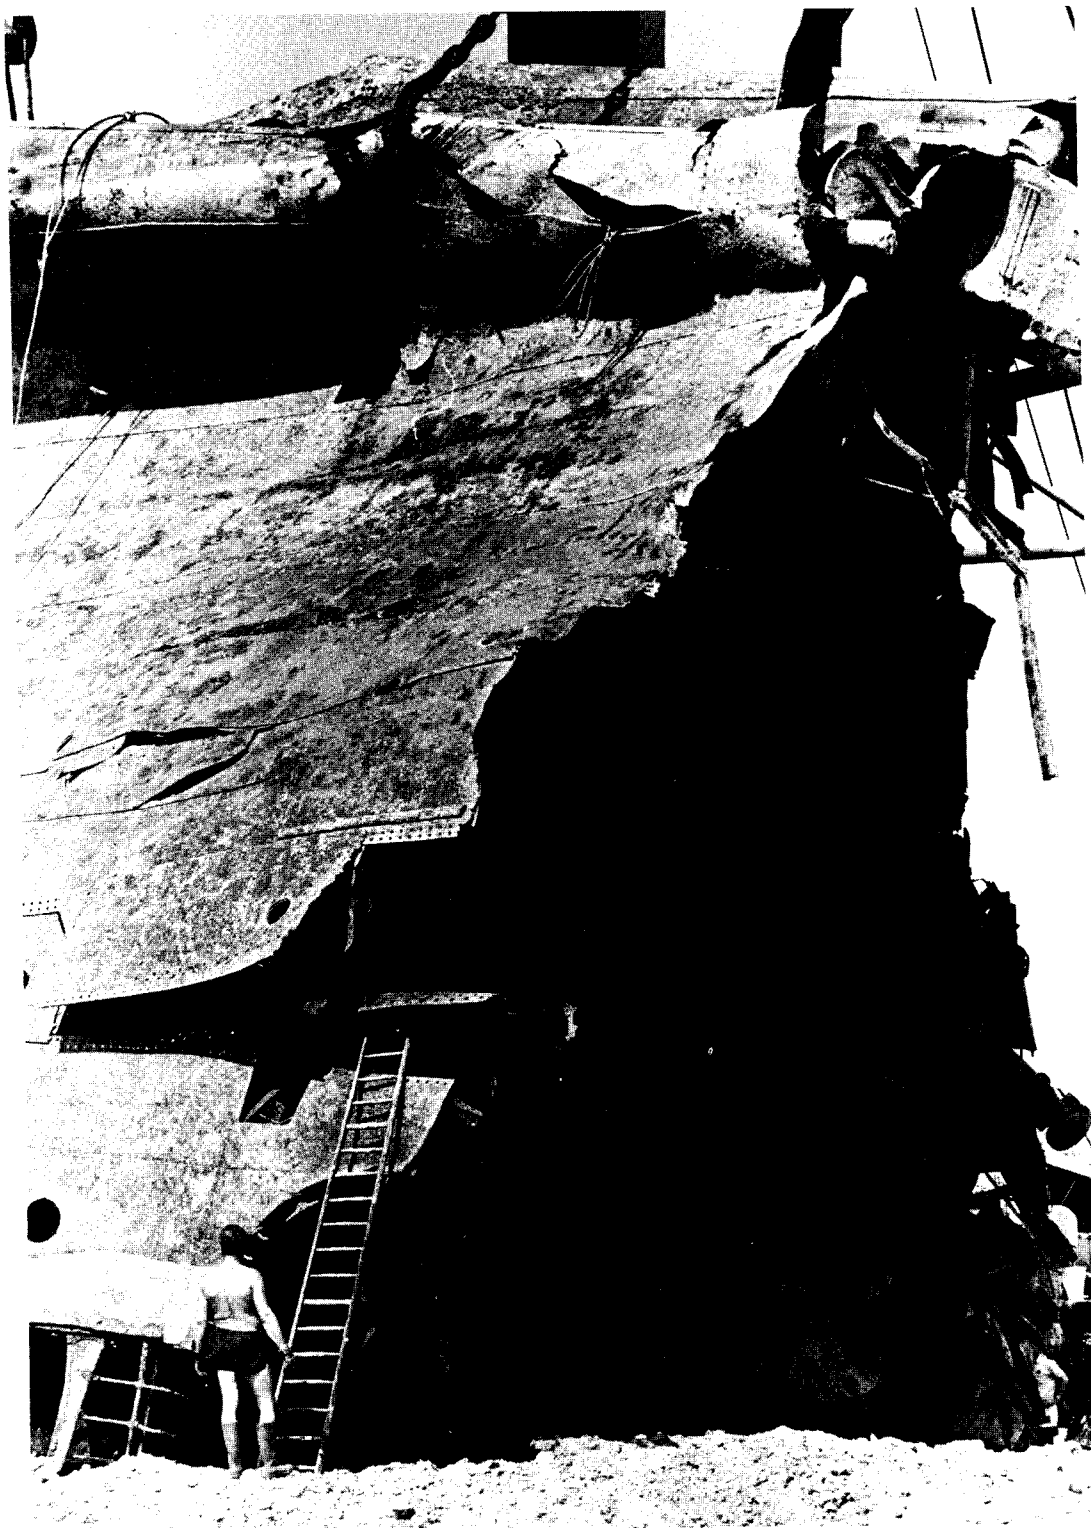
FIGURE V-17
Typical Cut Made Early
in MECCA Operation

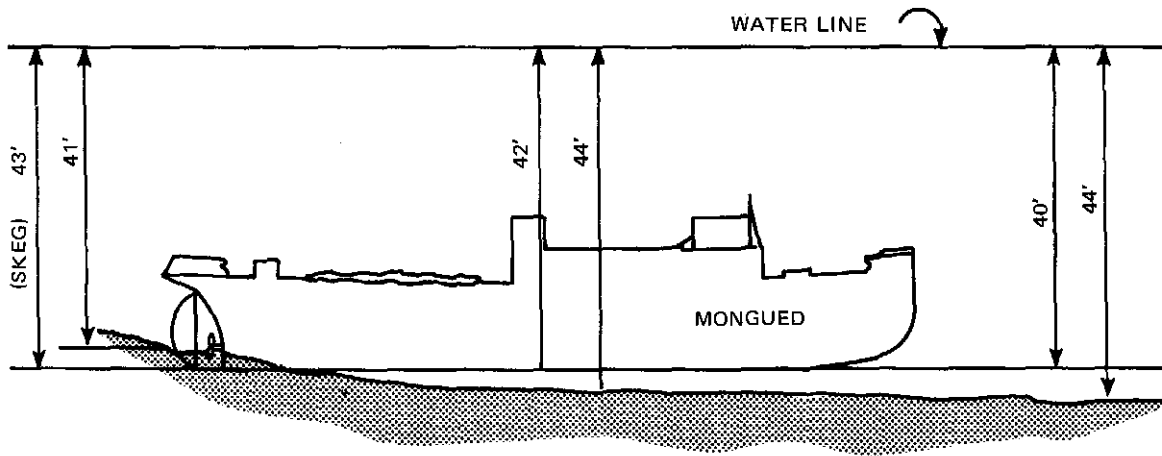
FIGURE VI-8
 MONGUED Grounded in Great Bitter Lake
 Prior to Last Lift

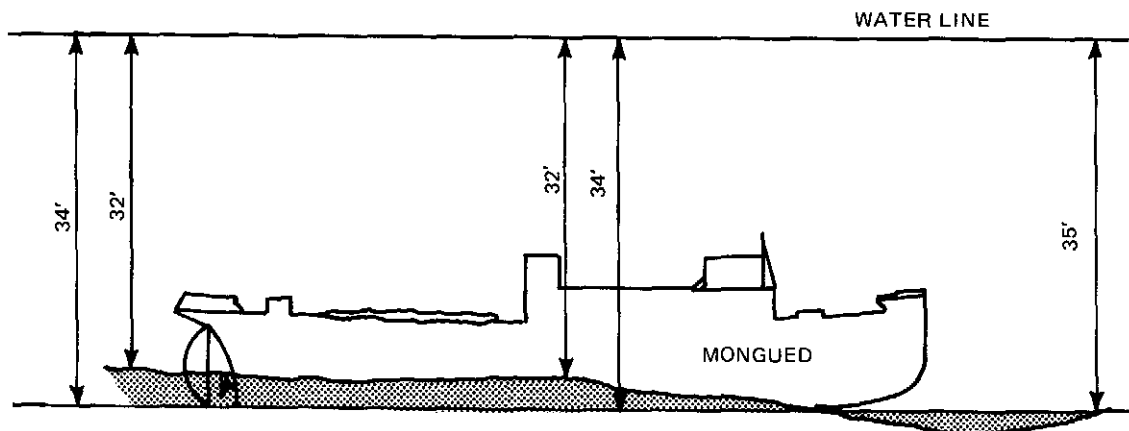
FIGURE VI-9
 MONGUED at Dumping Ground
 in Great Bitter Lake

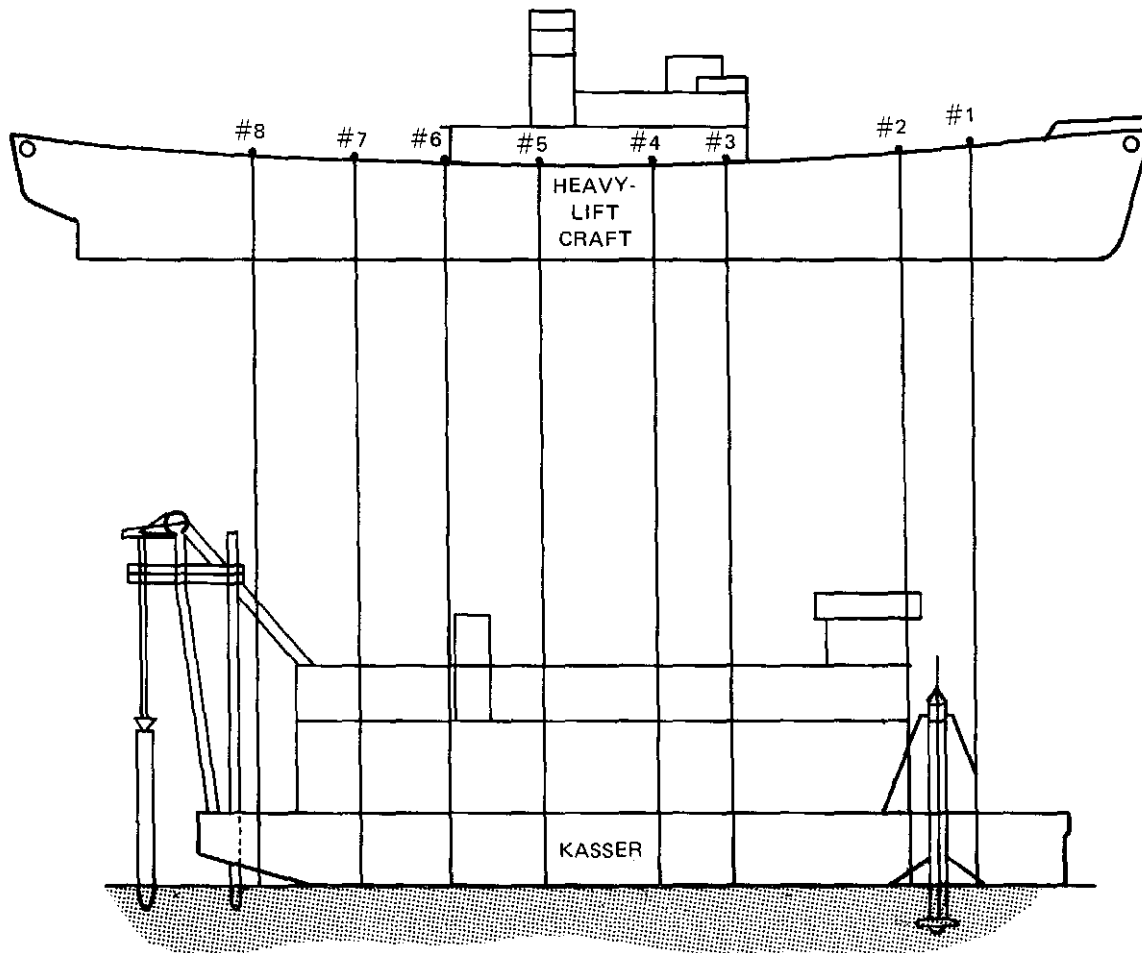
in the spud well; they were cleared by relocating them to lift position 13. An additional wire was passed at lift position 4 after being fairlead to lift position 5. Figure VI-11 illustrates the lift wire placement.

FIGURE VI-11
Arrangement of Lift Wires on KASSER

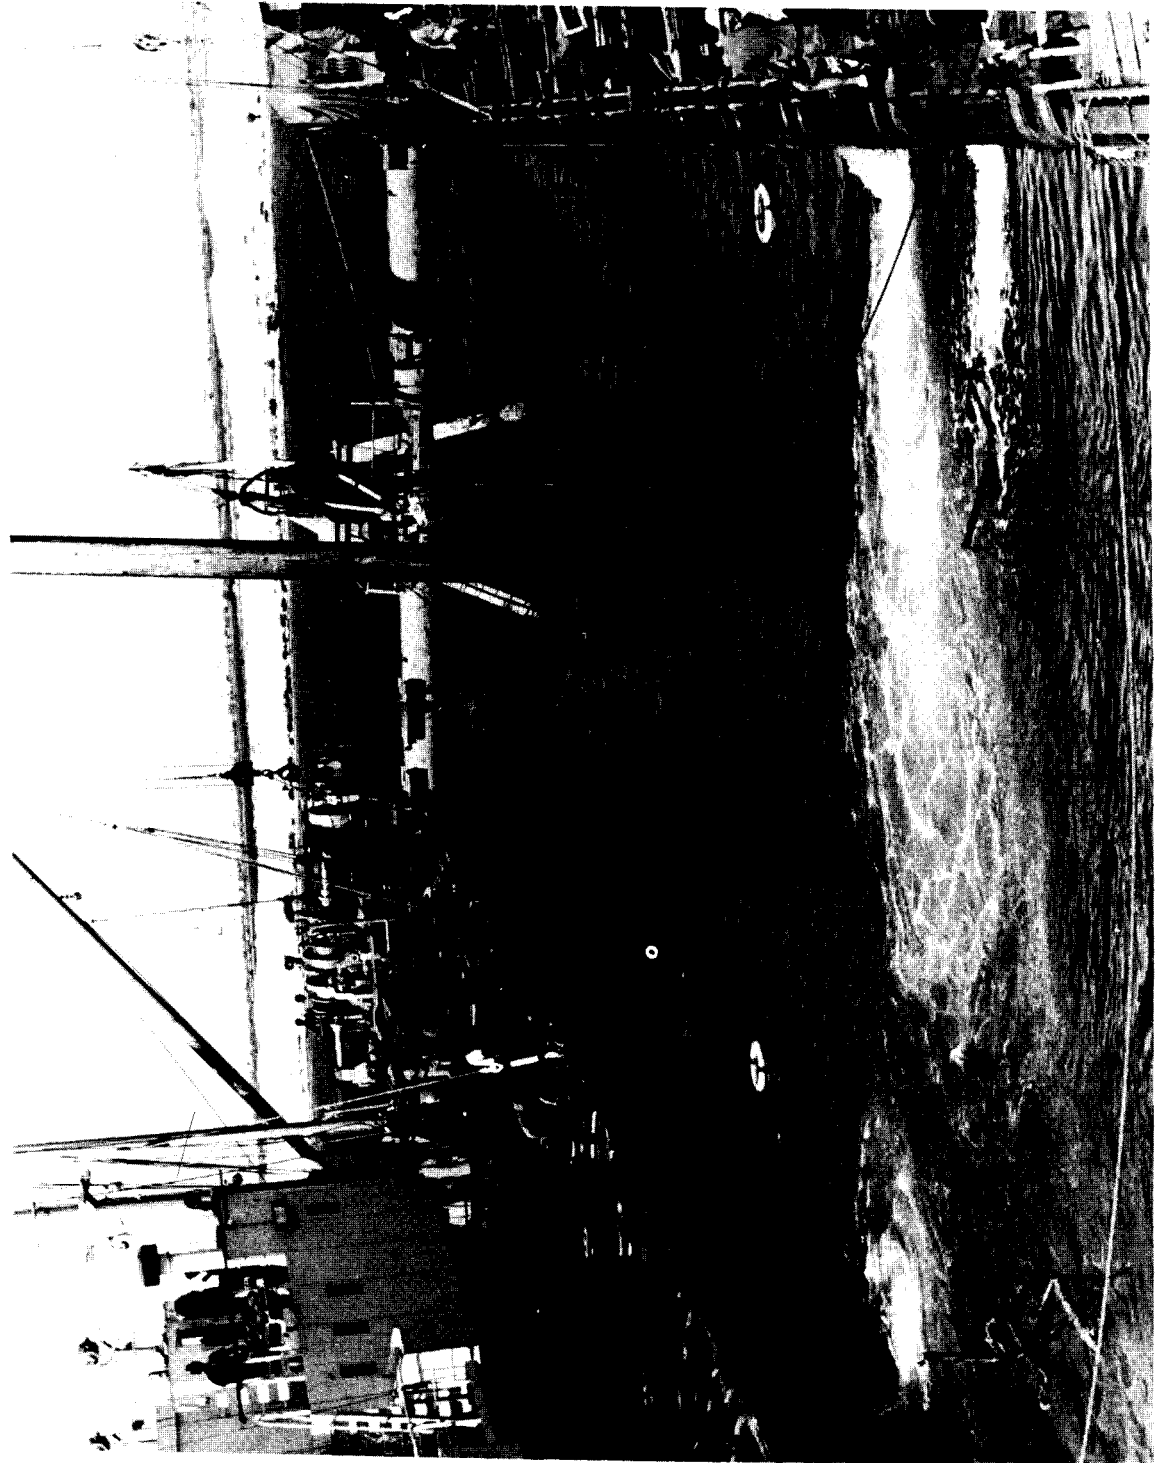
By 22 September, all 17 lift wires were in place. The lift craft was ballasted down, the wires were pinned, and the craft were deballasted to obtain a lift of 7 feet, as shown in Figure VI-12. With an 8-inch line to CRILLEY and CRANDALL, the tug SHAHM managed to pull the nest approximately 50 yards northward to Lake Timsah before grounding.

FIGURE VI-12
CRILLEY and CRANDALL
Deballasting to Lift KASSER

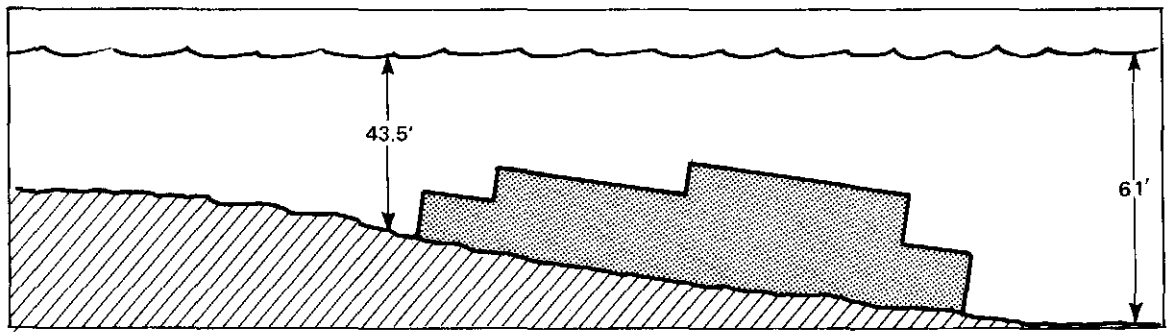
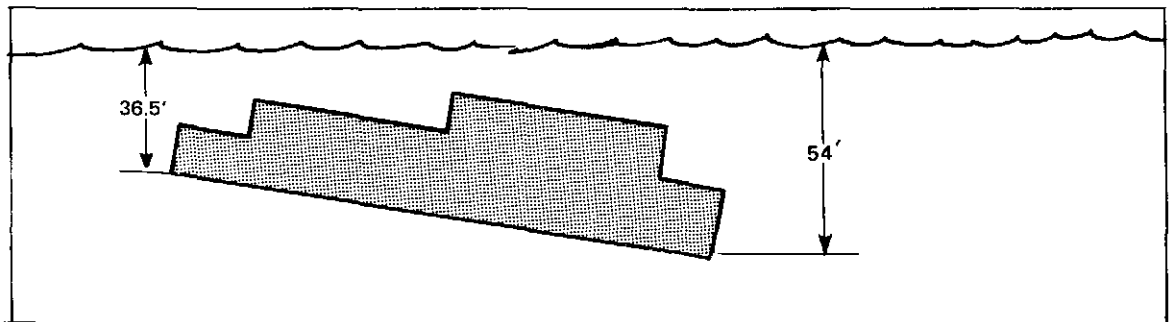
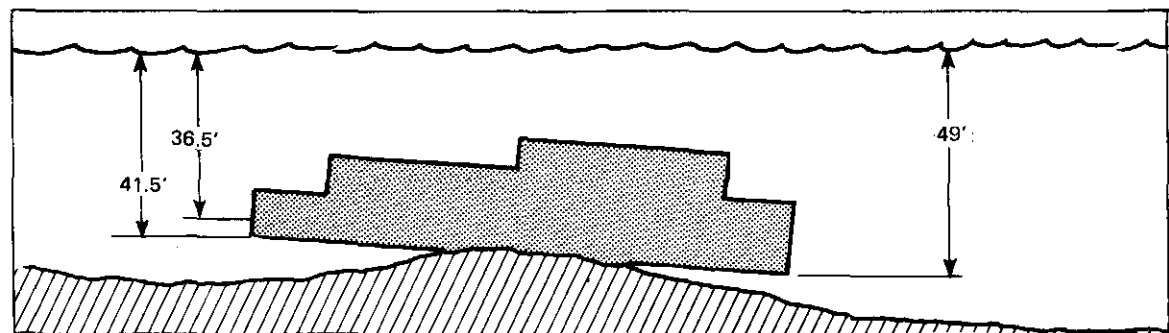
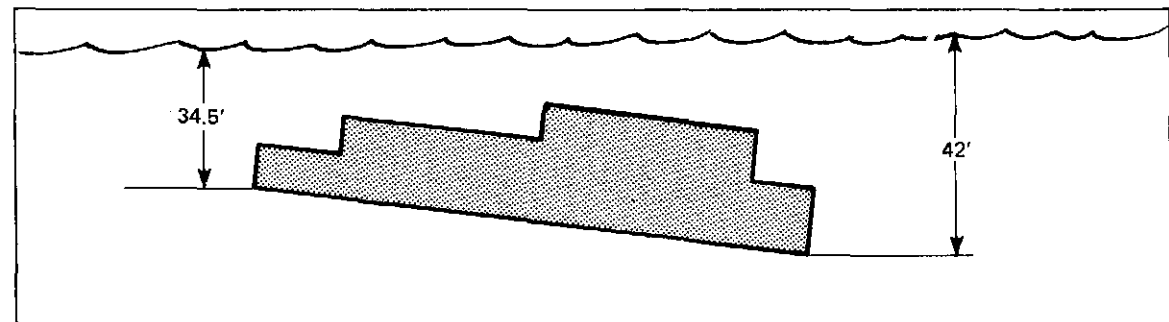
FIGURE VI-13
Lifting Sequence of KASSER

than the capability of the lift craft. Originally, the drafts of KASSER were 61 feet forward and 43.5 feet aft, as shown in Figure VI-13(a). The first lift of 7 feet, shown in Figure VI-13(b), was made on 22 September and the whole nest moved about 50 yards northward before grounding. As it turned out, the small grounded area caused the wreck to trim by the stern for a total change of 10 feet in trim. As shown in Figure VI-13(c), the net rise was 7 feet but the maximum and therefore controlling draft was reduced by 12 feet. The second lift raised KASSER another 7 feet to a maximum draft of 42 feet, sufficient to permit passage over the Deversoir Causeway, as illustrated in Figure VI-13(d). Thus, a planned third lift in Lake Timsah was eliminated. Figure VI-14 shows dredge KASSER suspended between CRANDALL and CRILLEY under tow to Great Bitter Lake.

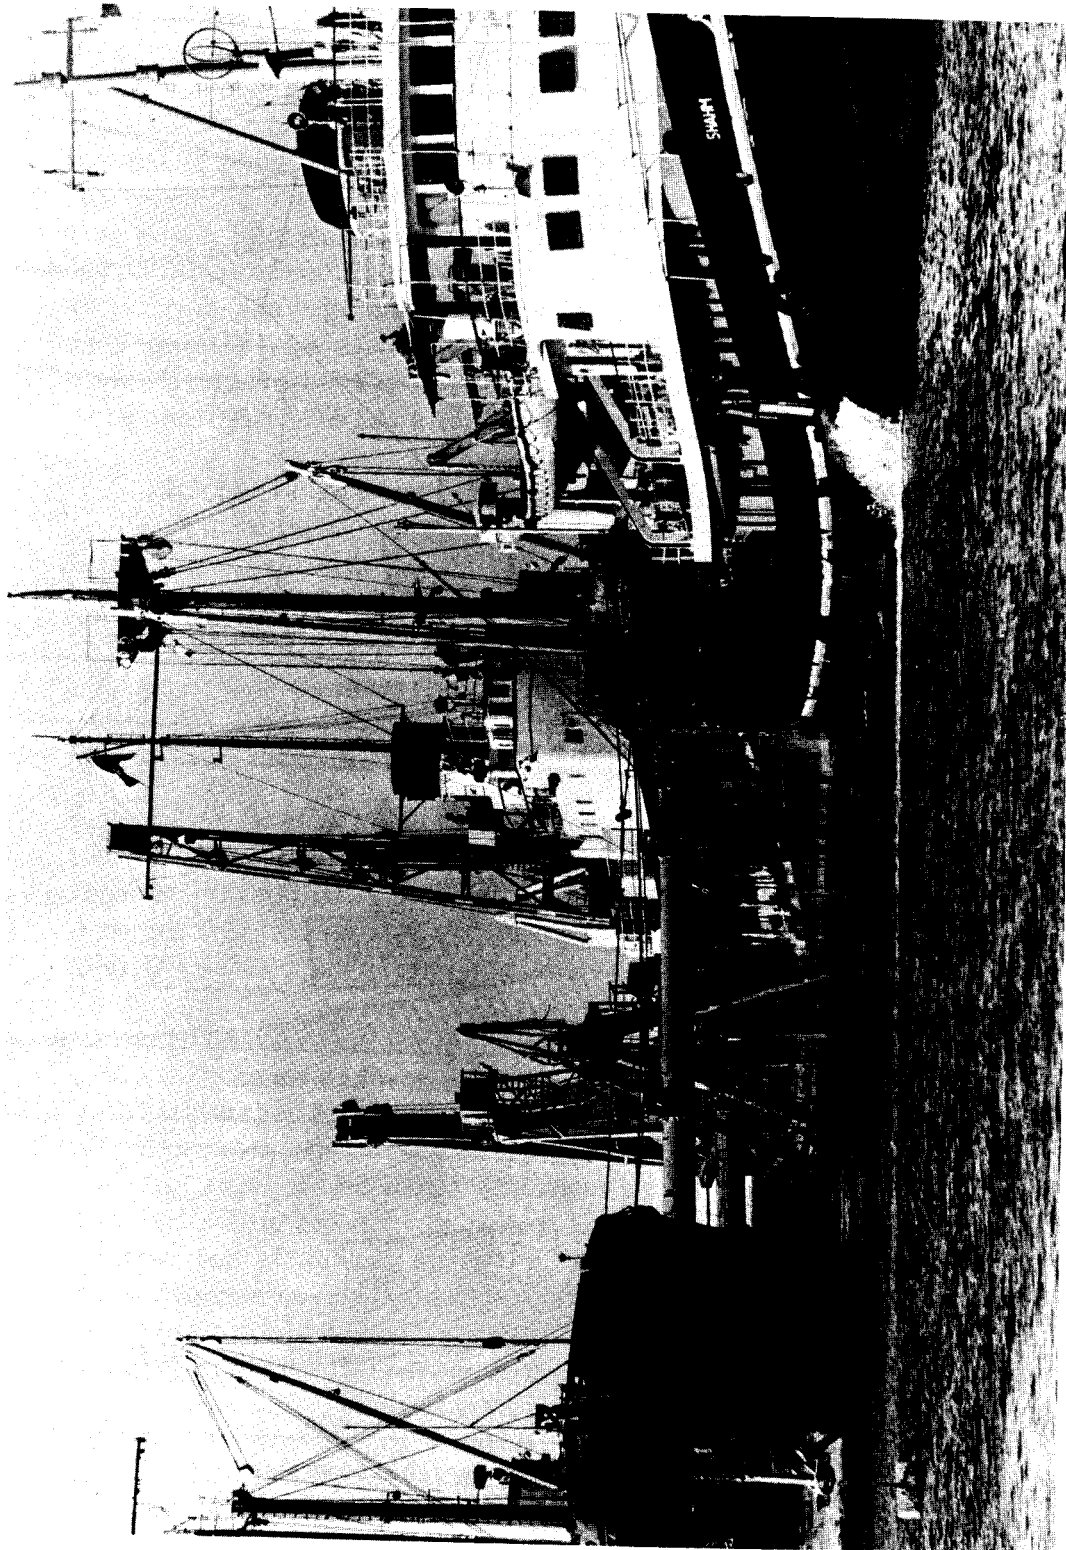
FIGURE VI-14
Dredge KASSER Suspended
Between CRANDALL and CRILLEY
Under Tow to Great Bitter Lake

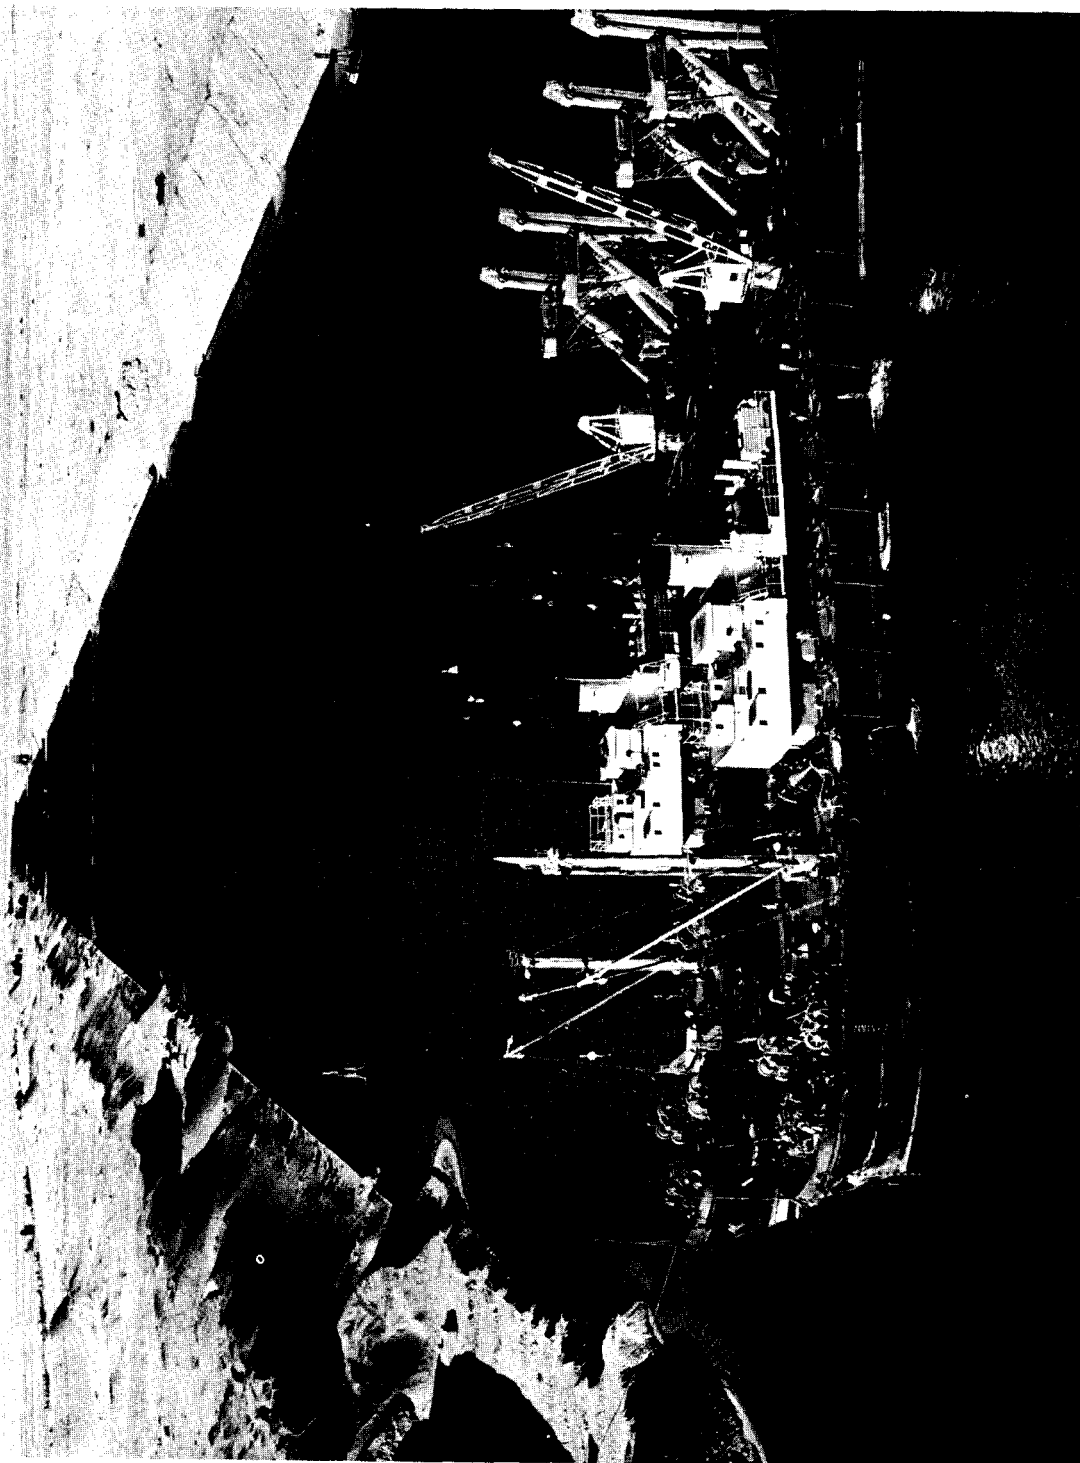
FIGURE VI-15
CRILLEY and CRANDALL Rigging
Heavy-Lift Wires Under DREDGE 23
