Description of document:	US Navy Salvage Report: Suez Canal Salvage Operations in 1974
Requested date:	20-December-2007
Released date:	17-December-2008
Posted date:	05-May-2009
Title of document	Suez Canal Salvage Operations in 1974
Source of document:	Department of the Navy Naval Sea Systems Command NAVSEAFOIA@navy.mil

SUEZ CANAL SALVAGE OPERATIONS IN 1974

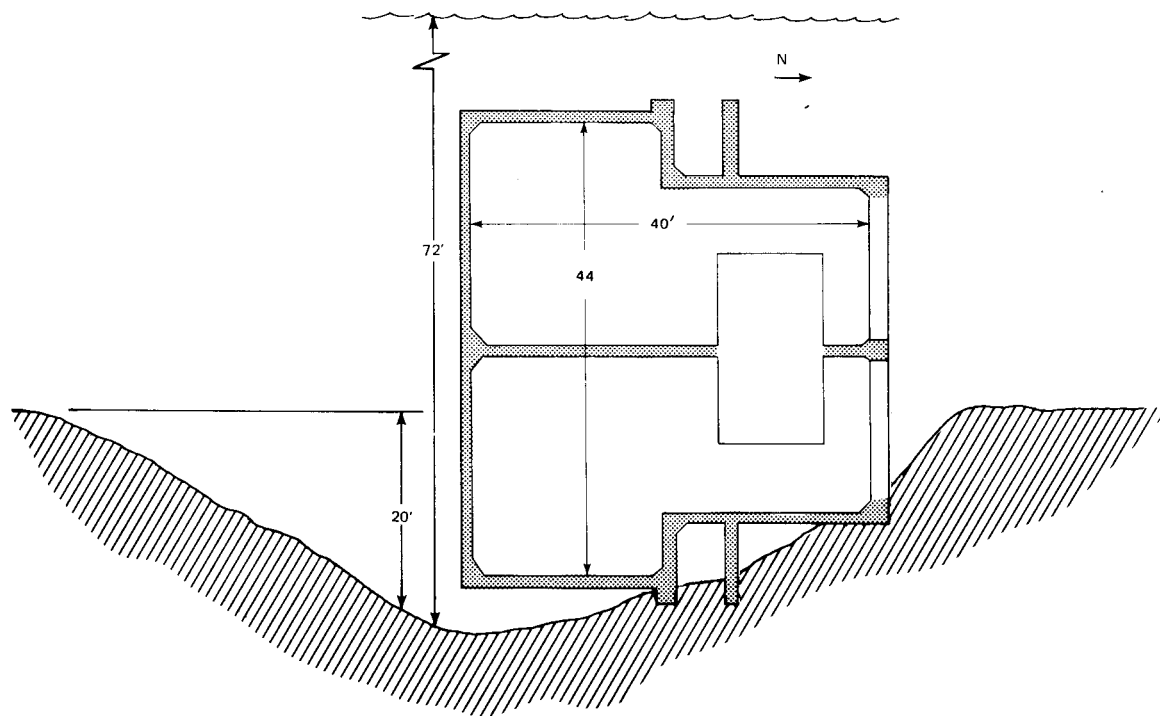
FIGURE VI-25
Western End Section of Concrete Caisson
Showing Bottom Topography

The section was estimated to weigh 1500 tons (wet) excluding any entrained silt. The goal was to lighten it enough for lift by the YHLC stern gantries (1200 tons total lift capacity).

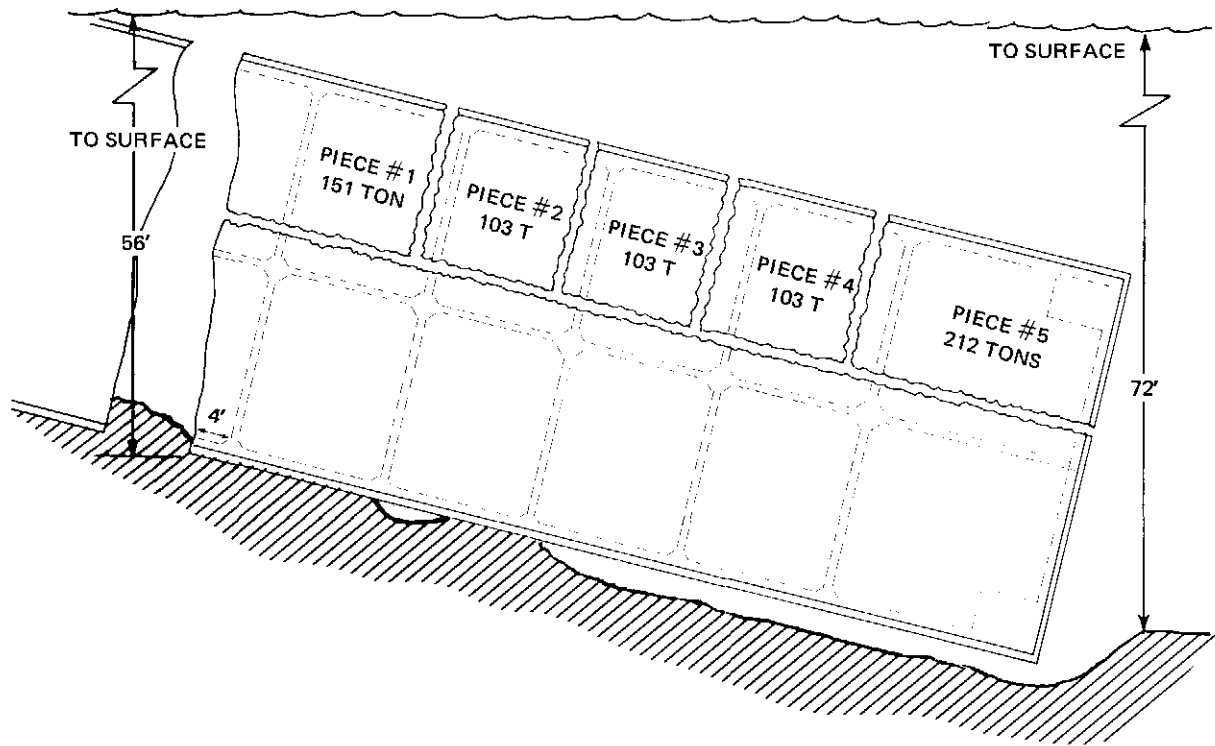
Lightening of the western end of the caisson called for removal of the upper compartments after cutting them into five sections of 100 to 200 tons each, as shown in Figure VI-26. These pieces would be within the 300-ton dynamic lift capacity of the outward gantry hooks of a single YHLC. The stern gantries of the lift craft would be used to lift the individual sections.

FIGURE VI-26
Caisson Bottom Section Showing Cuts

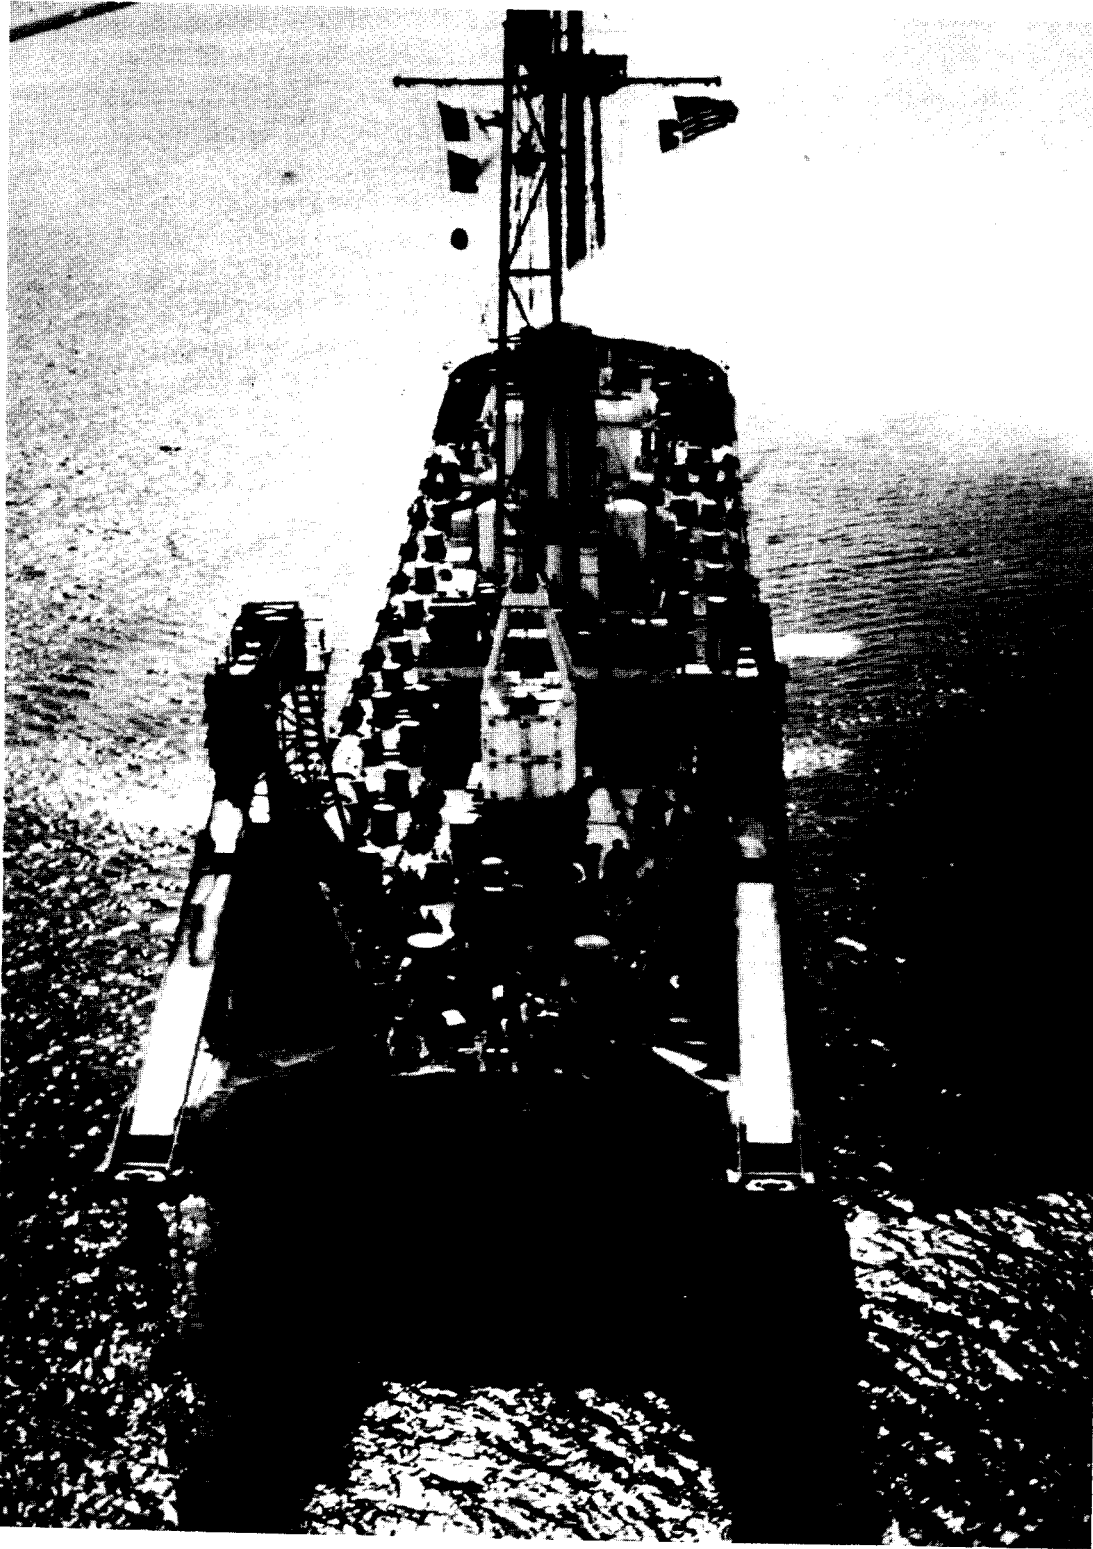
Upon lifting, the stern gantry rigging was two-blocked. The lift craft was ballasted so that it was trimmed 2 feet by the bow and towed to the dumping ground in the Great Bitter Lake, where the section was placed on the bottom and unrigged by divers. The second section was cut, lifted, and deposited in the dump area by CRILLEY on 4 November. The third and fourth sections of 100 tons each were lifted together to space the lift points further apart and thus reduce lateral loading on the stern gantry. They were removed as a single piece on 7 November by CRANDALL. The fifth section was completed by CRILLEY on 11 November. CRANDALL is shown lifting a caisson section with stern gantries in Figure VI-28.

FIGURE VI-28
CRANDALL Using Stern Lift Gantry
to Lighten Concrete Caisson

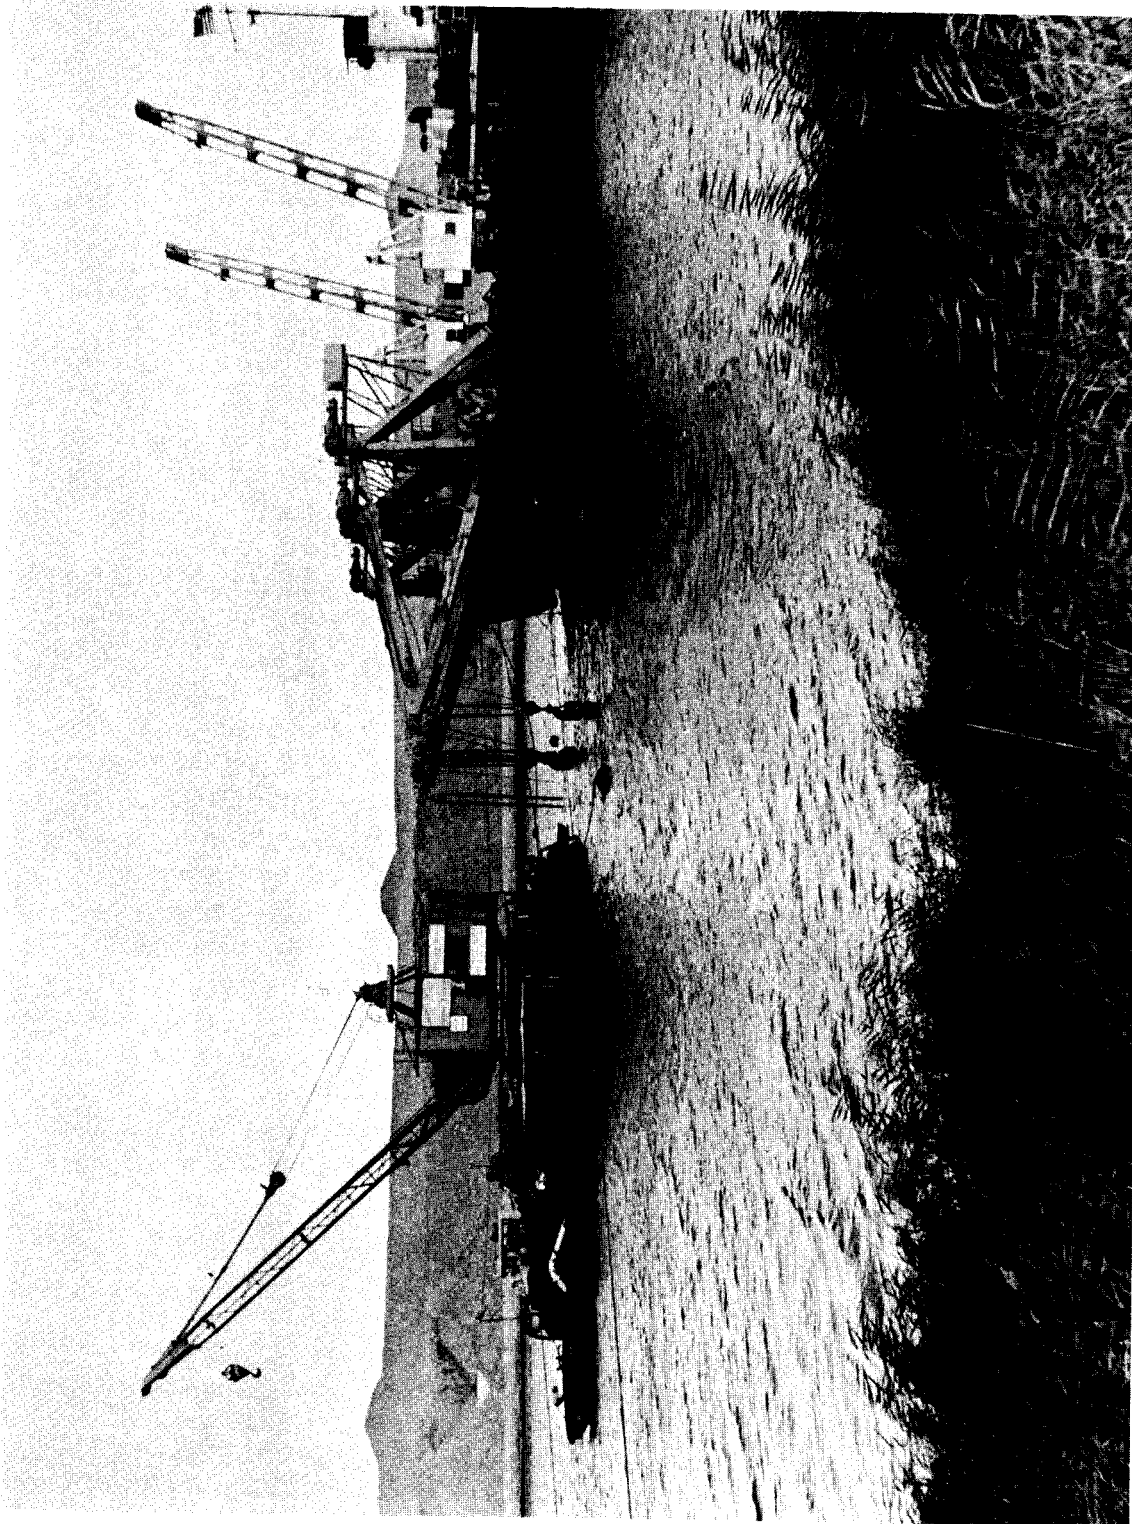
The lower portion of the western end had been lightened to an estimated 900 tons and could be stern lifted by the two lift craft, operating together. The section was in poor structural condition, but it was determined that it would be sound enough for lifting. On 12 November, CRANDALL and CRILLEY moored stern to the western section of the caisson, bows to the south. Bower anchors, quarter lines to prepositioned anchors, and lines to bollards on the Canal bank were used for the moor. A photograph of the craft positioned and being rigged for this lift is shown in Figure VI-29.

FIGURE VI-29
Rigging CRANDALL and CRILLEY
for Stern Gantry Lift of Western
End of Caisson

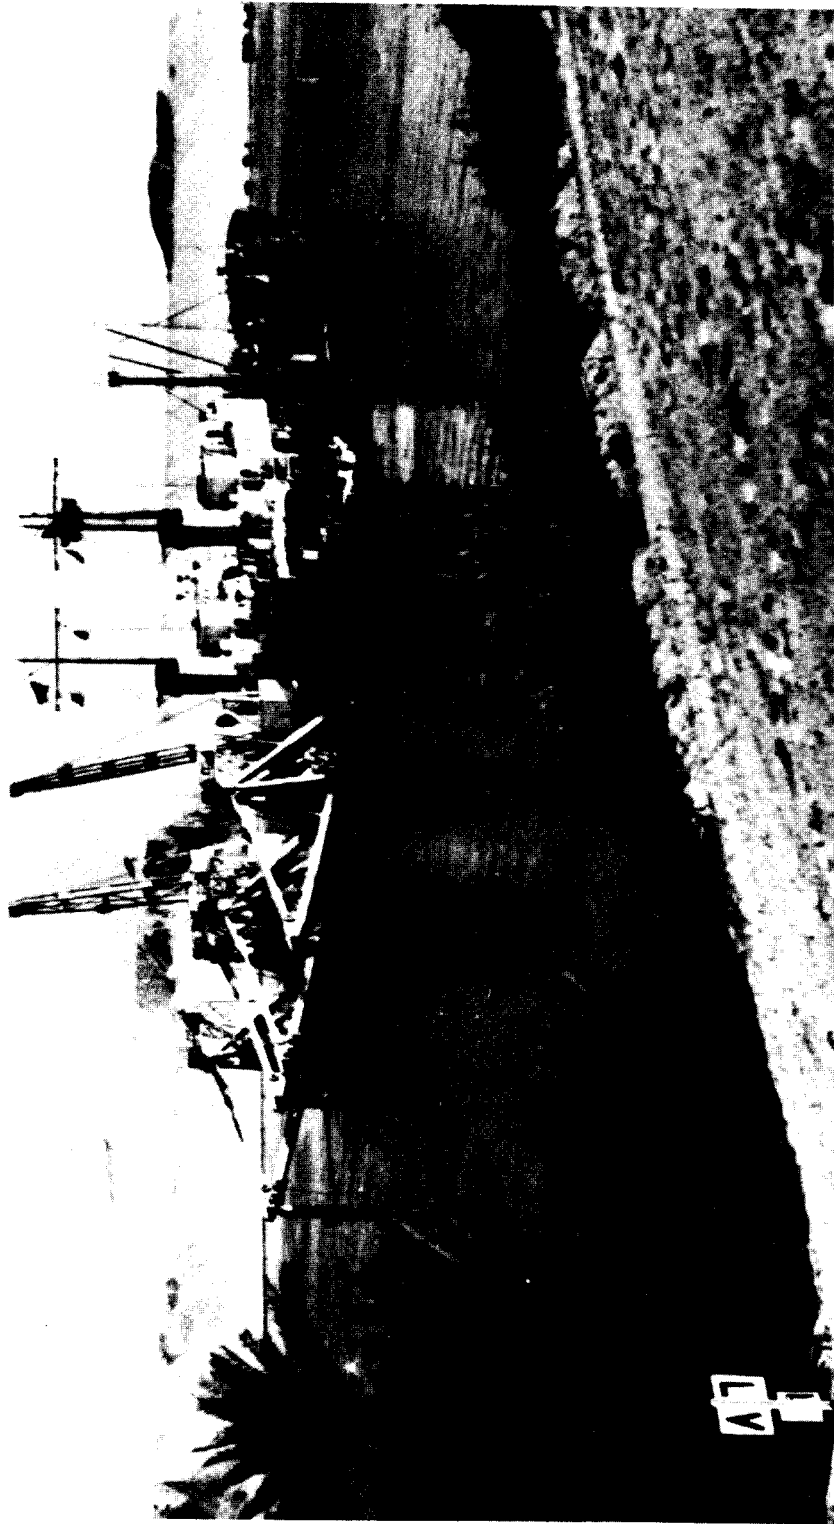
FIGURE VI-30
CRANDALL and CRILLEY Lifting
Western Section of Caisson
From Depression in Canal Bottom

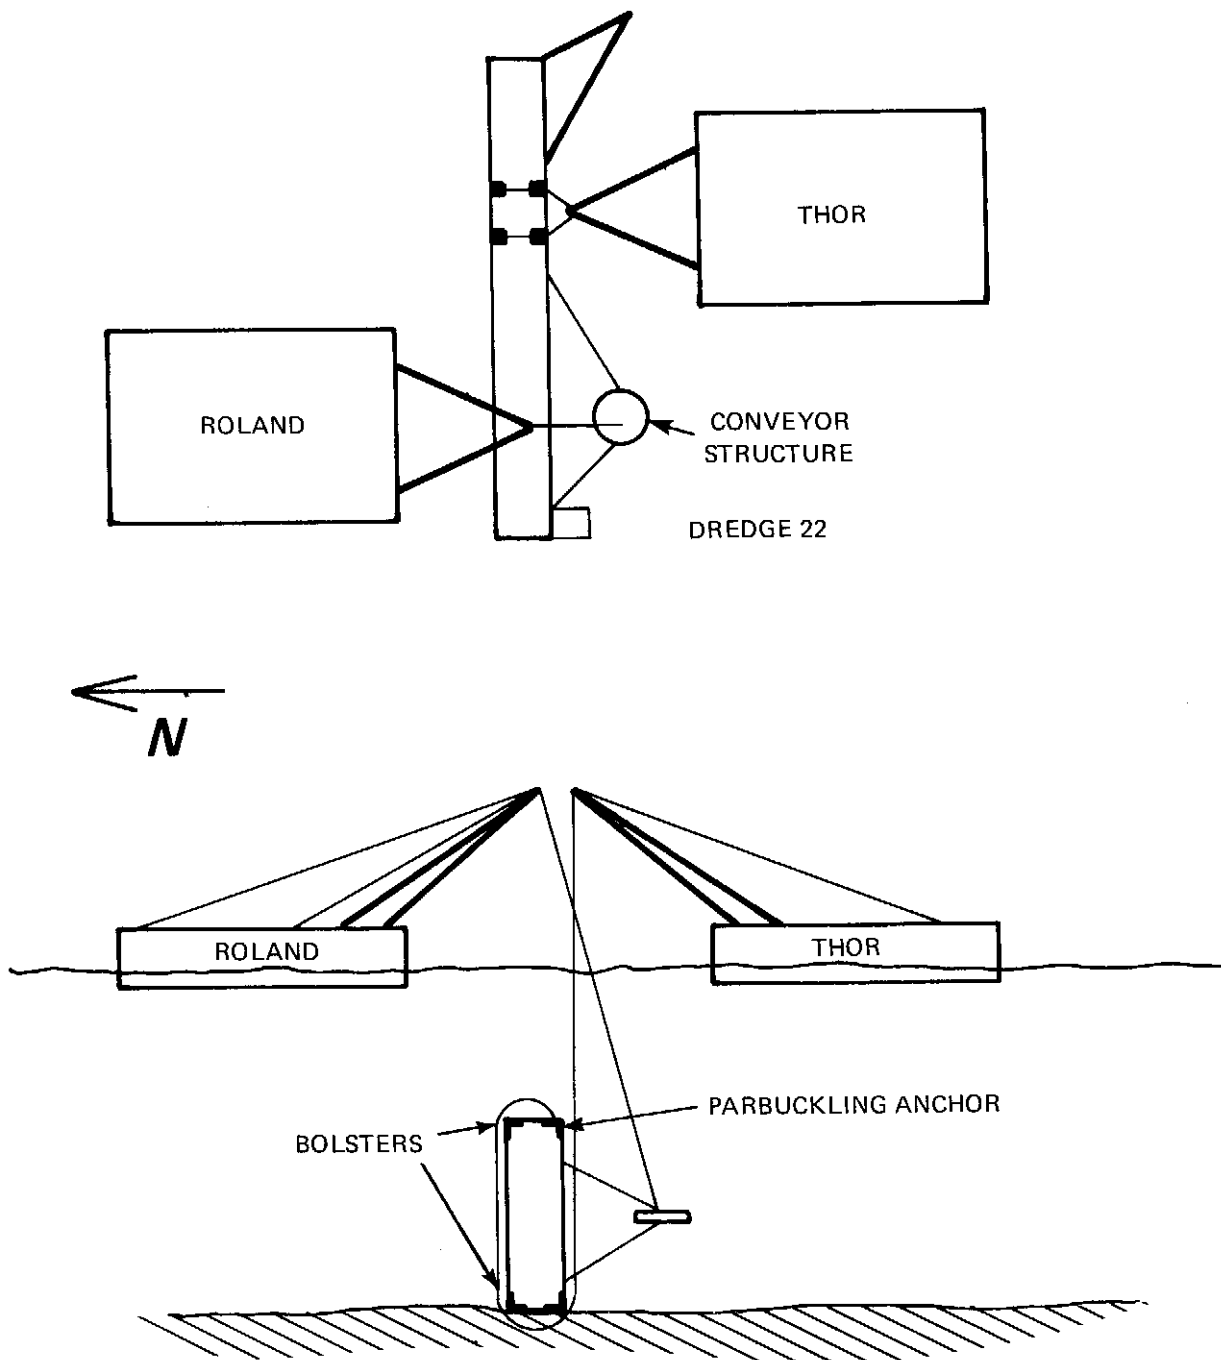
FIGURE VII-2
Parbuckling Arrangement, DREDGE 22

After DREDGE 22 was righted, it was discovered that the 3/8-inch thick by 4-foot long steel bolster at the turn of the bilge had crushed into the hull approximately 4 feet. The possibility of a more severe recurrence of this during application of the heavier lifting loads was cause for concern, especially in view of the poor condition of the hull of DREDGE 22. Precautions were taken to distribute the lifting loads over a wider area by constructing larger bolsters of 3/8-inch plate stiffened with five sections of railroad rails welded to the plate, as shown in Figure VII-4. Two of these bolsters, each 4 meters long, were to be fitted on each side at the stern and two others, each 6 meters long, were to be fitted on each side at the bow.

It would have been preferable to lift DREDGE 22 with ROLAND and THOR on the same side. However, because of the need to shift the lift points to avoid the area damaged by
