Description of document:	US Navy Salvage Report: USCGC Mesquite Salvage Operation Dec 89 - July 90, 19 July 1991
Requested date:	20-December-2007
Released date:	17-December-2008
Posted date:	05-May-2009
Title of document	SL740-AC-RPT-010/SUPSALV, 0910-LP-488-0600, USCGC Mesquite Salvage Operation Dec. '89 – July '90 Keweenaw Peninsula, Michigan
Source of document:	Department of the Navy Naval Sea Systems Command NAVSEAFOIA@navy.mil

USCGC MESQUITE SALVAGE OPERATION DEC. '89 - JULY '90 KEWEENAW PENINSULA, MICHIGAN

19 JULY 1991

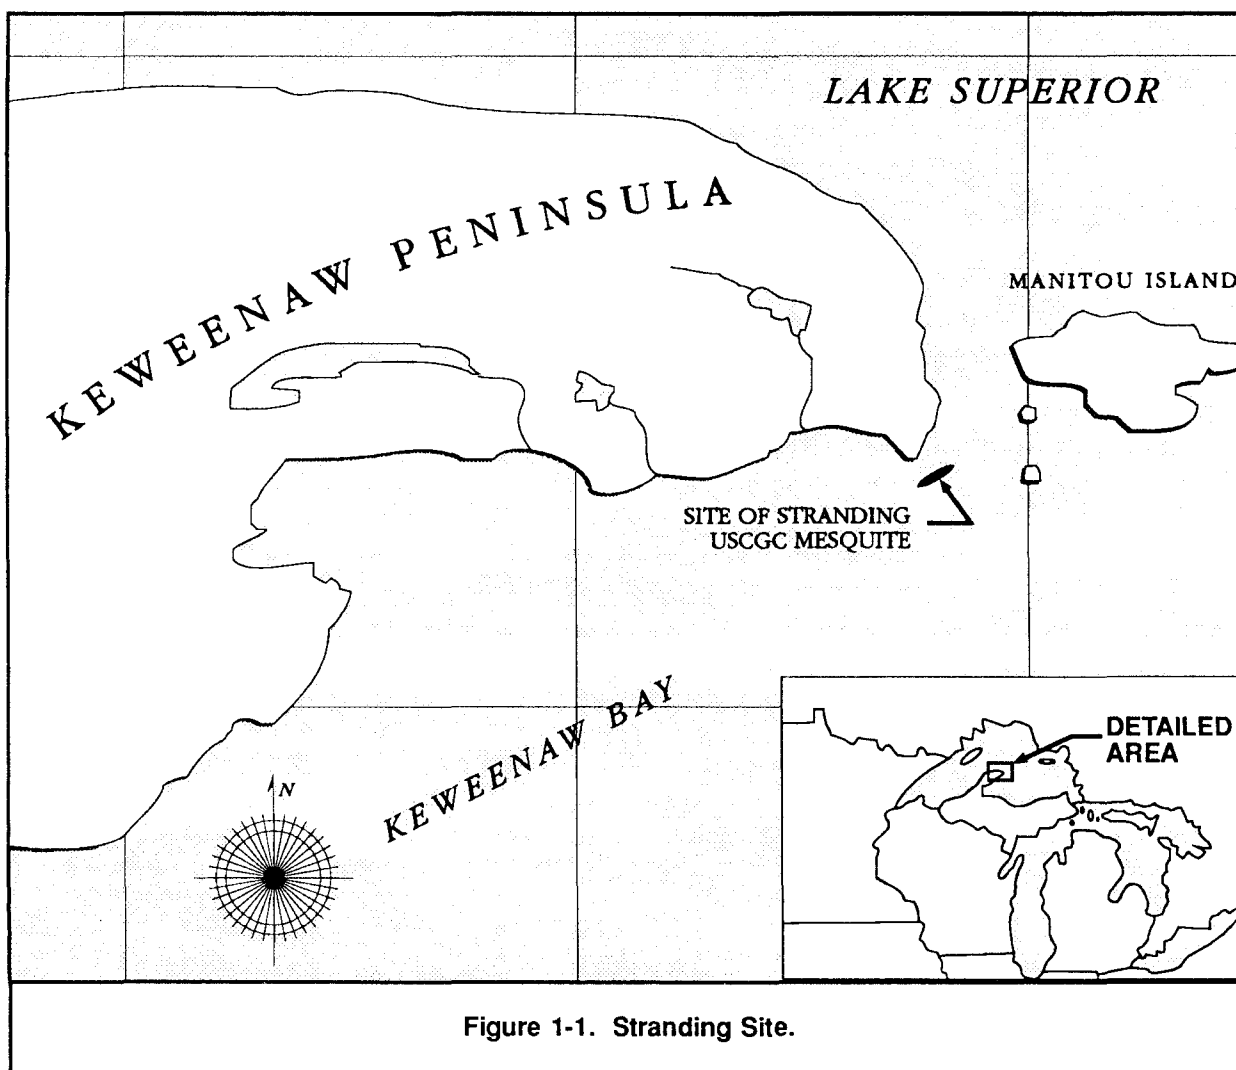
1-1.1 Situation. About 0230 local time on 4 December 1989, while tending Keweenaw Light Buoy LB1, the 180-foot United States Coast Guard Buoy Tender MESQUITE (WLB-305) stranded on a rock ledge in Lake Superior roughly one-half mile east-southeast of Keweenaw Point, near Copper Harbor, Michigan. MESQUITE lay aground in approximately 12 feet of water at a position reported as 47-23.8N, 87-43.95W. Figure 1-1 shows the stranding site.

Immediately after stranding, MESQUITE reported buckled hull plating and framing in the machinery compartment near frame 92, and flooding at around three gallons per minute. As the ship worked on the rock, flooding between frames 74 and 92 increased.

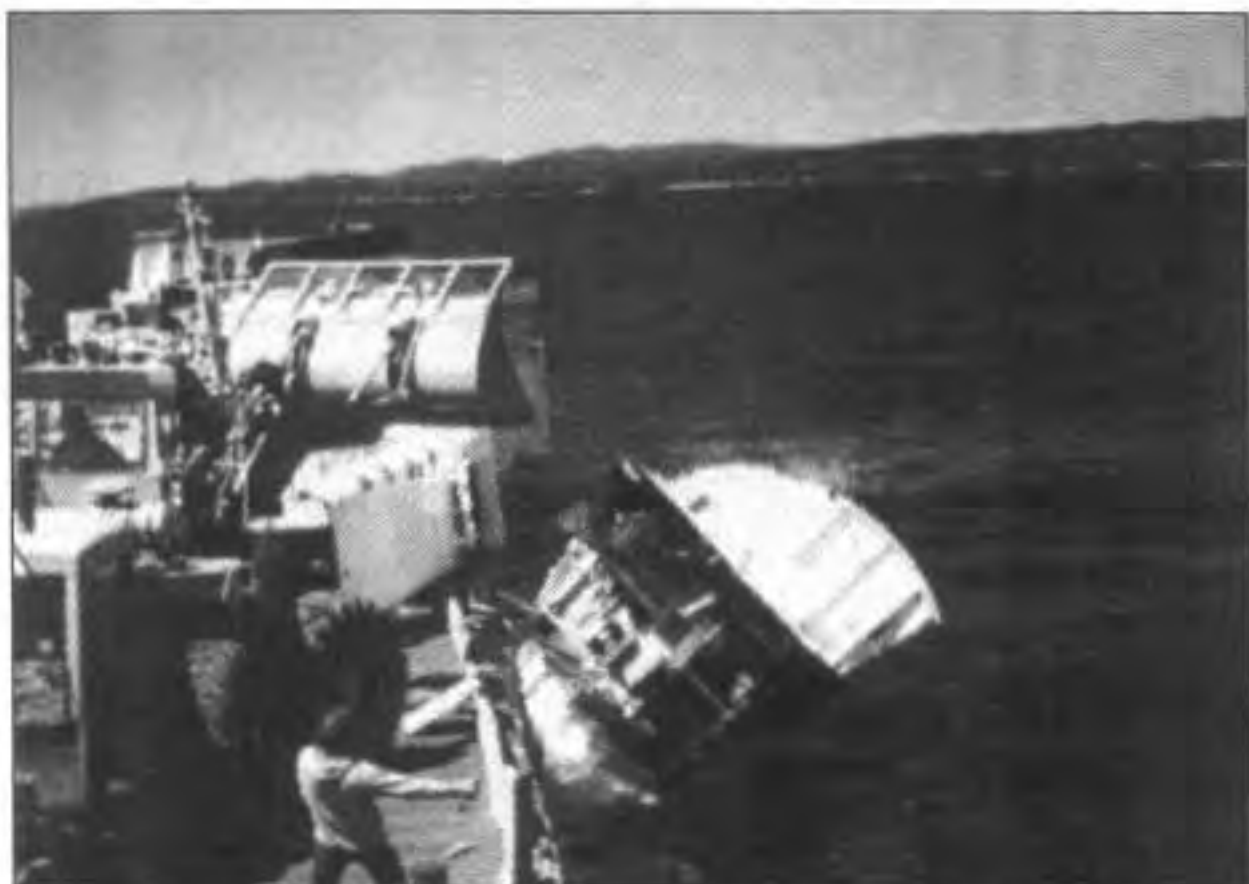
The superstructure and other expendable items taken from MESQUITE had been pushed overboard at the site, prior to moving MESQUITE (Figure 3-23).

Figure 3-23. Superstructure Being Pushed Overboard at Disposal Site.
