USS FRANK KNOX (DDR-742) STRANDING SALVAGE

NAVSHIPS 0994-002-6010

DEPARTMENT OF THE NAVY
NAVAL SHIP SYSTEMS COMMAND
WASHINGTON, D.C.

1968

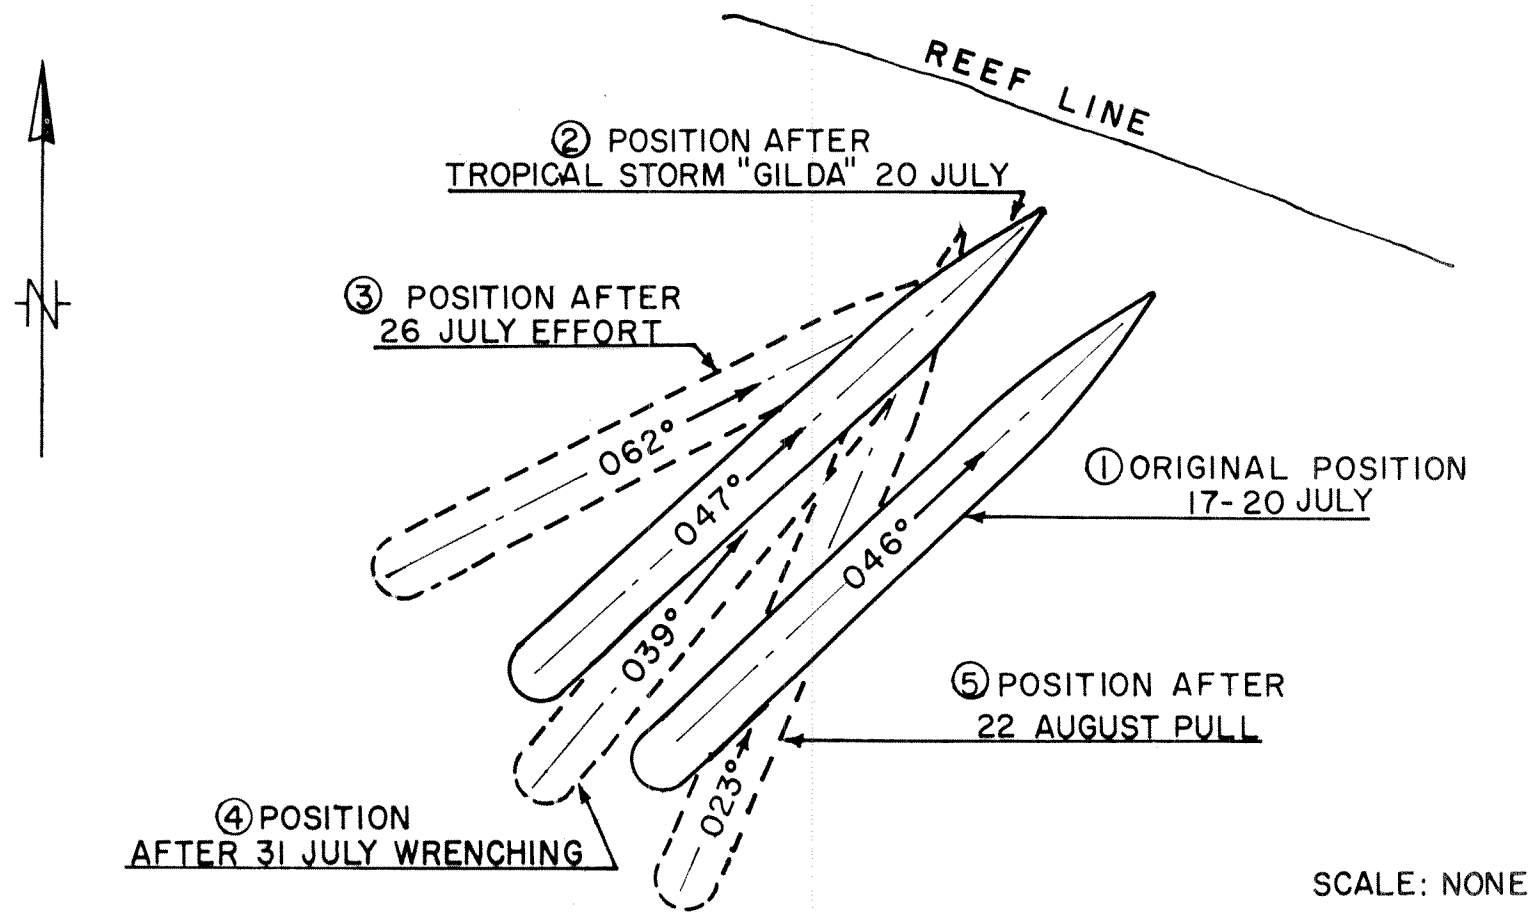
FIGURE D

VARIOUS POSITIONS OF THE STRANDED FRANK KNOX

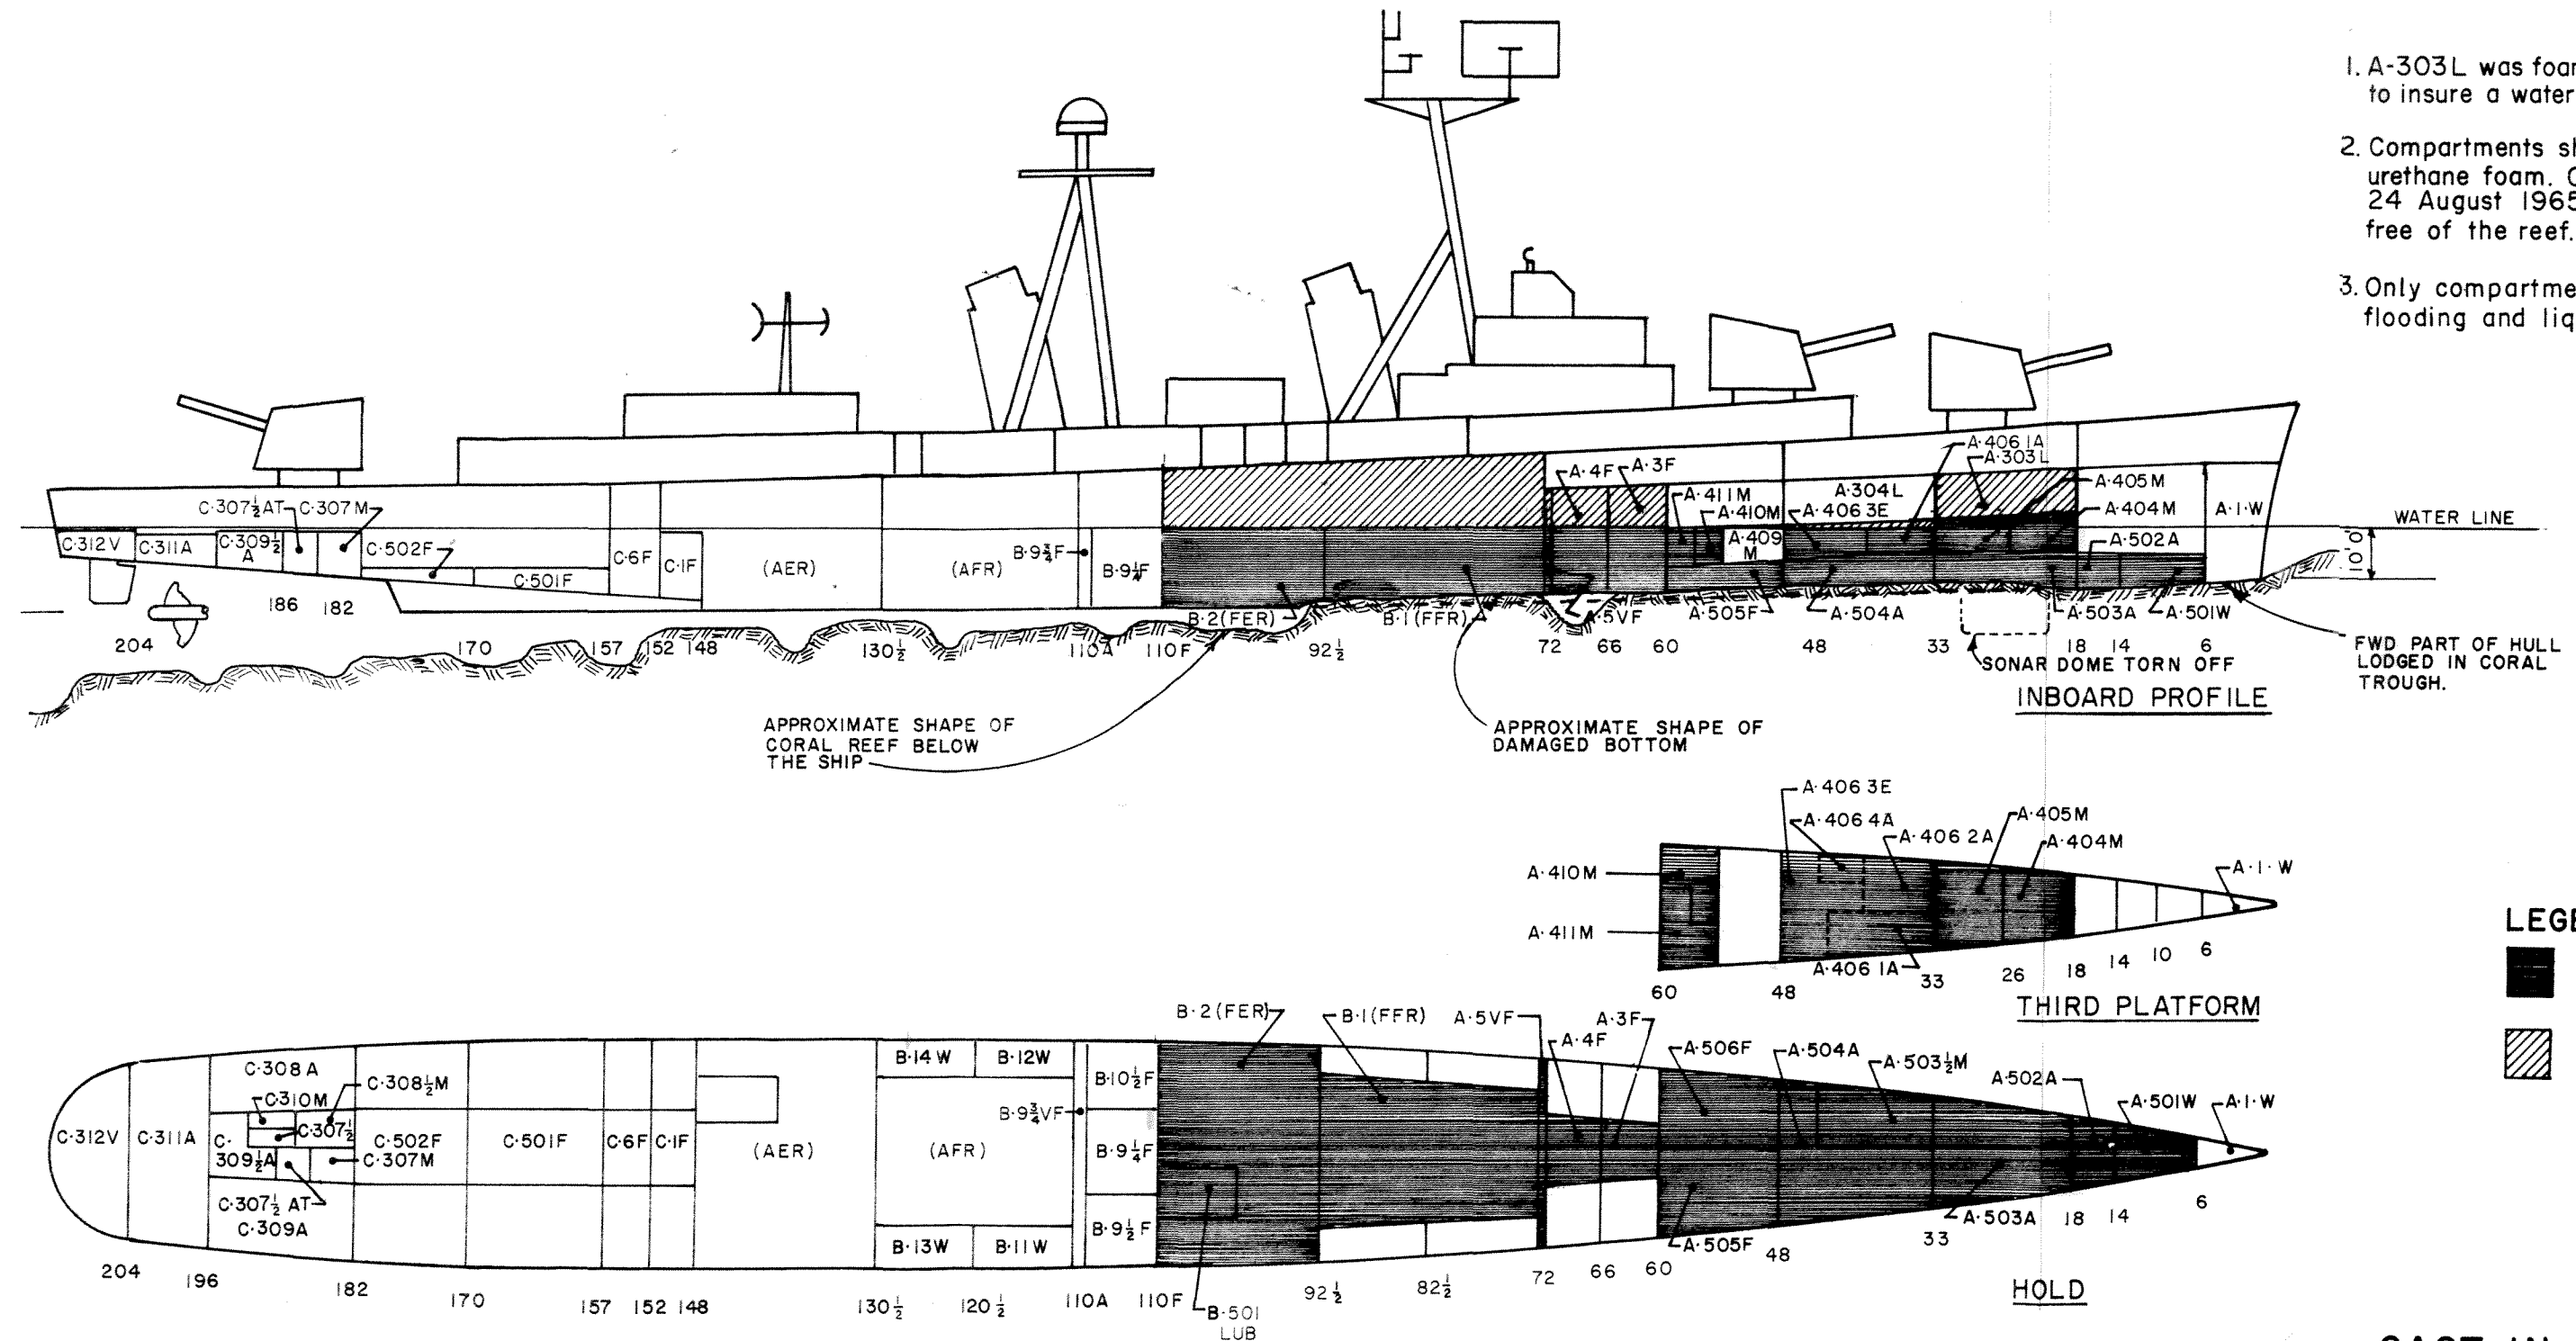
1. A-303L was foamed as a damage control measure to insure a water seal from A-405M & A-406M.
2. Compartments shown shaded were filled with urethane foam. Condition shown was as of 24 August 1965 prior to time ship was pulled free of the reef.
3. Only compartments and details relative to flooding and liquid loading are shown.

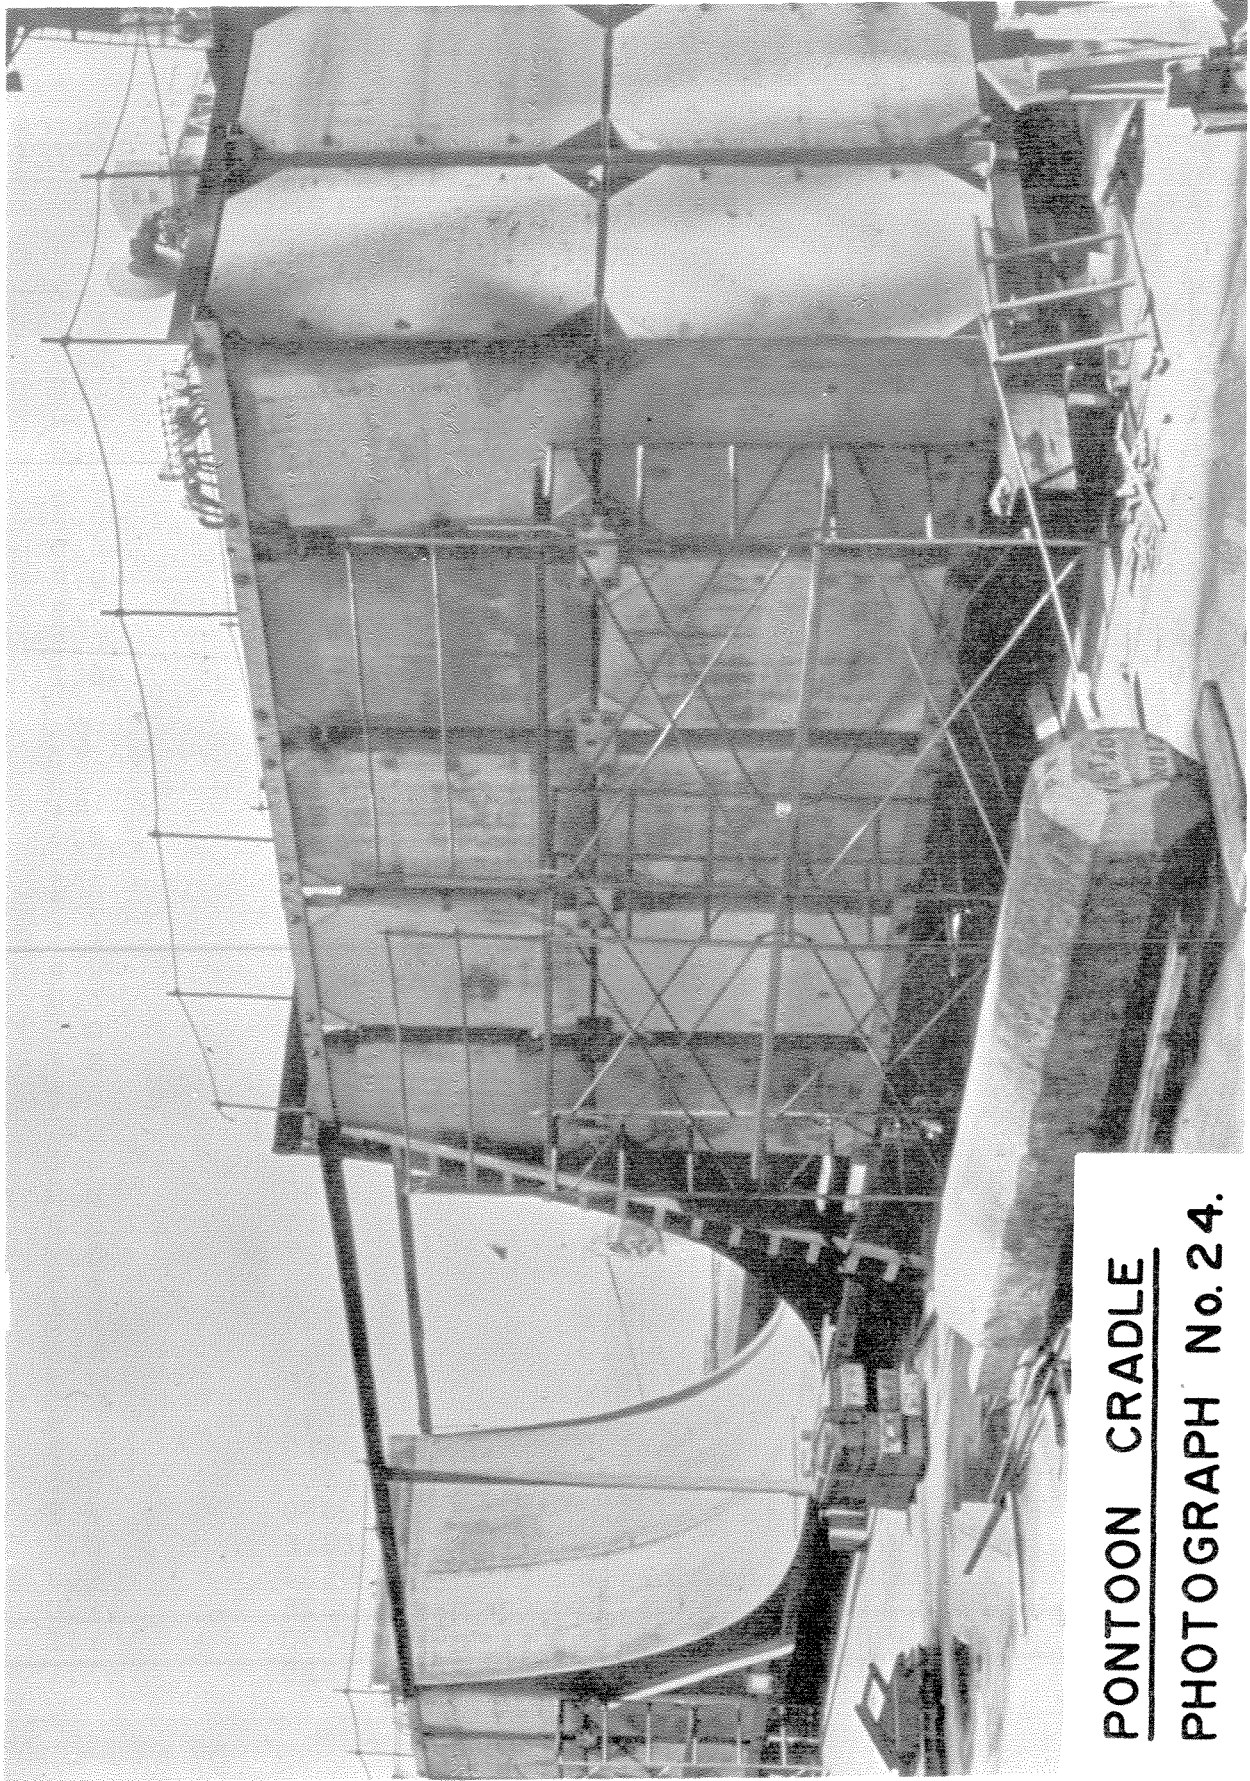
PONTOON CRADLE
PHOTOGRAPH No. 24.

1. Pontoon cradle. A large cradle fabricated from BUDOCKS pontoon cells was designed and built. This cradle was designed to be lifted to the scene in an LSD. It was to have been slid under the stern of FRANK KNOX to the mid-ships area where it would have provided 540 net tons of lift (see Photograph 24 page 85).
