Wiss, Janney, Elstner Associates, Inc.
330 Pfingsten Road
Northbrook, Illinois 60062
847.272.7400 tel
www.wje.com

September 1, 2020

Response Plan for the Arecibo Observatory Cable Failure

RESPONSE PLAN FOR THE AUXILIARY CABLE FAILURE AT THE ARECIBO OBSERVATORY

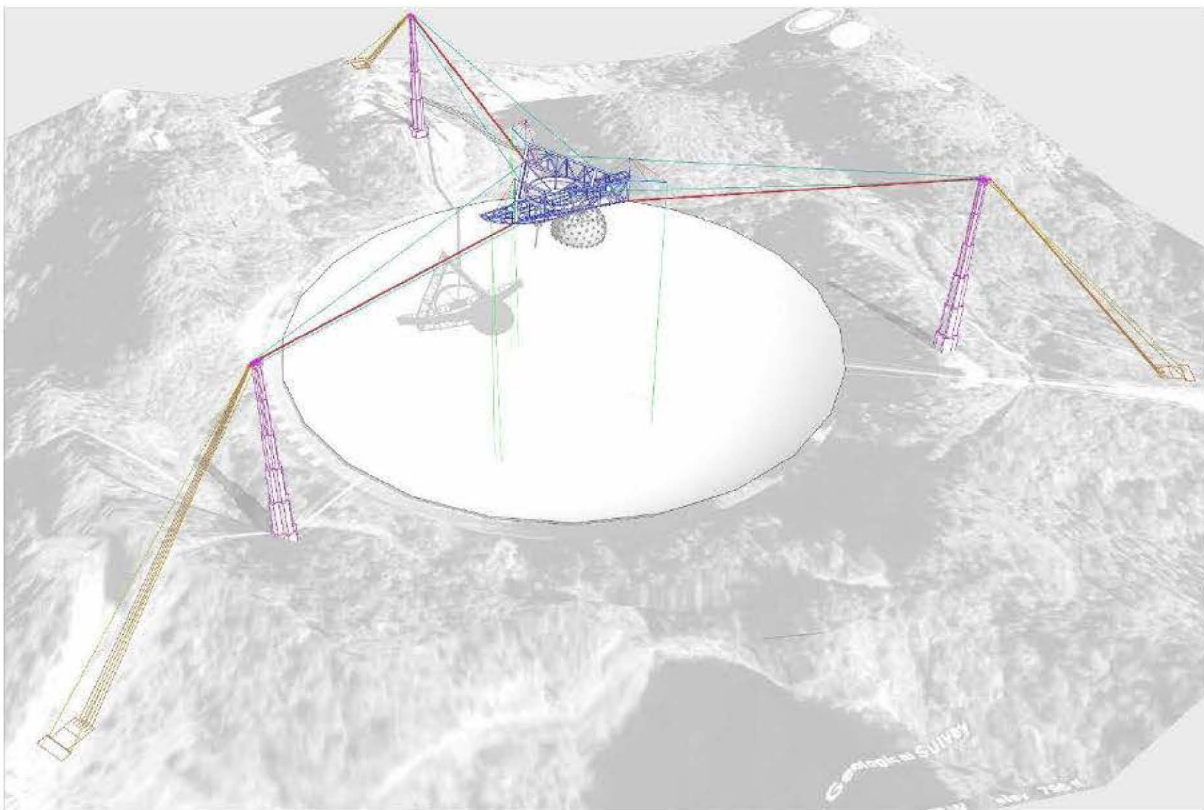
According to drawings provided for our review, the subject structure includes the following primary components (refer to Figure 1):

Figure 1. Arecibo Observatory with components color-coded.
