Description of document:	National Science Foundation (NSF) Documents Concerning the Arecibo Radio Observatory Response Plan
Requested date:	19-November-2020
Release date: Additional release date:	26-February-2021 14-April-2021
Posted date: Update posted date:	15-March-2021 11-April-2022
Note:	Material released 14-April-2021 begins on PDF page 18
Source of document:	National Science Foundation Attn: FOIA Officer 2415 Eisenhower Avenue Alexandria, Virginia 22314 Fax: (703) 292-9041 Email: <u>foia@nsf.gov</u>

Response Plan for the Arecibo Observatory Cable Failure

RESPONSE PLAN FOR THE AUXILIARY CABLE FAILURE AT THE ARECIBO OBSERVATORY

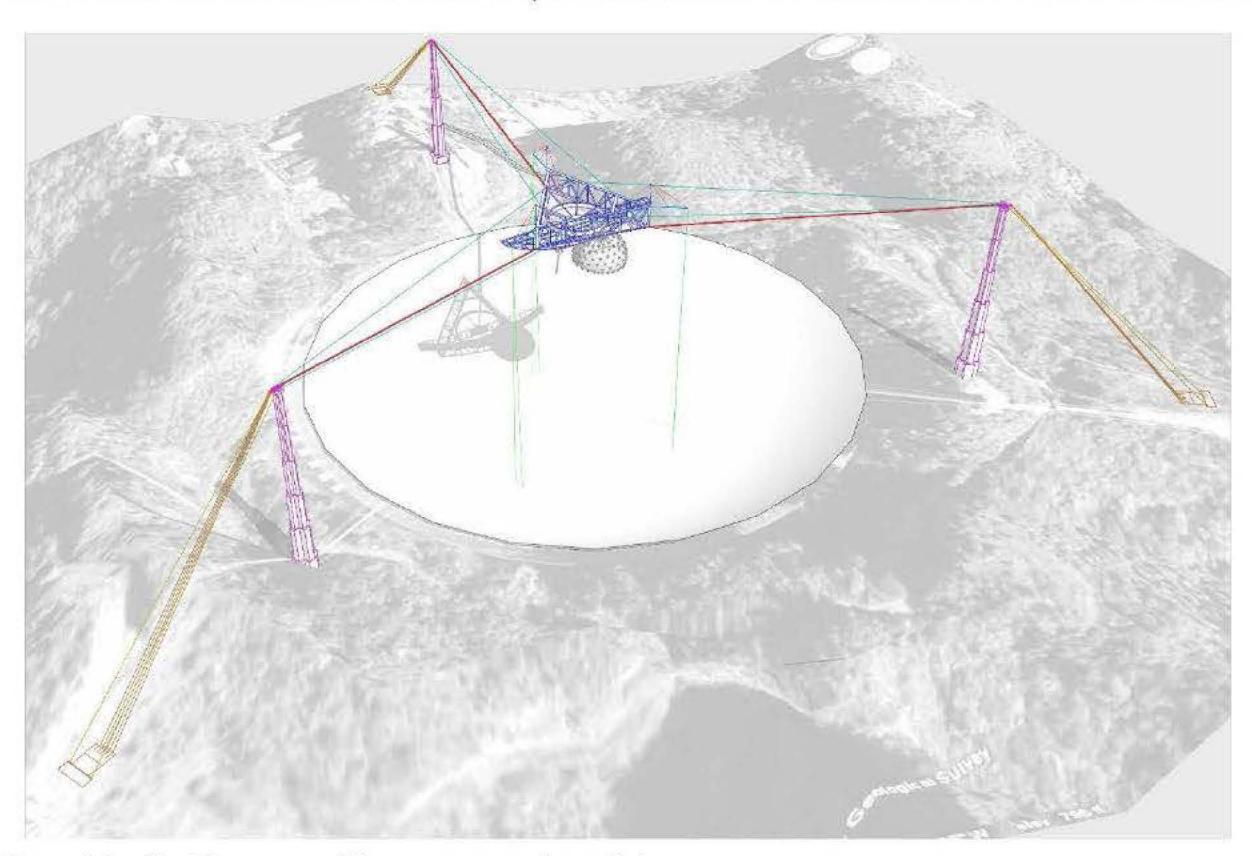
According to drawings provided for our review, the subject structure includes the following primary components (refer to Figure 1):

Figure 1. Arecibo Observatory with components color-coded.
