The Hubble Space Telescope Optical Systems Failure Report

November 1990

National Aeronautics and
Space Administration

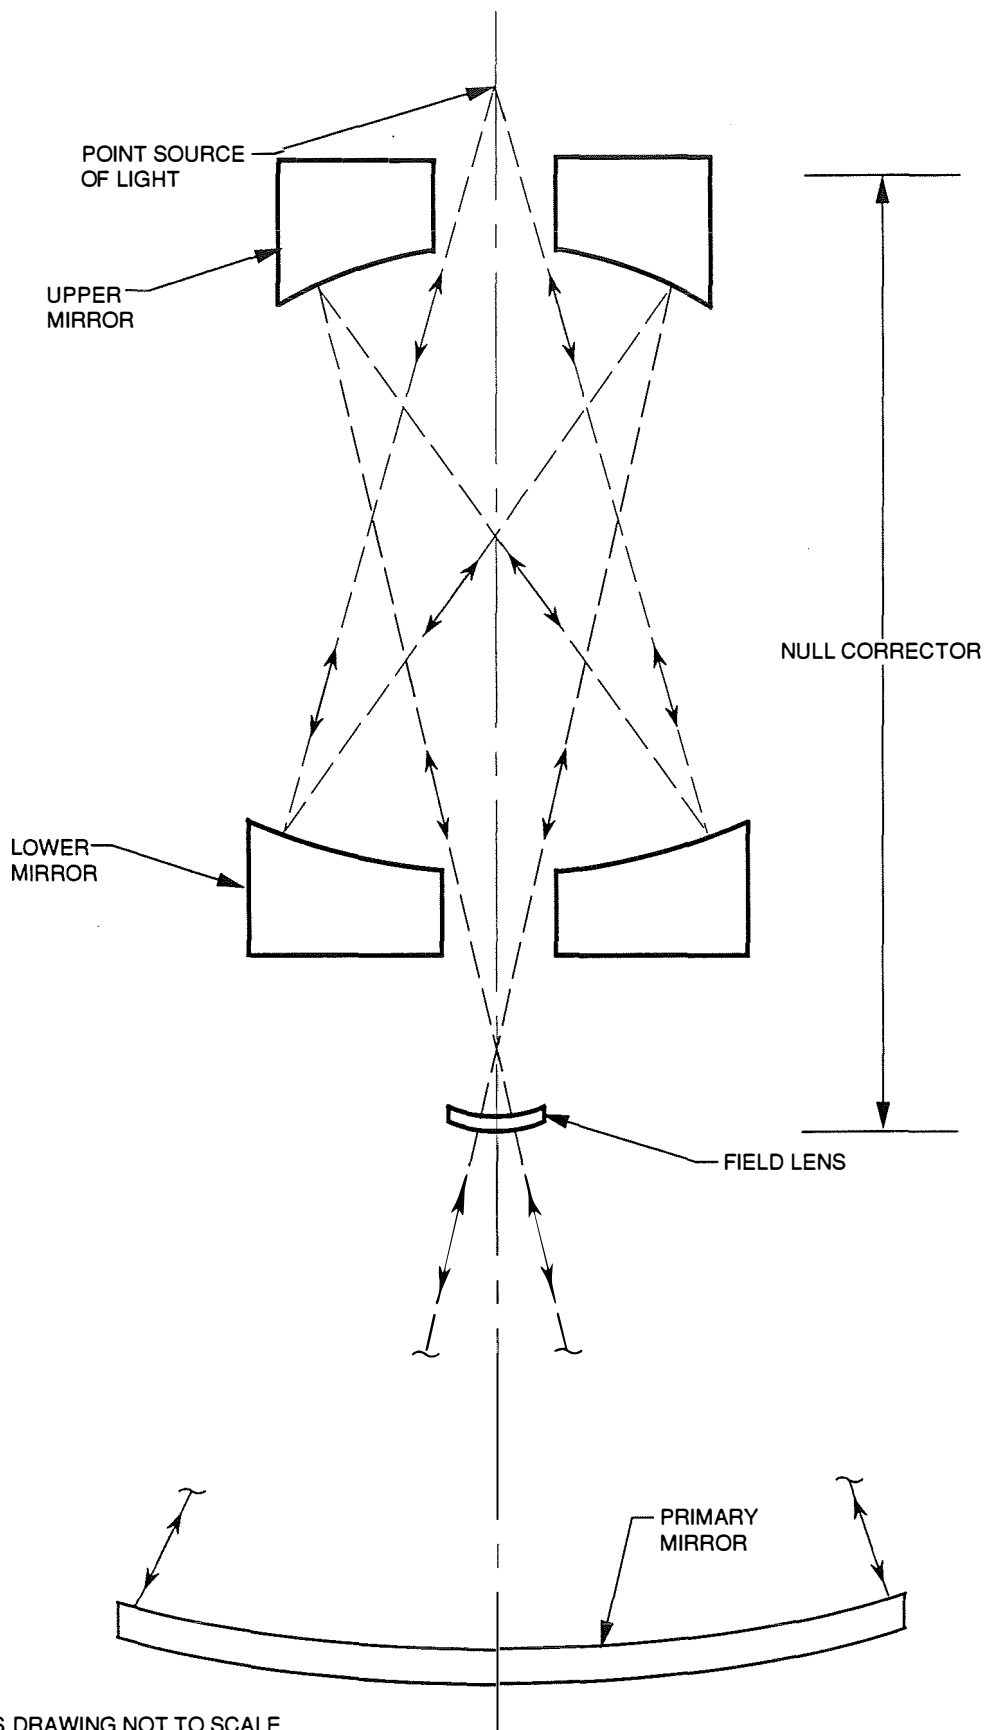
Figure 4-2. Reflective null corrector.

RNC was designed and built by the Perkin-Elmer Corporation for the HST Project. This unit had been preserved by the manufacturer exactly as it was during the manufacture of the mirror. When the Board measured the RNC, the lens was incorrectly spaced from the mirrors. Calculations of the effect of such displacement on the primary mirror show that the measured amount, 1.3 mm, accounts in detail for the amount and character of the observed image blurring.

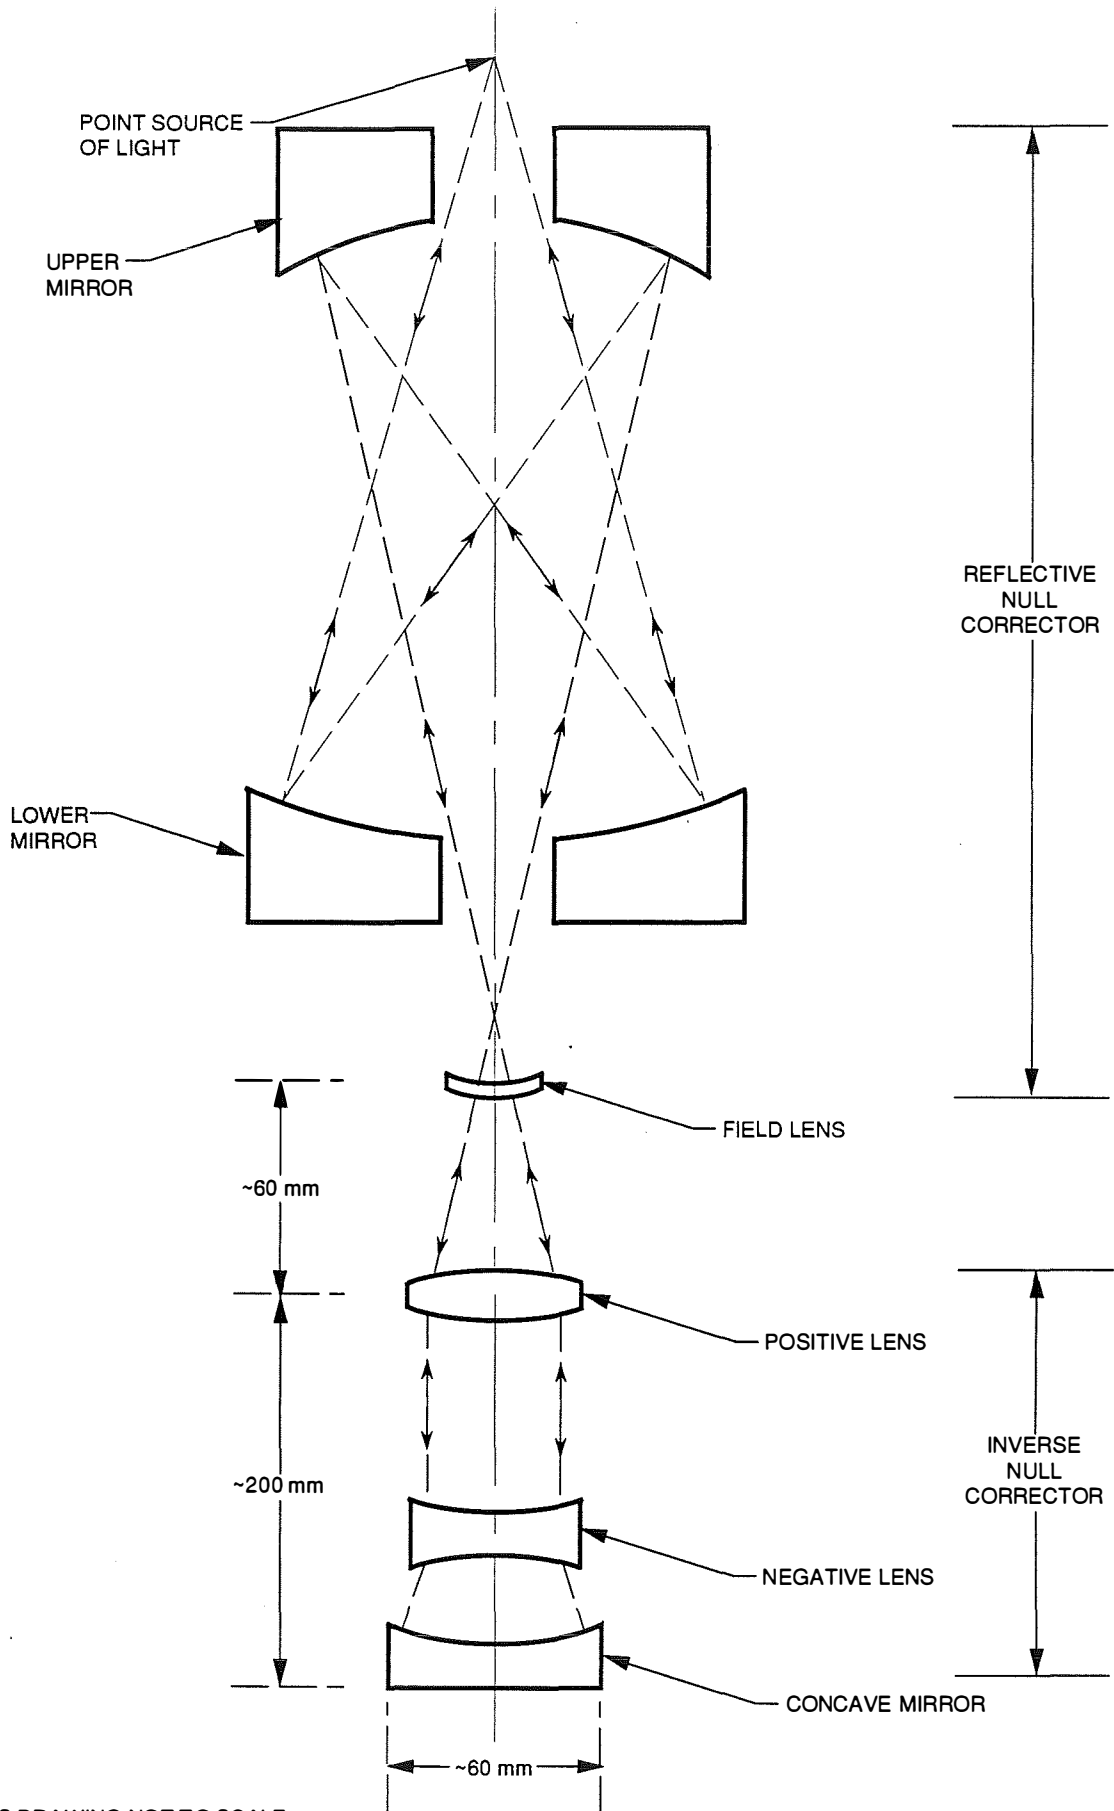
Figure 4-3. Inverse null corrector inserted below the reflective null corrector.

As a check on the position of the Coaxial Reference Interferometer (CORI) used with the RNC, an inverse null corrector (INC) was designed. When swung under the RNC, the INC would simulate a perfect mirror, just as a perfect primary mirror would appear with straight fringes when viewed through the RNC (Figure 4-3).

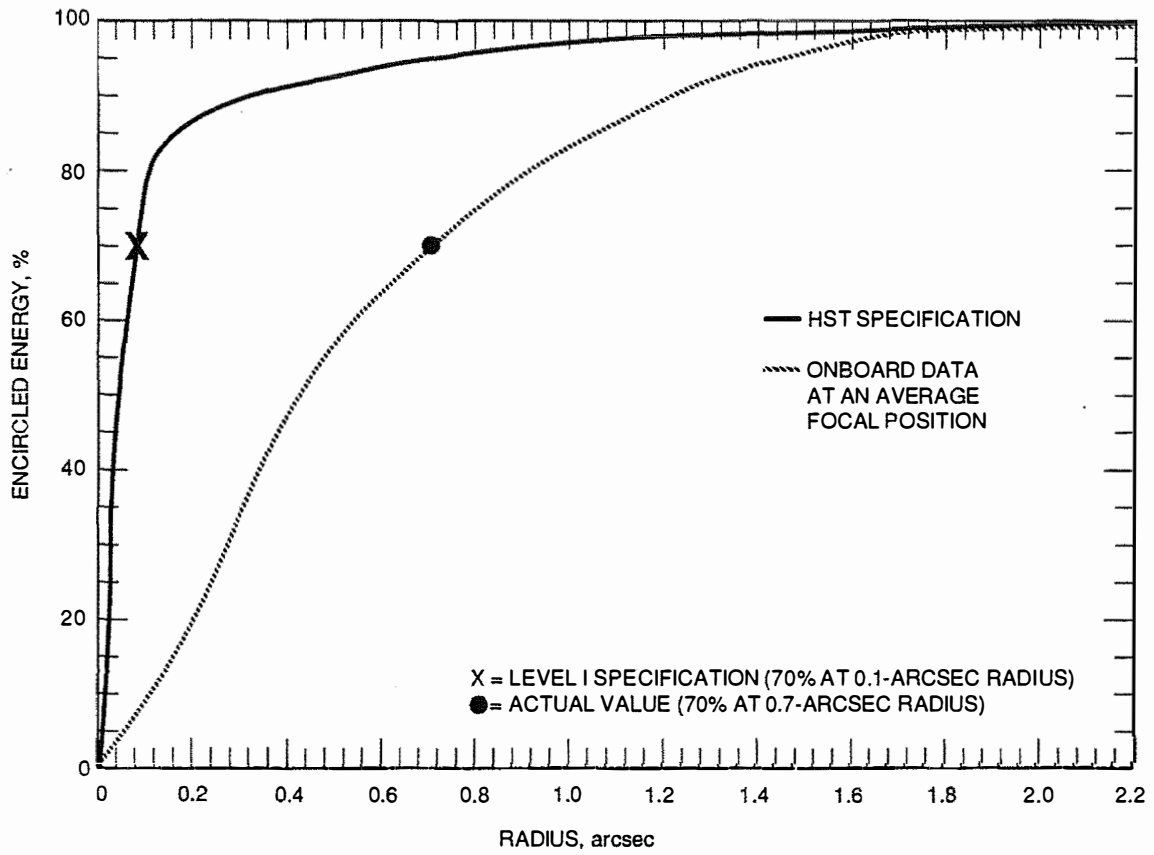
Figure 5-1. Encircled energy versus arcsecond radius of image produced by the HST.

The Level I specification for the HST is to achieve 70 percent encircled energy in a circle of 0.1-arcsecond radius and to meet a Rayleigh criterion (i.e., image resolution of two objects) of at least 0.1 arcsecond. Early in the checkout phase of the mission, it was discovered that the telescope did not meet the above requirement. Instead, the telescope focused 70 percent encircled energy into a 0.7-arcsecond radius. Figure 5-1 is a plot of the encircled energy percentage versus radius in arcseconds for both the specified HST performance and the actual performance.

- (8) When all these considerations are taken into account, at the best focus position, that is, the focus position that minimizes the rms wavefront error or puts the maximum energy into the central core of the image, 70 percent of the light from a single star is contained in a circle of about 0.7 arcsecond in radius (Figure 5-1).
