National Aeronautics and Space Administration (NASA)
Selected Apollo & Shuttle Lessons Learned 2014

Lesson 4: Selected Apollo & Shuttle Lessons Learned (Part 1)

Lesson 10: Selected Apollo & Shuttle Lessons Learned (Part 2)

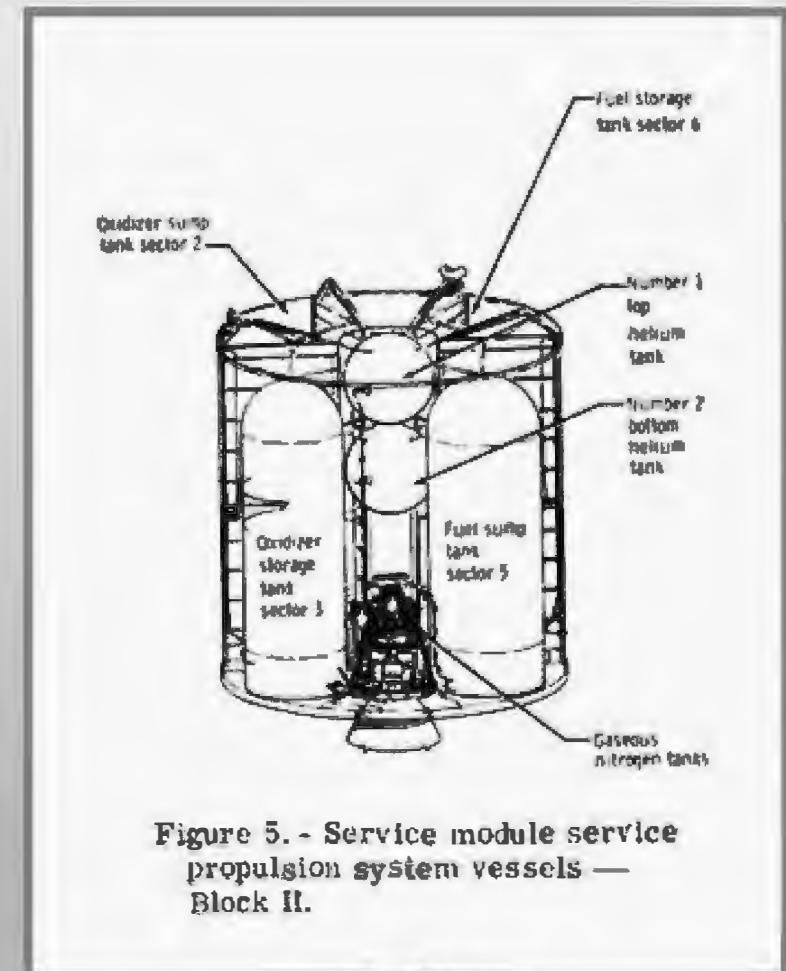
Figure 5. - Service module service propulsion system vessels — Block II.

- SPS was propulsion system that provided spacecraft with large velocity-change capability
- SPS used same hypergolic propellants as RCS
 - Oxidizer: nitrogen tetroxide (N_2O_4)
 - Fuel: Aerozine 50
- SPS fuel tank design
 - Material: Ti-6Al-4V
 - Environment: Aerozine 50 (methanol used in cold flow test)
 - Configuration: cylinder, 4 ft diam., 14 ft long, 0.055" thick
 - Usage: 2 in Service Module

- Oct. 1, 1966: SC-101 fuel tank leaked during cold flow test
 - Methanol used in place of Aerozine 50
 - Suspected stress corrosion cracking
 - Weld contamination also suspected
- Additional tank testing instituted to sort out SCC & weld contamination possibilities
 - Tanks to be tested in place
 - Tank considered to be a leaker
- Oct. 25, 1966: SC-017 fuel tank exploded during test
 - Tank installed in Service Module when tank exploded
 - SC-017's Service Module completely destroyed in explosion

- Stopped using methanol as referee fluid
- Scrapped all tanks that had been through cold flow test
- Applied fracture mechanics methodology to all pressure vessels in remainder of Apollo Program
 - Proof-test logic principally used
 - Many tanks already in inventory
 - Low number of cycles involved
 - Measured fracture toughness, fatigue & environmental crack growth properties of all tank materials
 - Parent, weld & HAZ
 - Measured K_{th} of actual flight propellants before each lunar mission

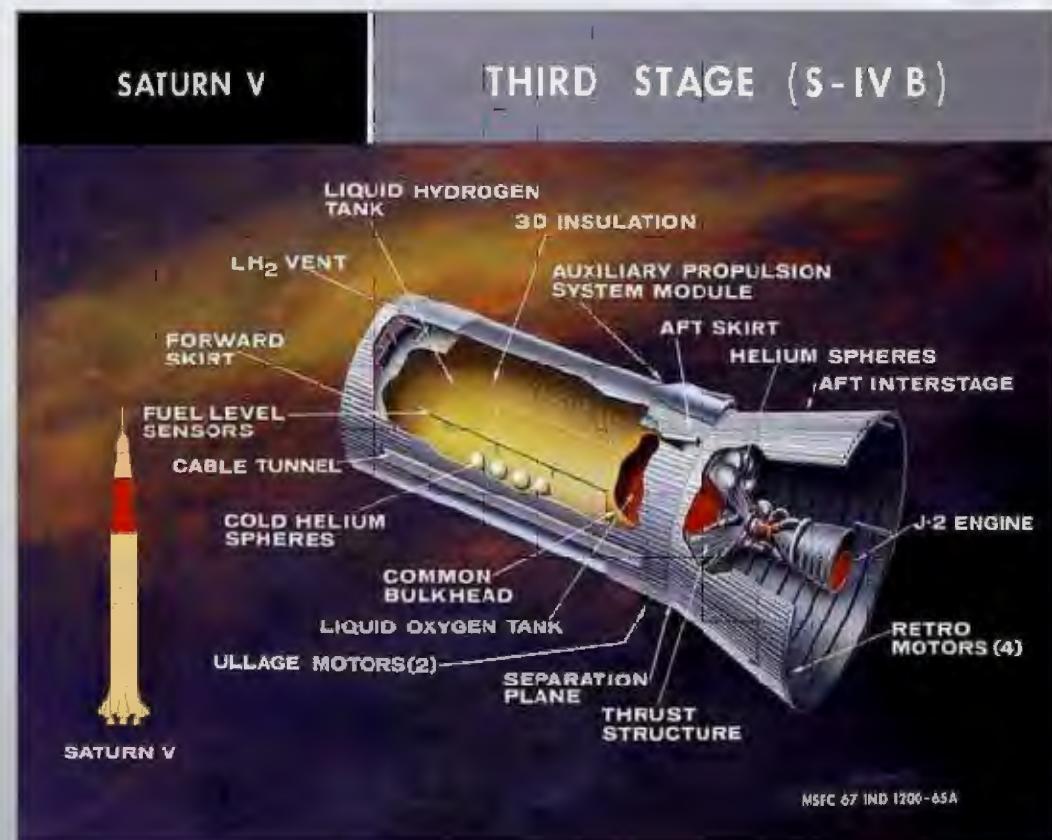
- Helium tanks pressurized S-IVB LOX & LH₂ tanks
- Helium tank design
 - Material: Ti-6Al-4V
 - Configuration: spherical, 27" diam., 0.333" thick
 - Usage: 12 per S-IVB stage
- S-IVB stage
 - Third stage of *Saturn V*
 - 20 ft diam. × 40 ft long
 - LOX/ LH₂ propellants
- S-IVB 503 stage was scheduled for *Apollo 8* (1st manned circumlunar mission)

Explosion destroyed entire S-IVB stage & severely damaged static firing test stand

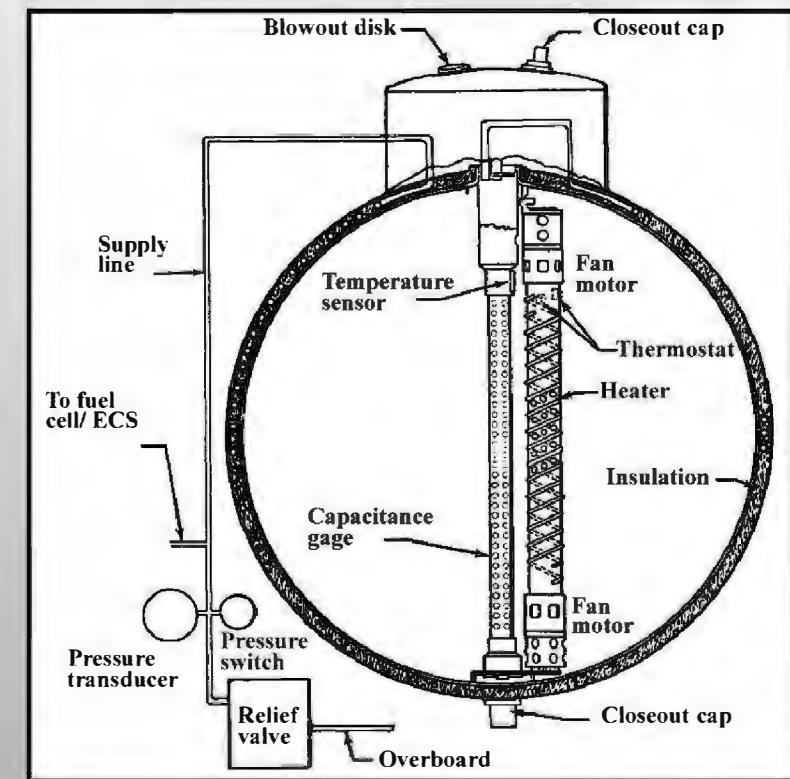
- Supercritical oxygen tanks provided breathing oxygen to CM & reactant oxygen to fuel cells for electrical power
- Oxygen tank design
 - Material: Inconel 718
 - Configuration: spherical, 25" diam. × 0.060" thick
 - Usage: 2 in Service Module
- Internal components—2 tube assemblies
 - Quantity gauge/fill tube
 - Heating element/stirring fans
