Smithsonian Institution (SI) three various documents, 2019-2021

FY2019 Smithsonian Facility Condition Assessment Report

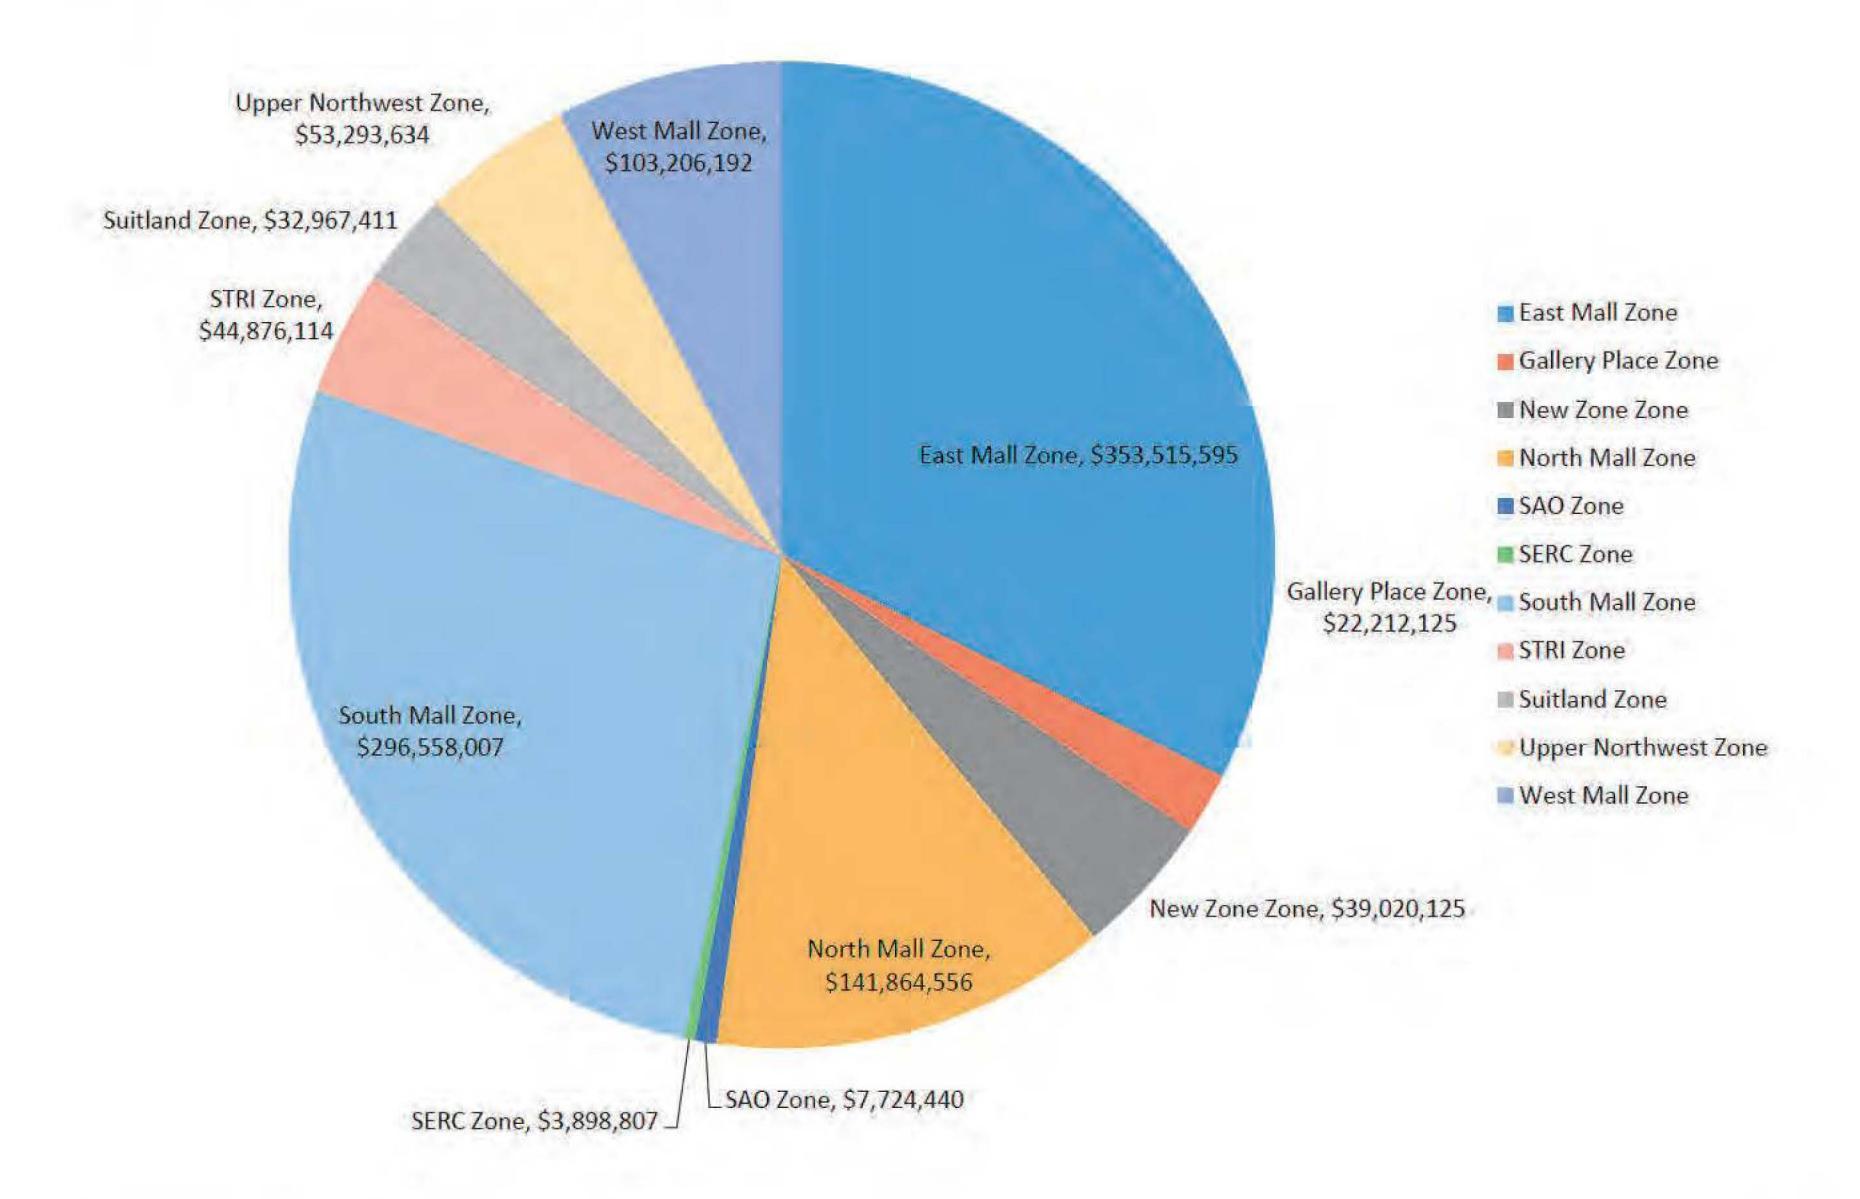
Figure 1 – FY19 Deferred Maintenance by Zone

Museums Rated Lowest to Highest %	FY19 FCI %	FY19 DM Cost
SIB	62.1%	\$73,386,119.06
AIB	63.5%	\$102,005,494.24
NASM-Mall	69.0%	\$279,375,228.77
Hirshhorn	81.2%	\$45,620,095.43
NASM-Dulles	85.7%	\$72,017,545.69
NMAH	87.8%	\$101,802,178.91
Quad	87.8%	\$62,628,826.98
Anacostia	90.1%	\$1,130,694.60
NMAI-NYC	91.5%	\$8,706,230.40
NMNH	93.4%	\$141,189,953.87
Freer	94.9%	\$12,917,471.07
Cooper-Hewitt NY	95.1%	\$16,020,200
NMAI-DC	96.3%	\$12,921,965.14
Reynolds Center	96.3%	\$17,354,187.44
Renwick	99.6%	\$219,481.51
NMAAHC-Mall	99.7%	\$1,403,762,.53
DM Ranking from Lowest to Highest		\$947,295,673.11

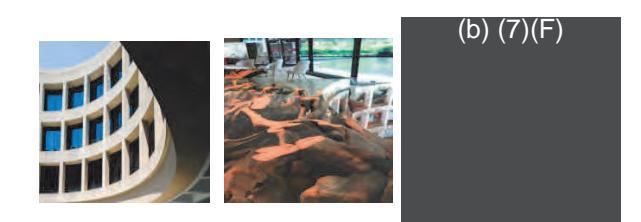
Hirshhorn Museum and Sculpture Garden

Major known issues in the Hirshhorn Building include leaking of the envelope, exacerbated by improper drainage at exterior concrete platforms, conveyance concerns with both the elevator and escalator, and hazardous roof leaks that pose the possibility of contributing to a roof failure if not addressed by replacement rather than minor repairs. Short and long-term strategies to address all these issues are in the Master Plan and should remain a high priority.

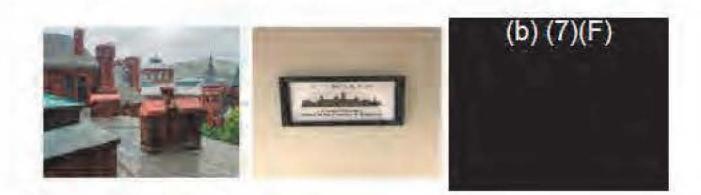
Smithsonian Institution Building

The SI building remains in poor condition and needs a major Capital Renovation Project in the future. A full assessment, down to the asset level, was performed in FY2014 reconfirming the need for a complete revitalization project. There is a design project called major revitalization for SI (castle) is in design phase, construction for this project is projected to start in FY22/23. It should be noted that certain systems including the mechanical piping is in an extremely deteriorated state. At this juncture the SF team is concerned that attempting partial fixes could cause further unintended and catastrophic consequences at other points within the line. There is a current risk of damage to collections that remain in the facility until the system is completely renovated.

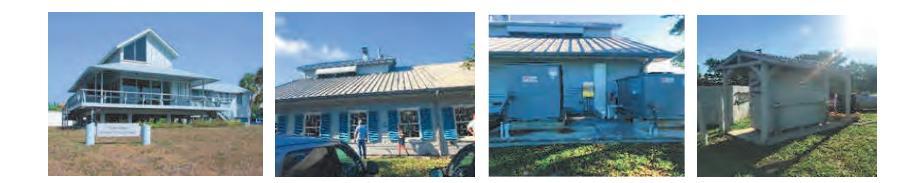
Fort Pierce, Florida Campus

This campus includes six buildings and multiple structures. The Marine Research Laboratory facilities at Ft. Pierce have had a major increase from the FY 2010 assessment and previous major deficiencies that were in the mechanical systems have been repaired or replaced in the main laboratory through a major maintenance project.

In FY17 the Tyson house underwent a \$100k project that replaced the deck, siding, windows, doors, and exterior plumbing. Hurricane Irma hit the Southeastern United States in September of 2017 and the Ft. Pierce dock and the transformer that is providing shore power were affected. In FY18, hurricane specific relief funding was provided to repair both items. In FY19 a maintenance project to repair and paint the main roof at a projected cost of \$60k is scheduled. During the last physical site assessment in FY19, the following deficiencies were noted:

- Exhaust fans need to be replaced.
- Condensation issues in main lab.
- Floors need to be replaced.
- Mechanical needs such as insulation, pipes, and air vacuum pumps need to be replaced.

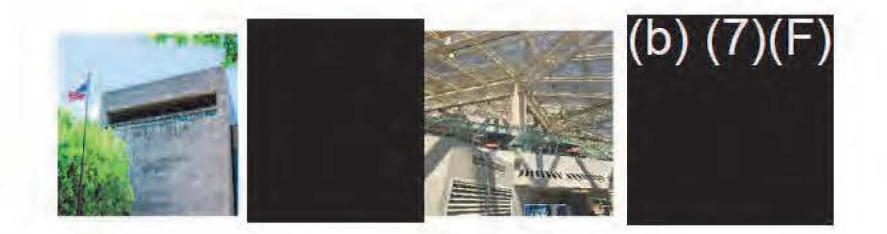
Significant deficiencies rest within the building envelope and HVAC system. Both require extensive overhauls. The Tennessee marble stone façade was found to have irreversible damage showing cupping and visible cracks. Stone forensic test findings revealed thermal hysteresis and moisture in the unusually thin stone likely causing the failure. Due to these failures, NASM will be undergoing a major renovation that will tackle issues with multiple systems including a complete roof replacement, HVAC upgrades with new boilers and chillers, electrical component upgrades, partial vertical transportation revitalization, and other various upgrades phased over the next 7 years.

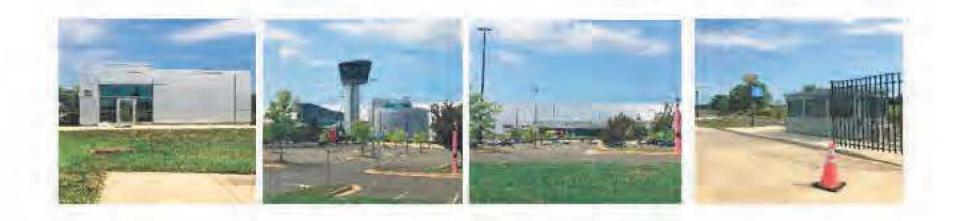
The assessment of Udvar-Hazy includes an additional eight buildings such as toll booths and storage buildings. The main deficiency is the failing roof system and is currently in its design phase with a planned construction project awarded in FY18. Repairs are being performed on an as needed basis to keep the facility open to the public. Other large maintenance concerns include the need to repair the parking lot and road, the ADA ramp retaining wall, an overhaul of the chiller, replacement of coils, replacement of the switchgear in the main building and generator replacements due to age. The new storage facility was constructed during FY18 at Udvar-Hazy.

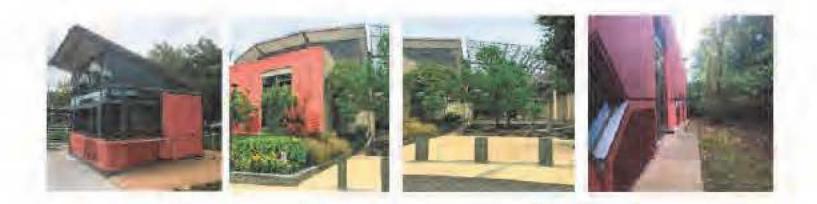
Cultural Resource Center for the American Indian Museum (CRC)

Consistent minor roof repairs continue to be required to bridge larger deficiencies, but replacement of a major portion of the roof is urgent as the roof has become an issue in every rain event. The larger repair must be addressed to protect collections. The front hardscape including the water feature needs capital renewal. The emergency generator and switchgear are undergoing a large capital revitalization project which is in the design phase with planned construction award in FY 20/21.

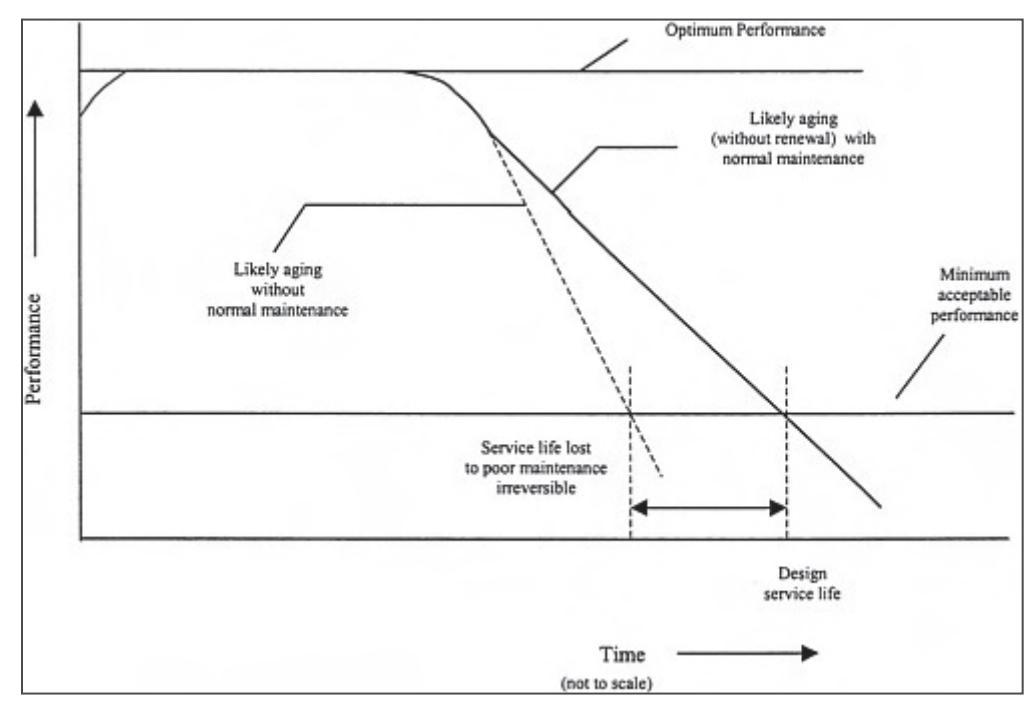
Figure 1 – Maintenance Impact on Design Life

The issues for federal facilities have been documented in the report *Stewardship of Federal Facilities: A Proactive Strategy for Managing the Nation's Public Assets* (NRC, 1998) and in the recent report *Predicting Outcomes of Investments in Maintenance and Repair of Federal Facilities* (NRC, 2012). They include:
