Description of document: General Services Administration (GSA) Infrastructure Assessment for the Weaver Building (the HUD Headquarters Building) 2013-2025

PROJECT: Department of Housing & Urban development (HUD) Headquarters – Weaver Building
Investigation of Deteriorated Concrete Beams, Floors & Walls

Robert C. Weaver Garage Feasibility Study Final Report Submission

ROBERT C. WEAVER BUILDING

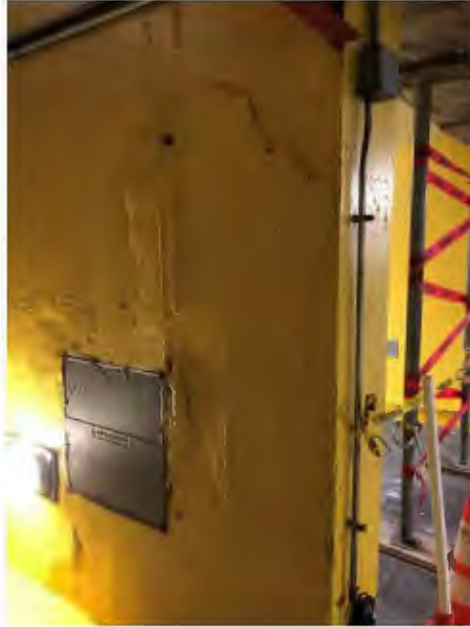
Concrete spall in wall at electrical panel and light.

Estimated quantity: 600 SF of wall repair

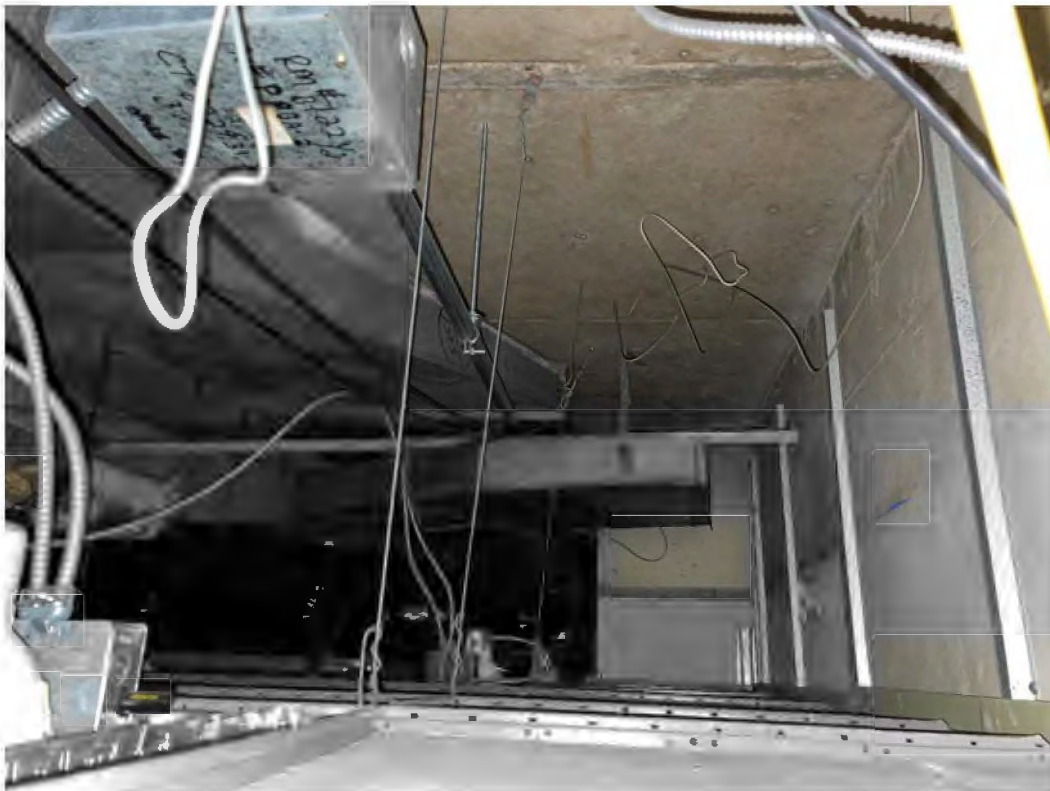
Additional observations: Room has suspended drop ceiling.

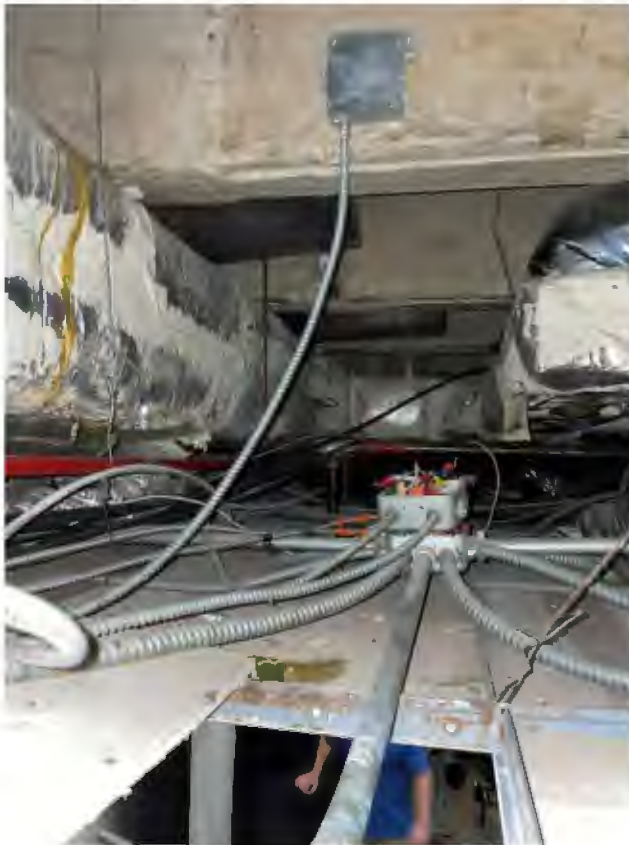
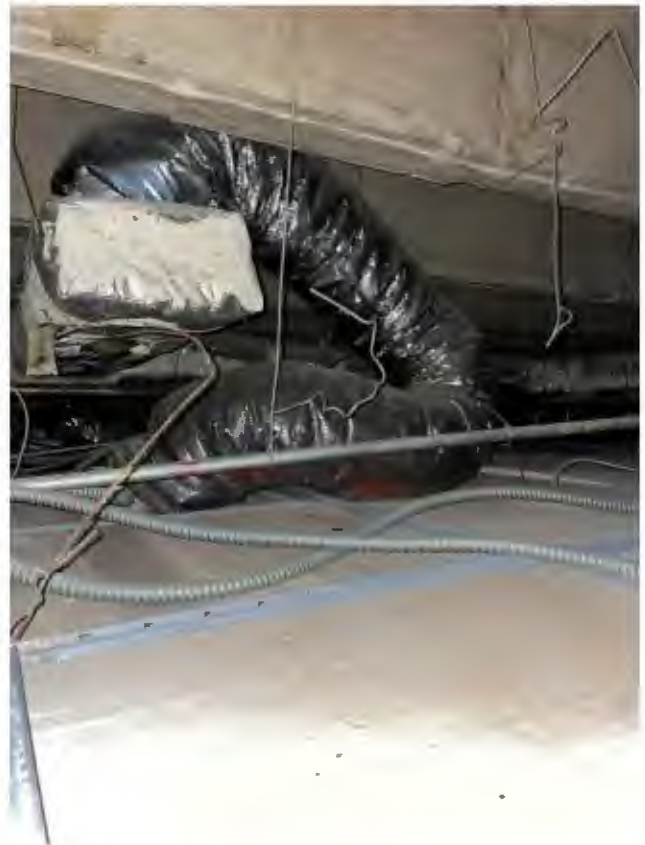
Additional observations: Room has suspended drop ceiling.

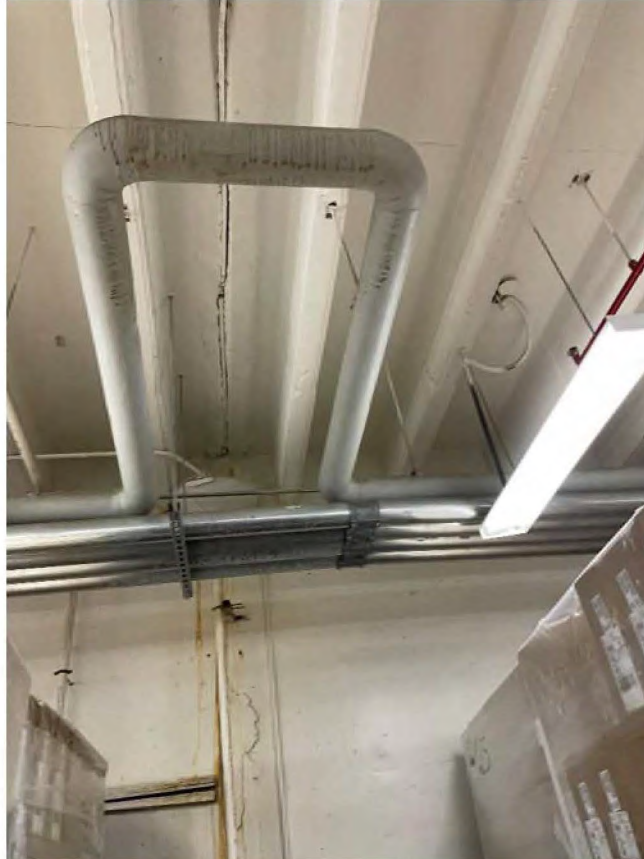
Additional observations: No additional ceiling, slab to slab is exposed. Fin tube radiation housing is significant deterioration below wall leak.

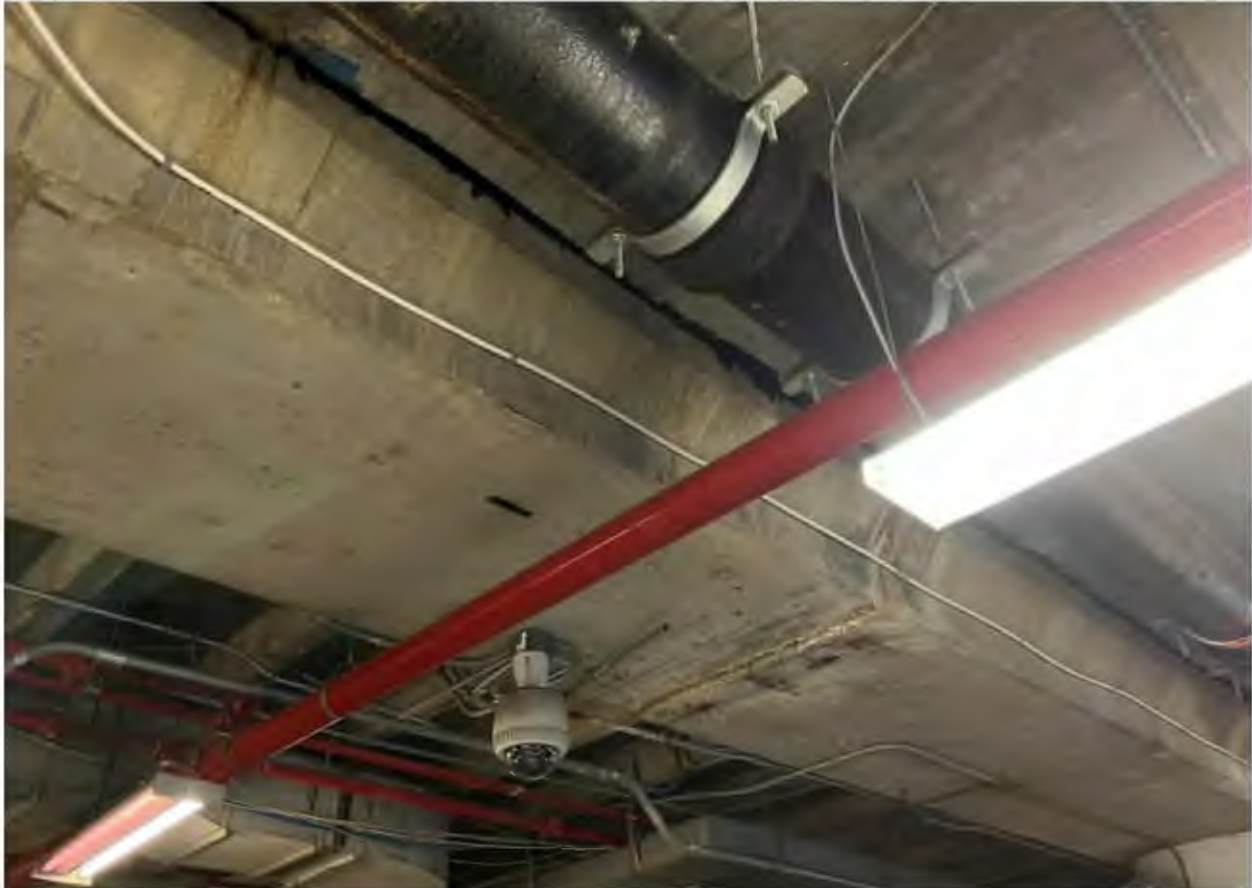
Location 1-B (Basement - Loading Dock)

The loading dock is protected by a sprinkler system. A 4" sprinkler main crosses the loading dock to building joint. The 4" sprinkler line protects the loading dock.

Disconnect and remove the 4" sprinkler line. Provide a new sprinkler line along the wall away from the joint and provide a temporary connection until the work is complete. Remove the temporary pipe and install the main back in its current location.

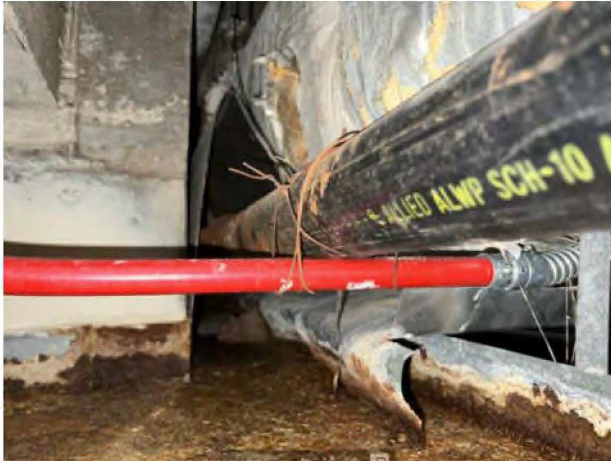
A 2.5" corroded schedule 10 black steel sprinkler cross main runs parallel to the leak capture trays between the tray along the room rear wall. Red fire alarm $\frac{3}{4}$ " conduit runs perpendicular.

Remove the corroded 2" cross main and connections to branch lines. Remove the fire alarm conduit and disconnect from existing notification appliances. Cap the sprinkler main. Reconnect the fire alarm equipment following the waterproofing work. Replace the sprinkler main which has been corroded and reconnect to existing branch lines following water proofing. Provide fire watch while sprinkler and fire alarm system are out of service.

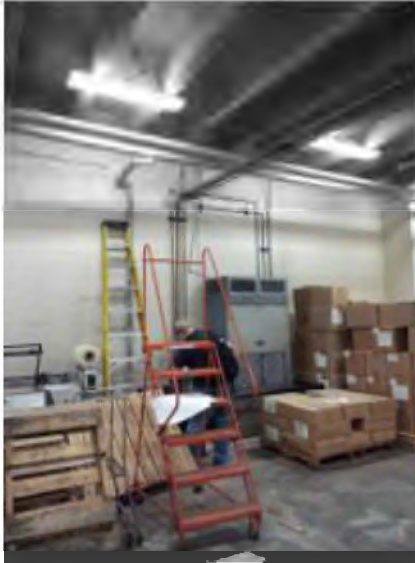
A 1" sprinkler branch and sprinkler are located adjacent to the area of waterproofing. The sprinkler is located over 5 feet from the wall. There is no fire alarm equipment.

Recommendations: Protect existing sprinkler piping during structural and fireproofing repairs.

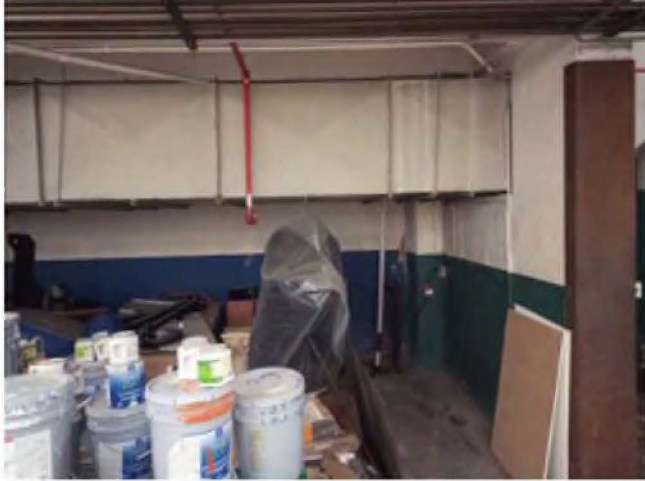
A 1" sprinkler line and sprinkler is located under the duct but over 5 feet from the waterproofing section. The sprinkler and branch line will need to be removed if the duct must be removed to correct the waterproofing. There is no fire alarm equipment.

Remove sprinkler and branch line since ductwork will be removed. Cap branch line and recharge sprinkler system. Provide fire watch during outage. Provide new sprinkler and locate existing branch line back under the ductwork.

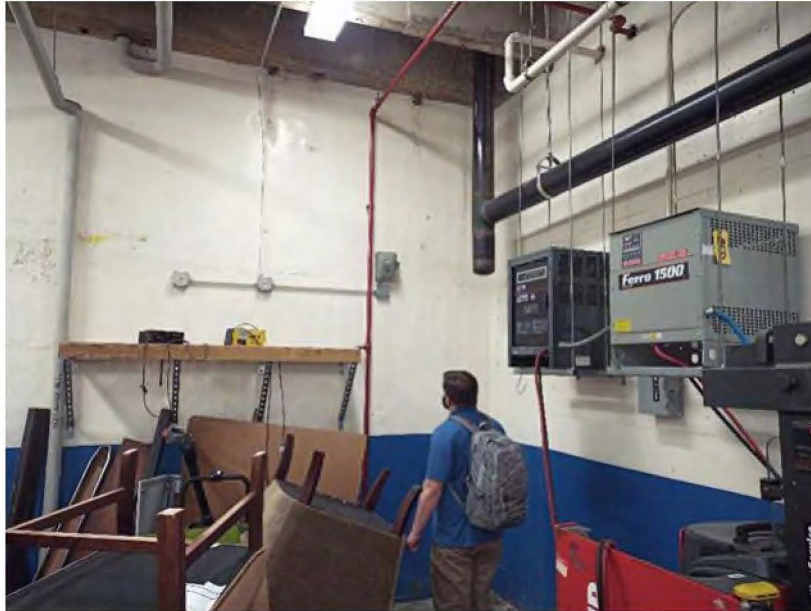
A sprinkler auxiliary drain is located on the wall. The exact location of the water proofing issue was not obvious during survey.

Remove the sprinkler drain after removing water from the system. Cap drain during work. Provide fire watch during outage. Reinstall existing drain following the work.

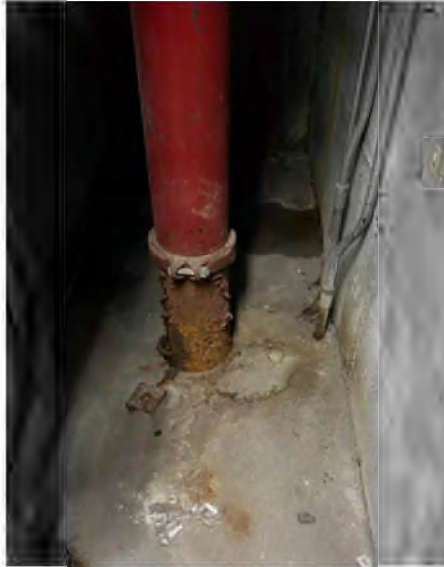
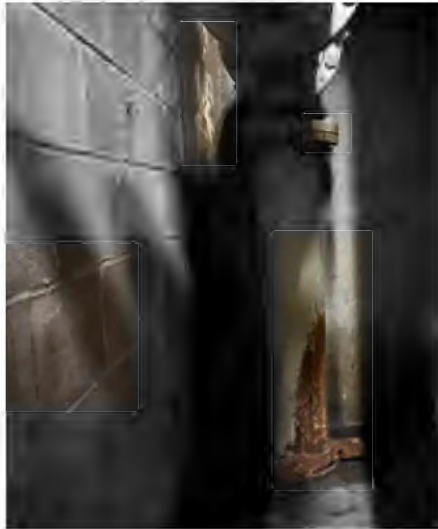
The garage has multiple incoming water lines. There are two 6" fire protection water lines. Neither water line is adjacent to the water proofing, however, there is substantial exterior corrosion.

Drain down the fire suppression system. Replace the corroded pipe. Provide new fire suppression pipe.

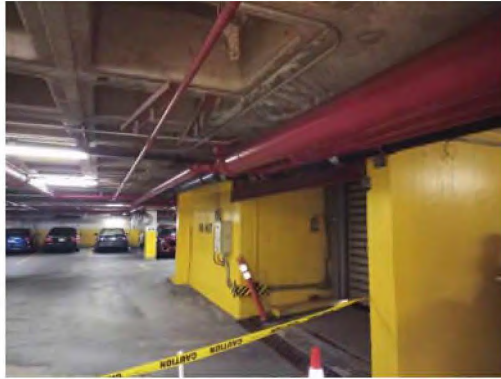
The fire suppression 6" sprinkler main is located right across the exit. Depending on the waterproofing location a sprinkler main also may need to be addressed.

Drain down the sprinkler system. Disconnect the sprinkler main and sprinkler branch line. Provide a new temporary sprinkler main during the work. Fill the sprinkler system. Following the work, disconnect the sprinkler temporary main and provide a new sprinkler pipe in the original location along the wall.

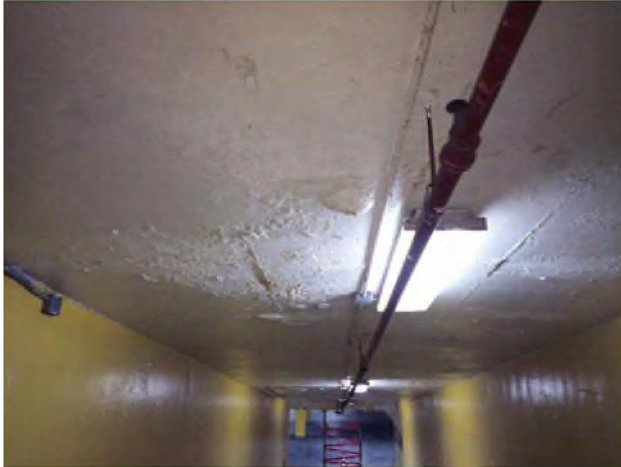
A sprinkler branch line goes down the entire ramp. There are seven sprinklers down the ramp.

The sprinkler system will be drained down. The branch line will need to be disconnected and removed. A fire watch will need to be provided during the water proofing. A new sprinkler branch line and sprinklers will need to be provided. Sidewall sprinklers and routing the sprinkler main along the wall, ceiling is suggested.

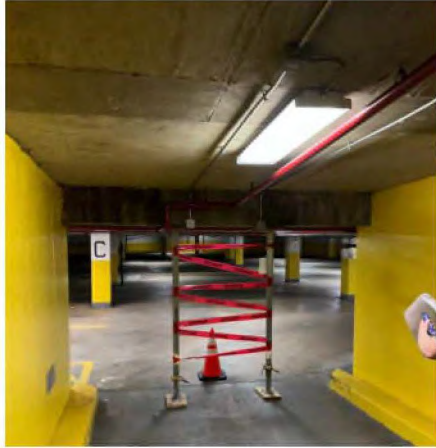
A sprinkler branch line goes down the entire ramp. There are seven sprinklers down the ramp.

The sprinkler system will be drained down. The branch line will need to be disconnected and removed. A fire watch will need to be provided during the water proofing. A new sprinkler branch line and sprinklers will need to be provided. Sidewall sprinklers and routing the sprinkler main along the wall, ceiling is suggested.

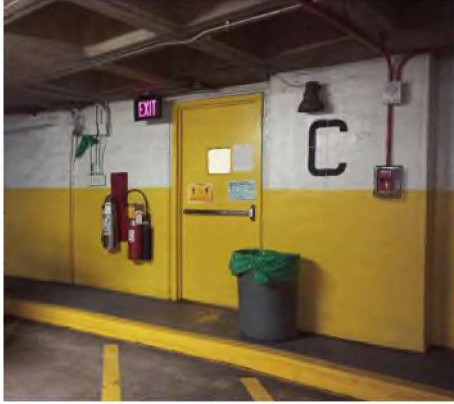
A speaker and manual pull station is located on the wall. A conduit runs under the drip pan to the equipment.

Depending on the work, the equipment could require removal. The equipment could also be worked around in the right condition. If the equipment cannot be worked around, disconnect and remove the equipment and replace following installation.

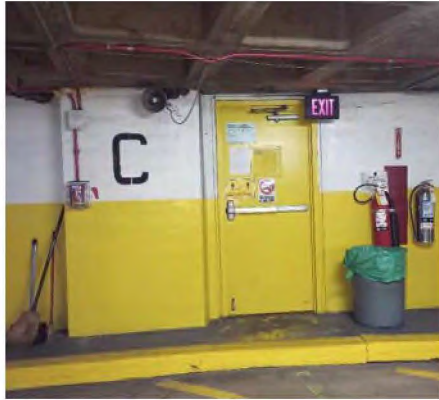
A speaker and manual pull station is located on the wall. A conduit runs under the drip pan to the equipment.

Depending on the work, the equipment could require removal. The equipment could also be worked around in the right condition. If the equipment cannot be worked around, disconnect and remove the equipment and replace following installation.

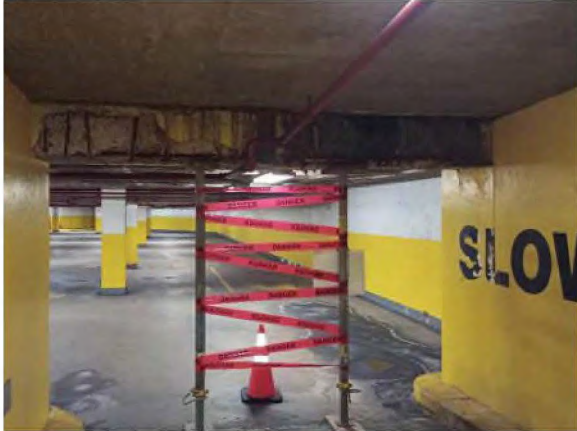
A sprinkler branch line goes down the entire ramp. There are seven sprinklers down the ramp.

The sprinkler system will be drained down. The branch line will need to be disconnected and removed. A fire watch will need to be provided during the water proofing. A new sprinkler branch line and sprinklers will need to be provided. Sidewall sprinklers and routing the sprinkler main along the wall, ceiling is suggested.

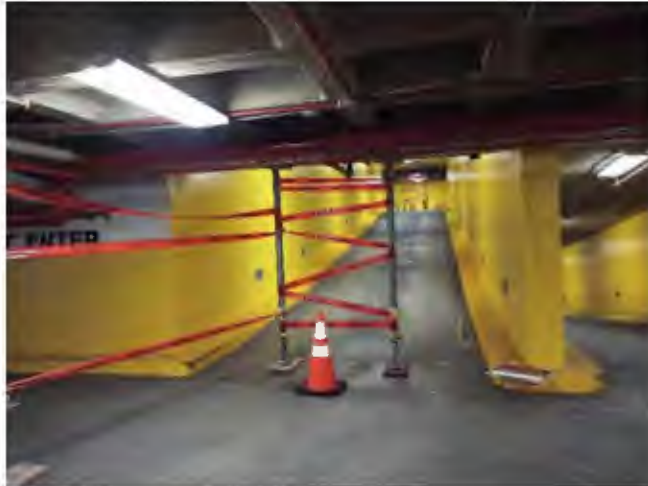
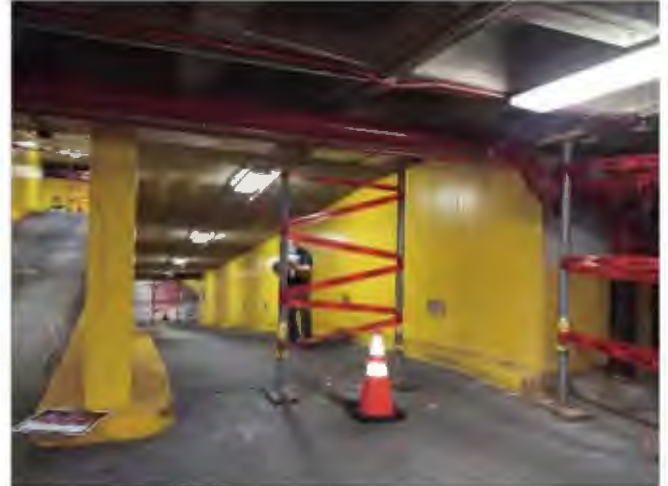
The Sprinkler main is 6".

The sprinkler main will need to be removed to correct the concrete condition and waterproof. The sprinkler system will be drained down. The sprinkler main and branch line will need to be disconnected and removed. A fire watch will need to be provided during the water proofing. A new sprinkler branch line and sprinklers will need to be provided. Sidewall sprinklers and routing the sprinkler main along the wall, ceiling is suggested.

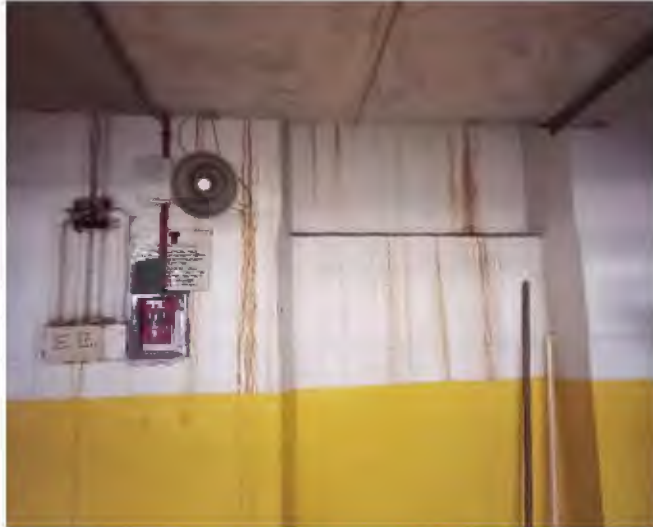
A speaker and manual pull station is located on the wall. A conduit runs under the drip pan to the equipment.

Disconnect and remove the fire alarm equipment and replace following installation. Provide a fire watch during outage. Reuse and reinstall the existing equipment.

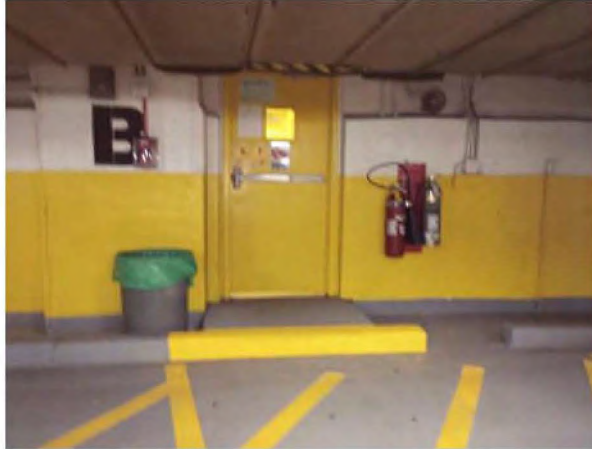
A speaker and manual pull station is located on the wall. A conduit runs under the drip pan to the equipment.

Disconnect and remove the fire alarm equipment and replace following installation. Provide a fire watch during outage. Reuse and reinstall the existing equipment.

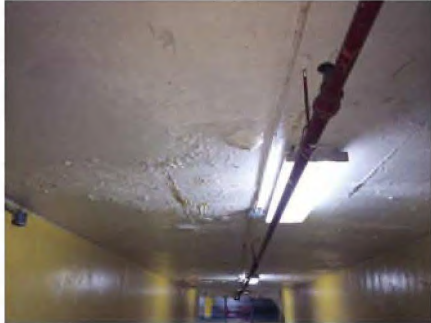
A sprinkler branch line goes down the entire ramp. There are seven sprinklers down the ramp.

The sprinkler system will be drained down. The branch line will need to be disconnected and removed. A fire watch will need to be provided during the water proofing. A new sprinkler branch line and sprinklers will need to be provided. Sidewall sprinklers and routing the sprinkler main along the wall, ceiling is suggested.

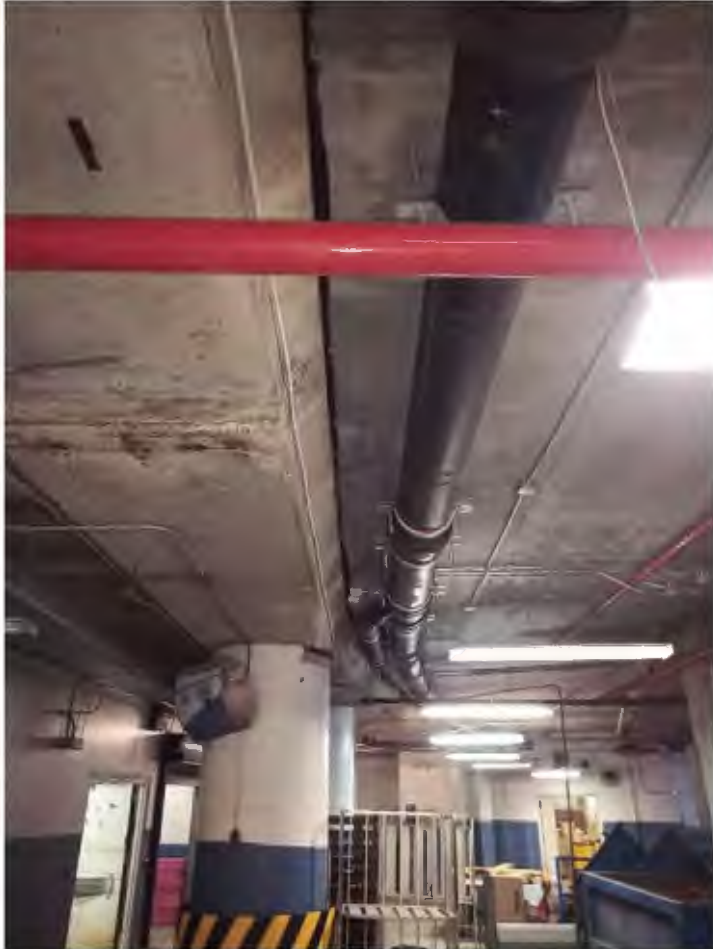
There are (6) pendant mounted fluorescent lighting fixtures within the area of work to be performed. The lighting fixtures are functional. There is no other electrical or telecommunications wiring in the proposed area of work.

Disconnect and remove the (6) closest pendant mounted fluorescent lighting fixtures with the area of work. Carefully tag and protect the existing branch circuit wiring for reuse. After the work of the project is complete, provide (6) pendant mounted fluorescent lighting fixtures to match the existing style and type, and install them at the original locations. Connect them to operate as before.

No work is recommended at this location associated with the telecommunications wiring.

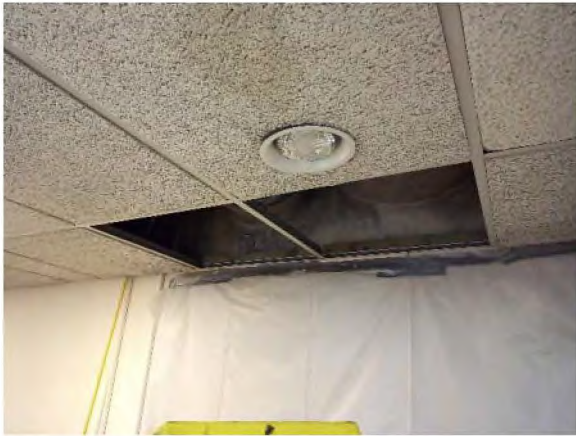
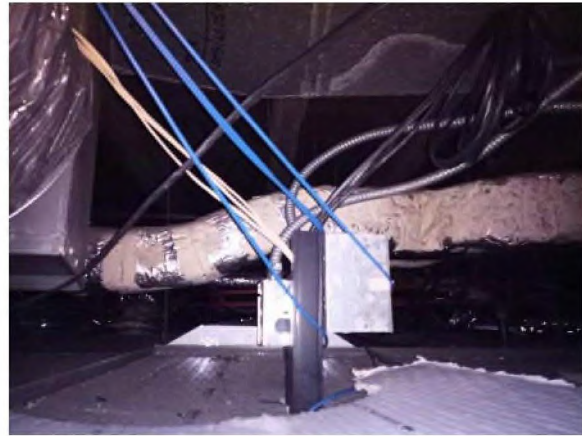
There is (1) recess mounted compact fluorescent lighting fixture located within the area of work to be performed. The lighting fixture is functional. There is a handful of telecommunications cables that are passing through the area of work.

Disconnect and remove the closest recess mounted compact fluorescent lighting fixture to the area of work. Carefully tag and protect the existing branch circuit wiring for reuse. After the work of the project is complete, and the suspended ceiling is repaired, provide (1) compact fluorescent lighting fixture to match the existing style and type, and install it at the original location. Connect it to operate as before.

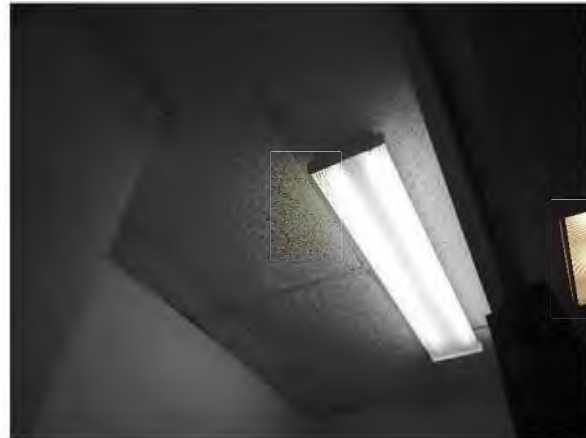
There are (2) 2'x4' recess mounted fluorescent lighting fixtures and one 4' long surface mounted fluorescent lighting fixture in and on the ceiling around the area of work to be performed. The lighting fixtures are functional. There is no other electrical or telecommunications wiring in the ceiling at this location.

Disconnect and remove the (3) closest fluorescent lighting fixtures to the area of work. Carefully tag and protect the existing branch circuit wiring for reuse. After the work of the project is complete, and the suspended ceiling is repaired, provide (2) recess mounted and (1) surface mounted fluorescent lighting fixtures to match the existing style and type, and install them at the original locations. Connect them to operate as before.

No work is recommended at this location associated with the telecommunications wiring.

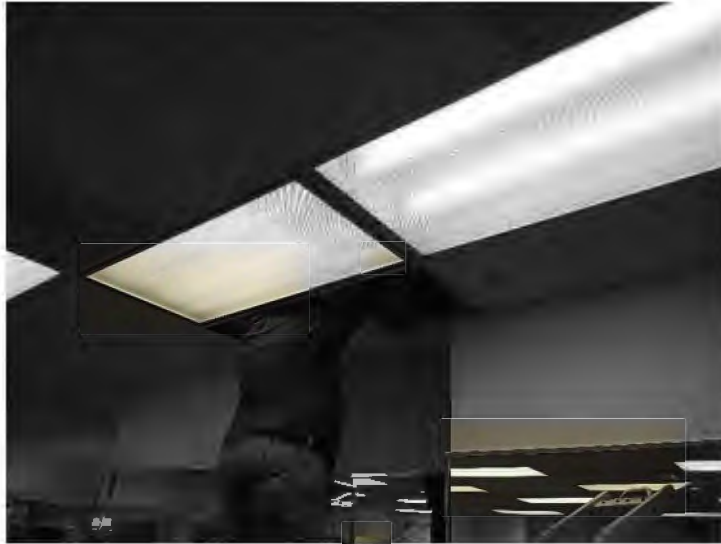
There are (2) 2'x4' recess mounted fluorescent lighting fixtures in the ceiling in or around the area of work to be performed. The lighting fixtures are functional. There is no other electrical or telecommunications wiring in the ceiling at this location.

Disconnect and remove the (2) closest recess mounted lighting fixtures to the area of work. Carefully tag and protect the existing branch circuit wiring for reuse. After the work of the project is complete, and the suspended ceiling is repaired, provide (2) fluorescent lighting fixtures to match the existing style and type, and install them at the original locations. Connect them to operate as before.

No work is recommended at this location associated with the telecommunications wiring.

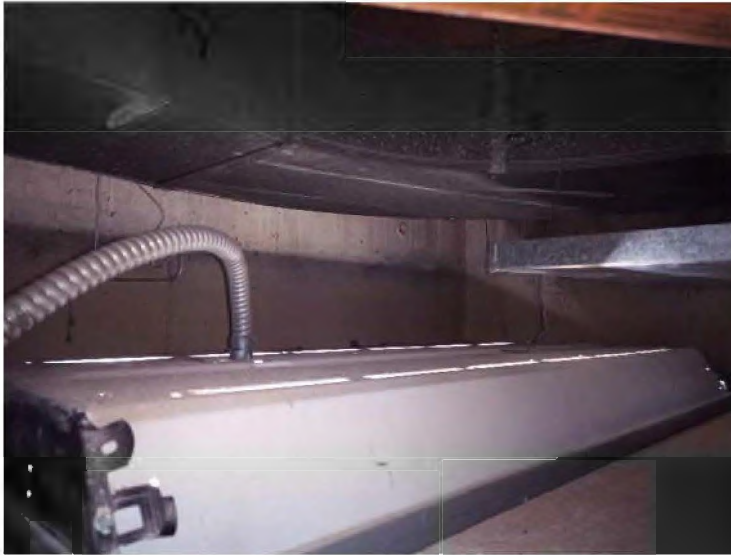
There are (2) 2'x4' recess mounted fluorescent lighting fixtures in the ceiling in or around the area of work to be performed. The lighting fixtures are functional. There is no other electrical or telecommunications wiring in the ceiling at this location.

Disconnect and remove the (2) closest recess mounted lighting fixtures to the area of work. Carefully tag and protect the existing branch circuit wiring for reuse. After the work of the project is complete, and the suspended ceiling is repaired, provide (2) fluorescent lighting fixtures to match the existing style and type, and install them at the original locations. Connect them to operate as before.

No work is recommended at this location associated with the telecommunications wiring.

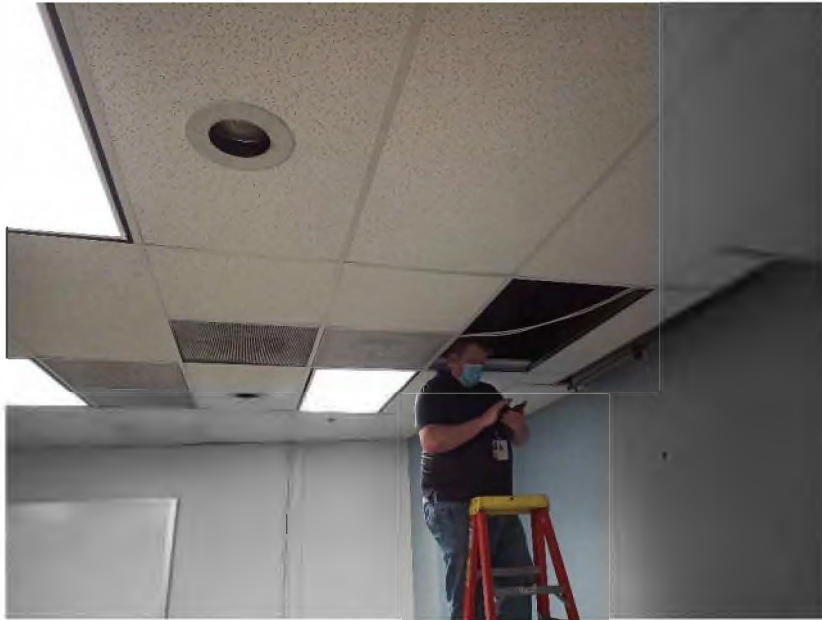
There is (1) 2'x4' recess mounted fluorescent lighting fixture within the area of work to be performed. The lighting fixture is functional. The recess mounted protector screen does not appear to be electric. There is no other electrical or telecommunications wiring in the ceiling at this location.

Disconnect and remove the closest recess mounted fluorescent lighting fixture within the area of work. Carefully tag and protect the existing branch circuit wiring for reuse. After the work of the project is complete, and the suspended ceiling is repaired, provide a recess mounted fluorescent lighting fixture to match the existing style and type, and install it at the original location. Connect it to operate as before.

No work is recommended at this location associated with the telecommunications wiring.

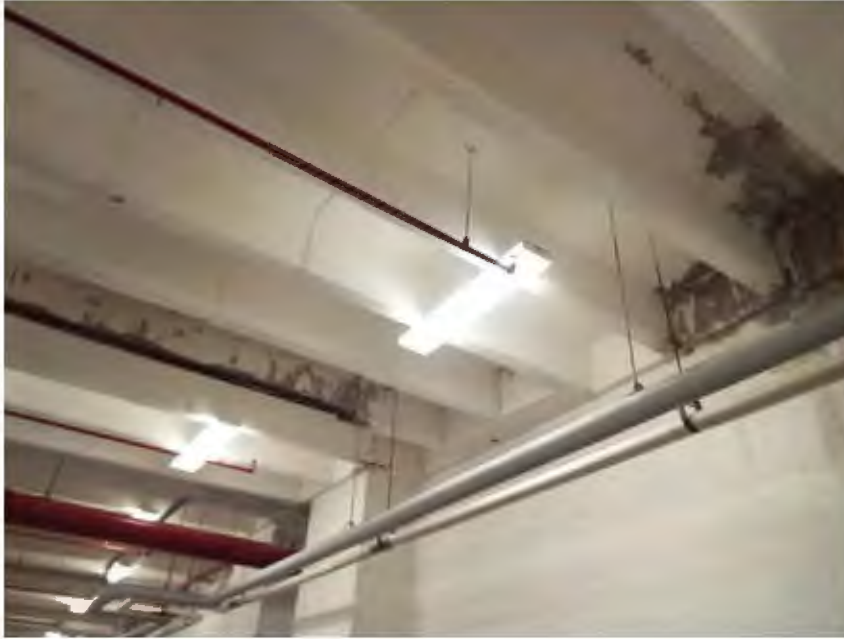
There are (2) pendant mounted fluorescent lighting fixtures within the area of work to be performed. The lighting fixtures are functional. There is no other electrical or telecommunications wiring in the proposed area of work.

Disconnect and remove the (2) closest pendant mounted fluorescent lighting fixtures with the area of work. Carefully tag and protect the existing branch circuit wiring for reuse. After the work of the project is complete, provide (2) pendant mounted fluorescent lighting fixtures to match the existing style and type, and install them at the original locations. Connect them to operate as before.

No work is recommended at this location associated with the telecommunications wiring.

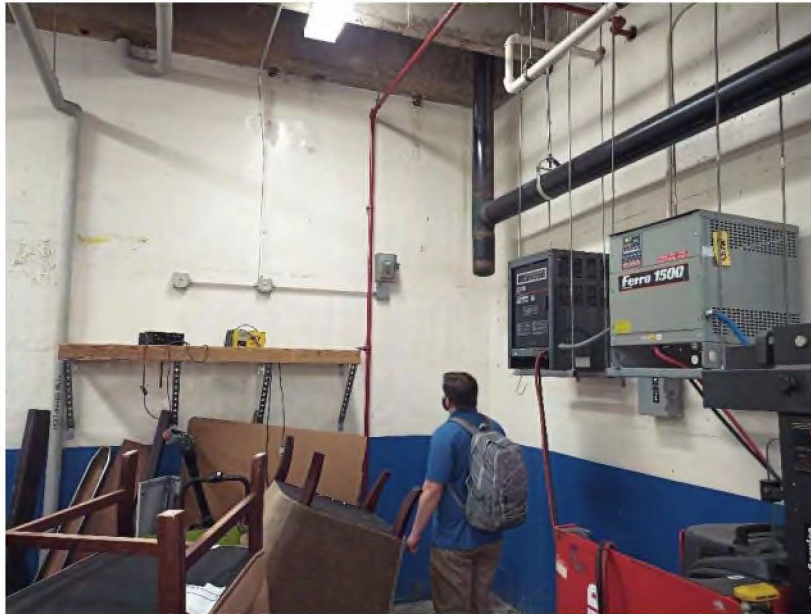
There are (2) pendant mounted fluorescent lighting fixtures within the area of work to be performed. The lighting fixtures are functional. There is no other electrical or telecommunications wiring in the proposed area of work.

Disconnect and remove the (2) closest pendant mounted fluorescent lighting fixtures with the area of work. Carefully tag and protect the existing branch circuit wiring for reuse. After the work of the project is complete, provide (2) pendant mounted fluorescent lighting fixtures to match the existing style and type, and install them at the original locations. Connect them to operate as before.

No work is recommended at this location associated with the telecommunications wiring.

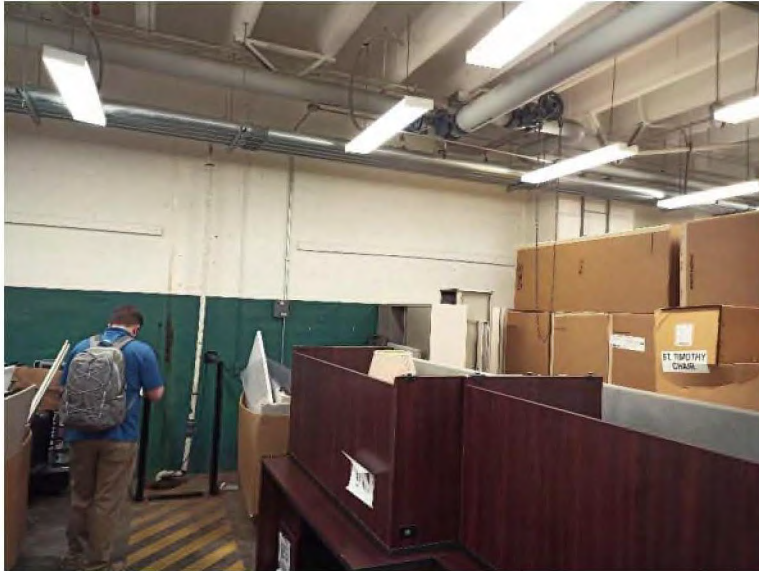
There are (2) pendant mounted fluorescent lighting fixtures within the area of work to be performed. The lighting fixtures are functional. There is no other electrical or telecommunications wiring in the proposed area of work.

Disconnect and remove the (2) closest pendant mounted fluorescent lighting fixtures with the area of work. Carefully tag and protect the existing branch circuit wiring for reuse. After the work of the project is complete, provide (2) pendant mounted fluorescent lighting fixtures to match the existing style and type, and install them at the original locations. Connect them to operate as before.

No work is recommended at this location associated with the telecommunications wiring.

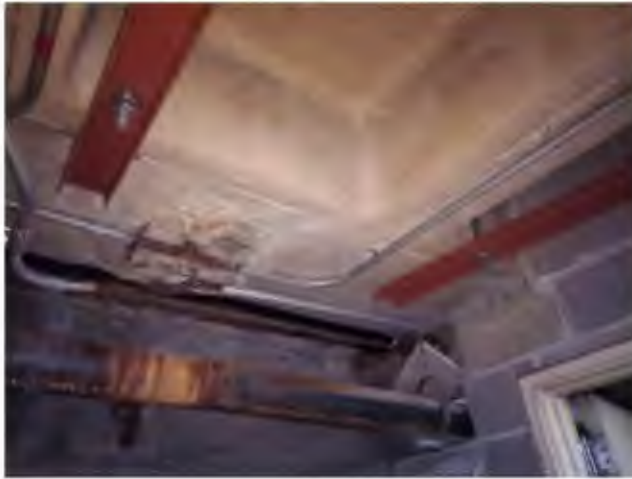
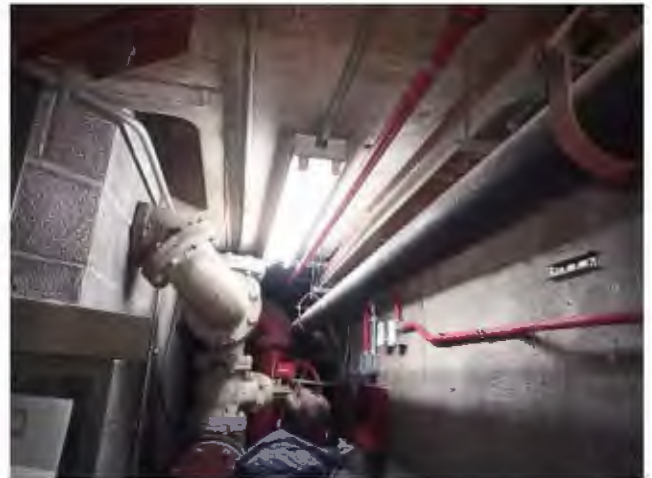
There is (1) surface mounted fluorescent lighting fixture within the area of work to be performed. The lighting fixture is functional. There is a mechanical unit location directly below the proposed area of work. There is no other electrical or telecommunications wiring in the proposed area of work.

Disconnect and remove the surface mounted fluorescent lighting fixture within the area of work. Carefully tag and protect the existing branch circuit wiring for reuse. After the work of the project is complete, provide a surface mounted fluorescent lighting fixture to match the existing style and type, and install it at the original location. Connect it to operate as before.

No work is recommended at this location associated with the telecommunications wiring.

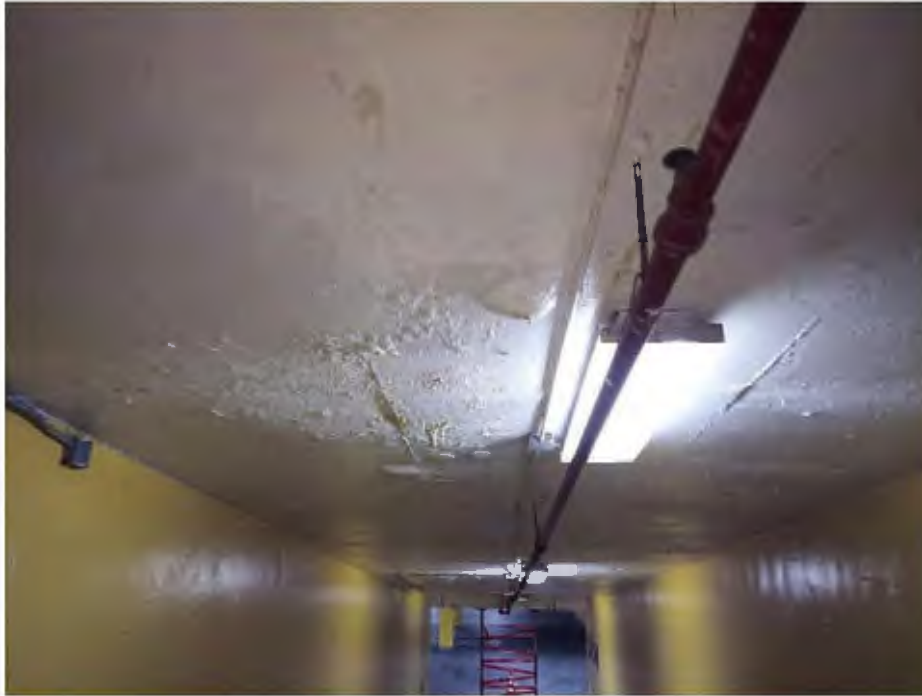
There is (1) surface mounted fluorescent lighting fixture within the area of work to be performed. The lighting fixture is functional. There is a mechanical unit location directly below the proposed area of work. There is no other electrical or telecommunications wiring in the proposed area of work.

Disconnect and remove the surface mounted fluorescent lighting fixture within the area of work. Carefully tag and protect the existing branch circuit wiring for reuse. After the work of the project is complete, provide a surface mounted fluorescent lighting fixture to match the existing style and type, and install it at the original location. Connect it to operate as before.

No work is recommended at this location associated with the telecommunications wiring.

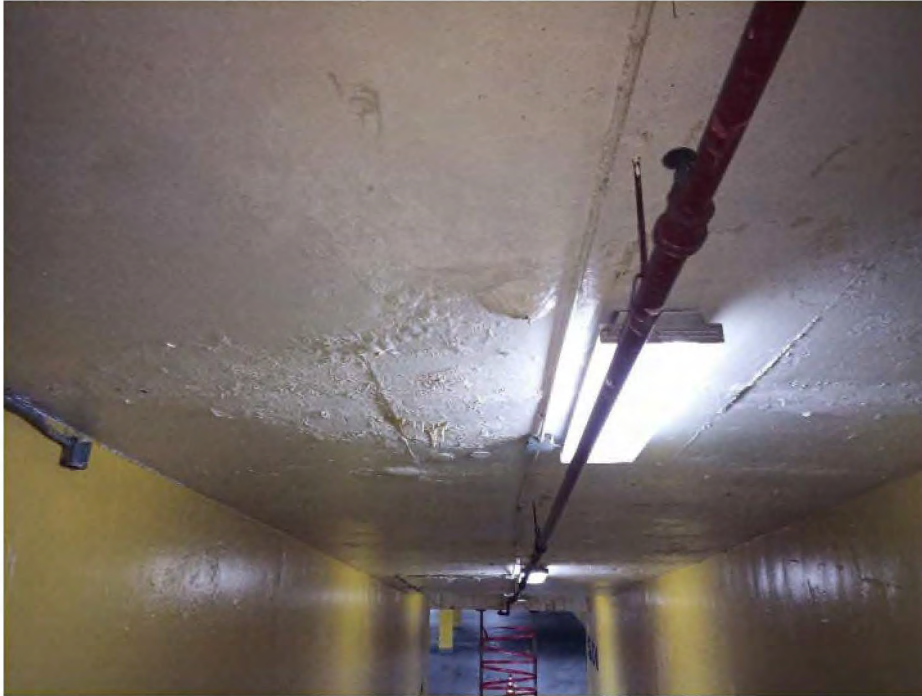
There is (1) surface mounted fluorescent lighting fixture within the area of work to be performed. The lighting fixture is functional. There is a mechanical unit location directly below the proposed area of work. There is no other electrical or telecommunications wiring in the proposed area of work.

Disconnect and remove the surface mounted fluorescent lighting fixture within the area of work. Carefully tag and protect the existing branch circuit wiring for reuse. After the work of the project is complete, provide a surface mounted fluorescent lighting fixture to match the existing style and type, and install it at the original location. Connect it to operate as before.

No work is recommended at this location associated with the telecommunications wiring.

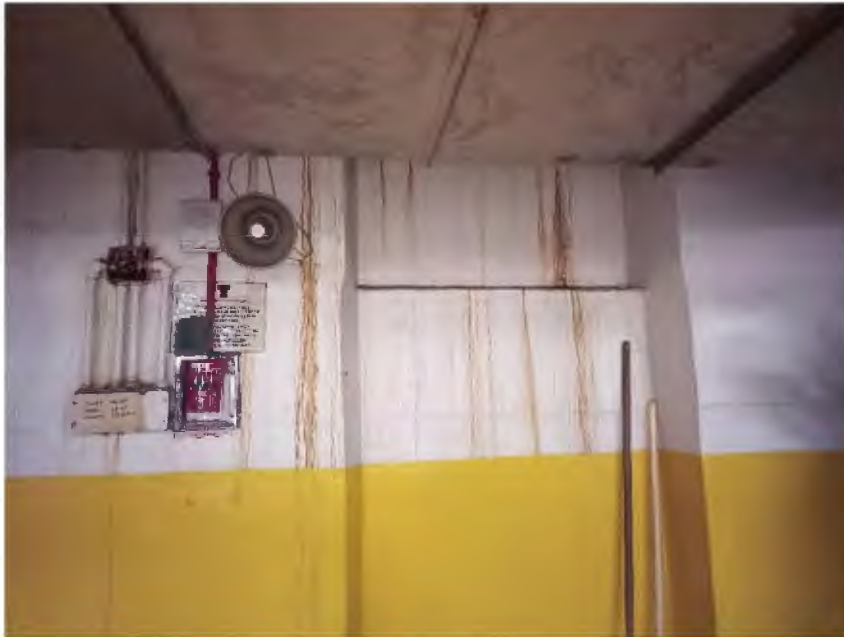
There are no lighting fixtures at or near the proposed area of work. There is a single branch circuit conduit located within the area of work. There is a public address speaker surface mounted on the wall near the proposed area of work. There are no other telecommunications cables or wires at or near the proposed area of work

There is no lighting work at this location. Circuit trace the (1) existing branch circuit conduit and conductors and identify to the Government prior to the start of construction. Carefully disconnect each existing branch circuit at the nearest existing junction box or device outside the area of work. Tag and protect for reuse. After the work of the project is complete, provide new branch circuit conduit and conductors and reconnect to operate as before.

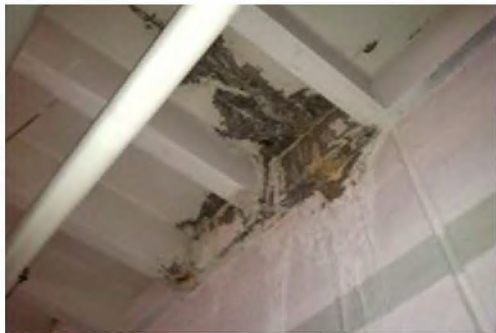
A2020 - Structural Slab Spalling - Repair

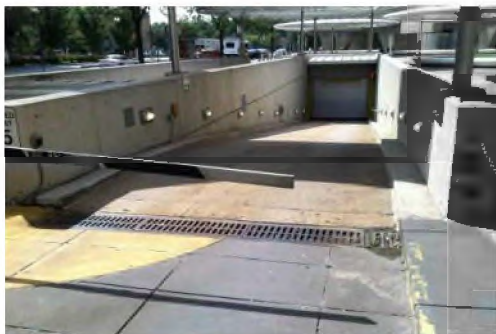
B1015 - Exterior Plaza Handrail Falloff Protection - Add

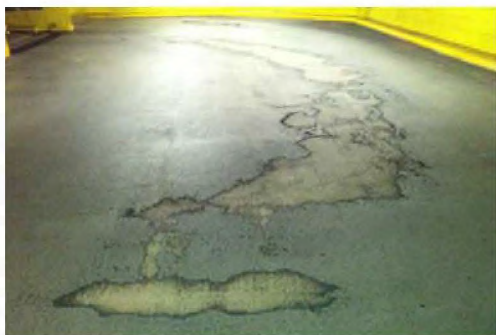
B1015 - Garage Ramp Falloff Protection - Add

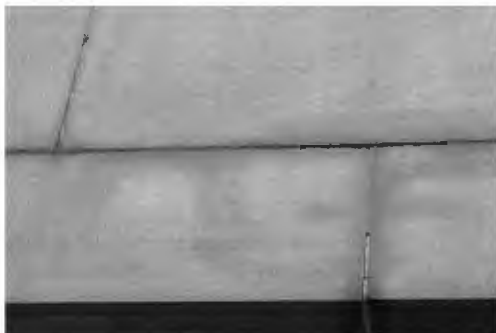
B1019 - Parking Decks - Repair

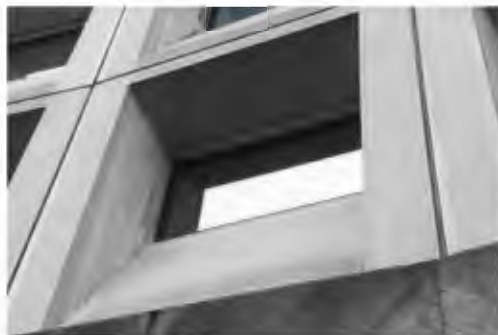
B2010 - Exterior Granite Facades - Repair

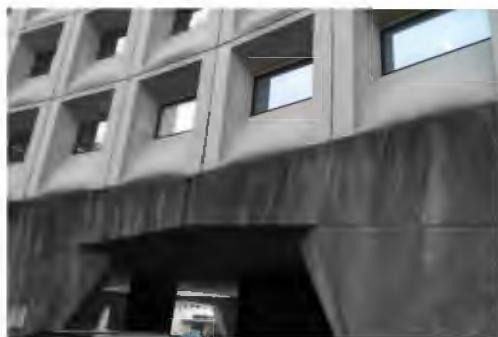
B2010 - Exterior Precast Levels 2-10 - Clean

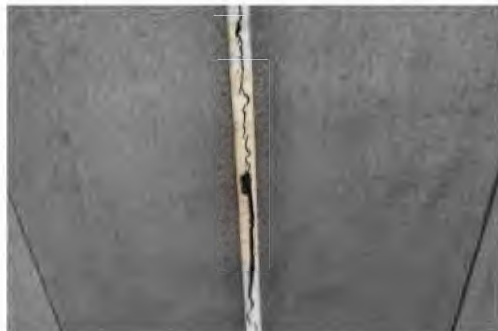
B2011 - Exterior Tree Columns Spalling - Repair

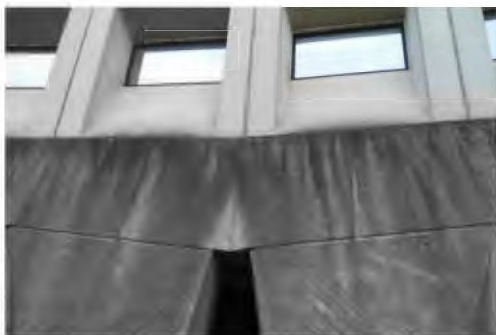
B2011 - Exterior Wall Expansion Joint - Replace

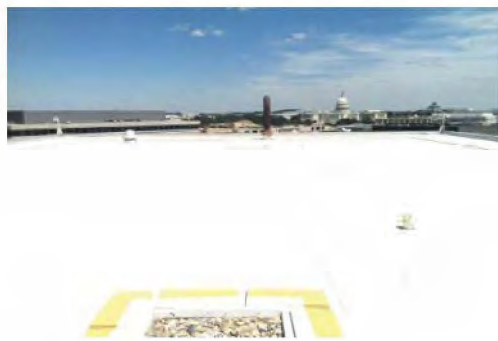
CODE/REGULATION. OSHA 1926 Subpart M - Fall Protection Standards. ANSI T-14.1-2001 Window Cleaning Safety (2001).

Action Name	B3011 - Roof System Fall Protection - Add
Option	Conventional
Prime Action	Yes
Description	<p>REMEDY. Add roof top fall protection pedestal tiebacks, approximately 10' behind the parapet. Anchor galvanized pedestals securely to concrete roof deck. Pull-out testing must be performed to ensure compliance with applicable standards.</p> <p>IMPLEMENTATION. Replacement will include roofing rework around added penetrations.</p>

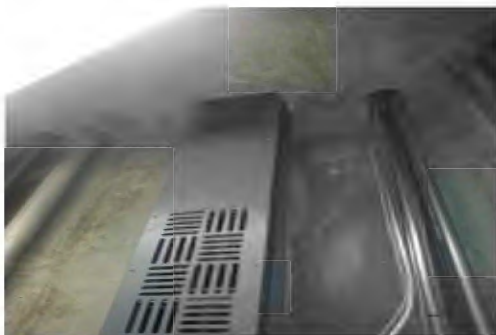
C1011 - Electrical Closet Shaft Opening - Add Rated Separation

CONDITION/PROBLEM: There is a shaft opening inside an electrical closet which requires rated separation.

CAUSE: Unknown.

CODE/STANDARD: NFPA 101 (2012): Section 8.3.5.1.

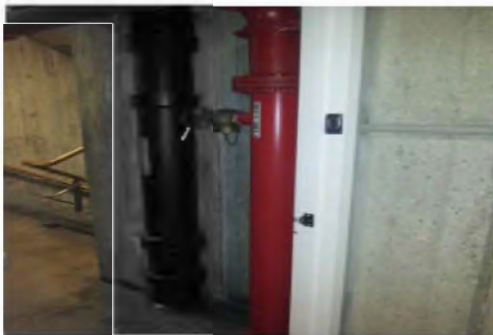
C1011 - Exposed 8 StormSewer Lines in Stairs - Add Rated Separation

CONDITION/PROBLEM. The 8" storm/sewer lines located in four of the egress stairs are exposed.

CAUSE. Original design did not require separation.

CODE/STANDARD. NFPA 101 (2012); Section 7.1.

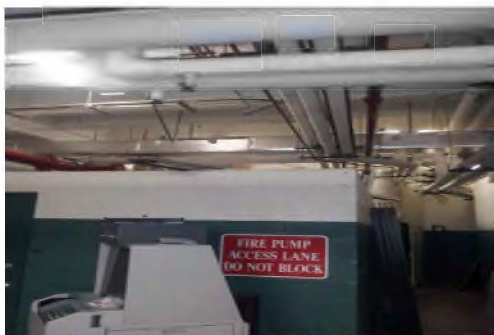
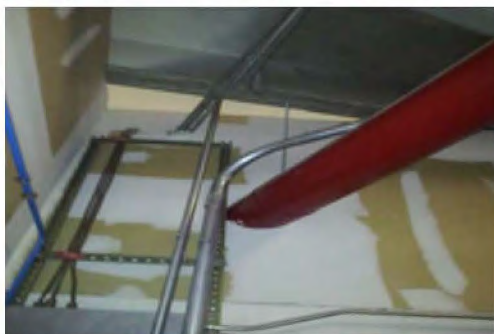
C1011 - Fire Pump Room - Add Rated Separation 1

CONDITION/PROBLEM. The fire pump is not enclosed in a rated room.

CAUSE. Unknown.

CODE/STANDARD. IBC (2012); Section 913.2.1

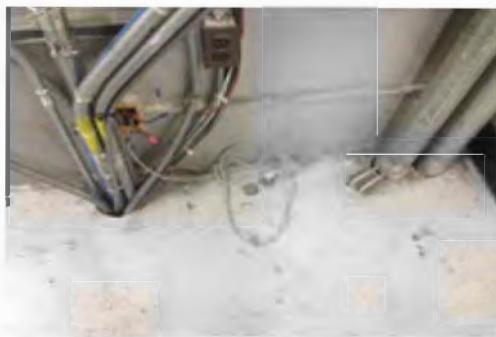
CONDITION/PROBLEM. Penetrations have been made in the 2-hour rated floors of the telephone and electrical closets, as well as the transformer vault.

CAUSE. Contractors and in-house personnel create penetrations in rated assemblies and do not properly seal them.

CODE/REGULATION. NFPA 101 (2012); Section 8.3.5.1.

Action Name	C1011 - Firestopping @ Floor Penetrations - Repair
Option	Conventional
Prime Action	Yes
Description	<p>REMEDY. Provide firestopping as required on both sides of floor penetrations.</p> <p>IMPLEMENTATION. Survey building to determine exact locations. Upon identification of locations, remove any debris from around the existing penetration. Install a listed firestopping material per the manufacturer's listing. Install a listed firestopping caulk where all conduit and cable are penetrating the rated assemblies.</p>
