Description of document: General Services Administration (GSA) Infrastructure Assessment for the Weaver Building (the HUD Headquarters Building) 2013-2025

PROJECT: Department of Housing & Urban development (HUD) Headquarters – Weaver Building
Investigation of Deteriorated Concrete Beams, Floors & Walls

Robert C. Weaver Garage Feasibility Study Final Report Submission

ROBERT C. WEAVER BUILDING

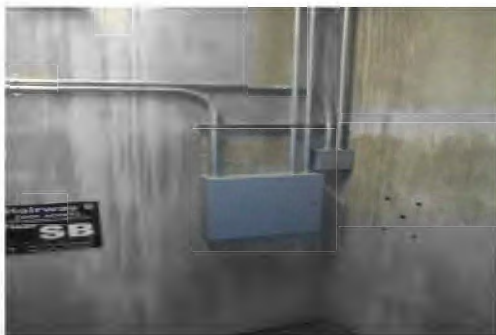
C1011 - Panels and Conduits Exposed in Stairs - Add Rated Separation

CONDITION/PROBLEM. Large 3" electrical conduits and panels are exposed in various fire stairs.

CAUSE. Unknown.

CODE/STANDARD. NFPA 101 (2012); Section 7.2.2.

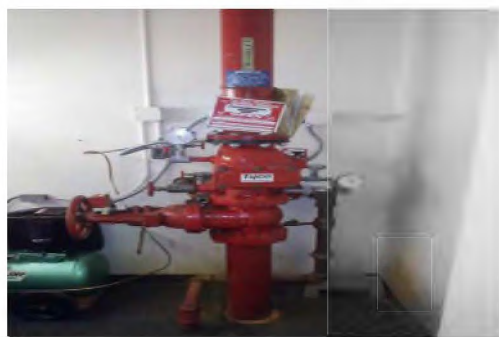
C1011 - Standpipes Not Enclosed - Add Rated Separation

CONDITION/PROBLEM. The standpipes on the first floor are not enclosed with fire resistant construction.

CAUSE. Unknown.

CODE/STANDARD. NFPA 101 (2012); Section 7.1.

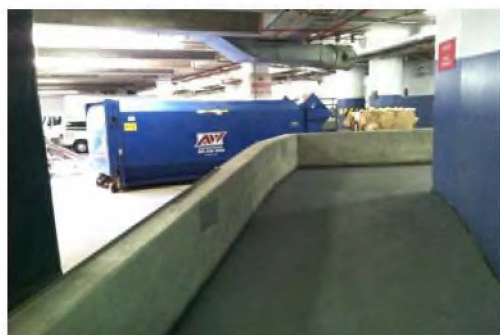
C2010 - Loading Dock Handrails - Provide Guards

CODE/REGULATION. National Fire Protection Association (NFPA), 2012 - 101. Life Safety Code. 7.2.2.4.4 Handrail Details.

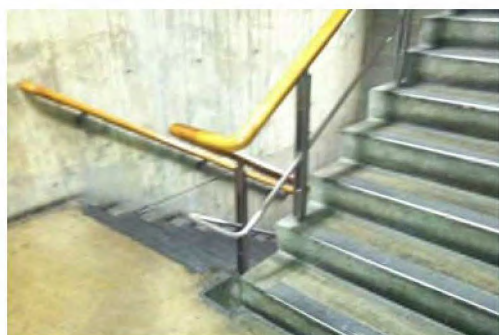
C2014 - Stair Guards and Handrails - Replace

CODE/REGULATION. National Fire Protection Association (NFPA), 2012 - 101, Life Safety Code. 7.2.2.4.4 Handrail Details.

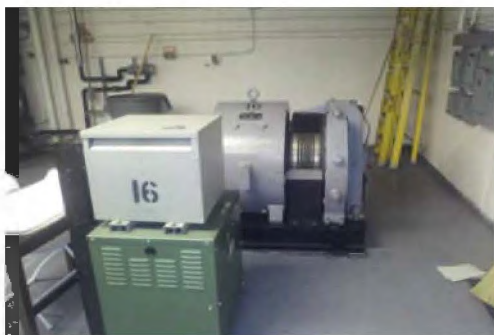
D1011 - Passenger Elevators - Modernize

CODE/REGULATION. International Building Code (IBC) Chapter 30, Elevators and Conveying Systems; Architectural Barriers Act Section 407, Elevators.

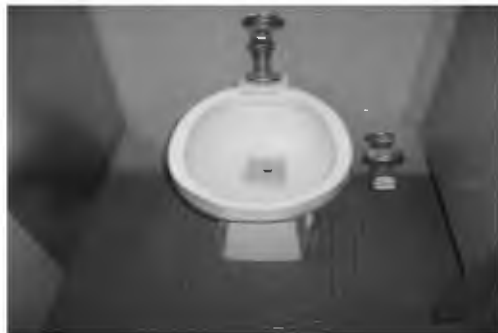
D2010 - Plumbing fixtures - Replace

Code Reference: ADA 4.15 through 4.24, GSA P100 5.20.

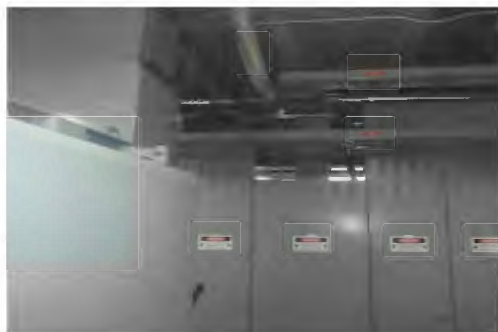
D4010 – Fire Sprinklers Electrical Rooms - Modify

CODE/REGULATION. National Fire Protection Association, NFPA 13 Standard for the Installation of Sprinkler Systems and NFPA 70 National Electrical Code.

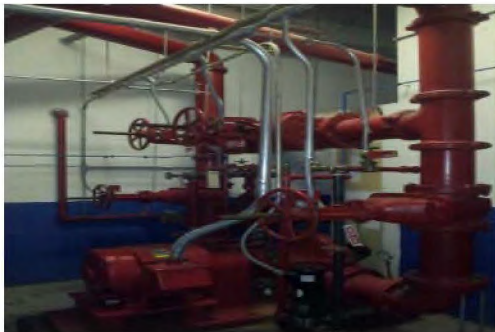
D4011 - Sprinkler Water Supply - Increase size of supply

CODE/STANDARD. NFPA 20 Section 11.2.6.2

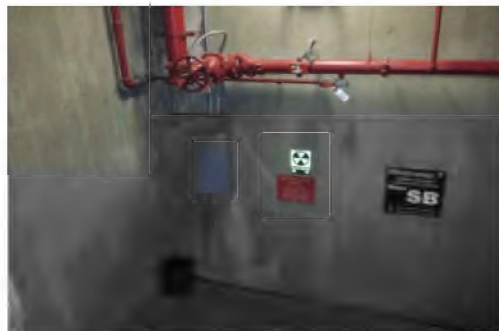
D4024 - Fire Hose Valve - Install

CODE/STANDARD: NFPA 101 Section 9.7.4.2

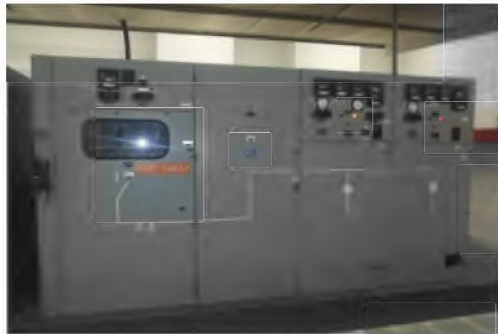
CONDITION/PROBLEM: The Primary Service Equipment is approaching 50 years in age and is beyond its useful life expectancy. Parts are no longer readily available and the installation does not meet current NEC and OSHA requirements.

CAUSE: Age.

CODE/REGULATION: NEC 110.26, 110.27
408, 490

Action Name	D5011 - Medium Voltage Primary Service Switchgear - Replace
Option	Conventional
Prime Action	Yes
Description	REMEDY: Replace the switchgear. IMPLEMENTATION: Replace entire service. Install a new switchgear to replace non-compliant & aging switchgear. Replace existing

Medium Voltage Primary Switchgear as well as obsolete feeders & branch circuits with deteriorated or degraded insulation should be replaced.

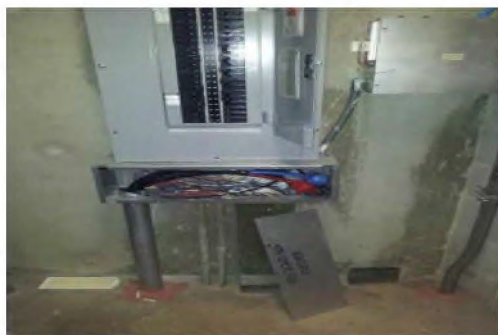
D5012 - Electric Distribution - Add New Power Risers

CONDITION/PROBLEM. Existing panels do not have spare circuits, and existing transformers are "buzzing" from overloading.

CAUSE. Increased electrical loads.

CODE/STANDARD. NEC 220

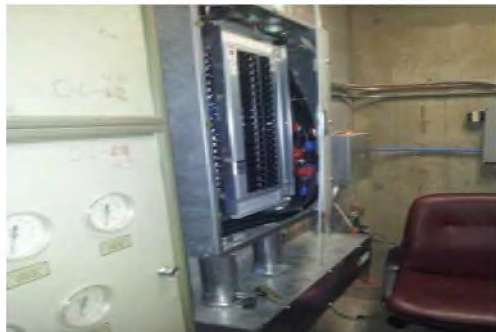
PROBLEM/CONDITION. There are multiple junction boxes, light switches, and receptacles that do not have covers attached, therefore exposing the wiring inside the box. Also many panels are missing blank circuit covers.

CAUSE. Poor maintenance.

CODE/STANDARD. NEC 370-28(3)(c).

Action Name	D5012 - Electrical Equipment Covers Missing - Replace
Option	Conventional
Prime Action	Yes
Description	REMEDY. Furnish and install covers as required. IMPLEMENTATION. During regular maintenance cycles replace missing covers.

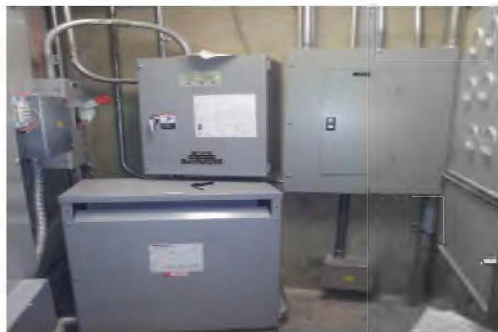
D5012 - Electrical Panels Clearance- Modify

CONDITION/PROBLEM. Electrical panels do not have the required working clearance in front of them.

CAUSE. Incorrect installation.

CODE/REGULATION. NEC 110.26.

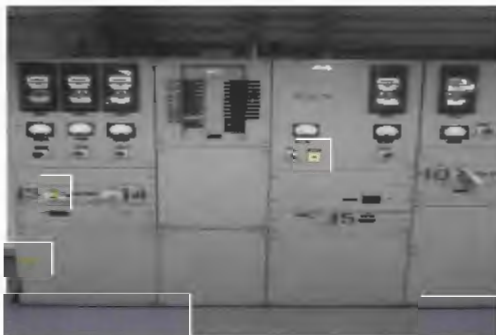
CONDITION/PROBLEM. The 480 volt elevator switchboards are beyond their reliable life.

CAUSE. Age.

Action Name	D5012 - Elevator Electrical Switchboard - Replace
Option	Conventional
Prime Action	Yes
Description	REMEDY. Replace the existing 600amp elevator switchboards located in the elevator machine rooms. IMPLEMENTATION. Estimates as shown reflect simple replacement of existing equipment.

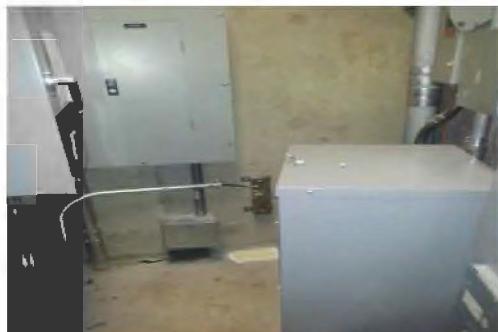
D5012 - Existing Electrical Busduct - Recondition

CONDITION/PROBLEM. The existing electrical busduct running up through the buildings electrical closets need to be reconditioned. This should include megger testing, checking connections for tightness, and checking equipment directly connected onto the duct.

CAUSE. Age

CODE/STANDARD. NFPA 70E

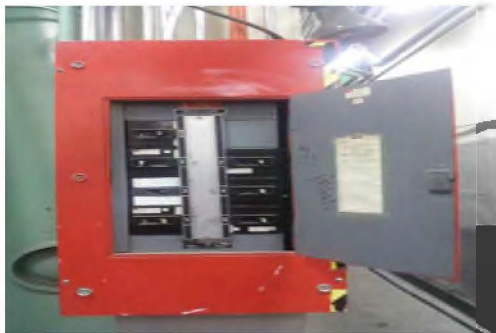
CONDITION/PROBLEM: Many of the low voltage branch panels in the Mechanical Rooms were made by manufacturers that are now out of business and have exceeded their useful life.

CAUSE: Age and normal use.

Action Name	D5012 - Mechanical Room Panels - Replace
Option	Conventional
Prime Action	Yes
Description	REMEDY: Replace original HVAC branch panels.

IMPLEMENTATION: Provide temporary power to critical circuits. Remove existing panel interiors and install new replacement interiors. Reconnect circuits.

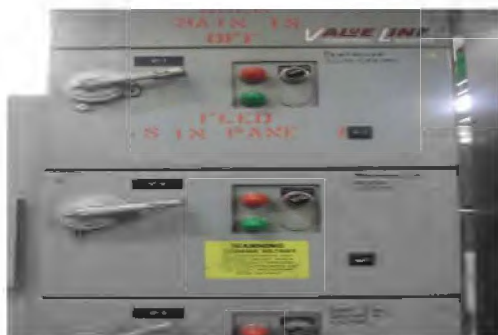
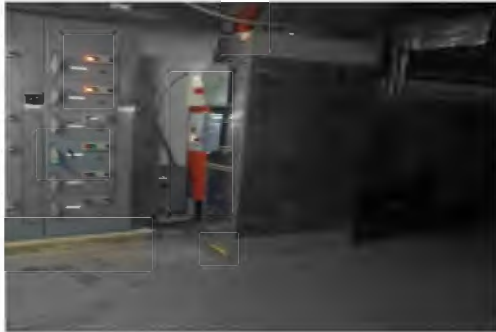
D5012 - Misc Electrical Equipment Motor Control Centers - Replace

CONDITION/PROBLEM: While most of the electrical distribution was replaced in the last ten years, there were some MCCs that were used as transition devices and then never taken out of service.

CAUSE: Age and normal use.

CODE/REGULATION: NEC 110-22 and 26. NEC 430

Description REMEDY. Replace obsolete motor control centers.

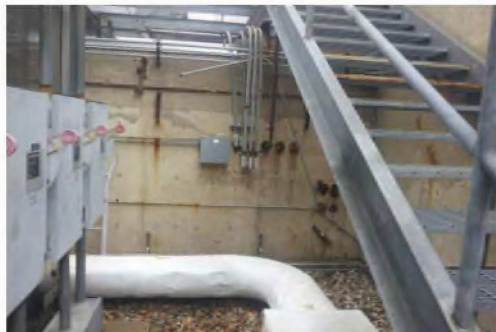
D5021 - Rooftop Electrical Outlets and Misc - Repair

CONDITION/PROBLEM. Receptacles roof near the Cooling Towers were exposed to the weather, and did not have WP covers. There were als several pieces of abandoned equipment and material left unsecured and rusting.

CAUSE. Age and obsolescence.

Action Name	D5021 - Rooftop Electrical Outlets and Misc. - Repair
Option	Conventional
Prime Action	Yes
Description	REMEDY. Provide weather proof covers for exterior receptacles and remove abandoned equipment. IMPLEMENTATION. Assess abandoned equipment and remove as necessary.

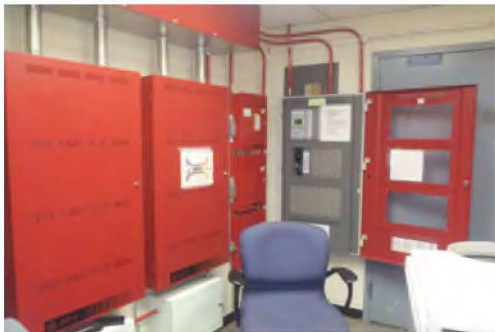
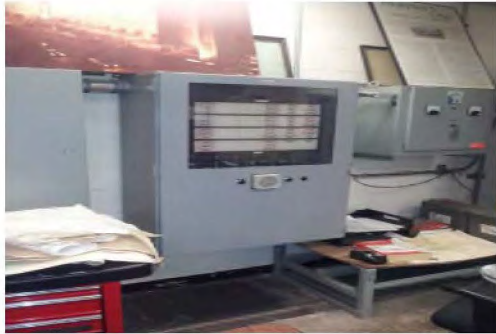
D5037 - Fire Alarm System - Replace 1

CONDITION/PROBLEM. The fire alarm system needs replacement (other than the EST3 which was replaced two years ago) due to the following reasons: older style strobes are located throughout the building; there is insufficient strobe coverage throughout the building (i.e., lack of strobes in copy rooms, workrooms, and conference rooms, overspacing in bathrooms, corridors and open offices, etc.); strobes are located above 80" in many locations throughout the building; older style conventional system that is no longer manufactured; no smoke detectors are provided in any of the mechanical, electrical, or telephone rooms/closets; the pull stations at the central stairs are located at 62" – well above the maximum height; the duct smoke detectors are not working; the garage dry sprinkler system is not currently monitored; the penthouse only has two bells – one of which is damaged.

CAUSE. Revisions to code requirements since original design, construction and obsolescence of equipment.

CODE/REGULATION. International Building Code, Chapter 9, Fire Protection Systems

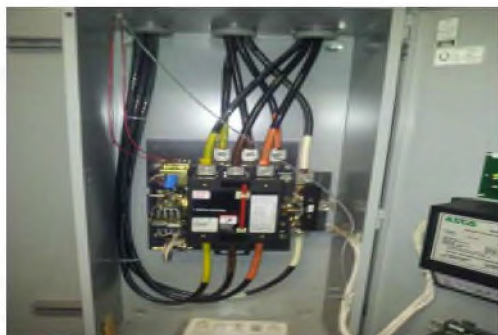
D5091 - Emergency Grounding System Study - Perform

CODE/STANDARD. NEC 250

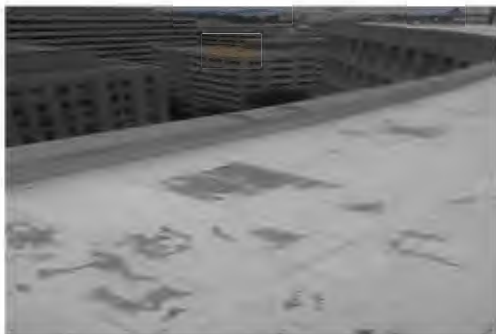
D5091 - Lightning Protection System – Install

CODE/REGULATION. NFPA 780- Standard for the installation of lightning protection systems.

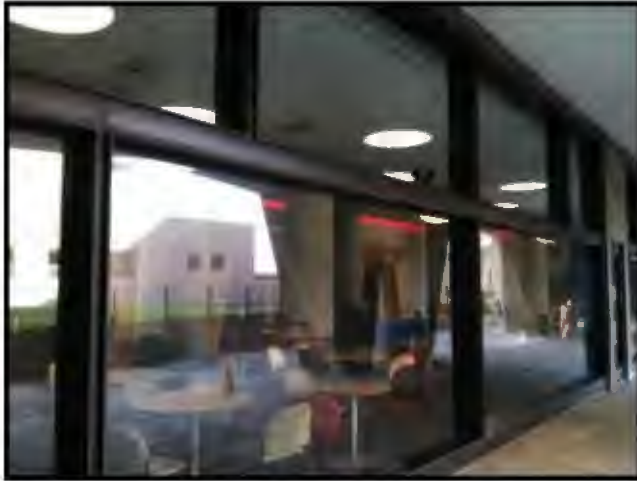
B2011 - Exterior Wall Expansion Joint - Replace

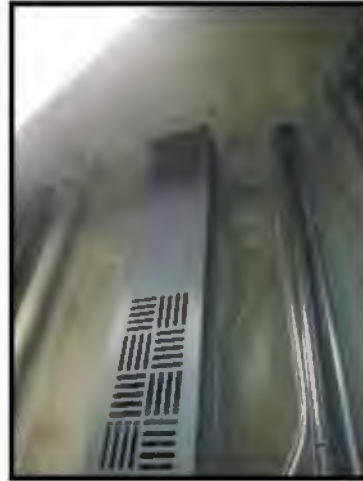
B2023 - Storefront Inserts - Install

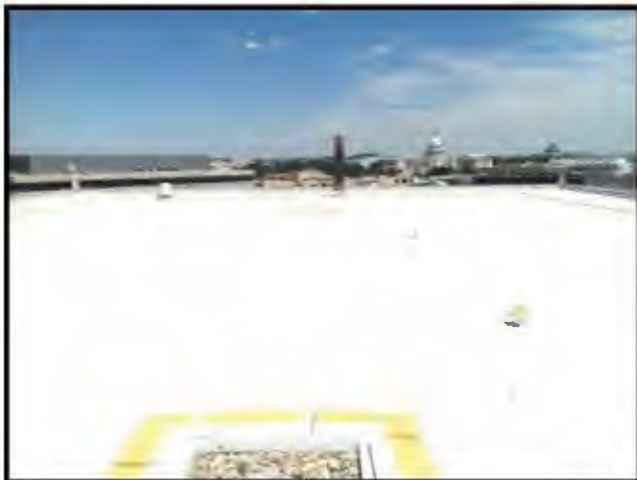
C1011 - Electrical Closet Shaft Opening - Add Rated Separation

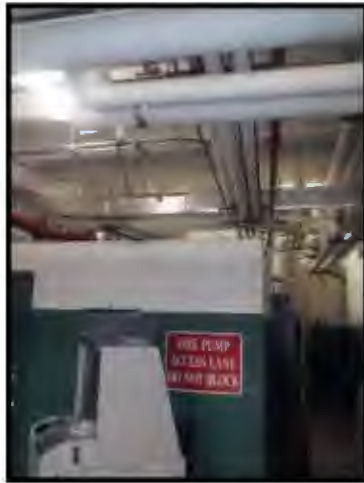
C1011 - Exposed 8 StormSewer Lines in Stairs - Add Rated Separation

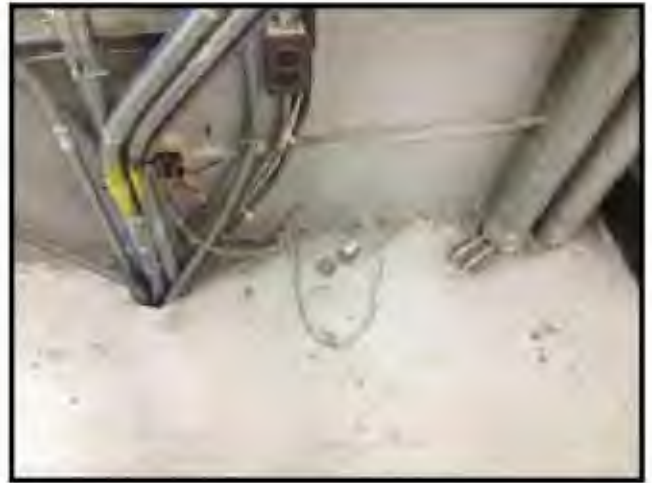
C1011 - Fire Pump Room - Add Rated Separation 1

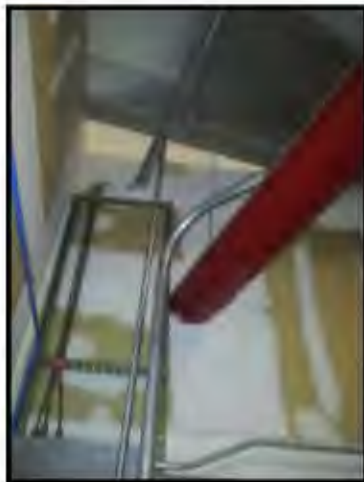
C1011 - Firestopping @ Floor Penetrations - Repair

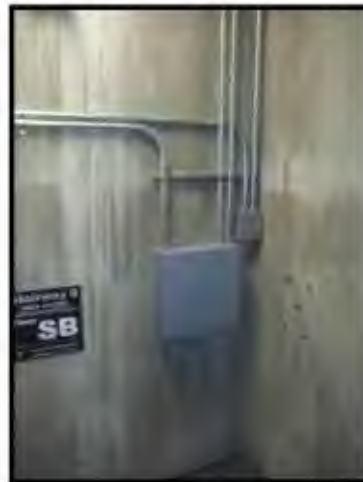
C1011 - Fire Pump Room - Add Rated Separation 2

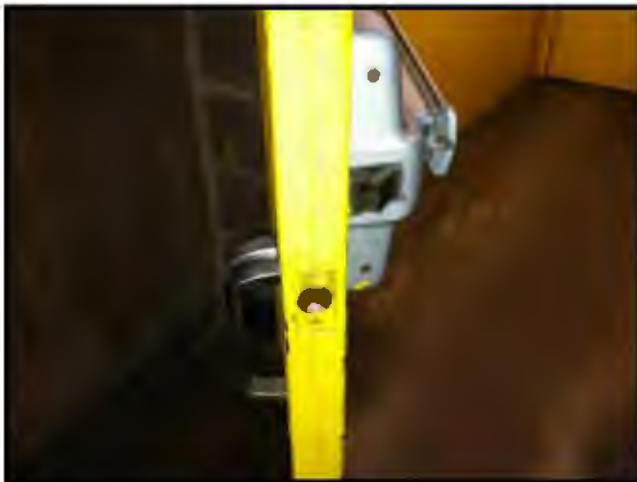
C1023 - Door Hardware - Replace

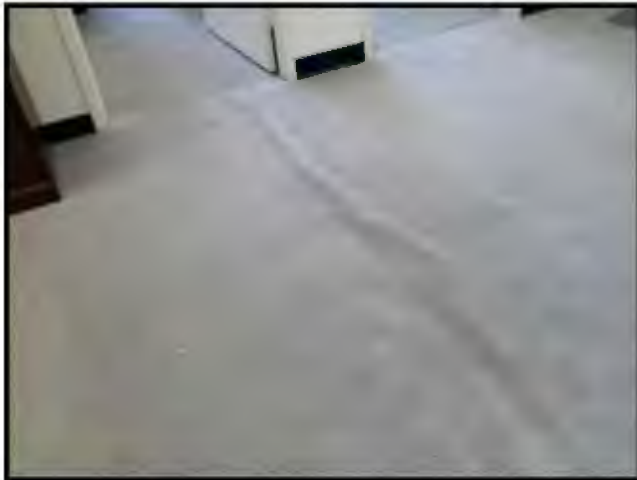
C3025 - Carpet Tile - Replace

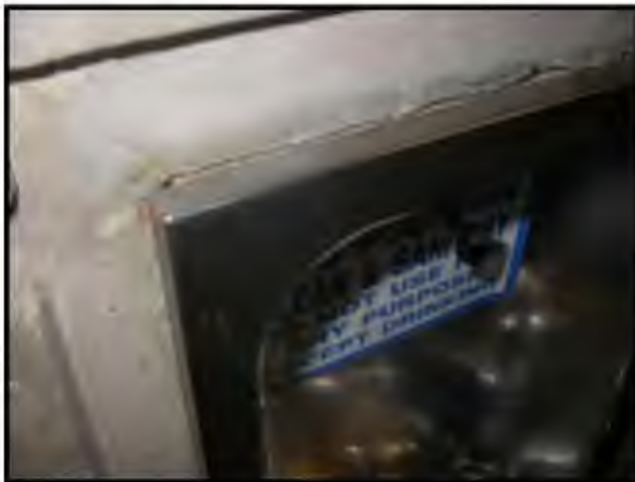
D2020 - Restroom Water Pressurization System - Replace 1

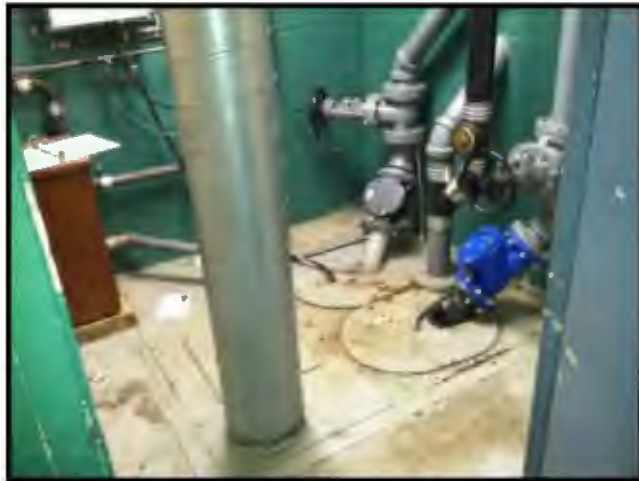
D2020 - Restroom Water Pressurization System - Replace 2

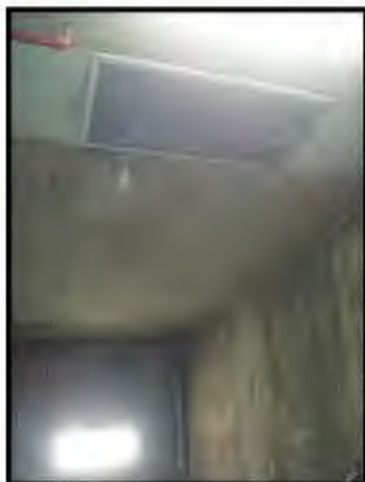
D3042 - Garage Exhaust Ventilation System - Upgrade

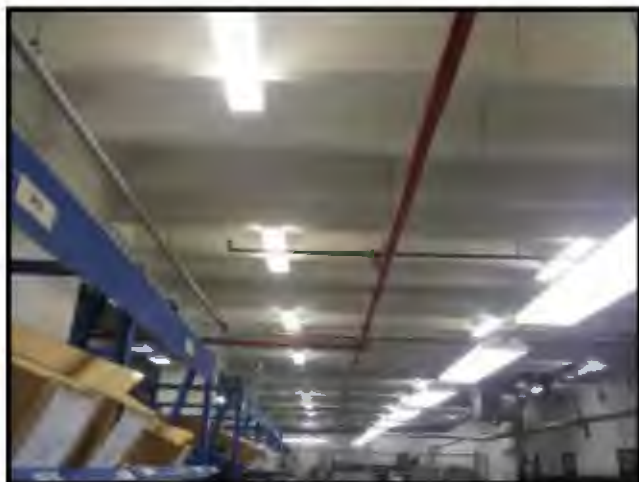
D4010 - Sprinklers - Install

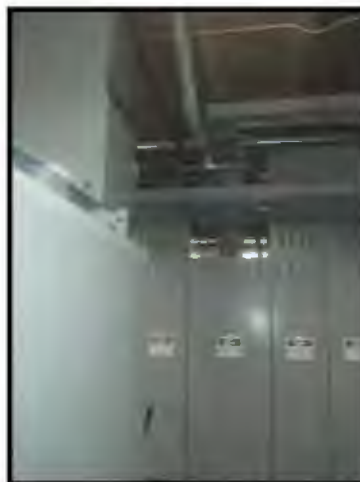
D4010 - Arm Over Sprinkler Supports - Install

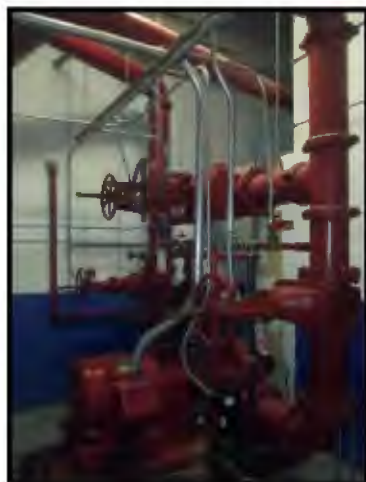
D4010 – Fire Sprinklers Electrical Rooms - Modify

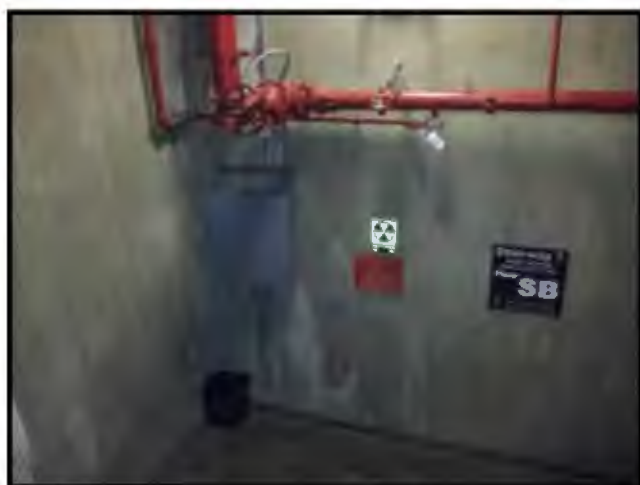
D4095 - Electrical Vault Ducts - Install Dampers

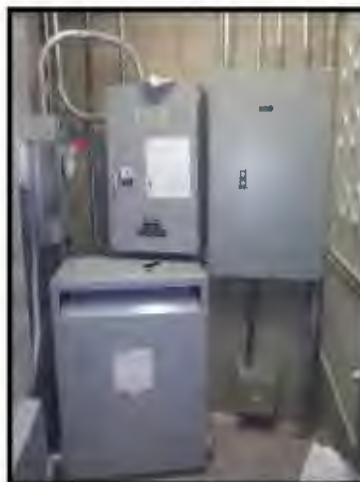
D5012 - Electric Distribution - Add New Power Risers

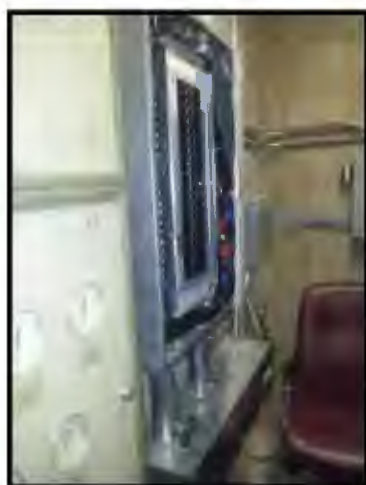
D5012 - Electrical Panels Clearance- Modify

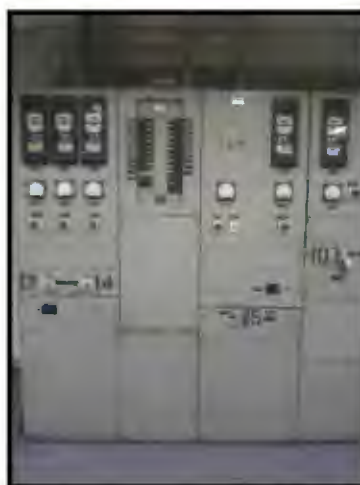
D5012 - Electrical Equipment Covers Missing - Replace

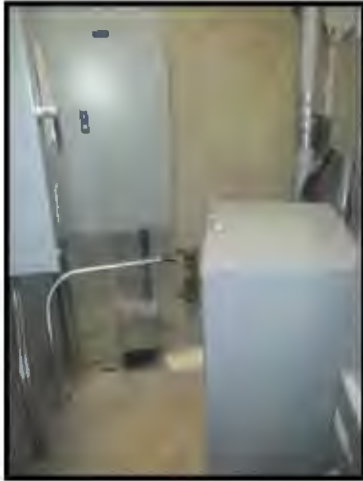
D5012 - Elevator Electrical Switchboard - Replace

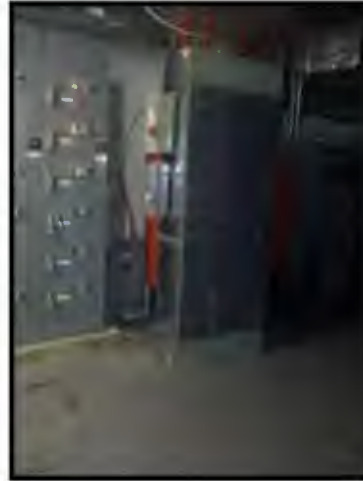
D5012 - Existing Electrical Busduct - Recondition

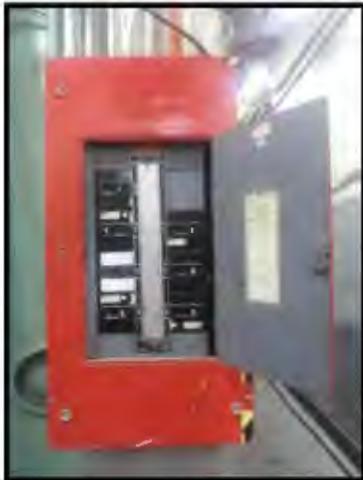
D5012 - Misc Electrical Equipment Motor Control Centers - Replace

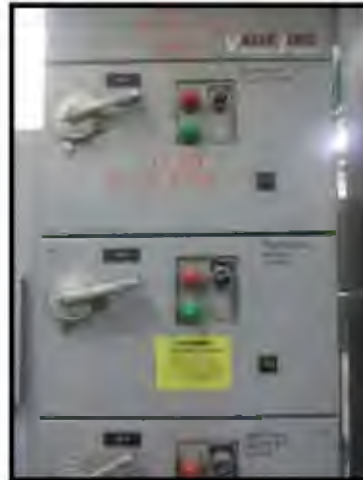
D5012 - Mechanical Room Panels - Replace

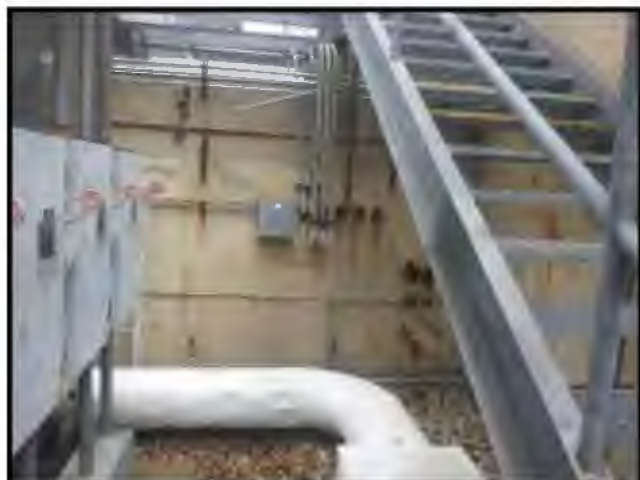
D5012 - Misc Electrical Equipment Motor Control Centers - Replace 2

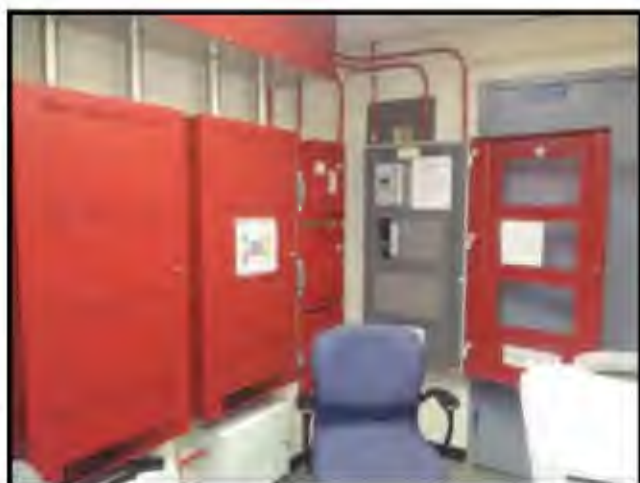
D5037 - Fire Alarm System - Replace 2

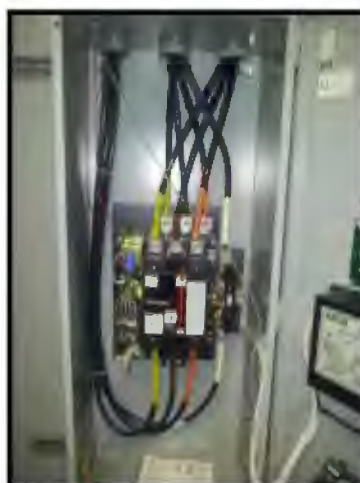
D5037 - Fire Alarm System - Replace 1

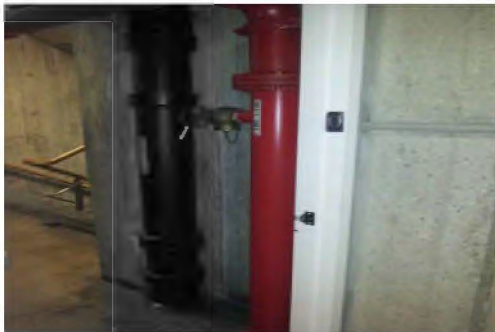
CODE/STANDARD. NFPA 101 (2012); Section 7.1.

C1011 - Exposed 8 StormSewer Lines in Stairs - Add Rated Separation

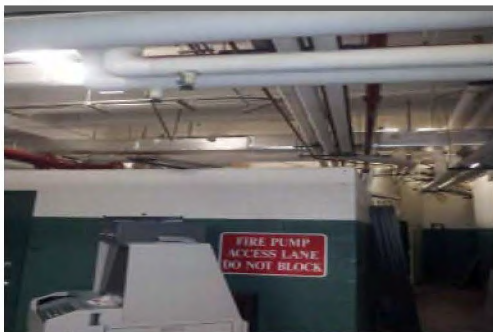
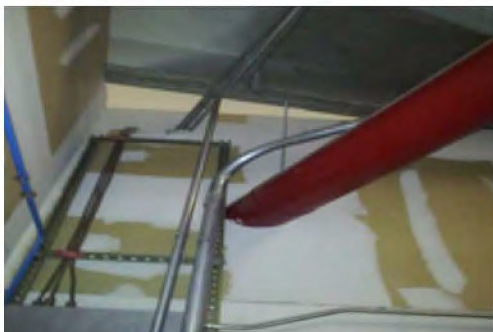
CODE/STANDARD. IBC (2012); Section 913.2.1

C1011 - Fire Pump Room - Add Rated Separation 1

C1011 - Fire Pump Room - Add Rated Separation 2

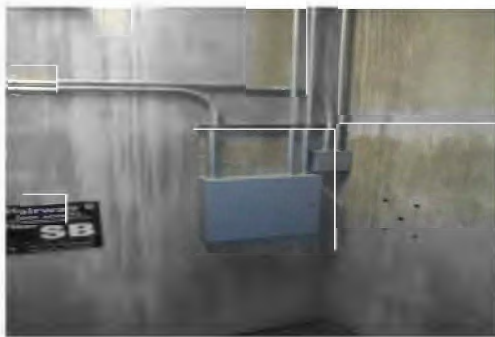
CODE/STANDARD. NFPA 101 (2012); Section 7.2.2.

C1011 - Panels and Conduits Exposed in Stairs - Add Rated Separation

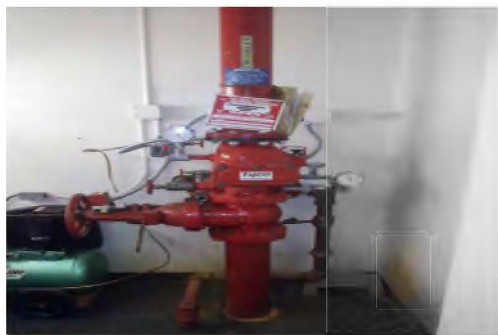
CODE/STANDARD. NFPA 101 (2012); Section 7.1.

C1011 - Standpipes Not Enclosed - Add Rated Separation

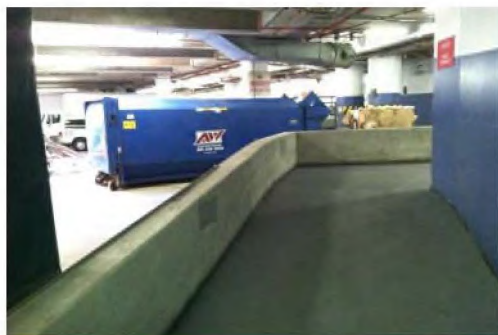
CODE/REGULATION. National Fire Protection Association (NFPA), 2012 - 101. Life Safety Code. 7.2.2.4.4 Handrail Details.

C2010 - Loading Dock Handrails - Provide Guards

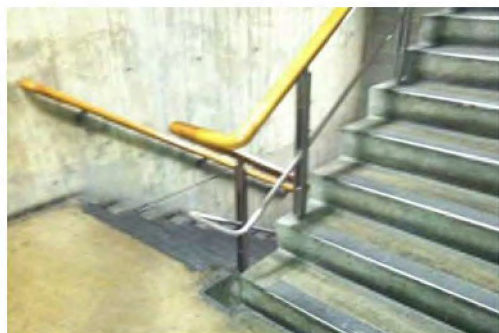
CODE/REGULATION. National Fire Protection Association (NFPA), 2012 - 101, Life Safety Code. 7.2.2.4.4 Handrail Details.

C2014 - Stair Guards and Handrails - Replace

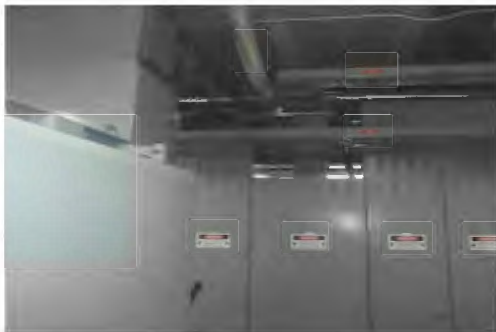
CODE/REGULATION. National Fire Protection Association, NFPA 13 Standard for the Installation of Sprinkler Systems and NFPA 70 National Electrical Code.

D4010 – Fire Sprinklers Electrical Rooms - Modify

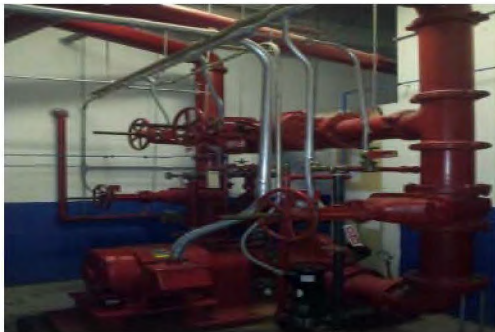
CODE/STANDARD. NFPA 20 Section 11.2.6.2

D4011 - Sprinkler Water Supply - Increase size of supply

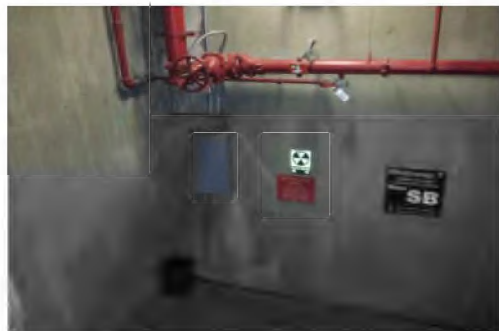
CODE/STANDARD: NFPA 101 Section 9.7.4.2

D4024 - Fire Hose Valve - Install

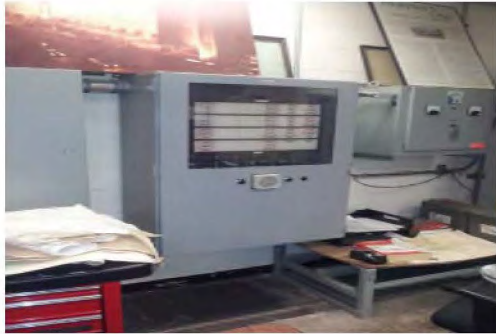
D5037 - Fire Alarm System - Replace 2

CONDITION/PROBLEM. The fire alarm system needs replacement (other than the EST3 which was replaced two years ago) due to the following reasons: older style strobes are located throughout the building; there is insufficient strobe coverage throughout the building (i.e., lack of strobes in copy rooms, workrooms, and conference rooms, overspacing in bathrooms, corridors and open offices, etc.); strobes are located above 80" in many locations throughout the building; older style conventional system that is no longer manufactured; no smoke detectors are provided in any of the mechanical, electrical, or telephone rooms/closets; the pull stations at the central stairs are located at 62" – well above the maximum height; the duct smoke detectors are not working; the garage dry sprinkler system is not currently monitored; the penthouse only has two bells – one of which is damaged.

CAUSE. Revisions to code requirements since original design, construction and obsolescence of equipment.

Action Name	Replace the fire alarm system
Option	Conventional
Prime Action	Yes
Description	REMEDY. Replace the fire alarm system.

IMPLEMENTATION. Replace the fire alarm system with a new integrated code compliant fire alarm system. Replace all initiating and alarm devices. Install additional initiating and alarm devices where required by the latest code. Provide fireman's telephones throughout the building in the stairs and elevator lobbies. Provide speakers throughout the building for audibility/intelligibility purposes. Provide strobe alarm devices in all common areas and in mechanical areas with ambient noise levels above 85 dBA. Coordinate the fire alarm device locations and installation with surrounding electrical, mechanical and plumbing systems.
